33RD RCI INTERNATIONAL CONVENTION & TRADE SHOW

Avoiding Condensation in Low-Slope Roofing Assemblies

Case Study

San Francisco Apartment

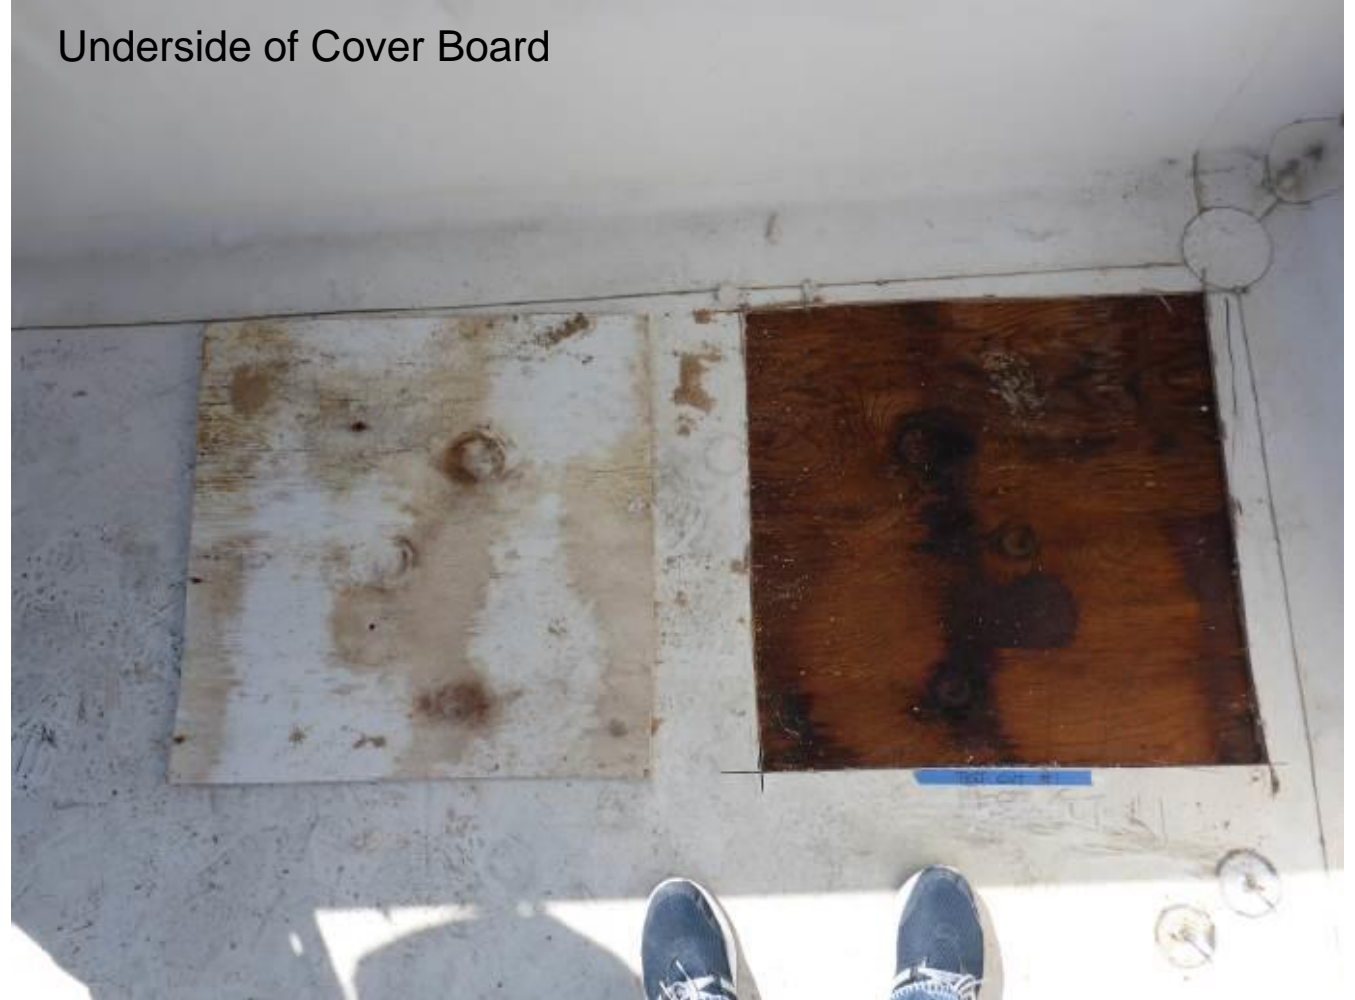
Underside of Cover Board

Nail Pull Thru Testing:
5/8" Moderate Damage
Avg. 495 lb.

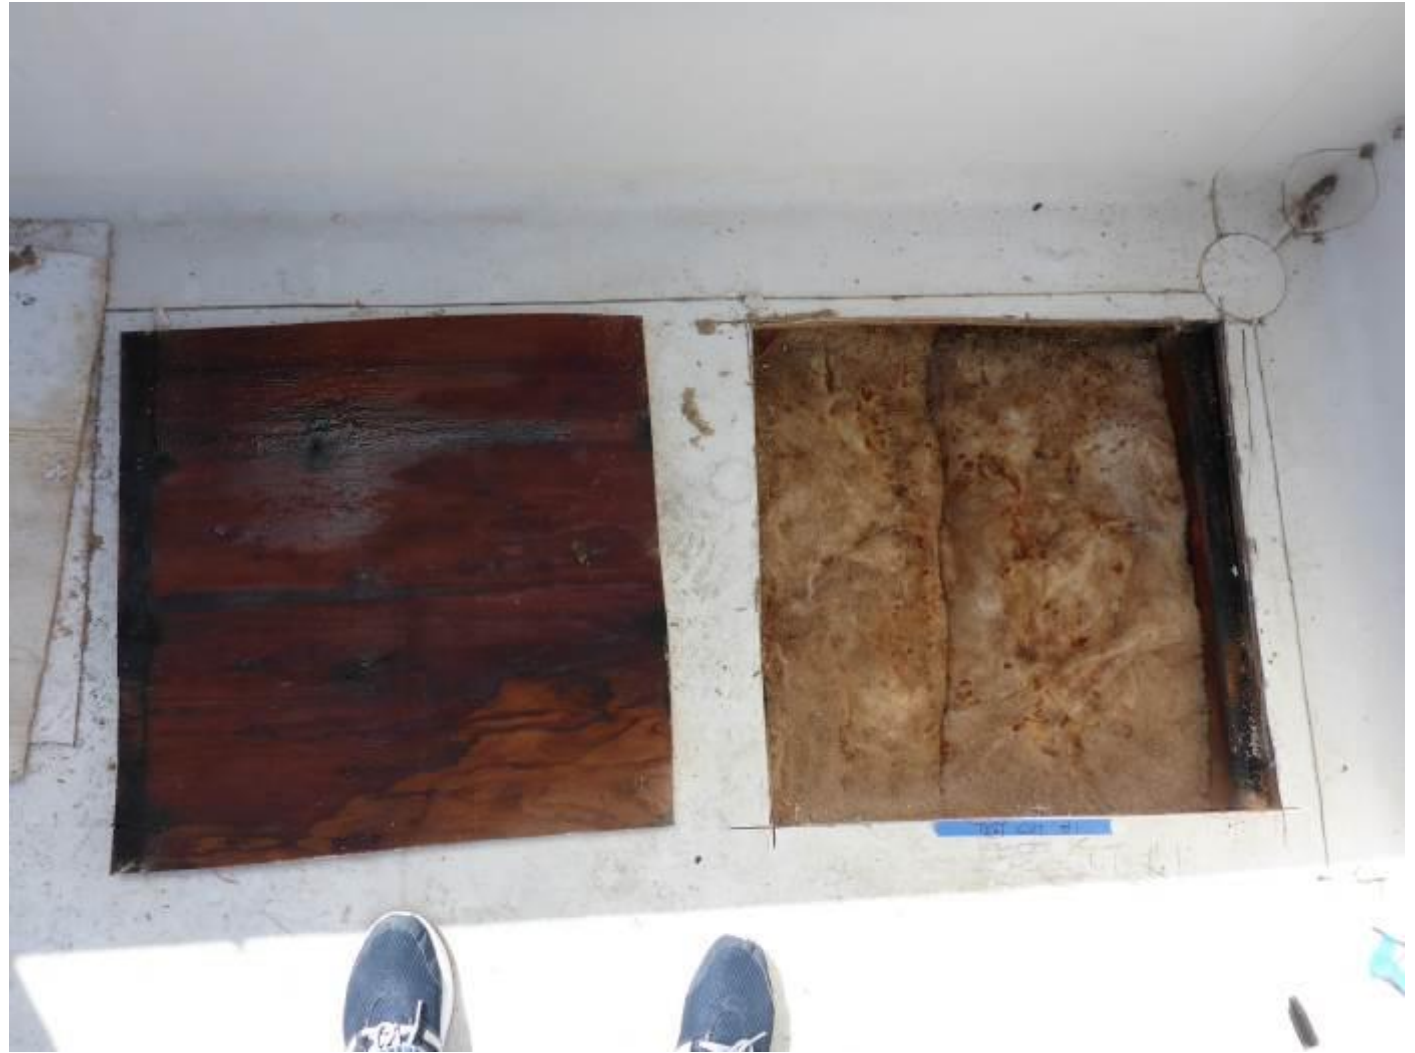
Damage at Plywood Cricket, Framing & Batt

Calibration Test Cut #1a,
Damage Level Severe
(condensation related)

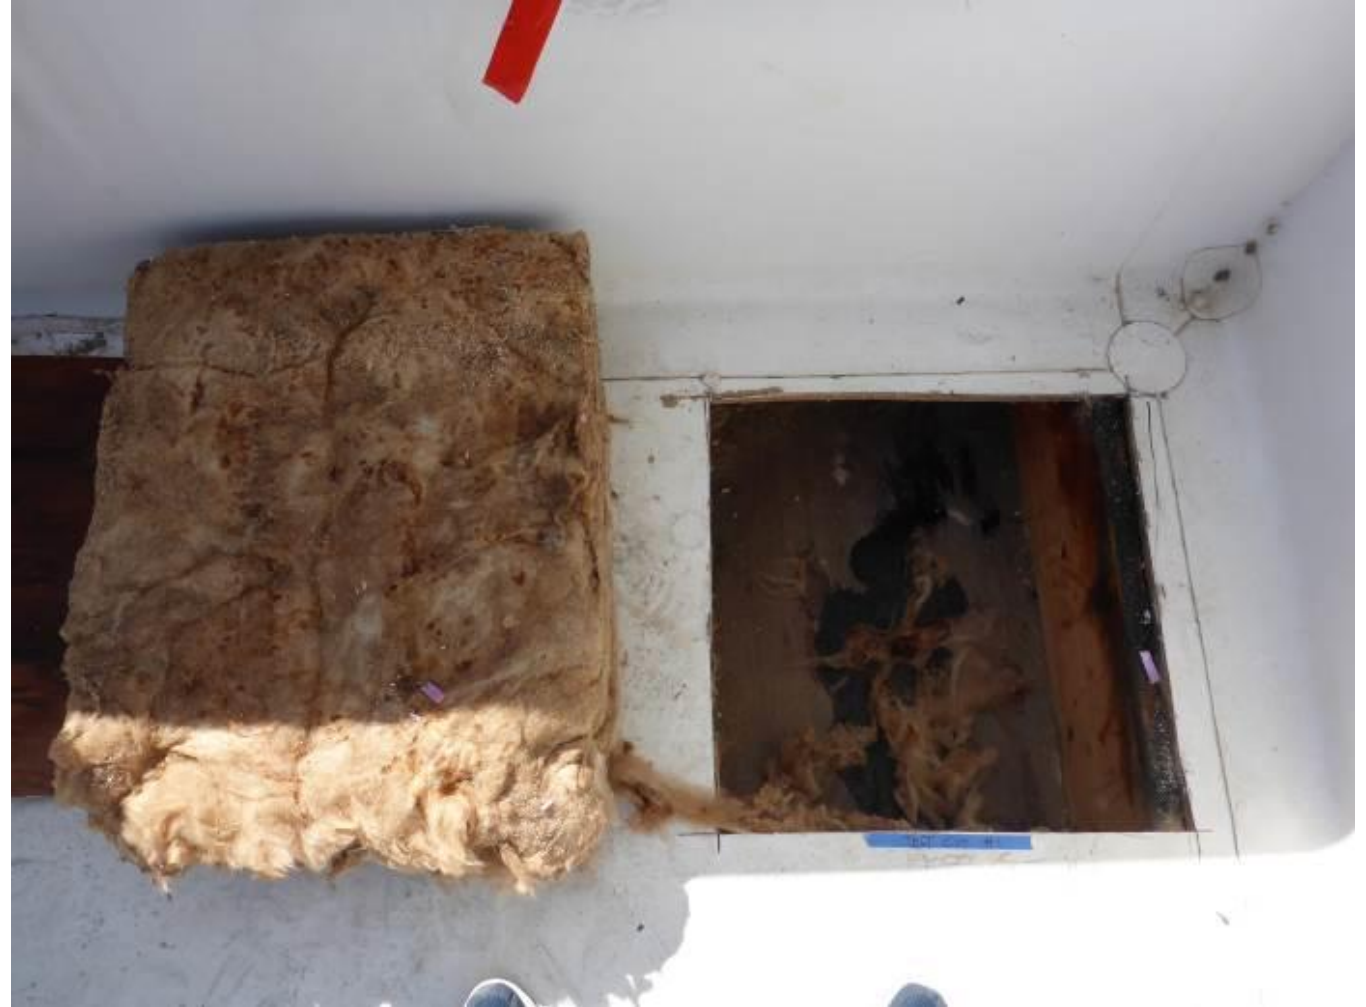
Damage within Cricket Cavity

Calibration Test Cut #1a,
Damage Level Severe
(condensation related)

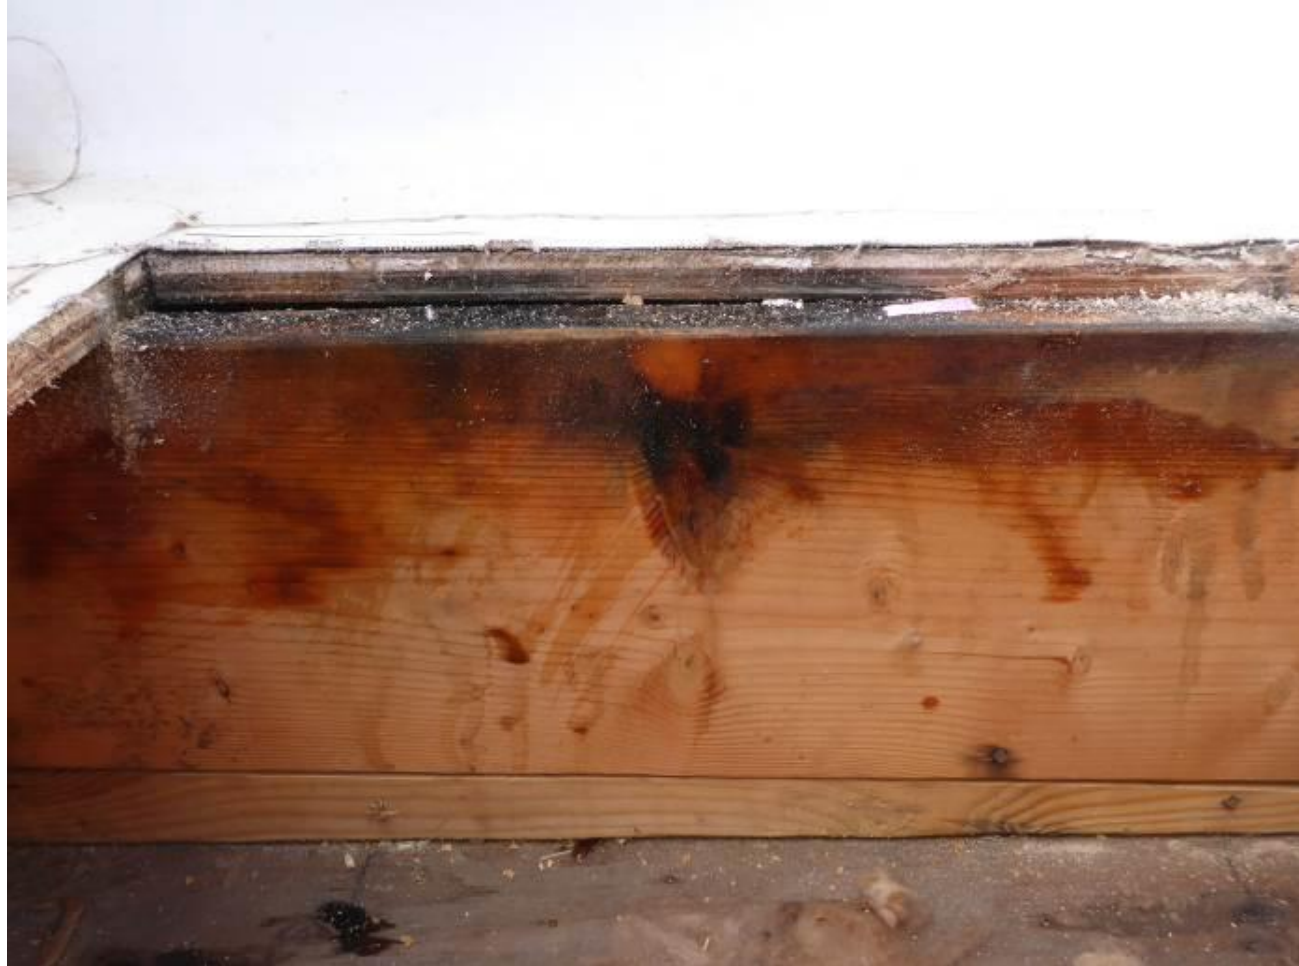
Damage on Cricket Framing

Calibration Test Cut #1a,
Damage Level Severe
(condensation related)

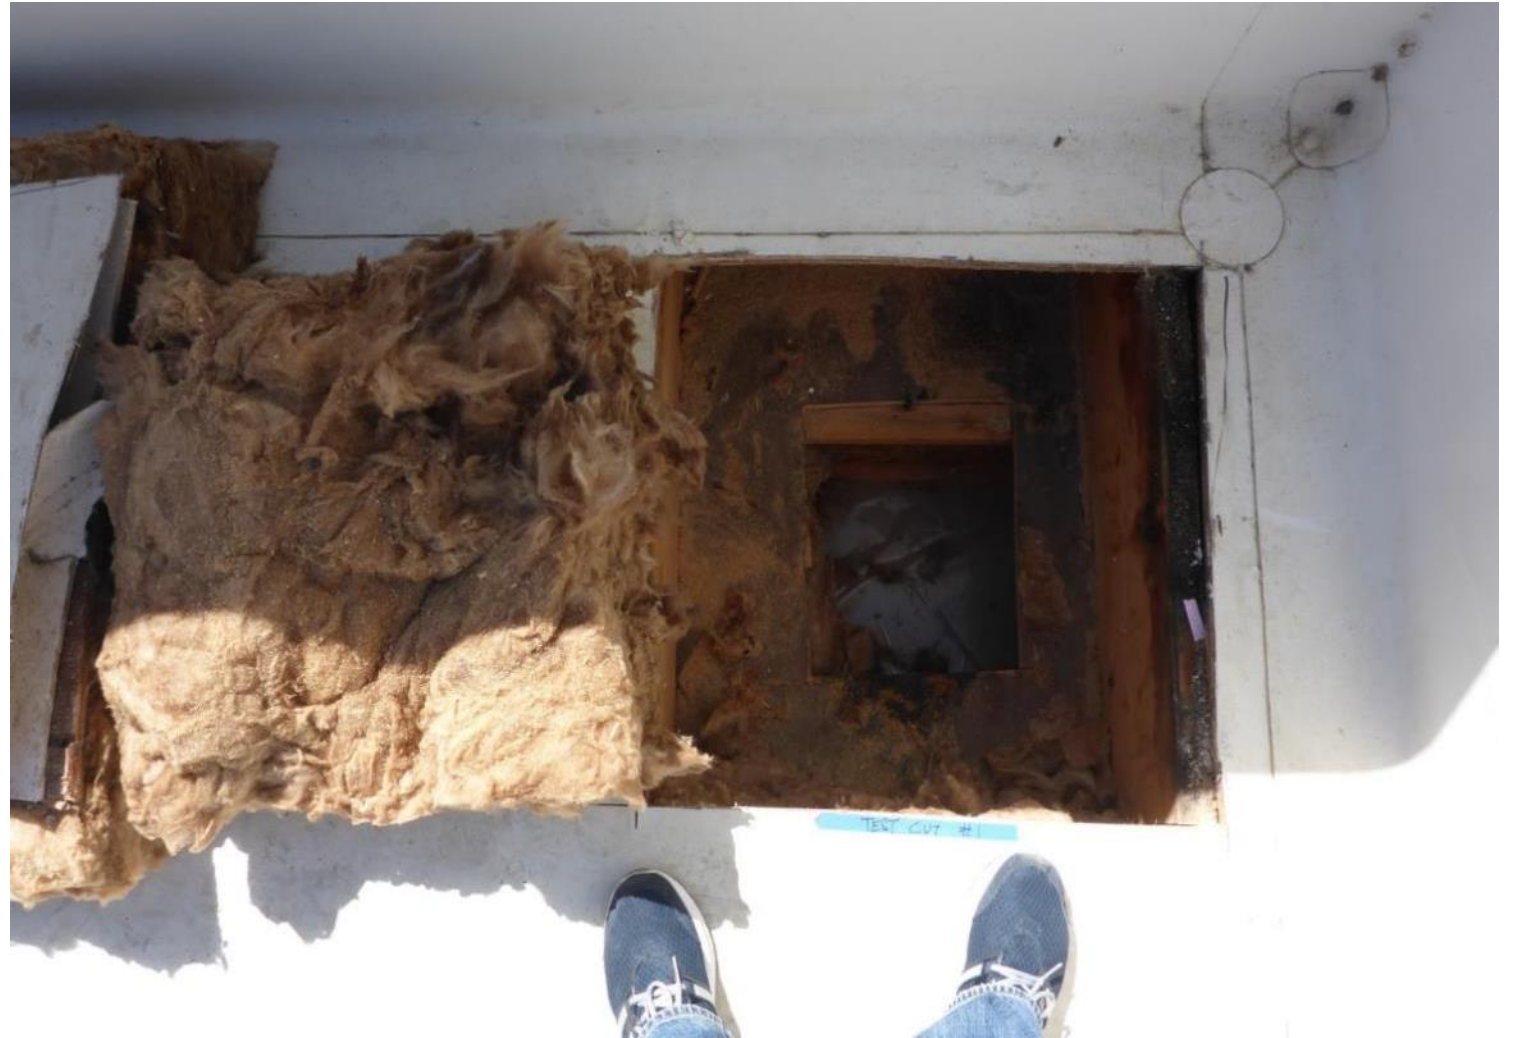
Calibration Test Cut #1a

Stained Insulation Batt in Roof Cavity

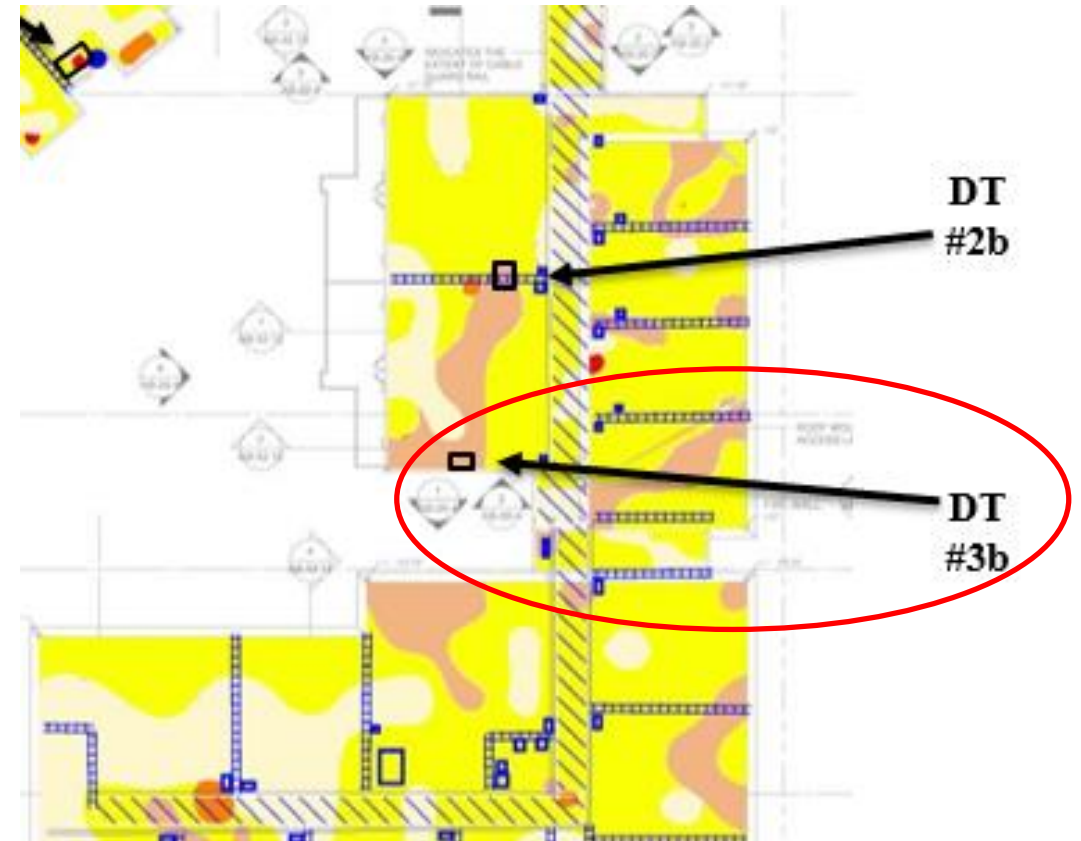
Destructive Test Cut #3b

- Test Cut Location: Level 5 Roof Area, Roof to parapet wall
- Test cut exhibiting severe damage from vapor intrusion, and had a moderate nuclear gauge reading.

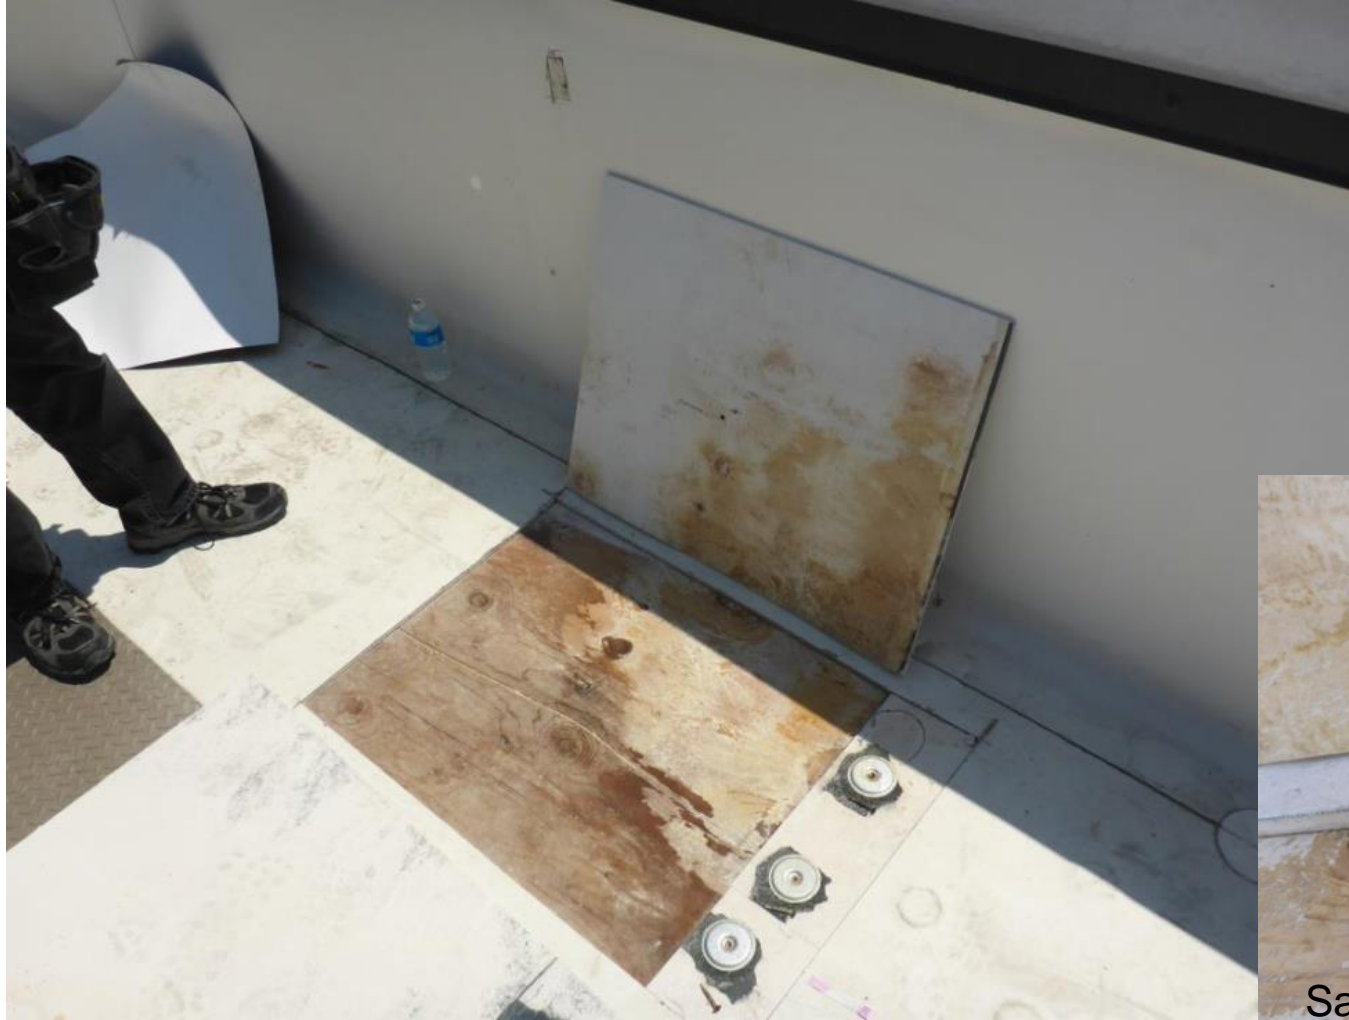
Damaged Plywood Cricket and Cover Board

Test Cut #3b, Damage Level
900 (condensation related)

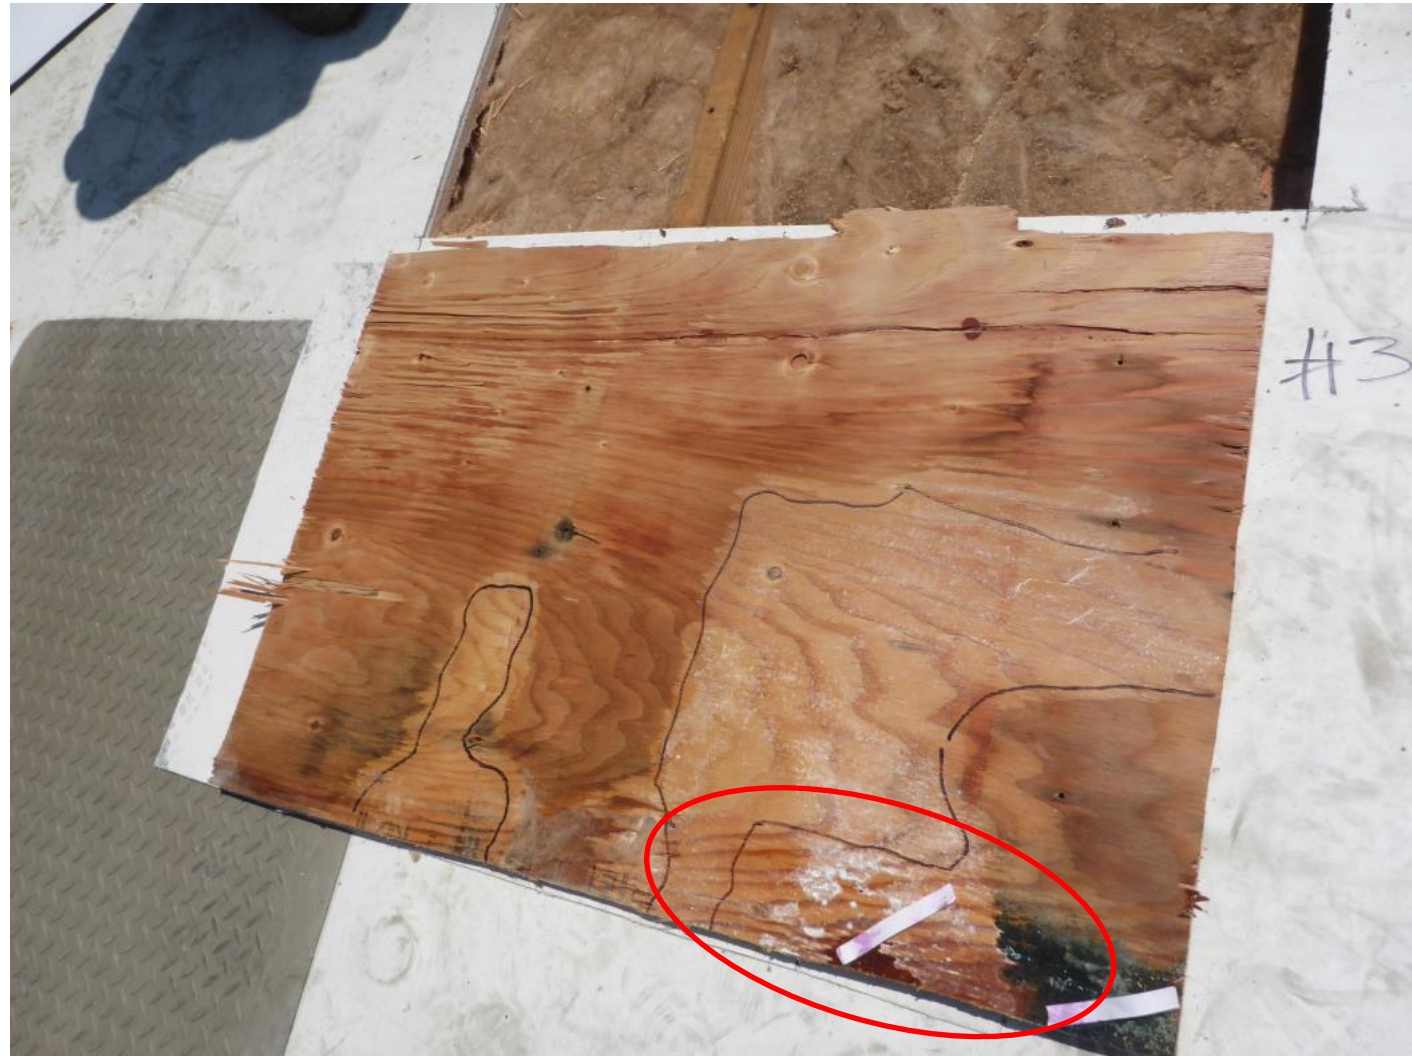
Destructive Test
Cut #3b

Damage on Backside of Plywood Cricket

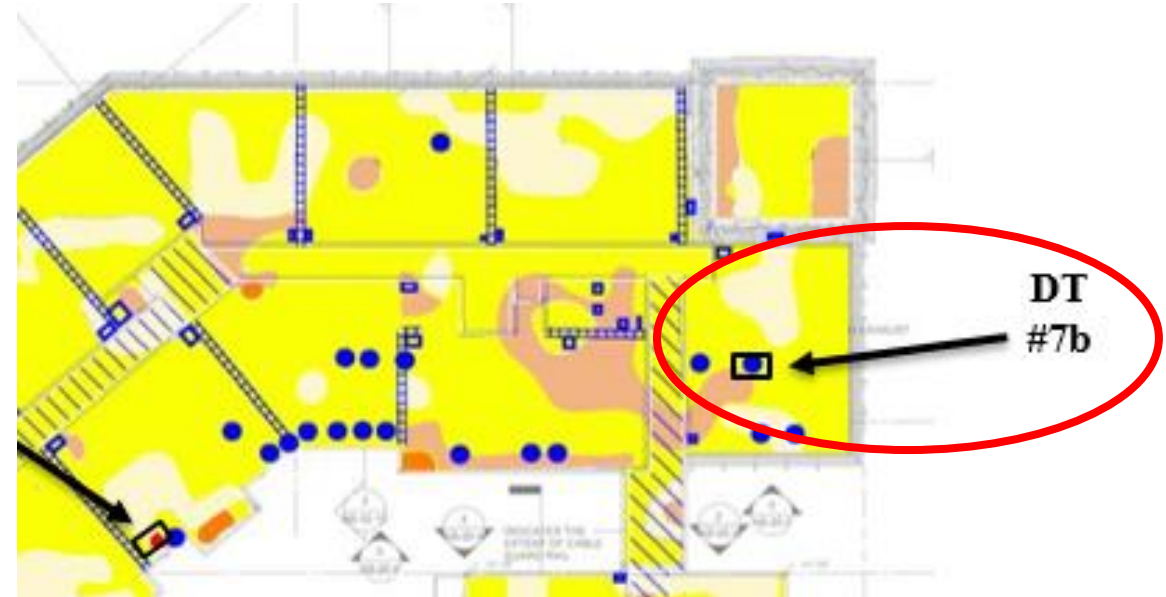
Destructive Test Cut #7b

- Test Cut Location: Level 5 Roof Area, Adjacent to roof drains
- Test cut exhibiting severe condensation damage, noted soft spot, had a low Troxler reading, and had high Tramex moisture content levels.

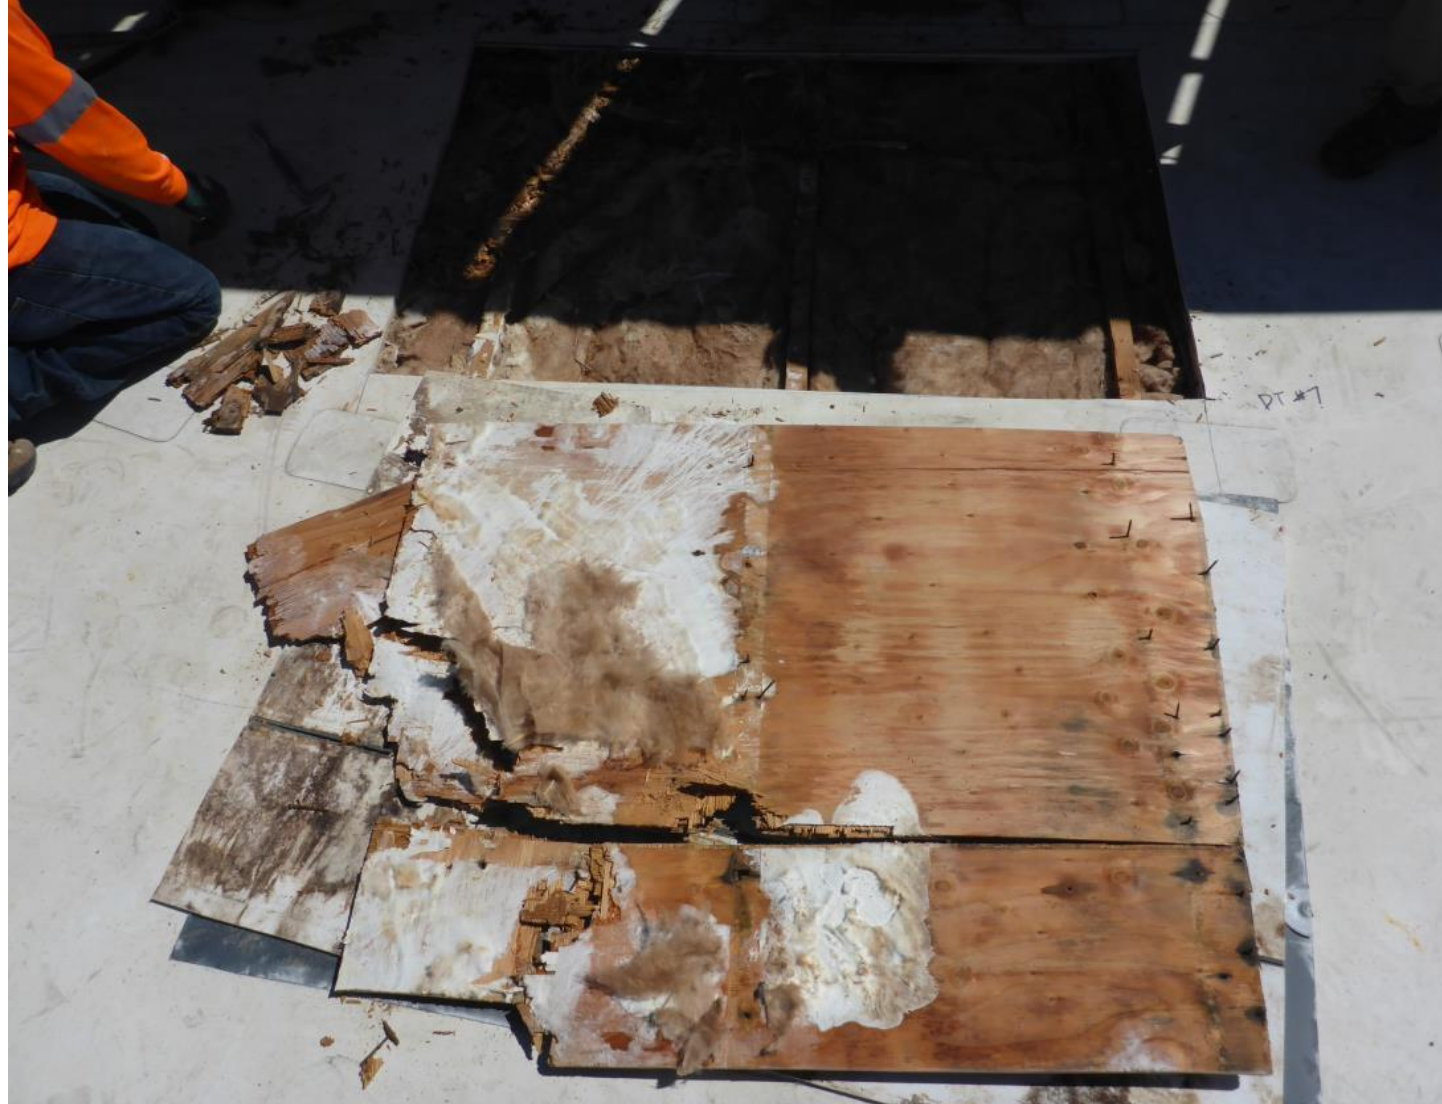
Destructive Test Cut #7b

Plywood Cricket Wood Rot and Organic Growth

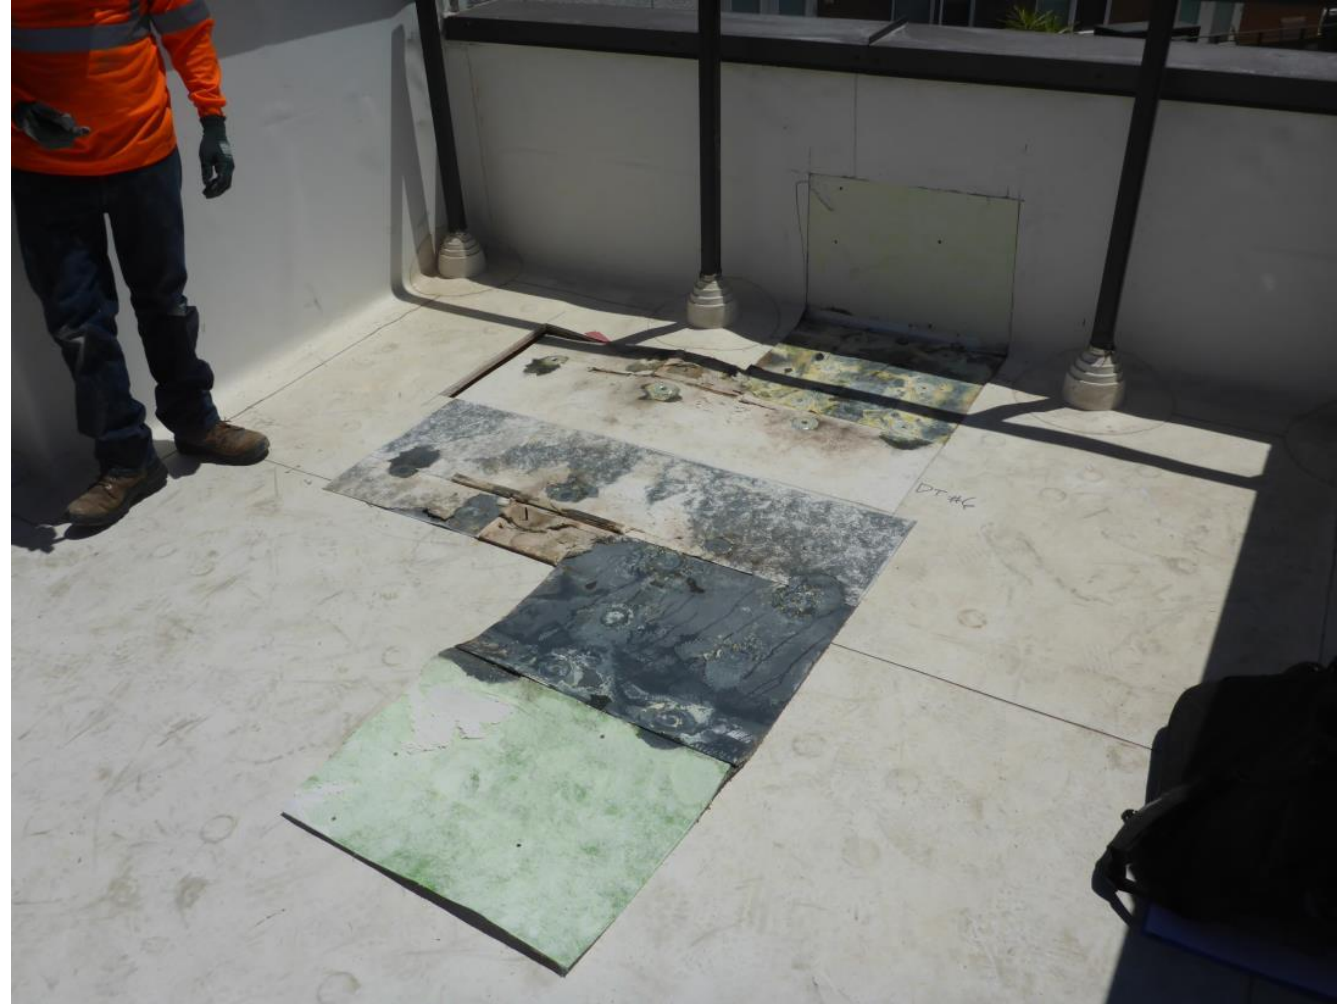
Destructive Test Cut #6b

Moisture Between Membrane and Cover Board

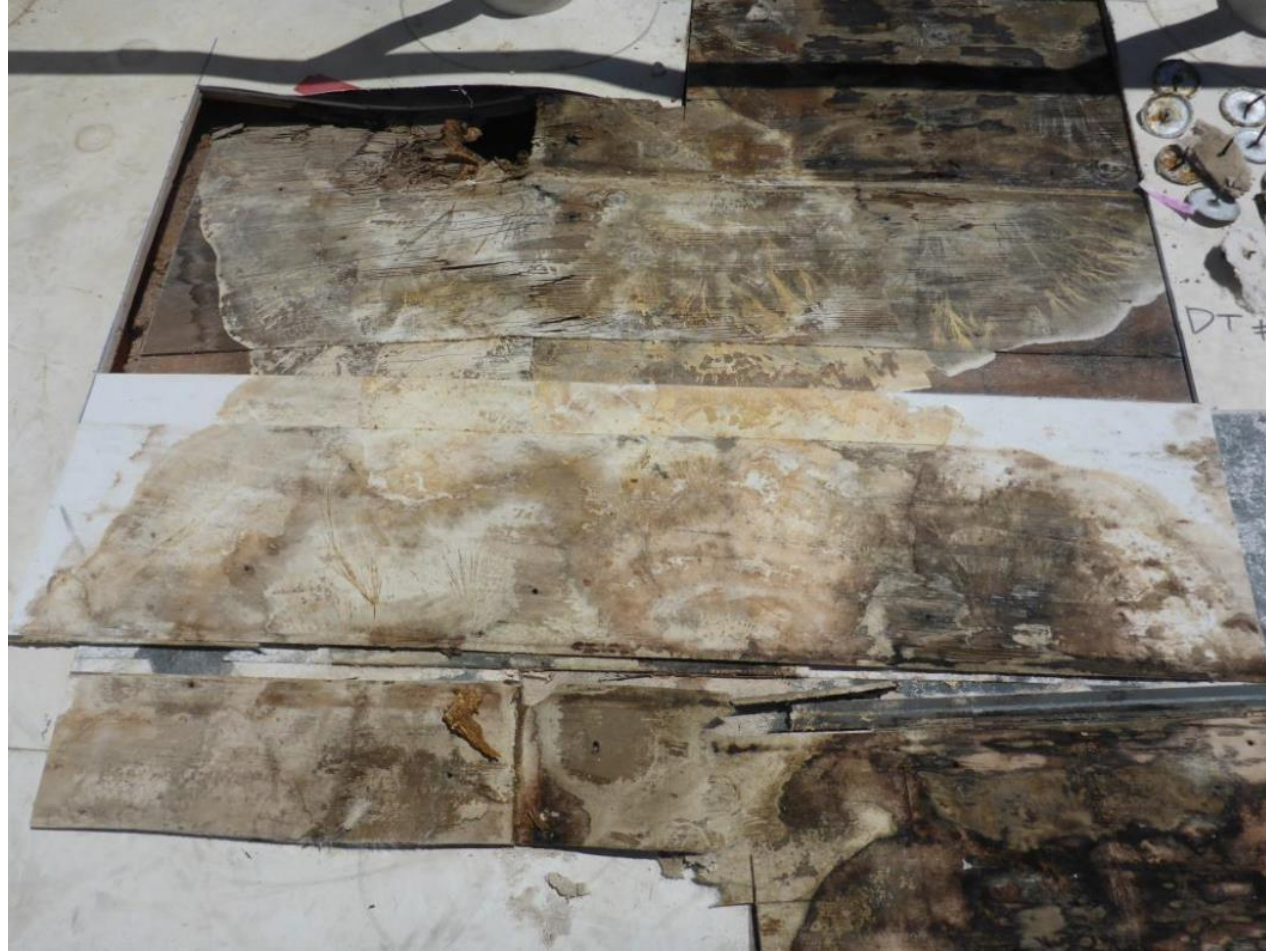
Plywood Cricket Wood Rot and Organic Growth

Destructive Test Cut #6b, Damage level 900 (condensation related)

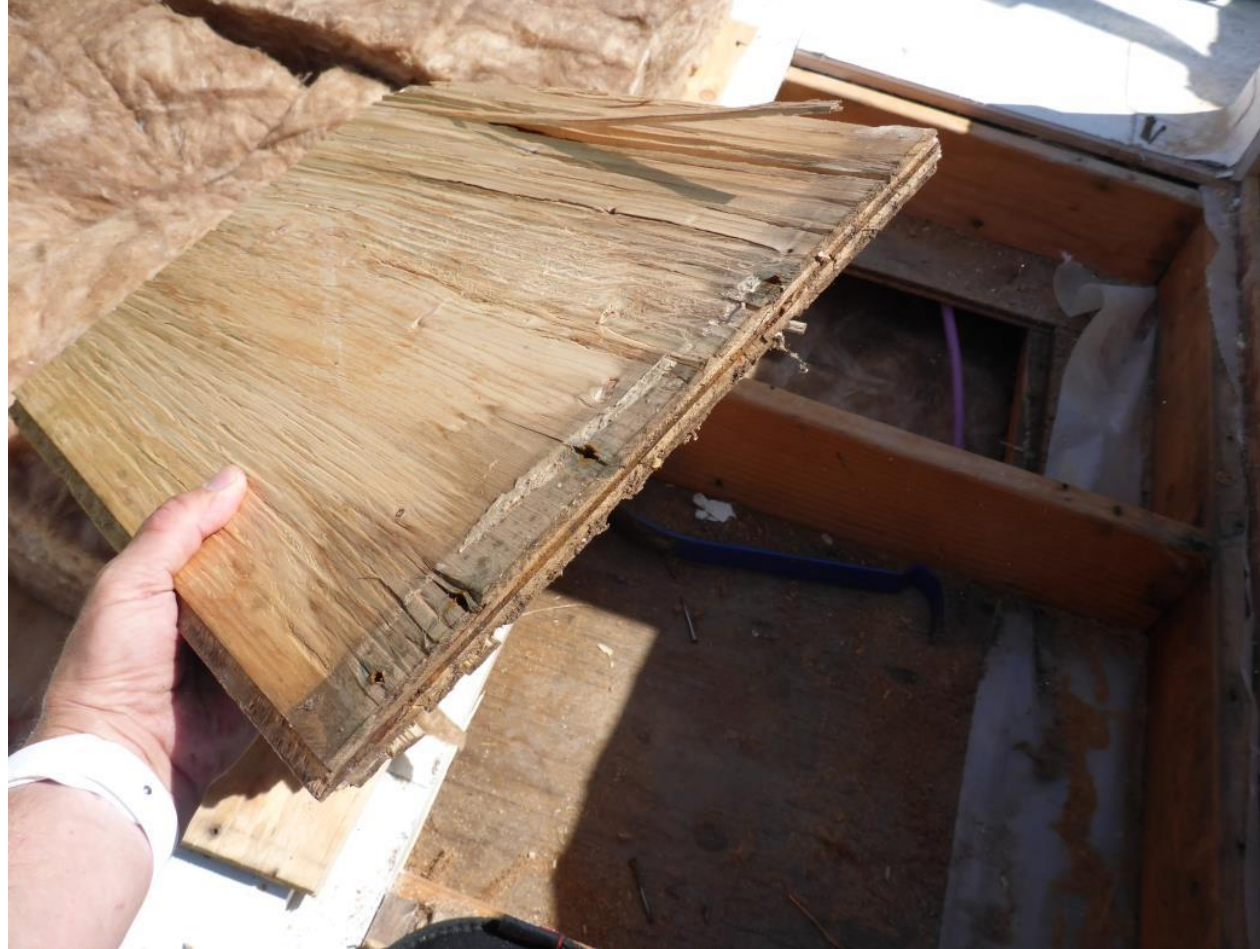
Damage Underneath the Plywood Deck Edge

Water Damage Due to Rain
