33RD RCI INTERNATIONAL CONVENTION & TRADE SHOW

Avoiding Condensation in Low-Slope Roofing Assemblies

Case Study

San Francisco Apartment

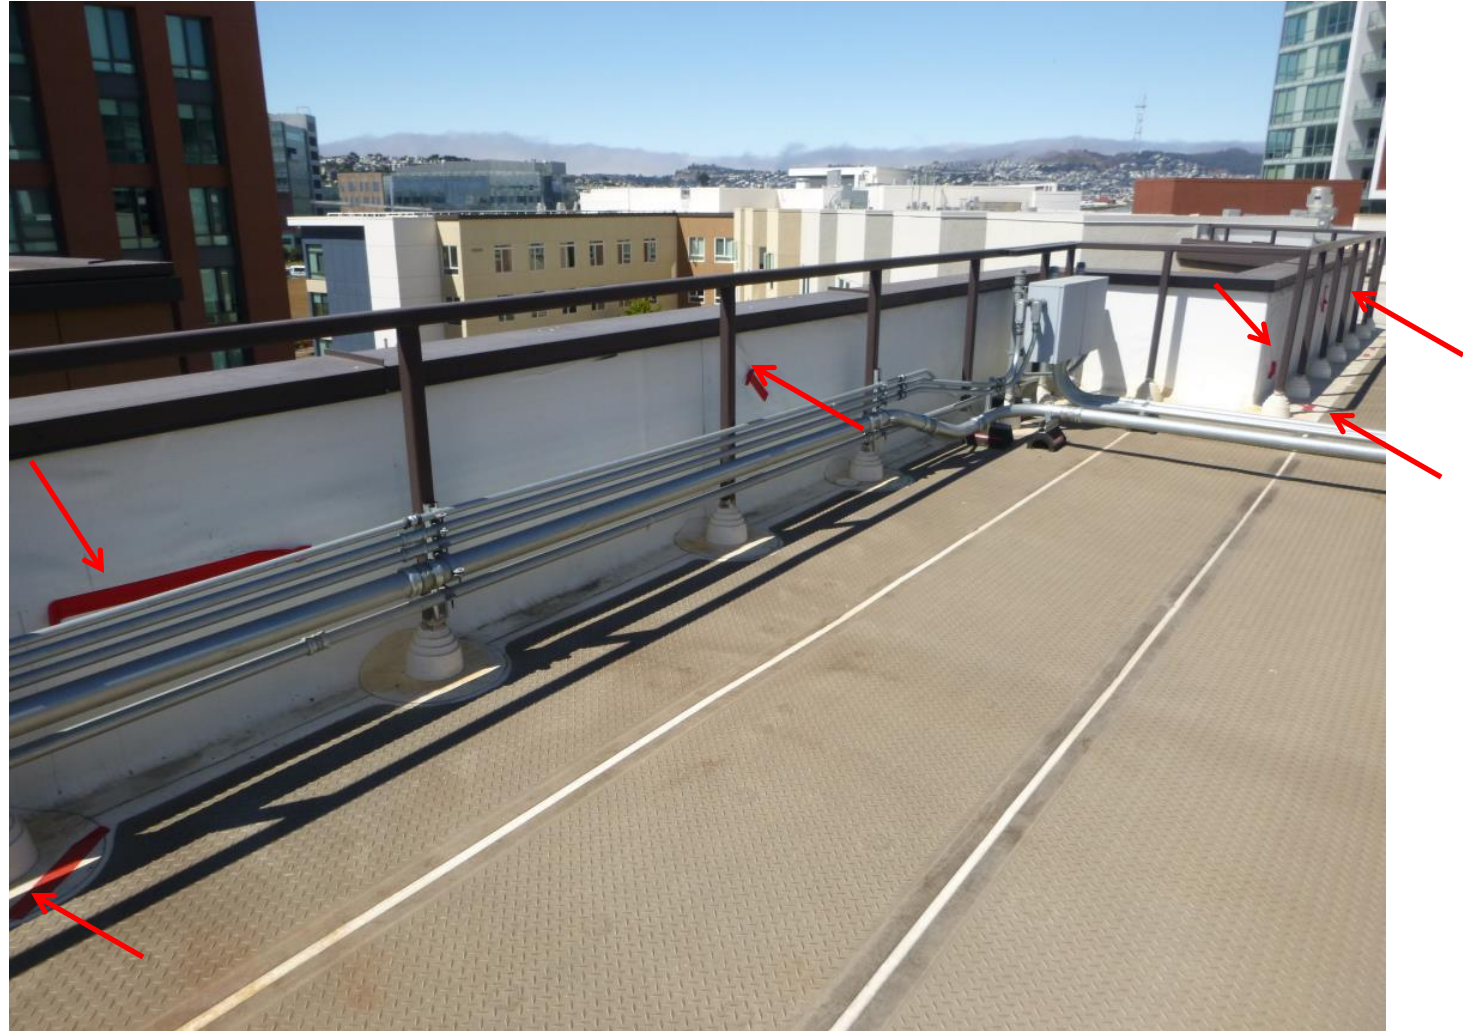
“Soft” Parapet Wall and Base Flashing Locations

Level 5 Roof
Area

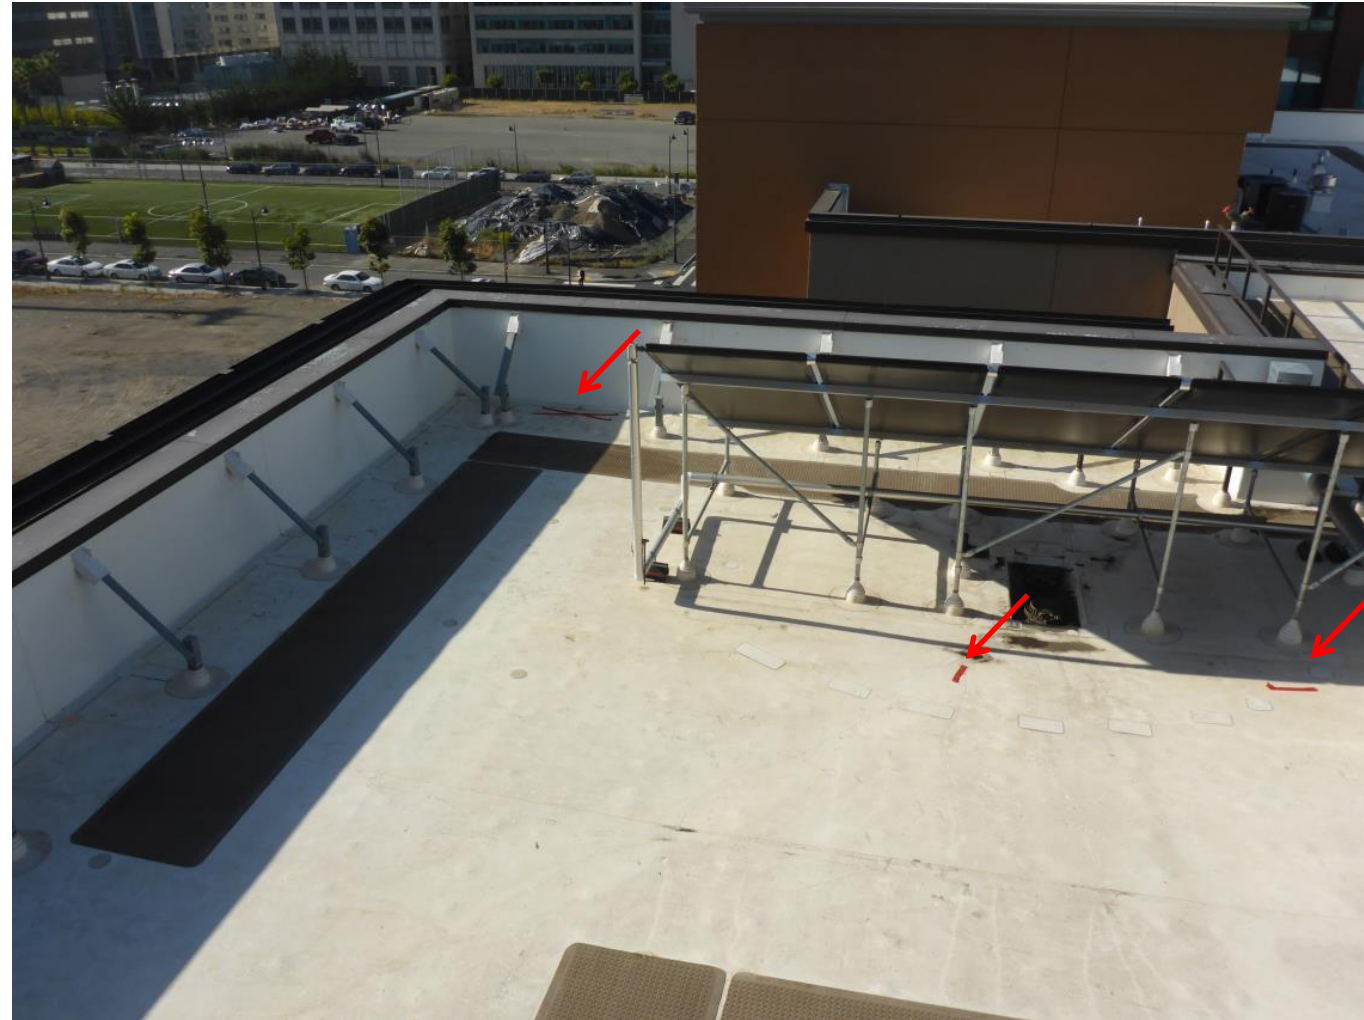
“Soft” Roofing Locations In Field of Roof

Adjacent to solar
pipe stanchions
and other pipe
penetrations

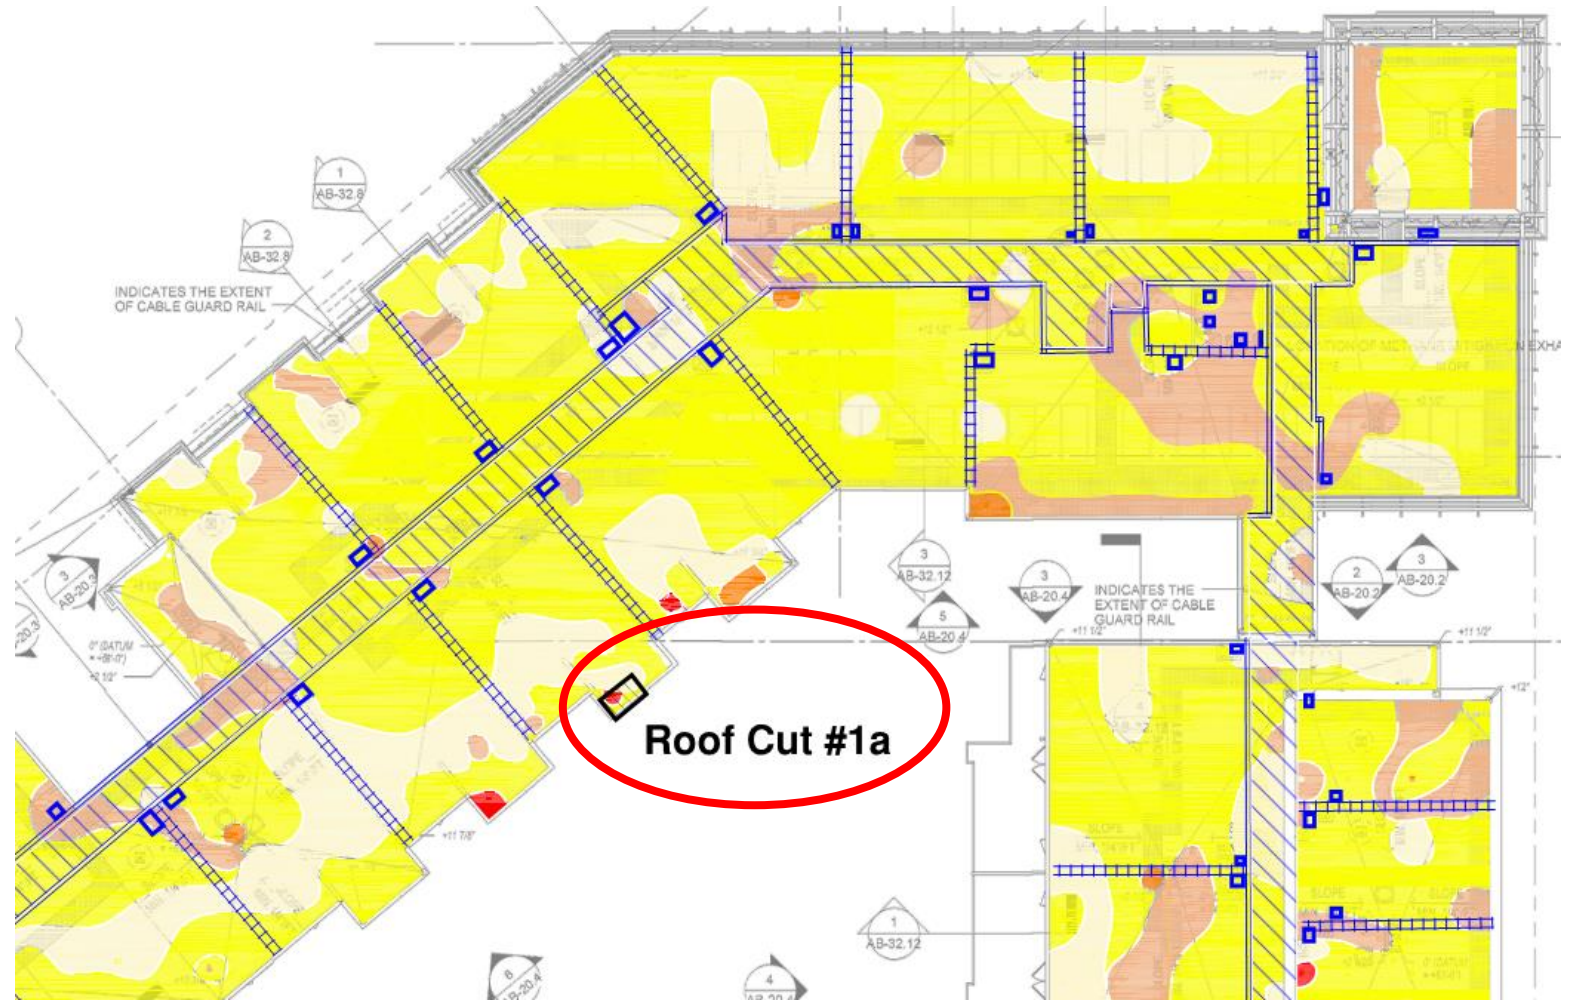
Calibration Test Cut #1a

Level 5 Roof Area

Test cut exhibiting damage from vapor intrusion, high nuclear gauge moisture content levels.

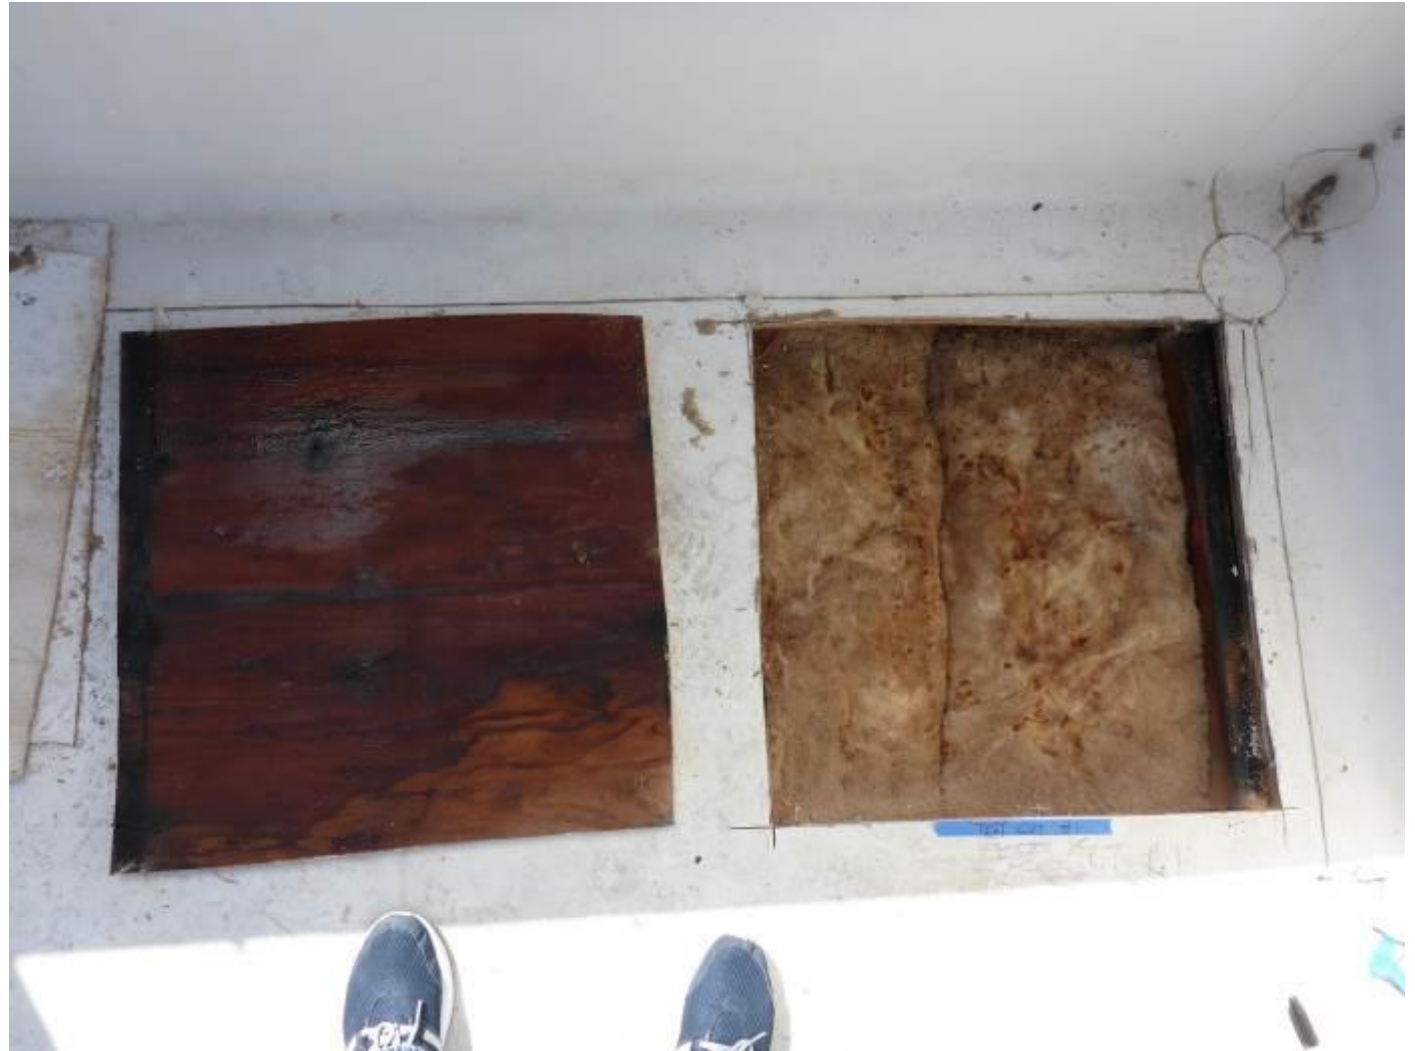
Damage at Plywood Cricket, Framing & Batt

Calibration Test Cut #1a,
Damage Level Severe
(condensation related)

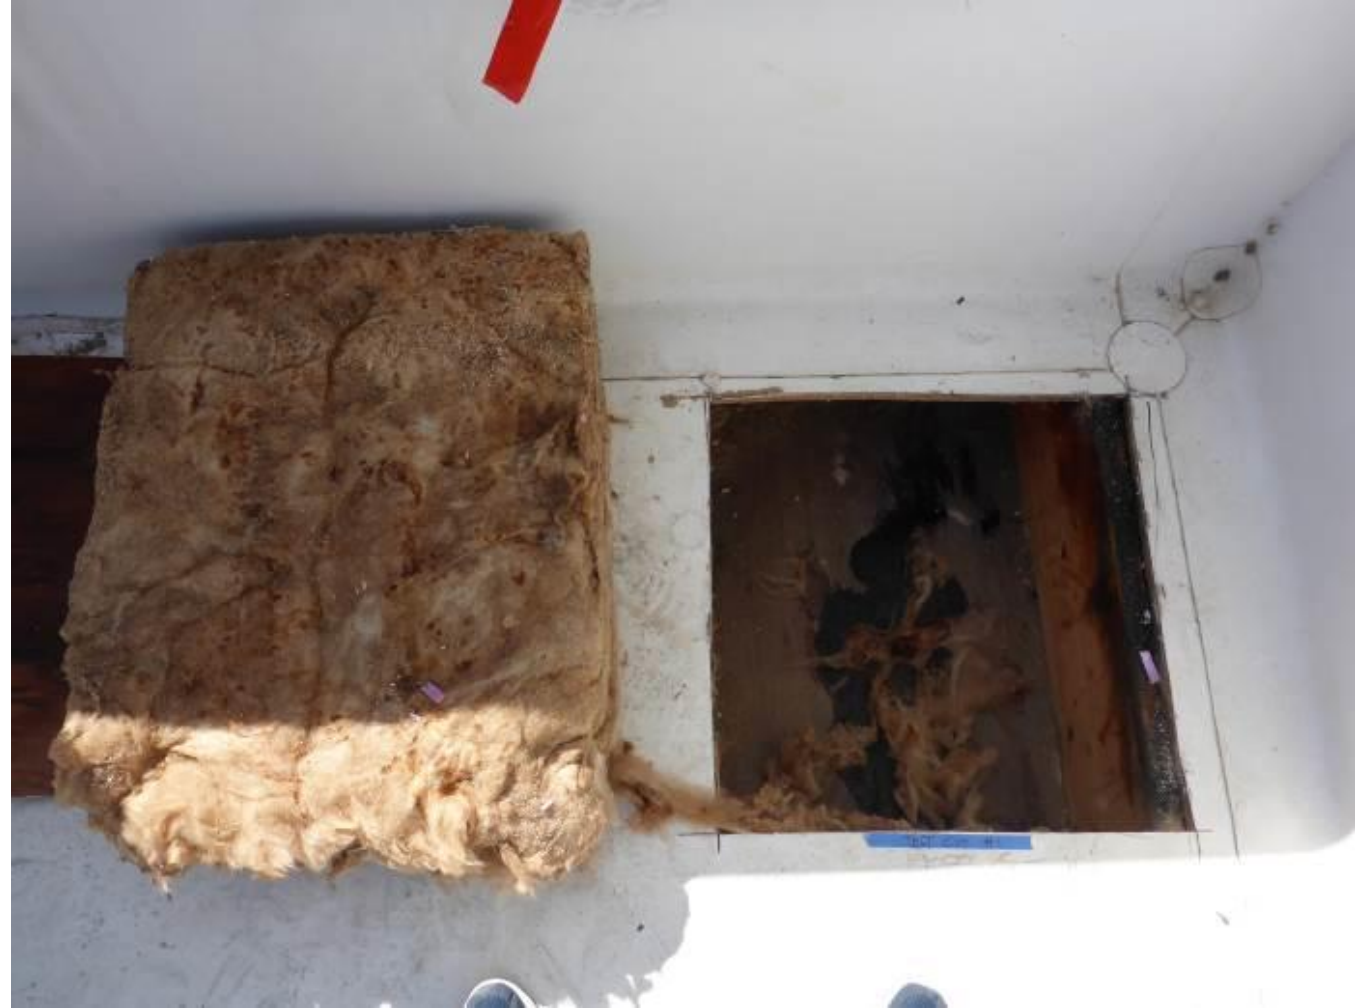
Damage within Cricket Cavity

Calibration Test Cut #1a,
Damage Level Severe
(condensation related)

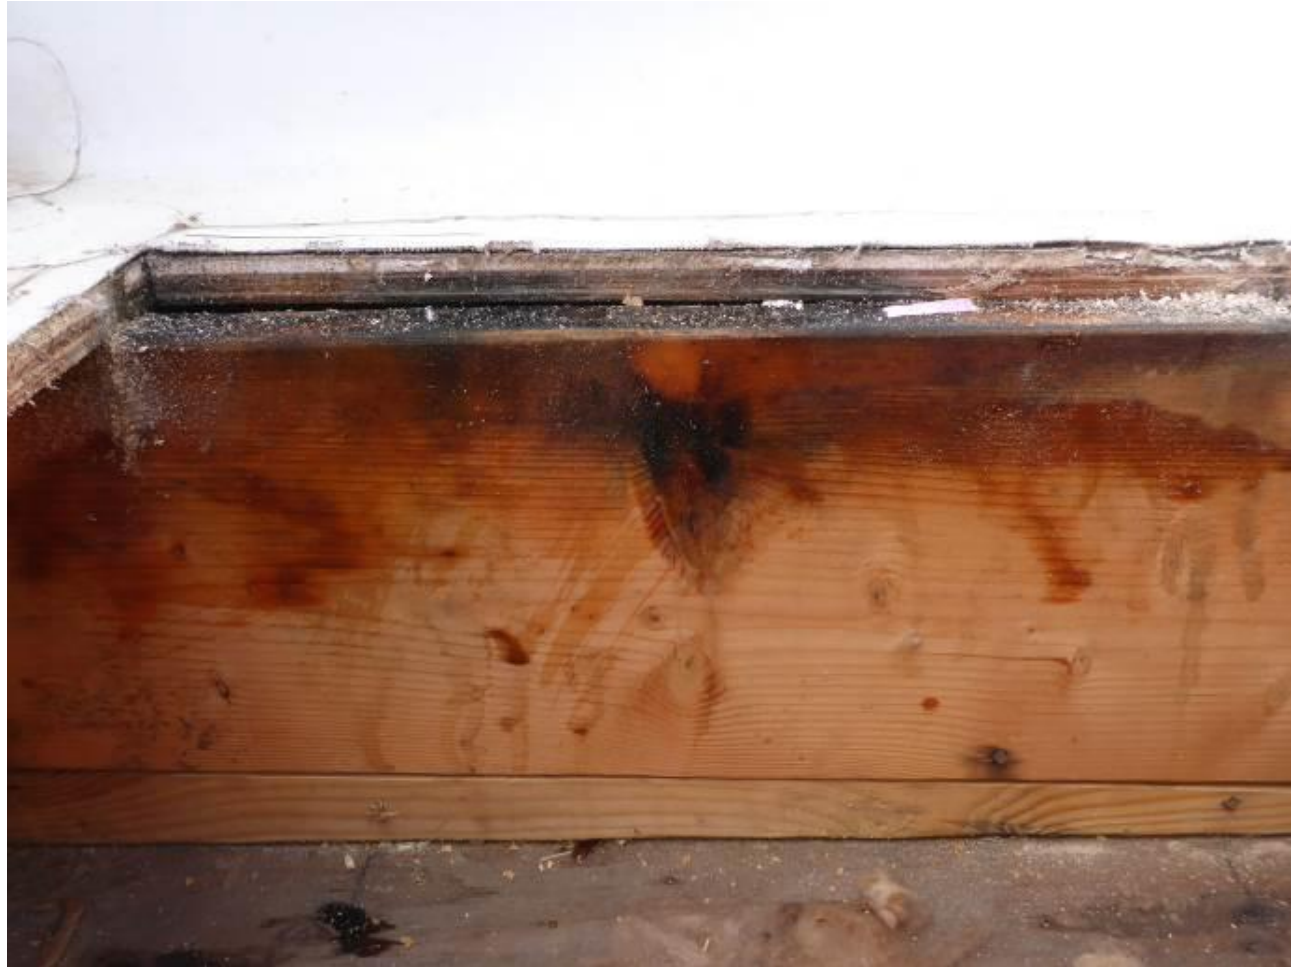
Damage on Cricket Framing

Calibration Test Cut #1a,
Damage Level Severe
(condensation related)

Damage Limited to
this area

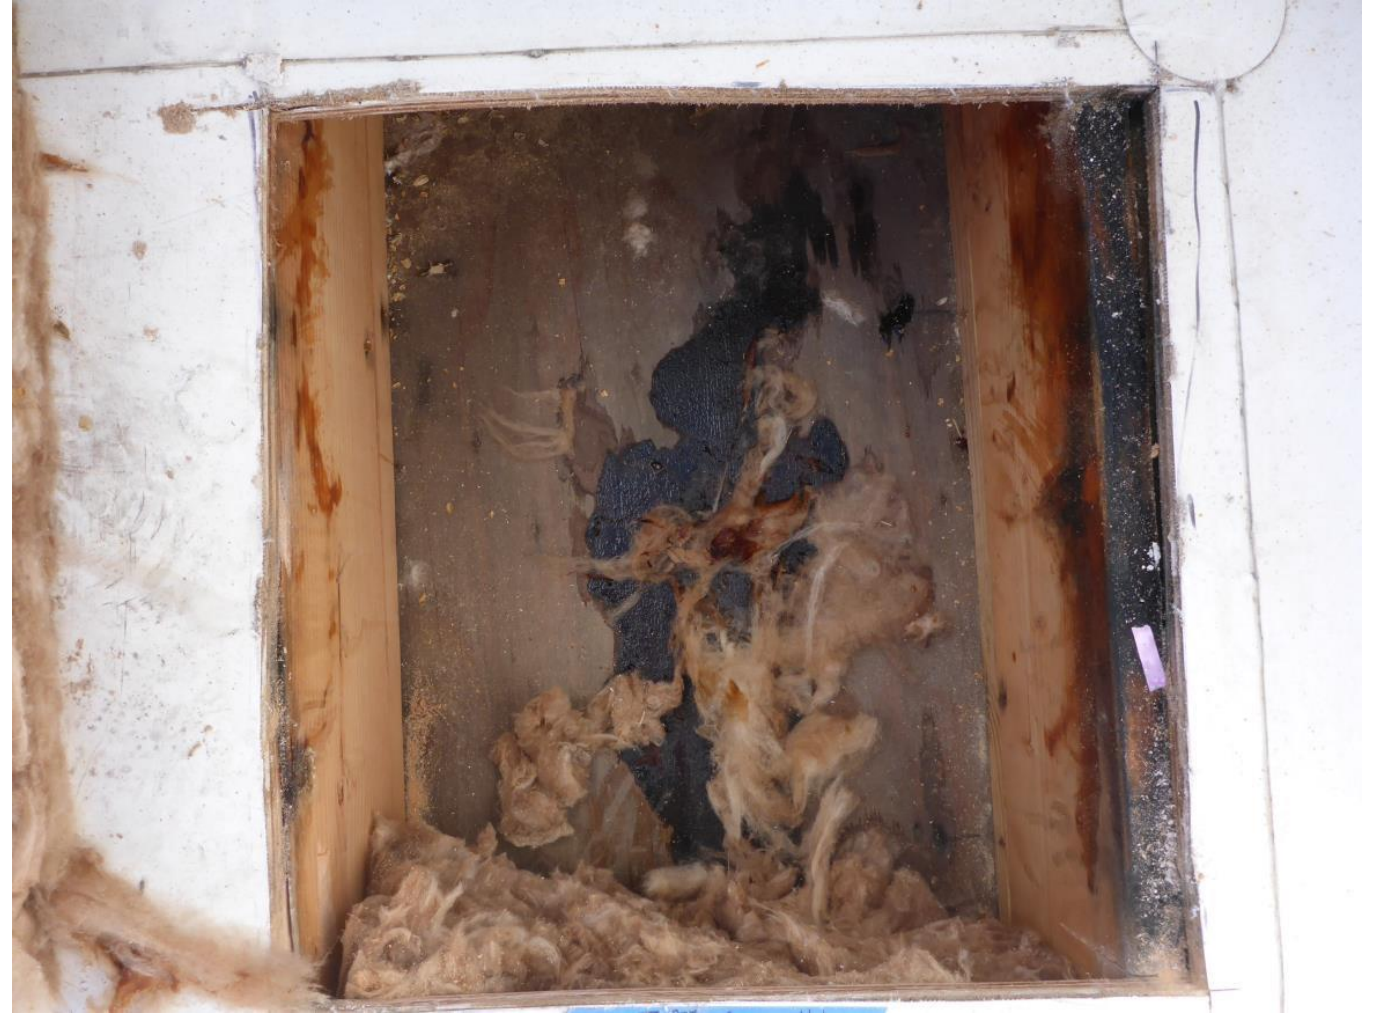
Topside View of Structural Plywood Sheathing

Calibration Test Cut #1a

Nail Pull Thru Testing:
3/4" Moderate Damage
Avg. 285 lb.

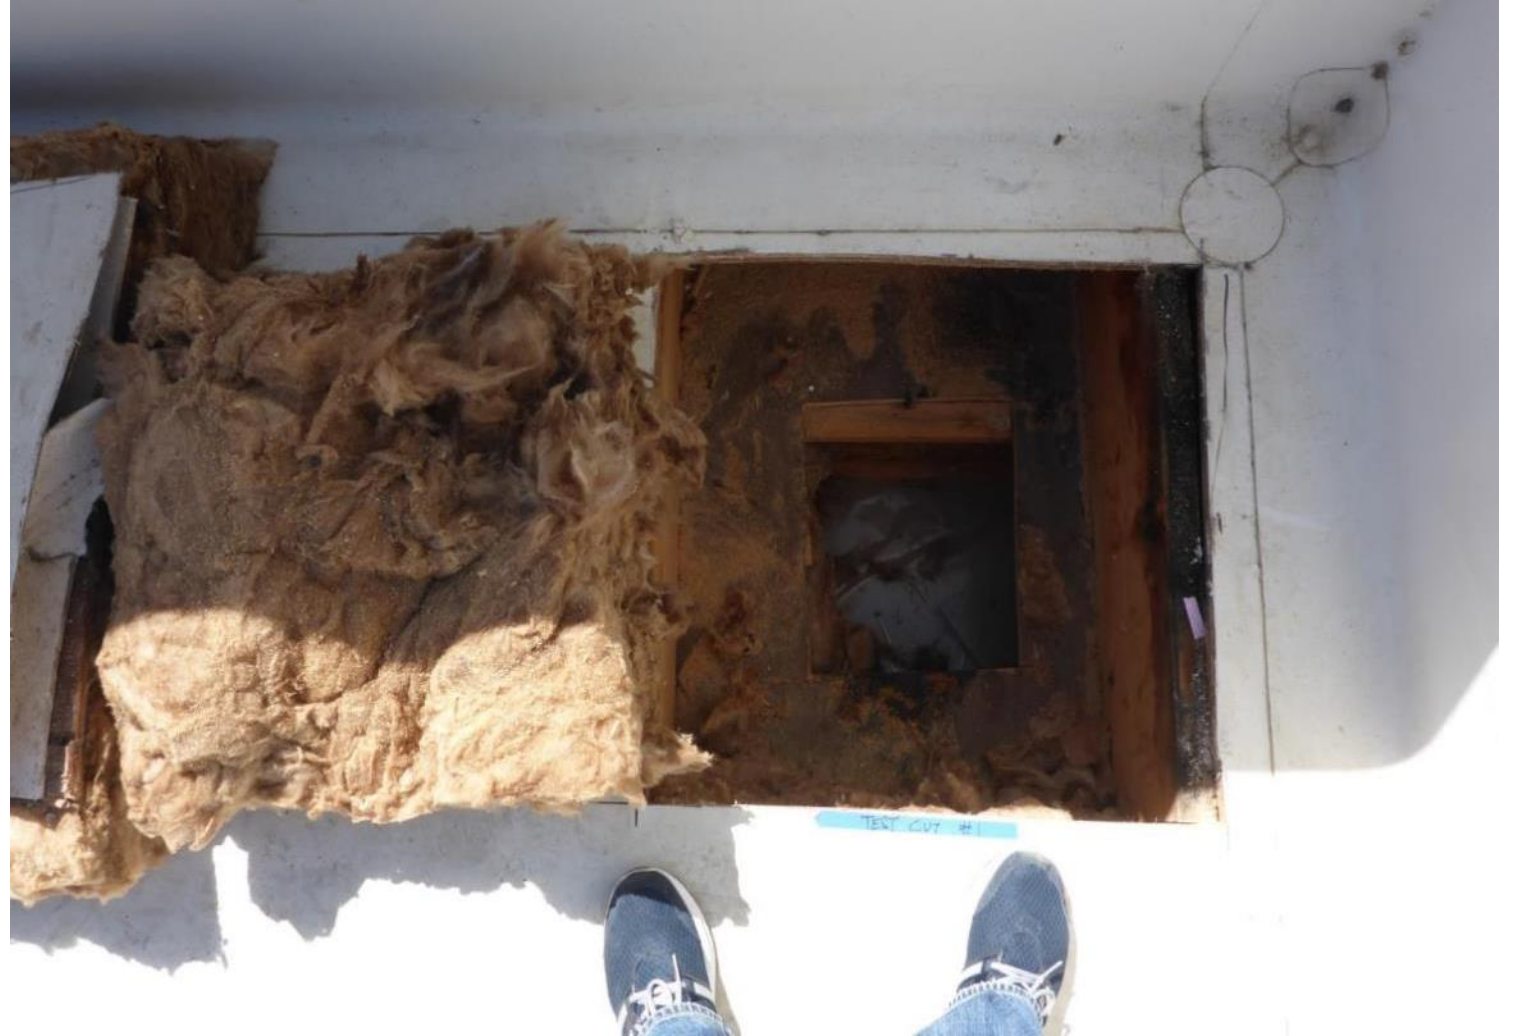
Stained Insulation Batt in Roof Cavity

Calibration Test Cut #1a

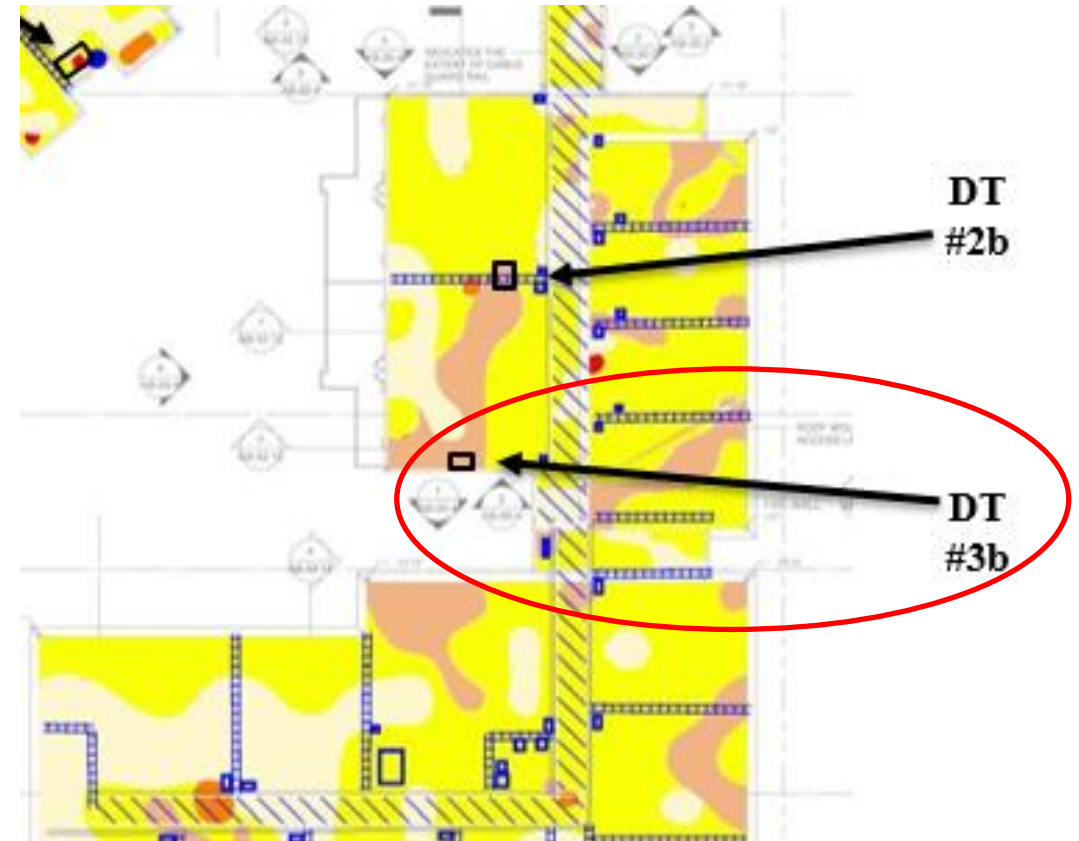
Destructive Test Cut #3b

- Test Cut Location: Level 5 Roof Area, Roof to parapet wall
- Test cut exhibiting severe damage from vapor intrusion, and had a moderate nuclear gauge reading.

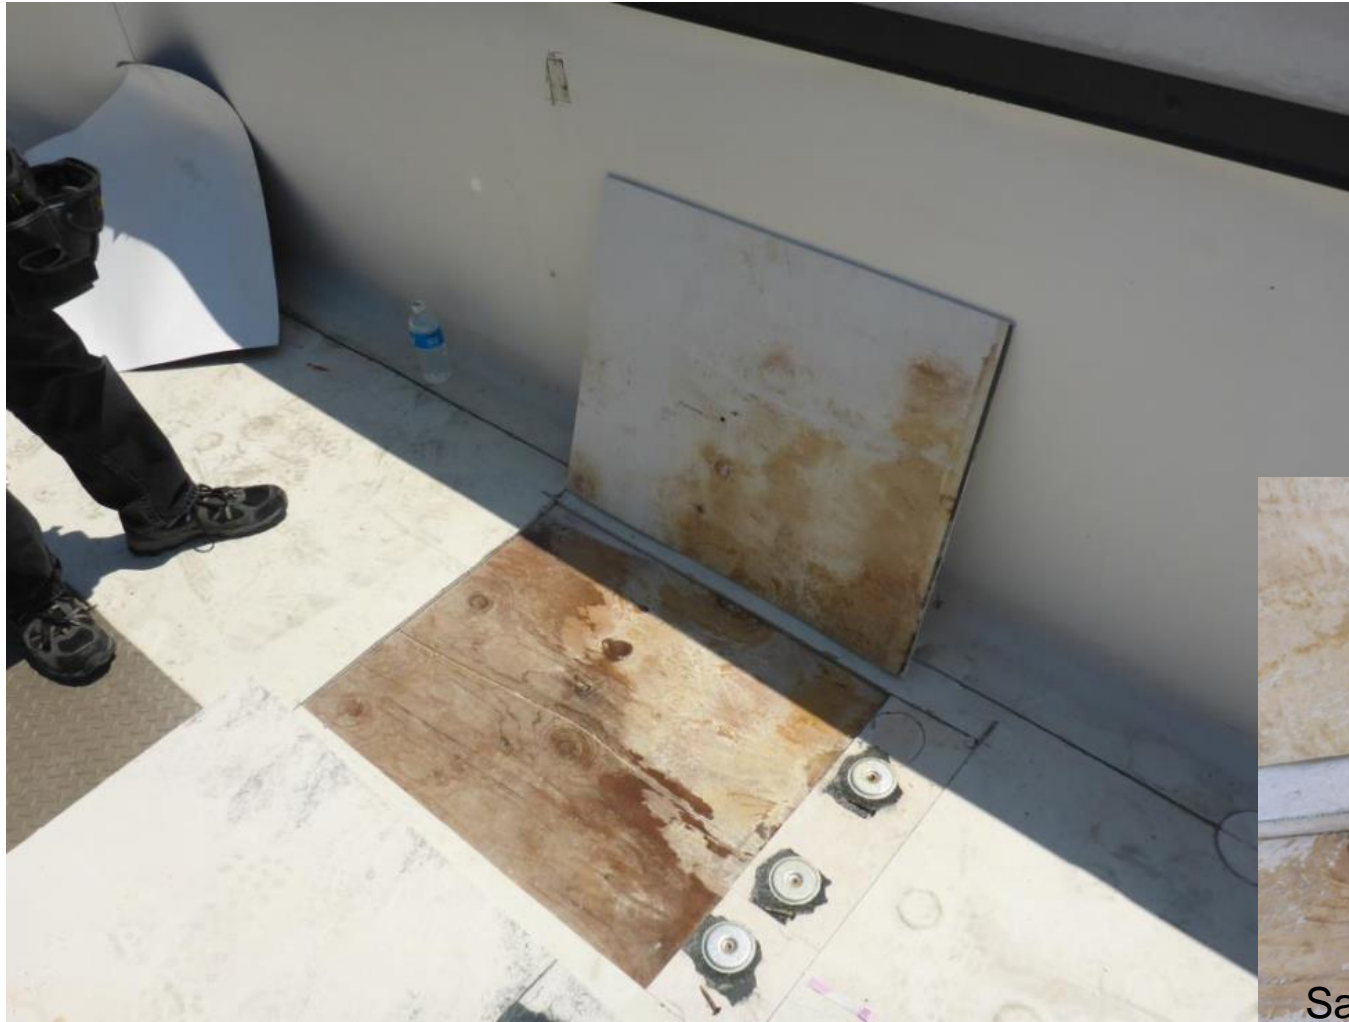
Damaged Plywood Cricket and Cover Board

Test Cut #3b, Damage Level
900 (condensation related)

Nail Pull Thru Testing:
5/8" Moderate Damage
Avg. 298 lb.

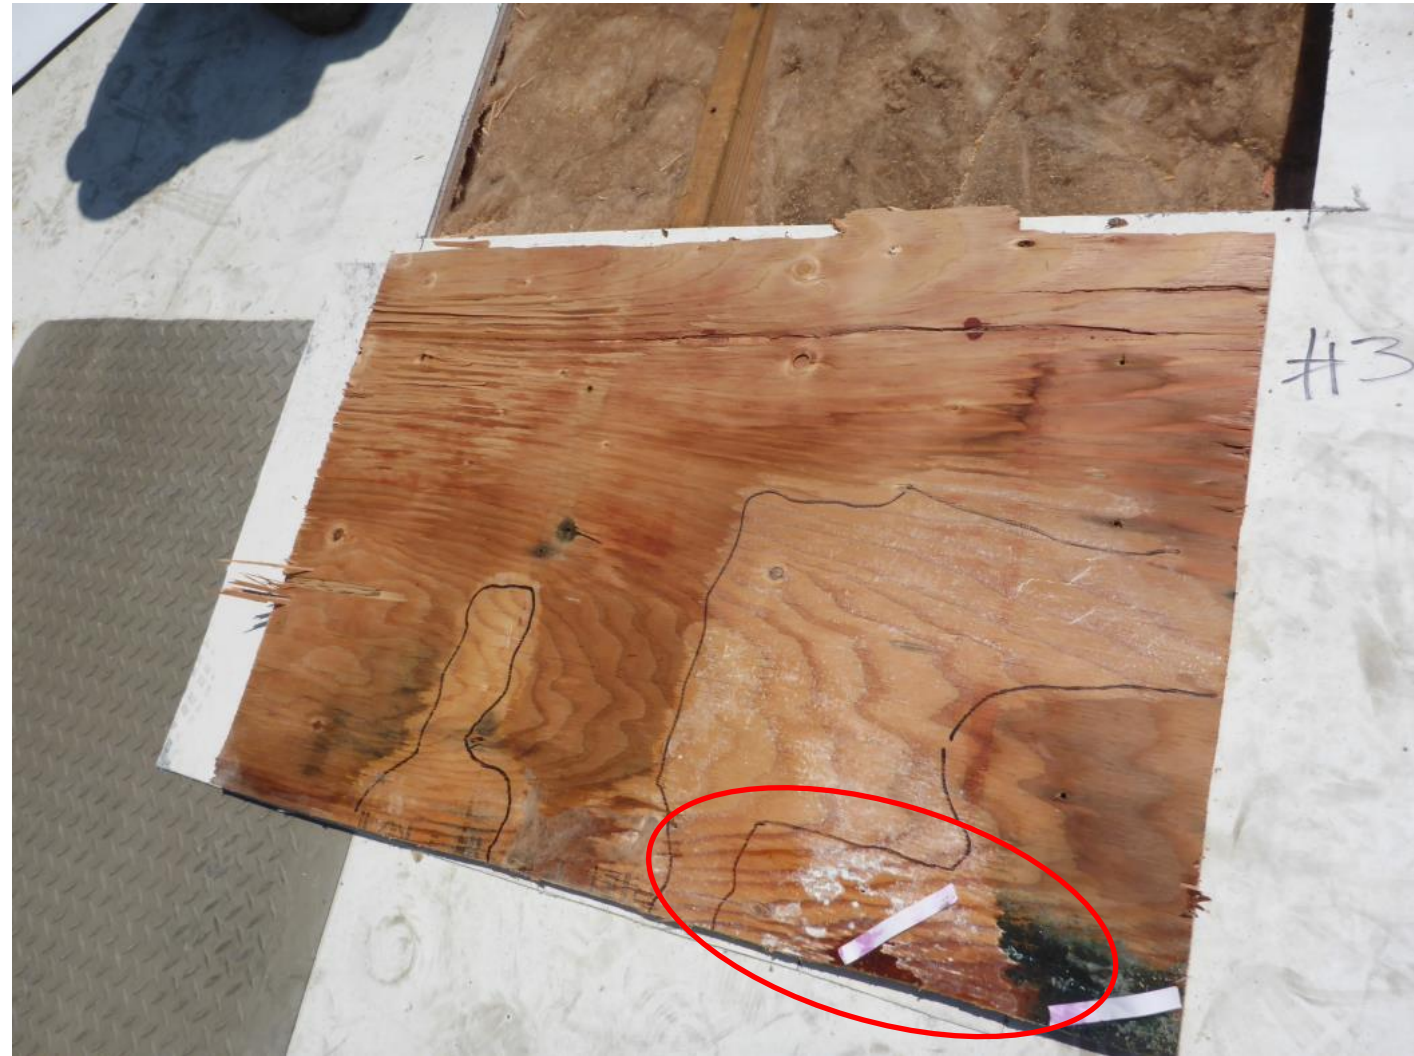
Damage on Backside of Plywood Cricket

Destructive Test
Cut #3b

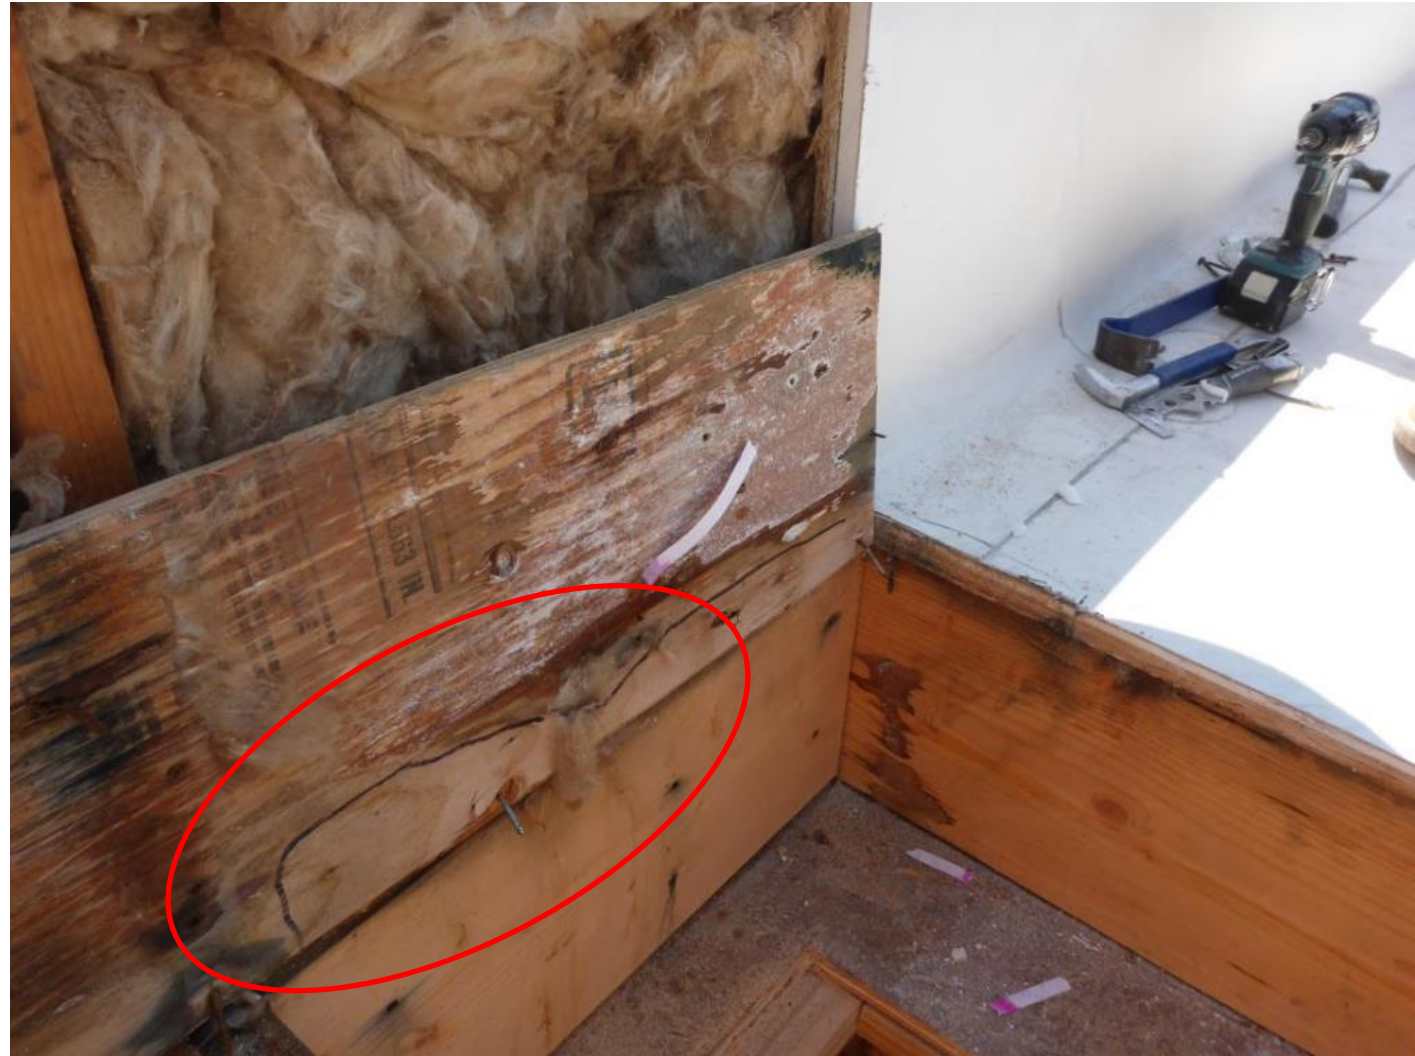
Water and Staining within Cricket Cavity

Destructive
Test Cut #3b

Nail Pull Thru Testing:
5/8" Moderate Damage
Avg. 586 lb.

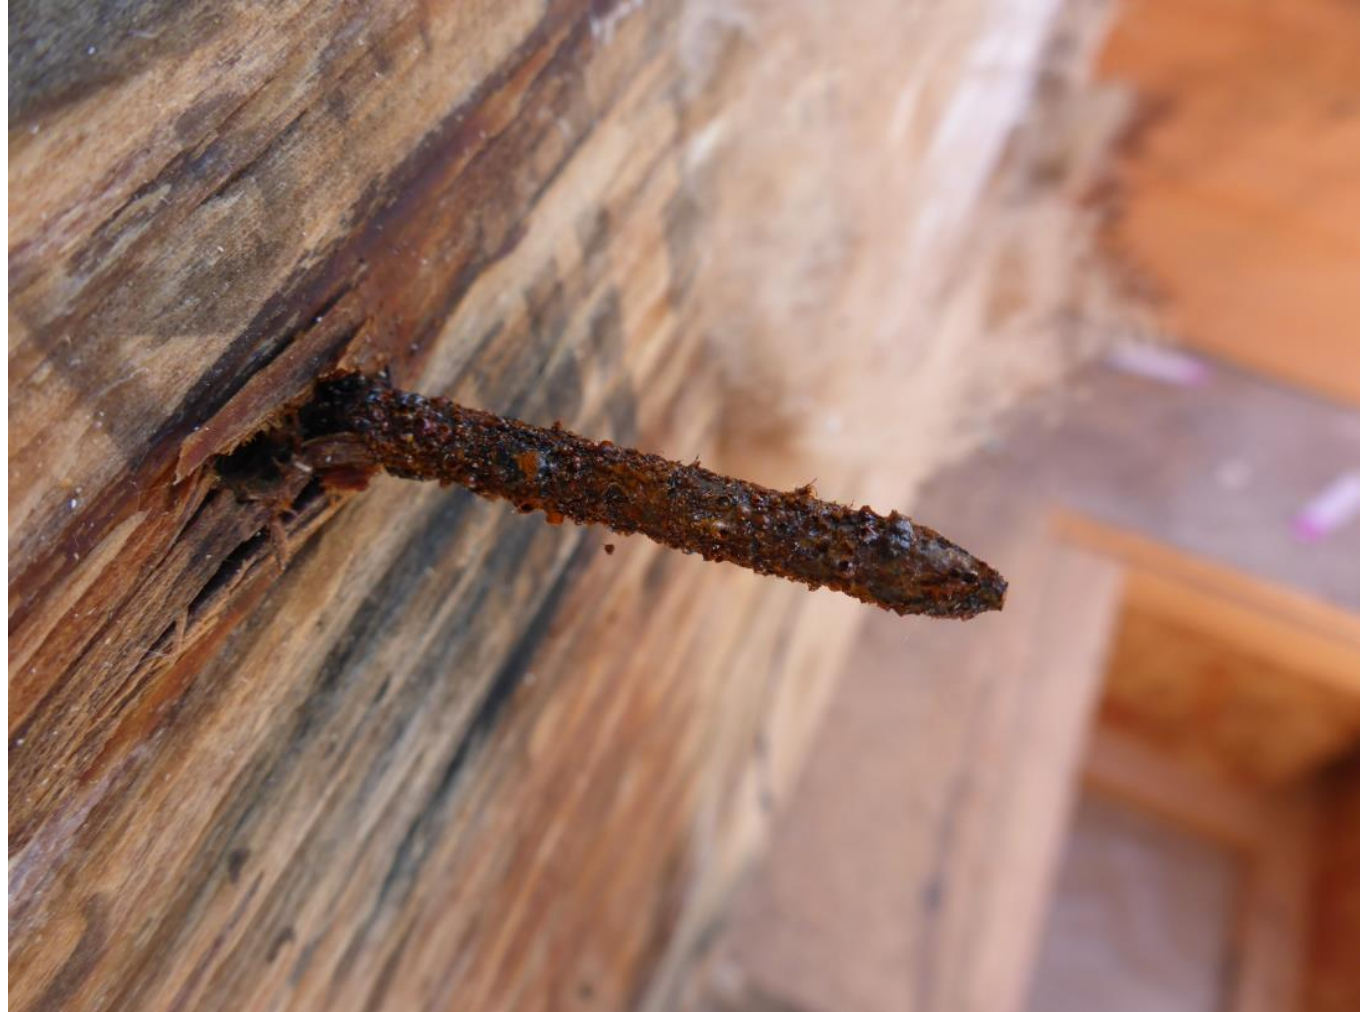
Corroding Fastener in Cricket Sheathing

Destructive Test Cut #3b,

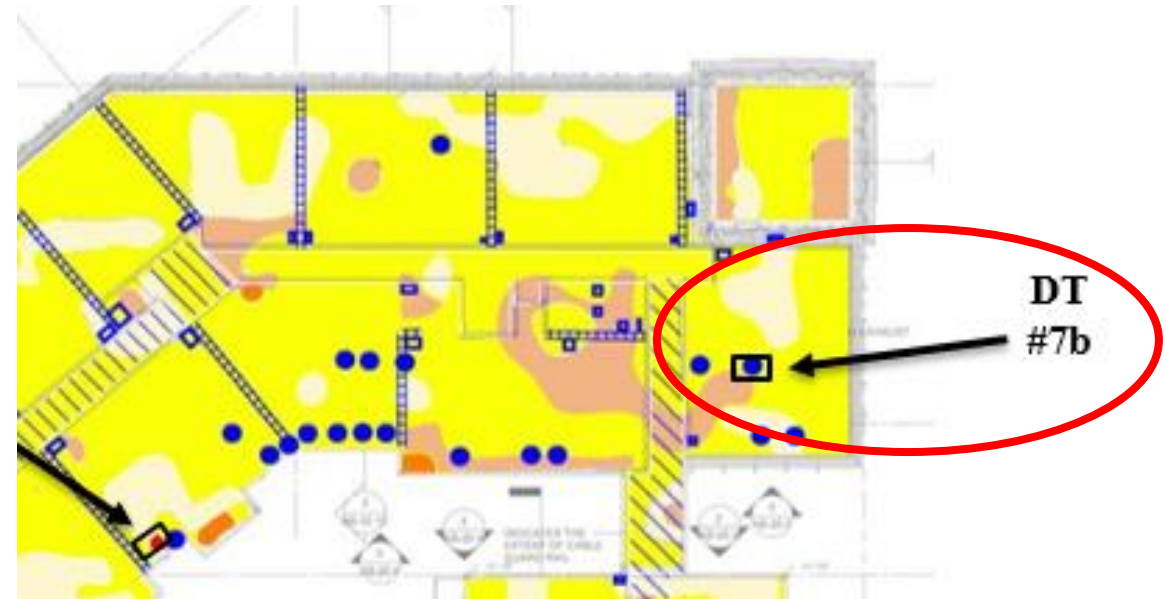
Destructive Test Cut #7b

- Test Cut Location: Level 5 Roof Area, Adjacent to roof drains
- Test cut exhibiting severe condensation damage, noted soft spot, had a low Troxler reading, and had high Tramex moisture content levels.

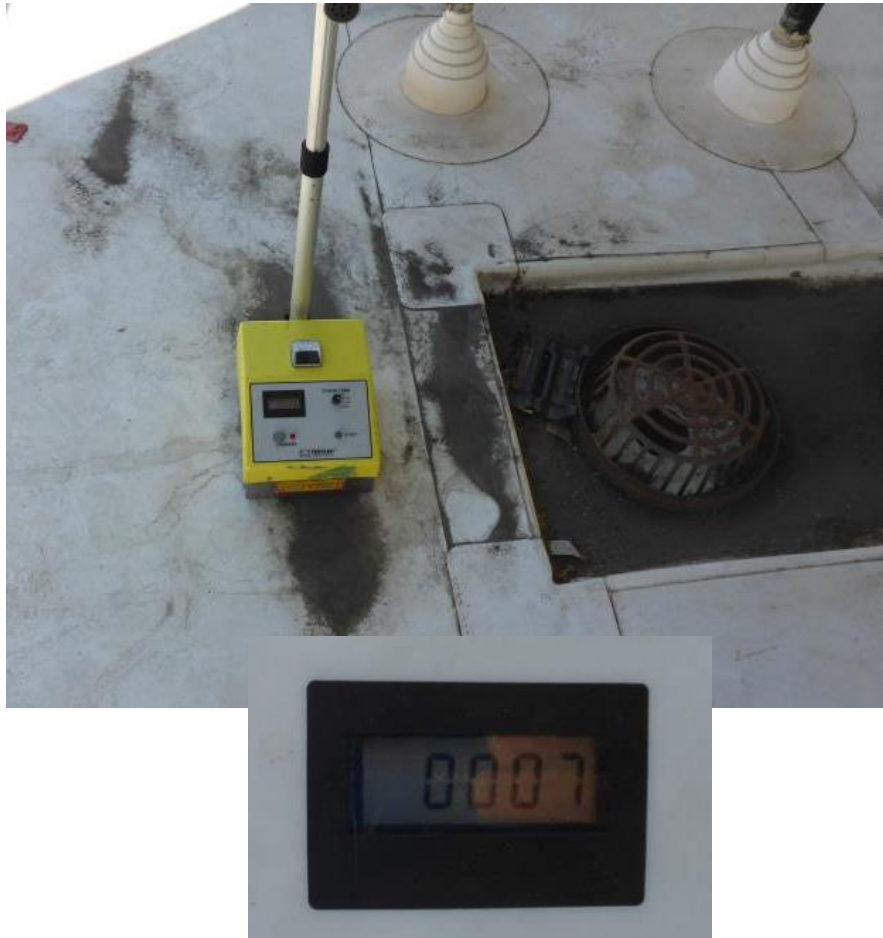
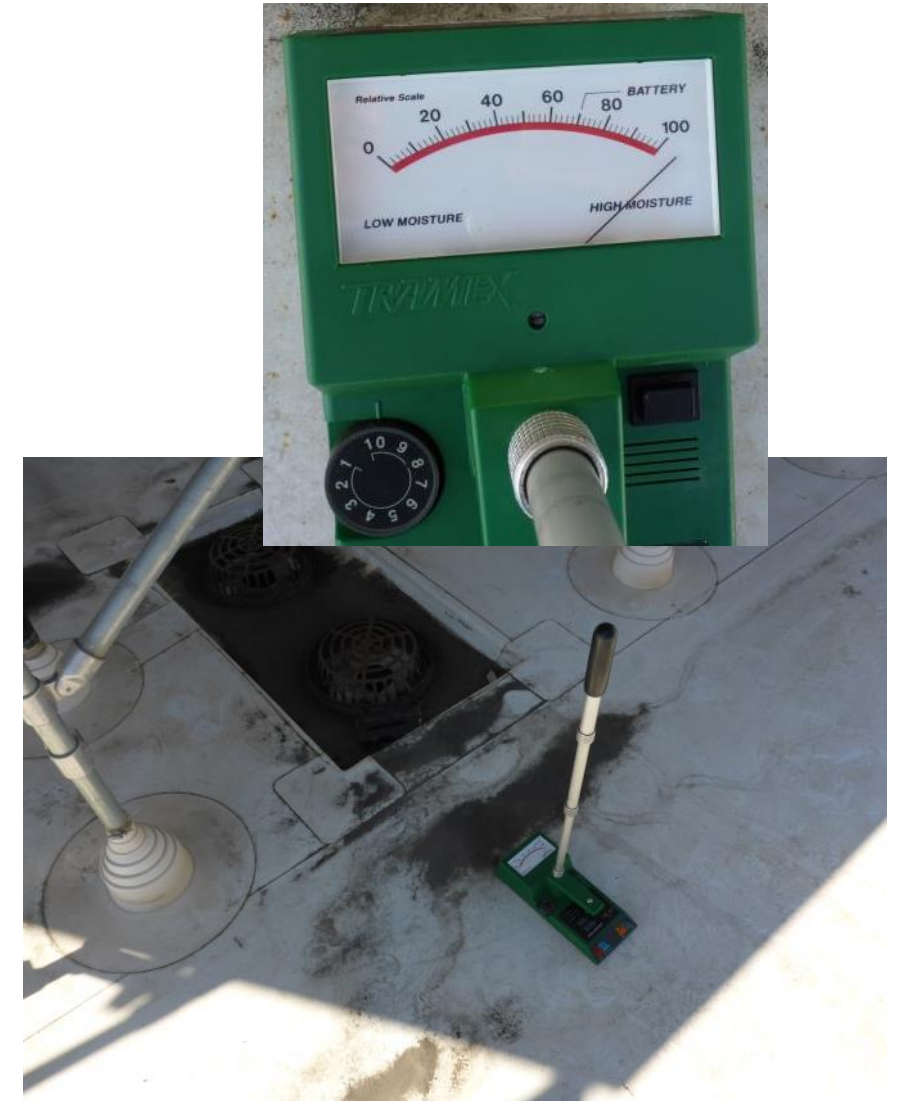
Moisture Scan Results

Destructive Test Cut #7b (Soft Spot)

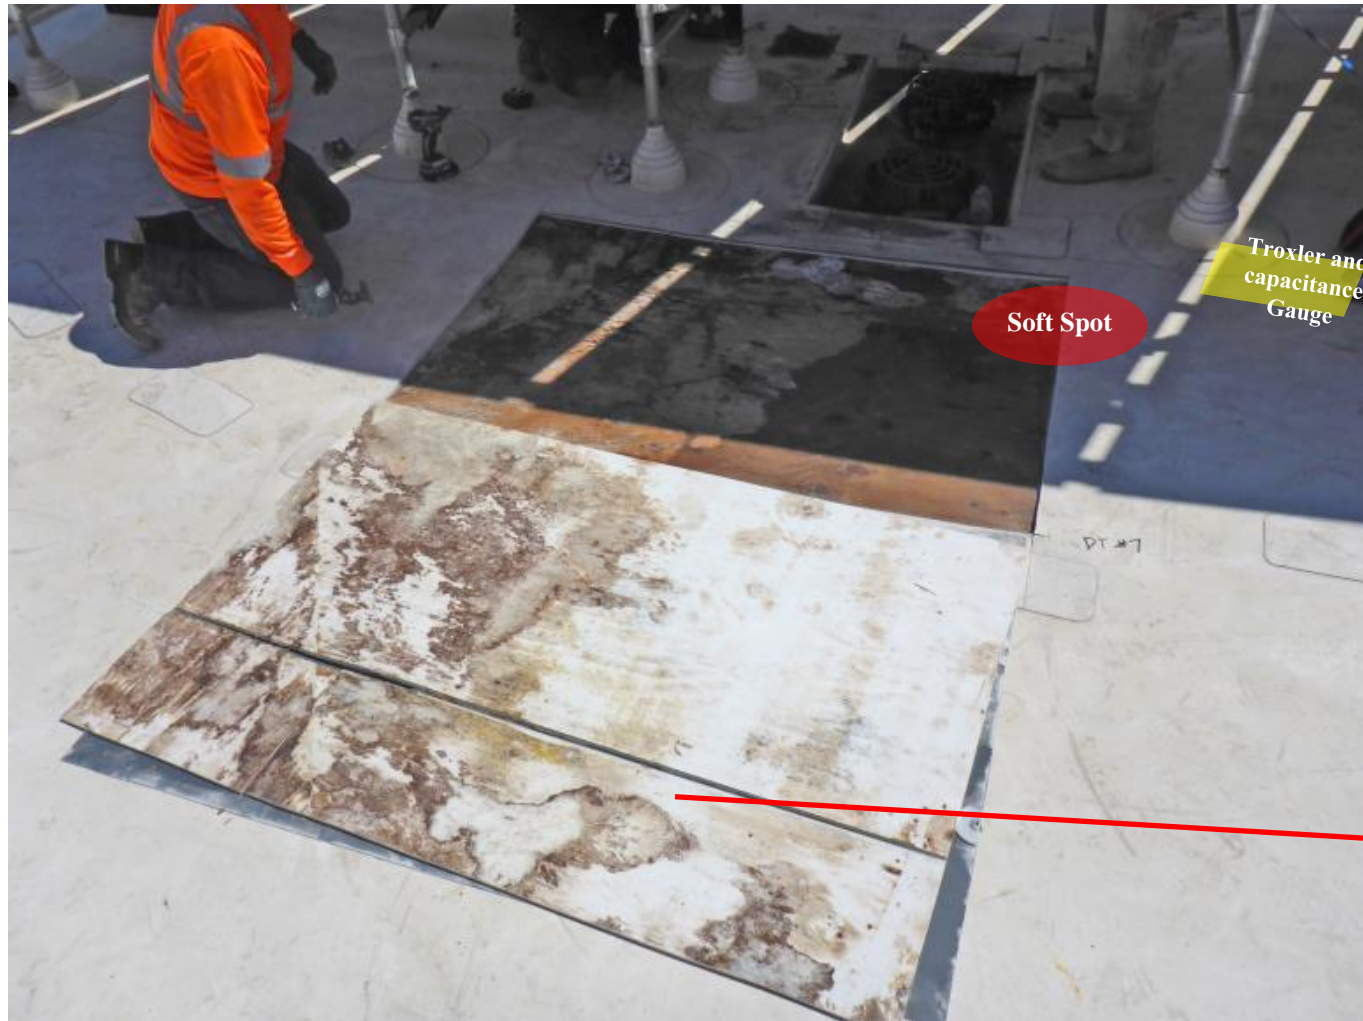
Destructive Testing Cut # 7b, Severe Damage

Nail Pull Thru Testing:

5/8" Severe Damage

Avg. 98 lb.

5/8" Slight Damage

Avg. 354 lb.
