33RD RCI INTERNATIONAL CONVENTION & TRADE SHOW

Avoiding Condensation in Low-Slope Roofing Assemblies

Case Study

San Francisco Apartment

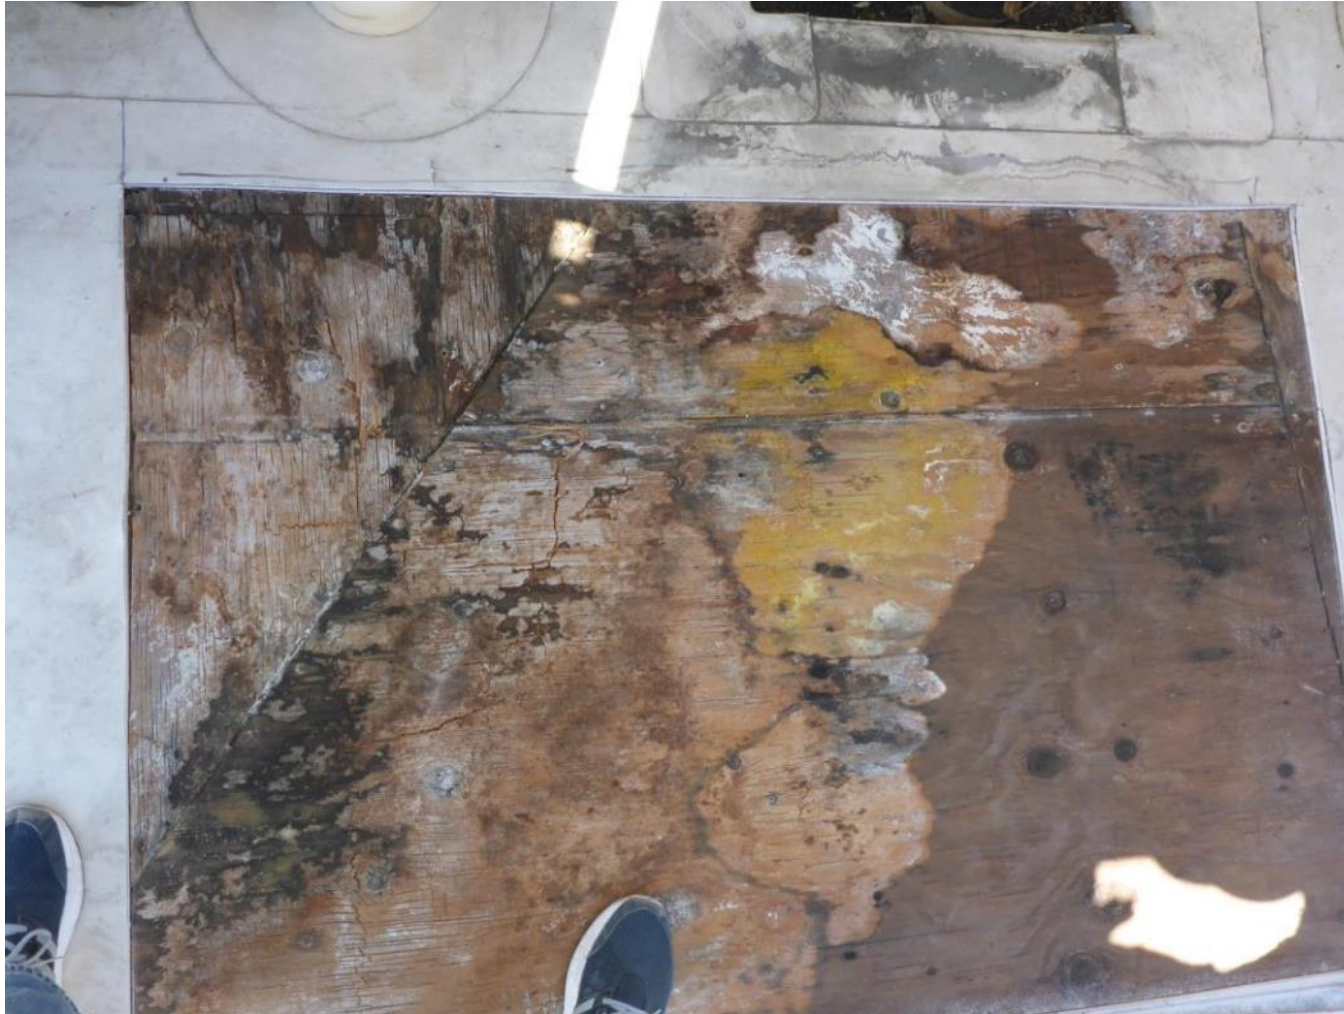
Destructive Testing Cut # 7b, Severe Damage

Destructive Test Cut #7b,
Damage Level 900
(condensation related)

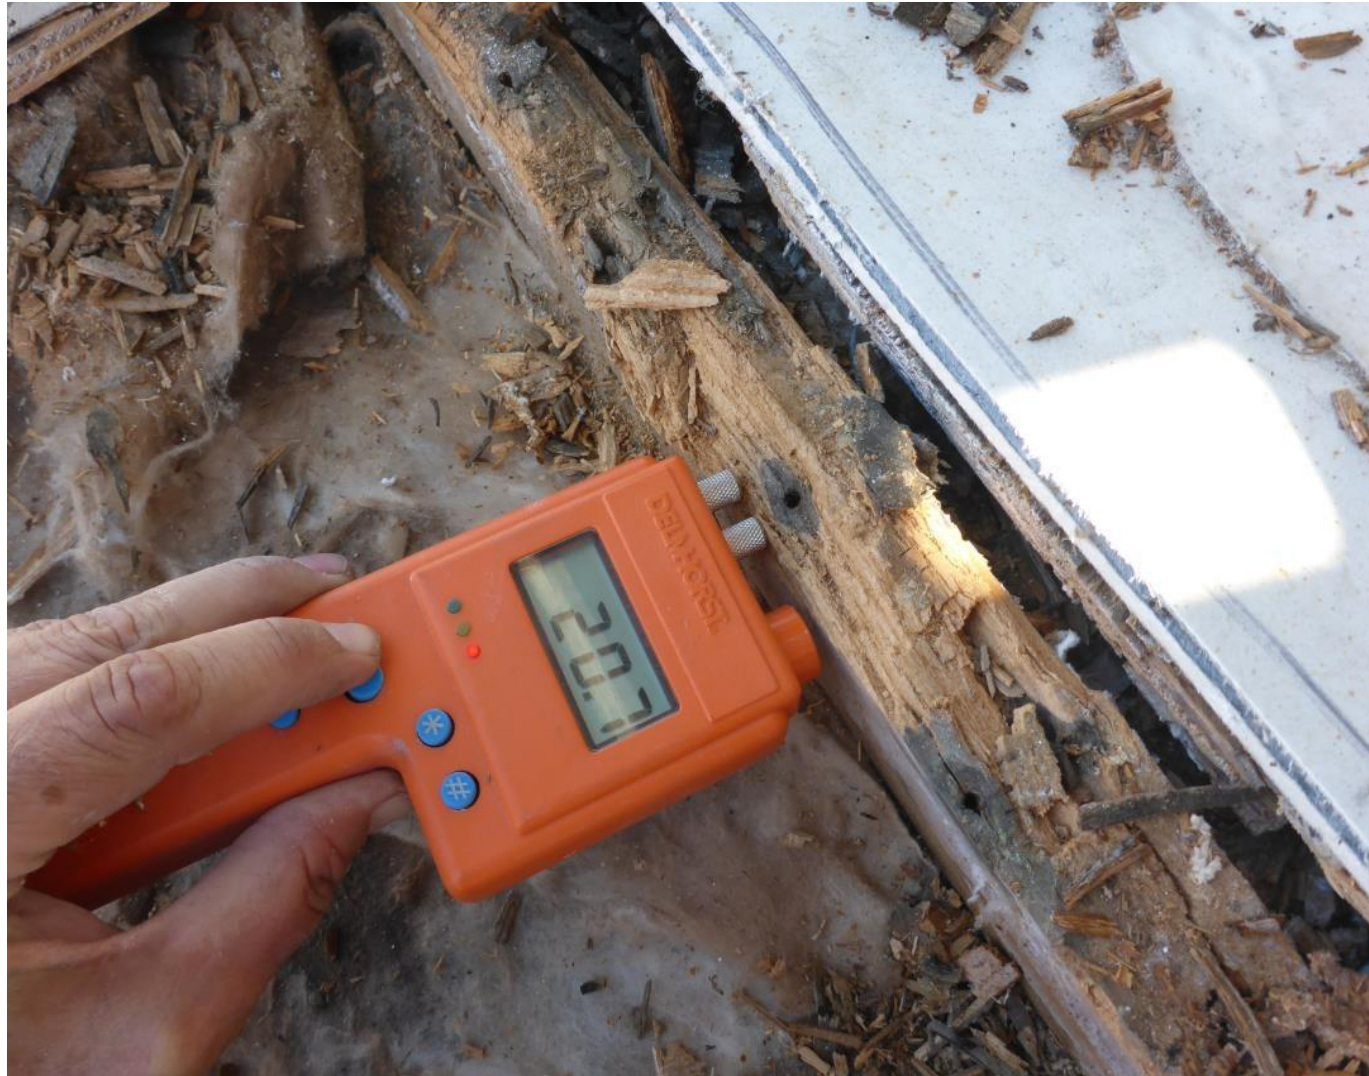
Wood Rot and Elevated Moisture Content

Destructive Test Cut #7b

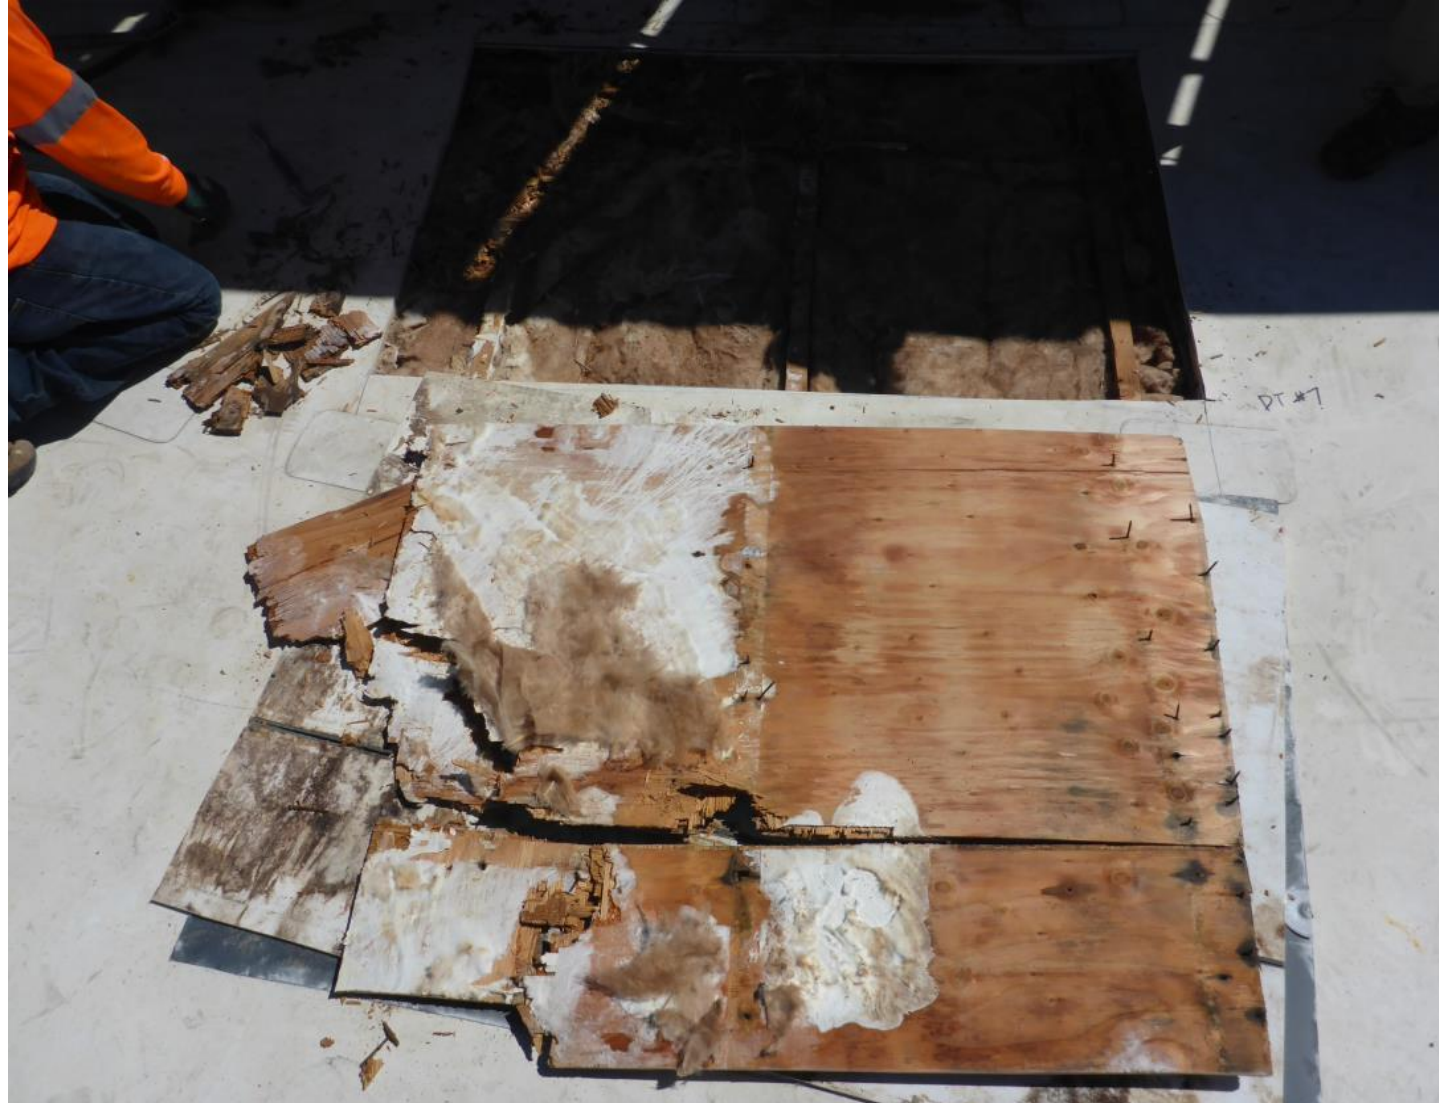
Plywood Cricket Wood Rot and Organic Growth

Destructive Test Cut #7b

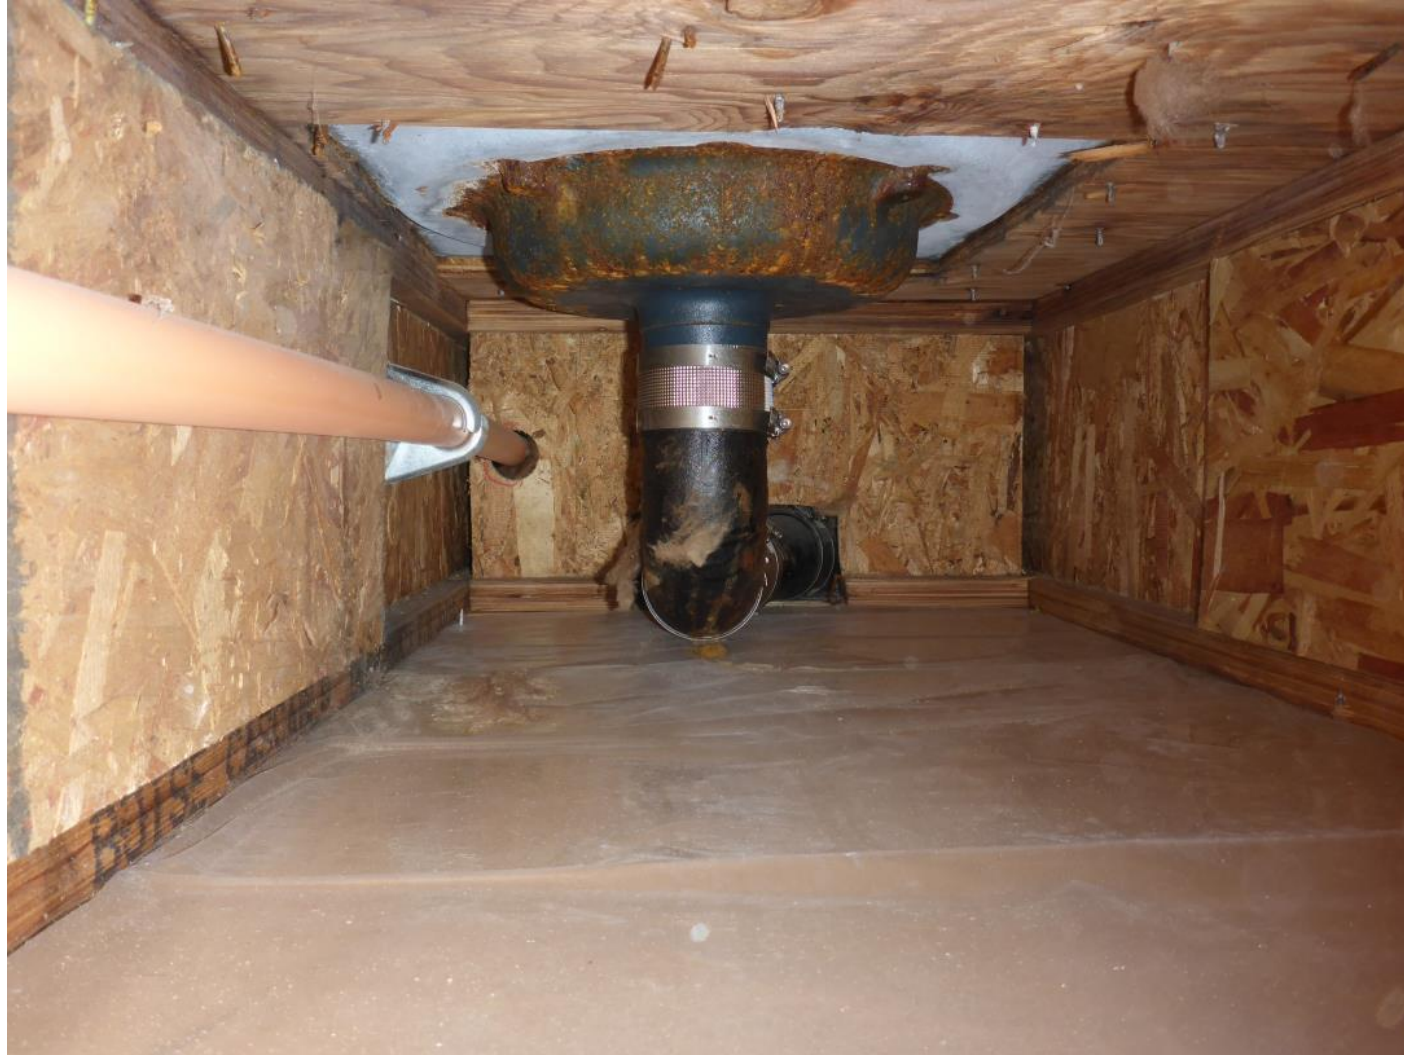
Corroding Drain Bowl

Destructive Test Cut #7b

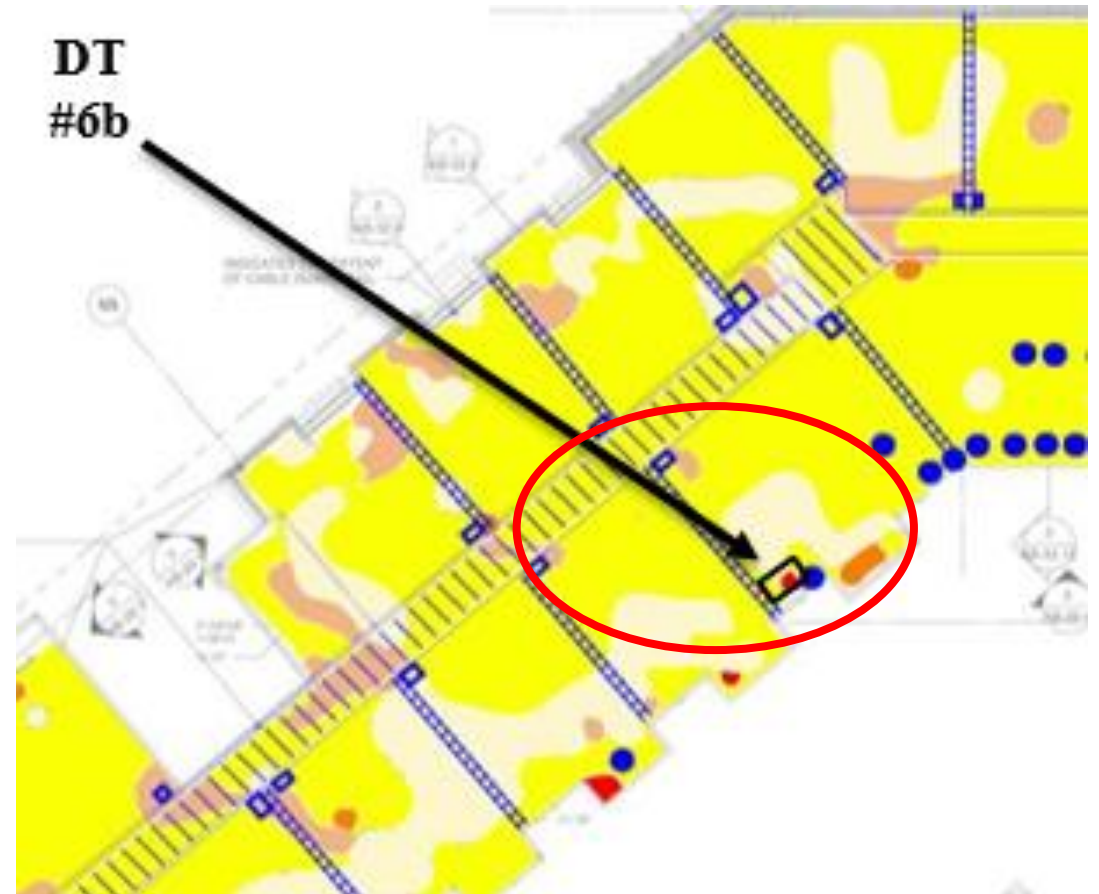
Destructive Test Cut #6b

- Test Cut Location: Level 5 Roof Area, Roof to parapet wall
- Test cut exhibiting severe condensation damage, noted soft spot, and had a high nuclear guage reading.

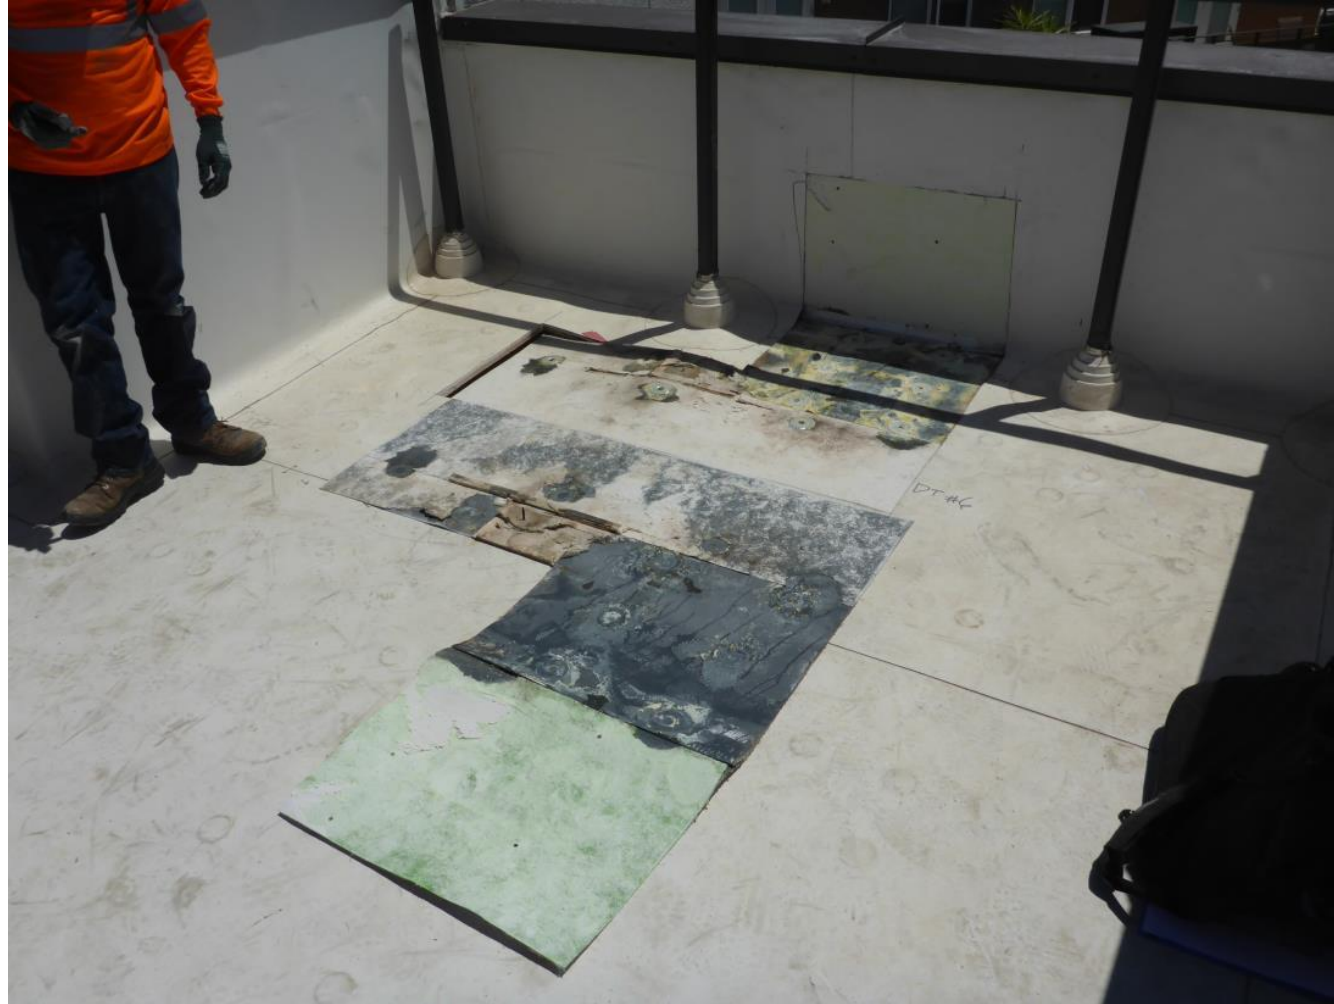
Moisture Between Membrane and Cover Board

Destructive Test Cut #6b

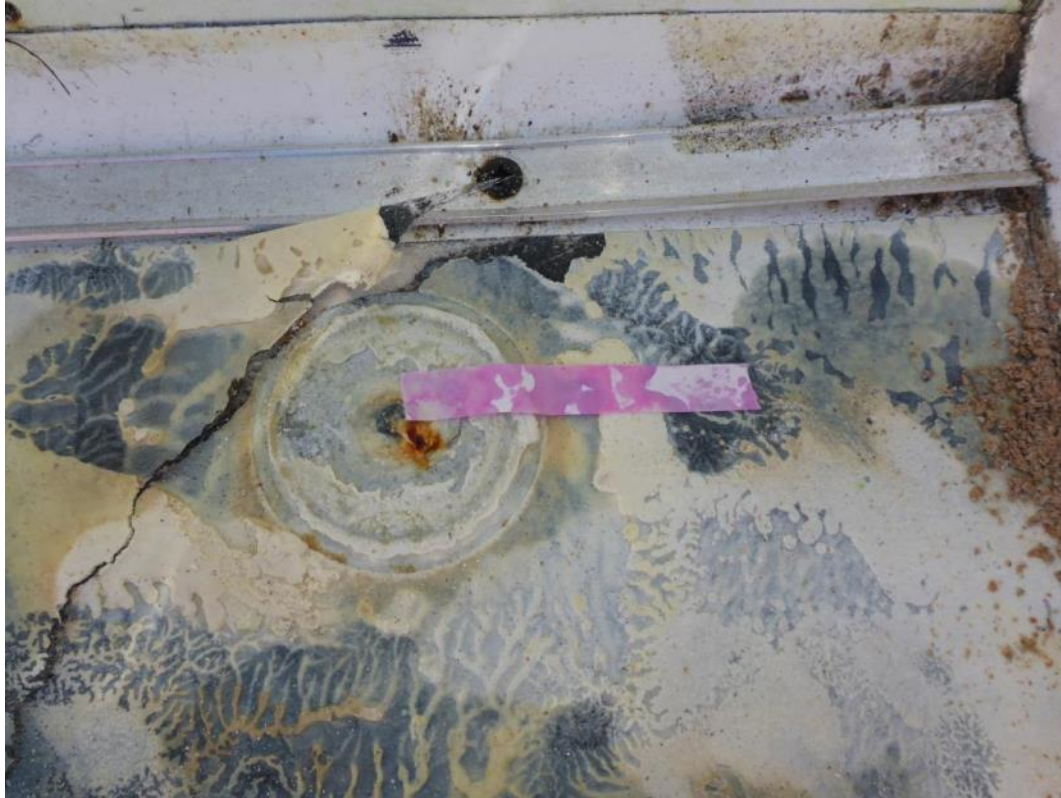
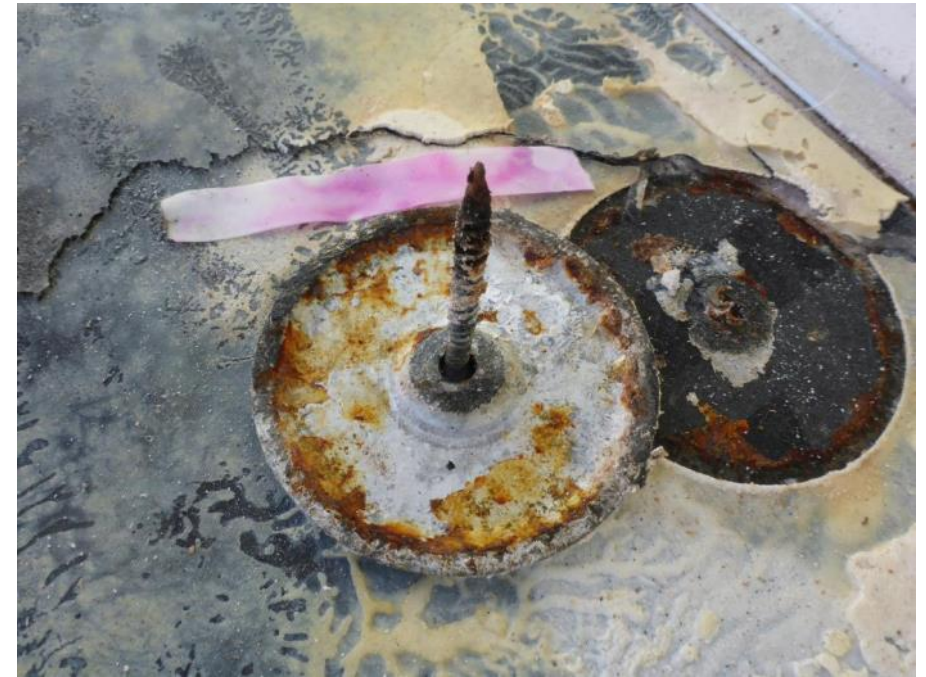
Moisture Between Membrane and Cover Board

Destructive Test Cut #6b, Damage level 900 (condensation related)

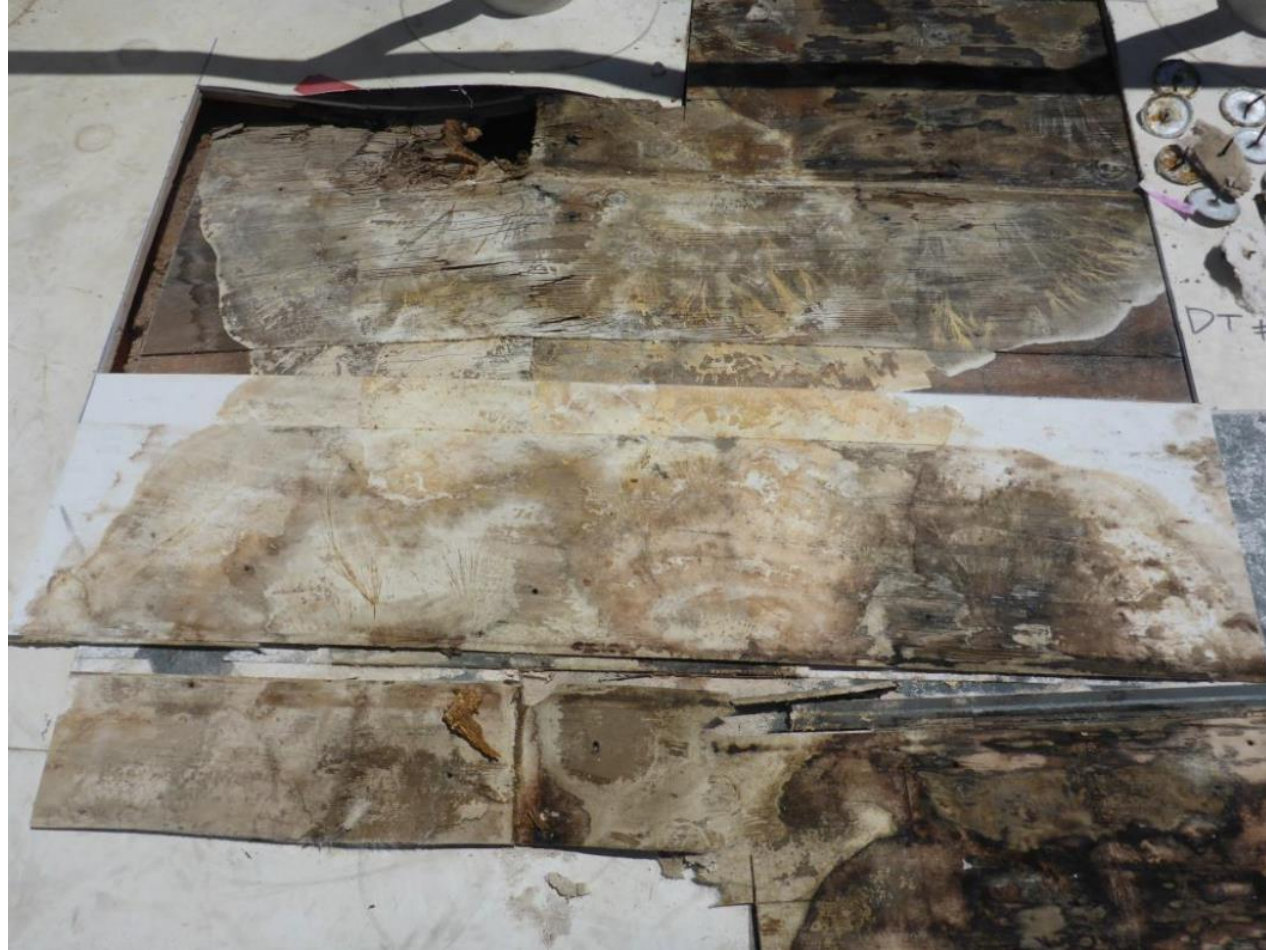
Plywood Cricket Wood Rot and Organic Growth

Destructive Test Cut #6b, Damage level 900 (condensation related)

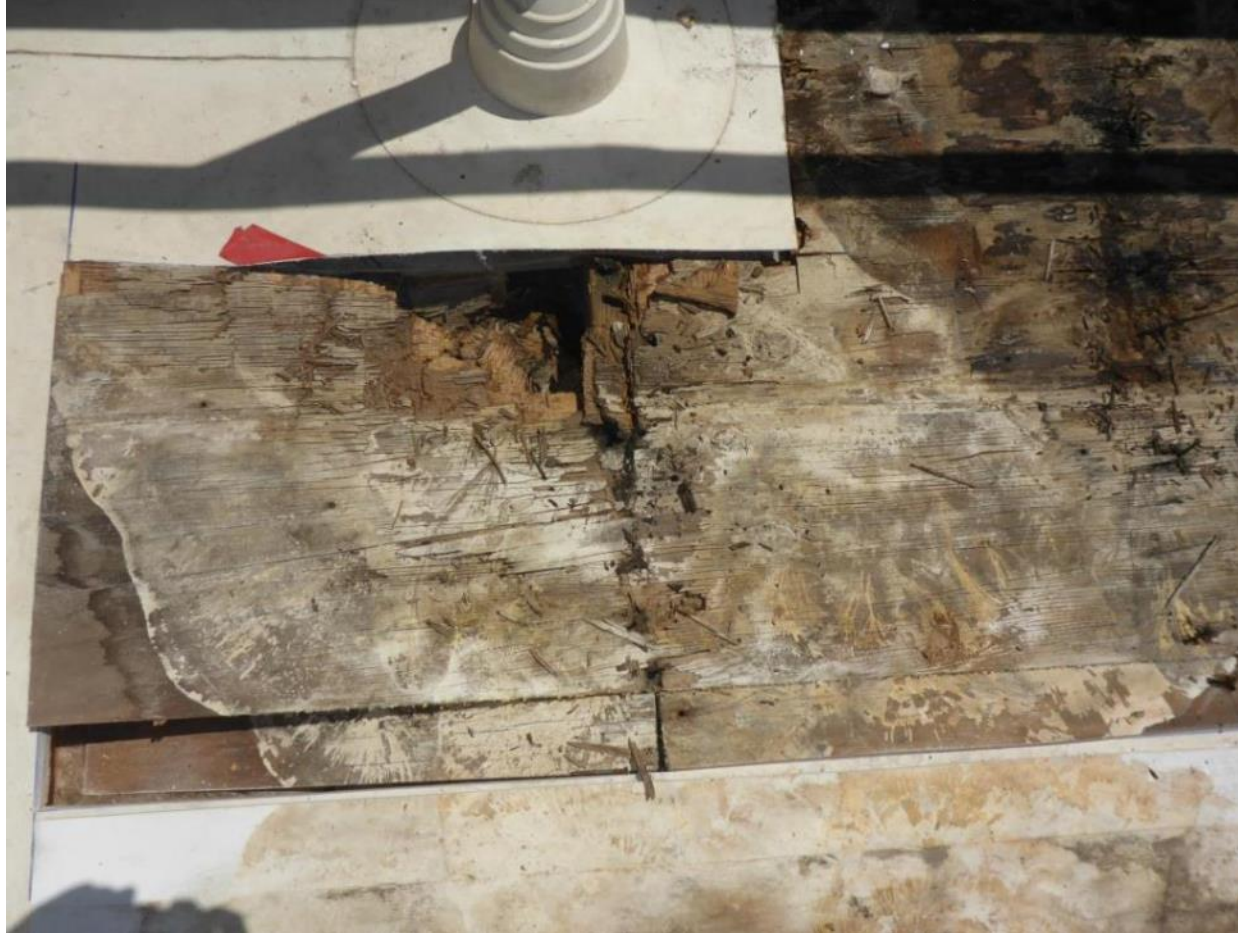
Plywood Cricket Wood Rot and Organic Growth

Destructive Test Cut #6b, Damage
level 900 (condensation related)

Nail Pull Thru Testing:

5/8" Very Severe Damage

Avg. **28 lb.**

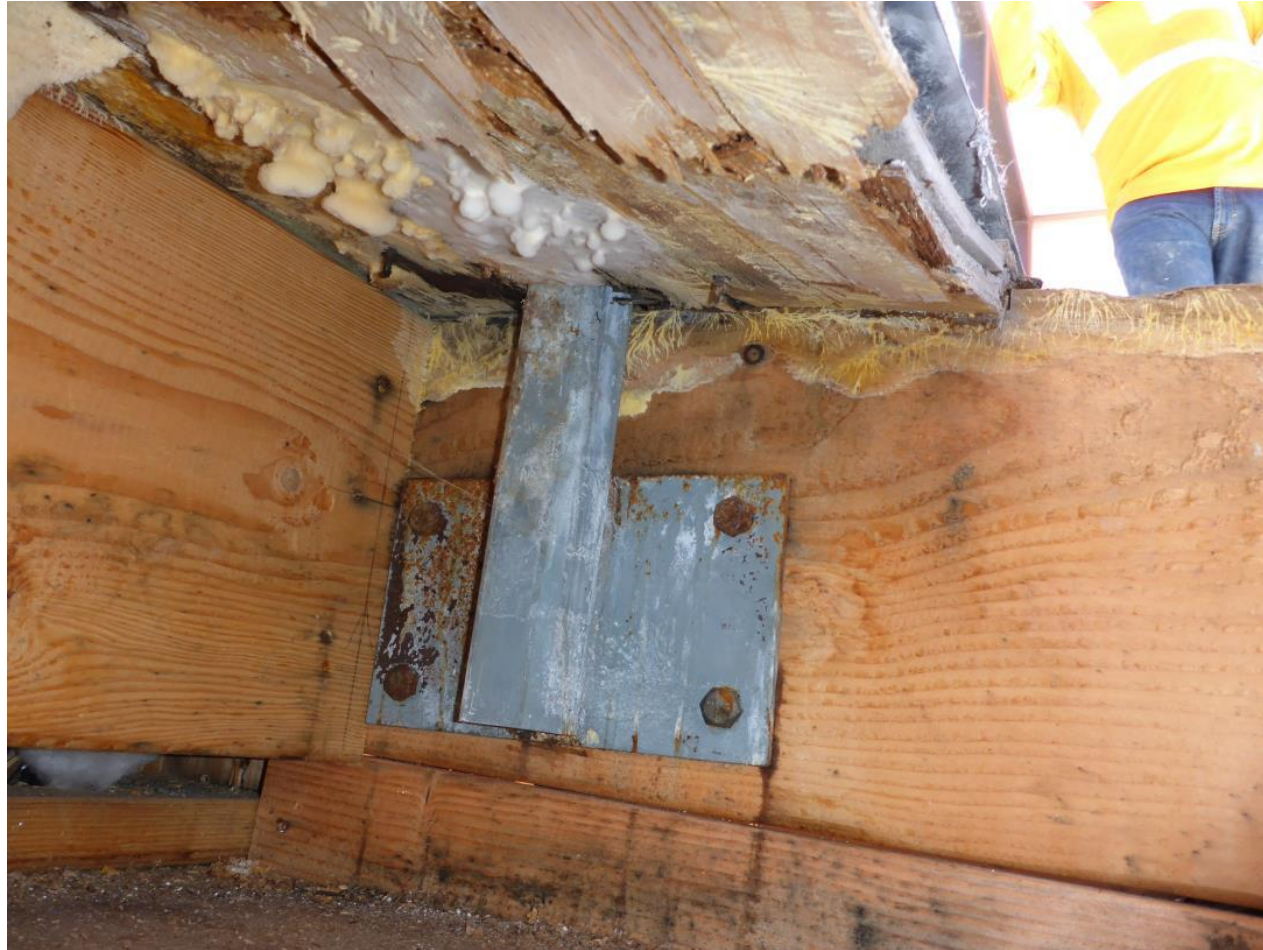
Severe Damage at Metal Hand Railing Base

Destructive Test Cut #6b, Damage level 900 (condensation related)

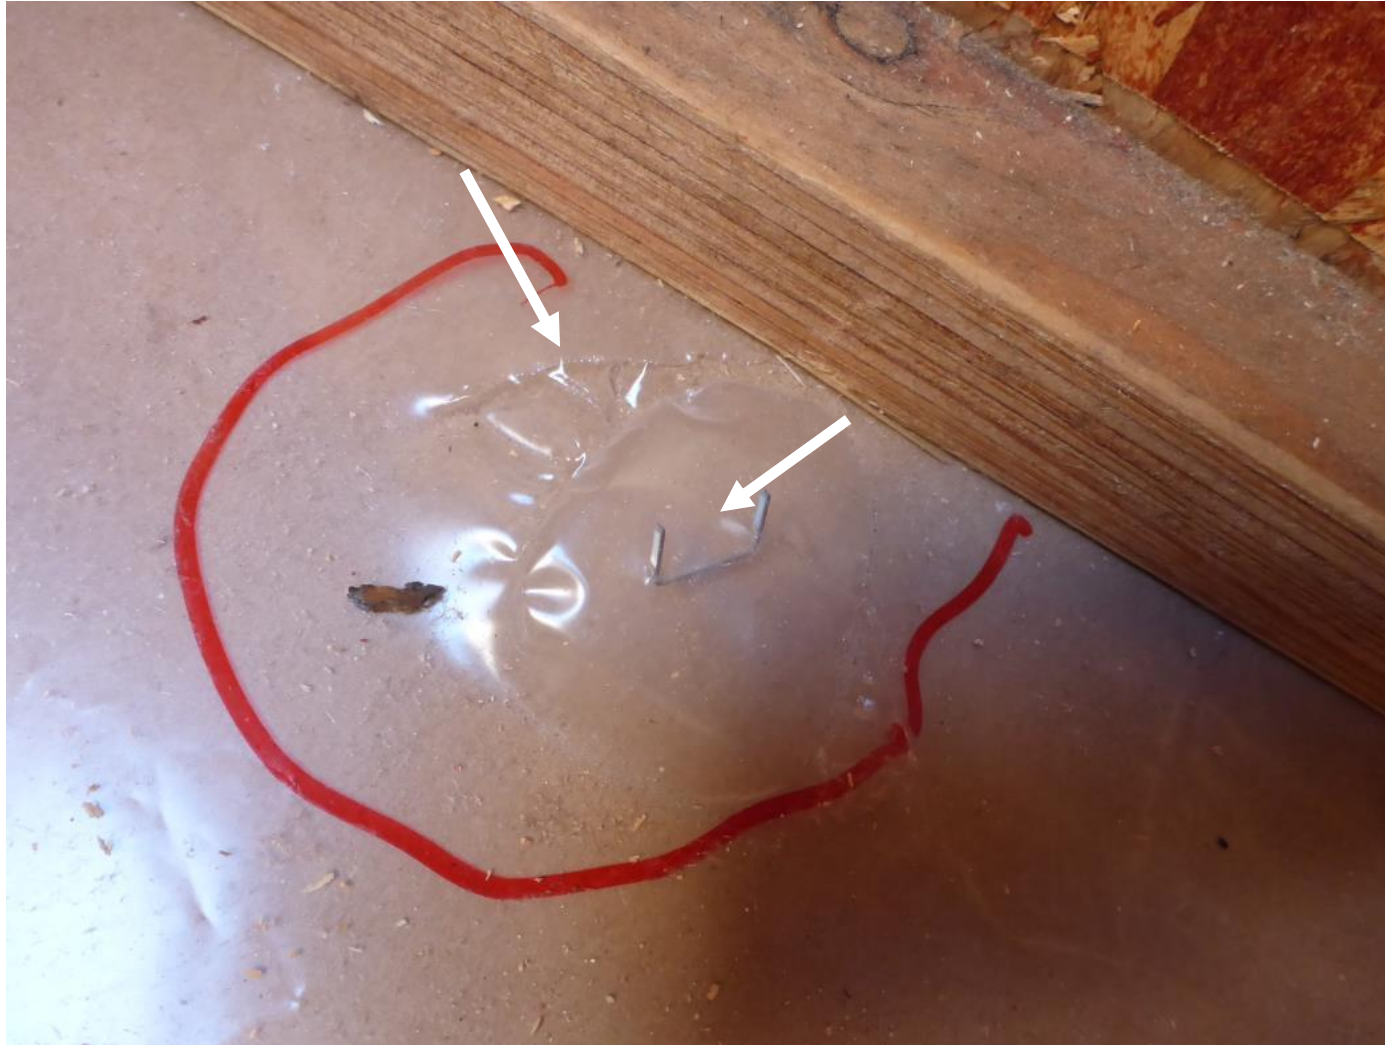
Torn Vapor Retarder

Destructive Test Cut #4b

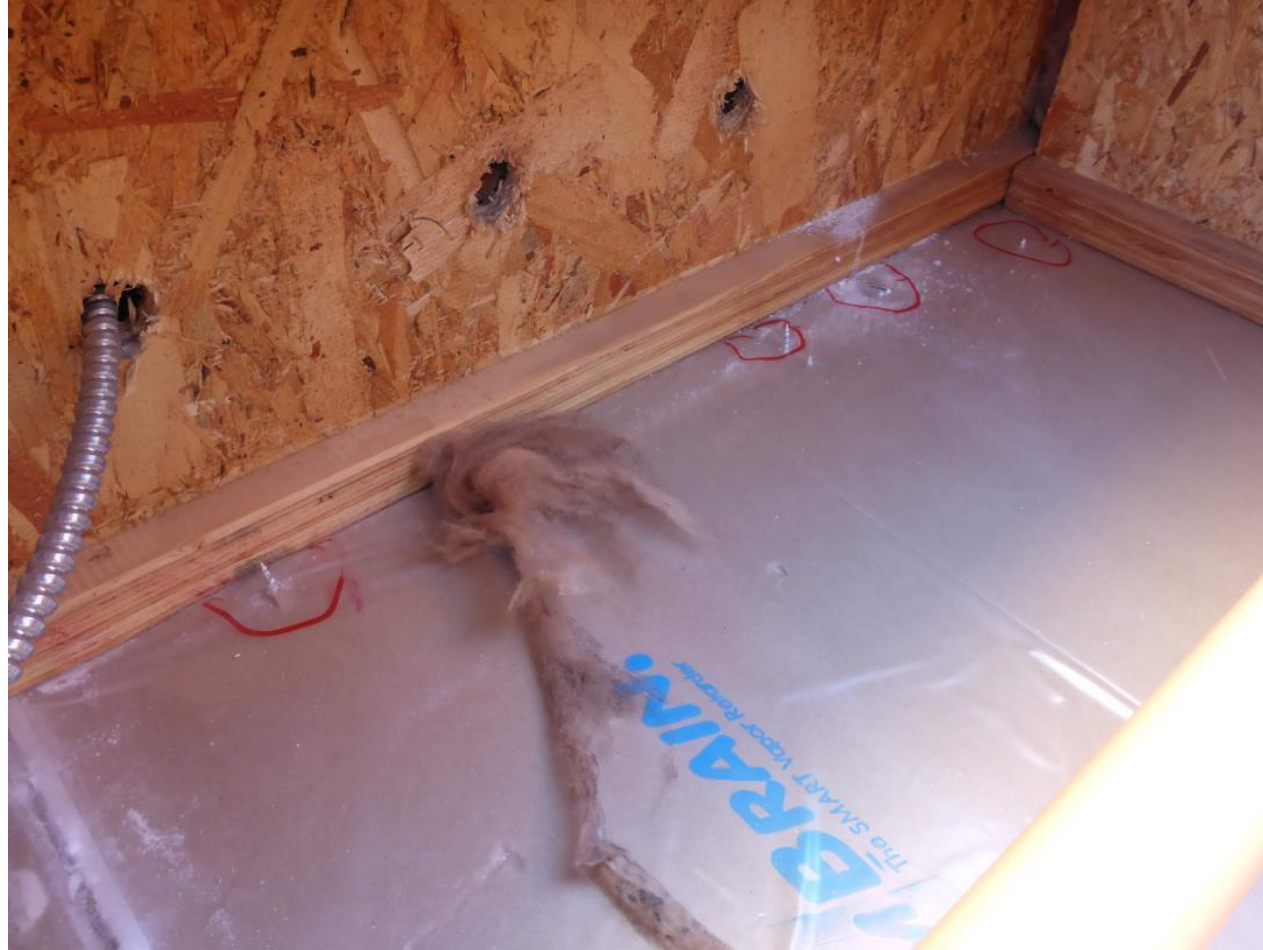
Drywall Screws Not Installed in to Framing

Destructive Test Cut #5b

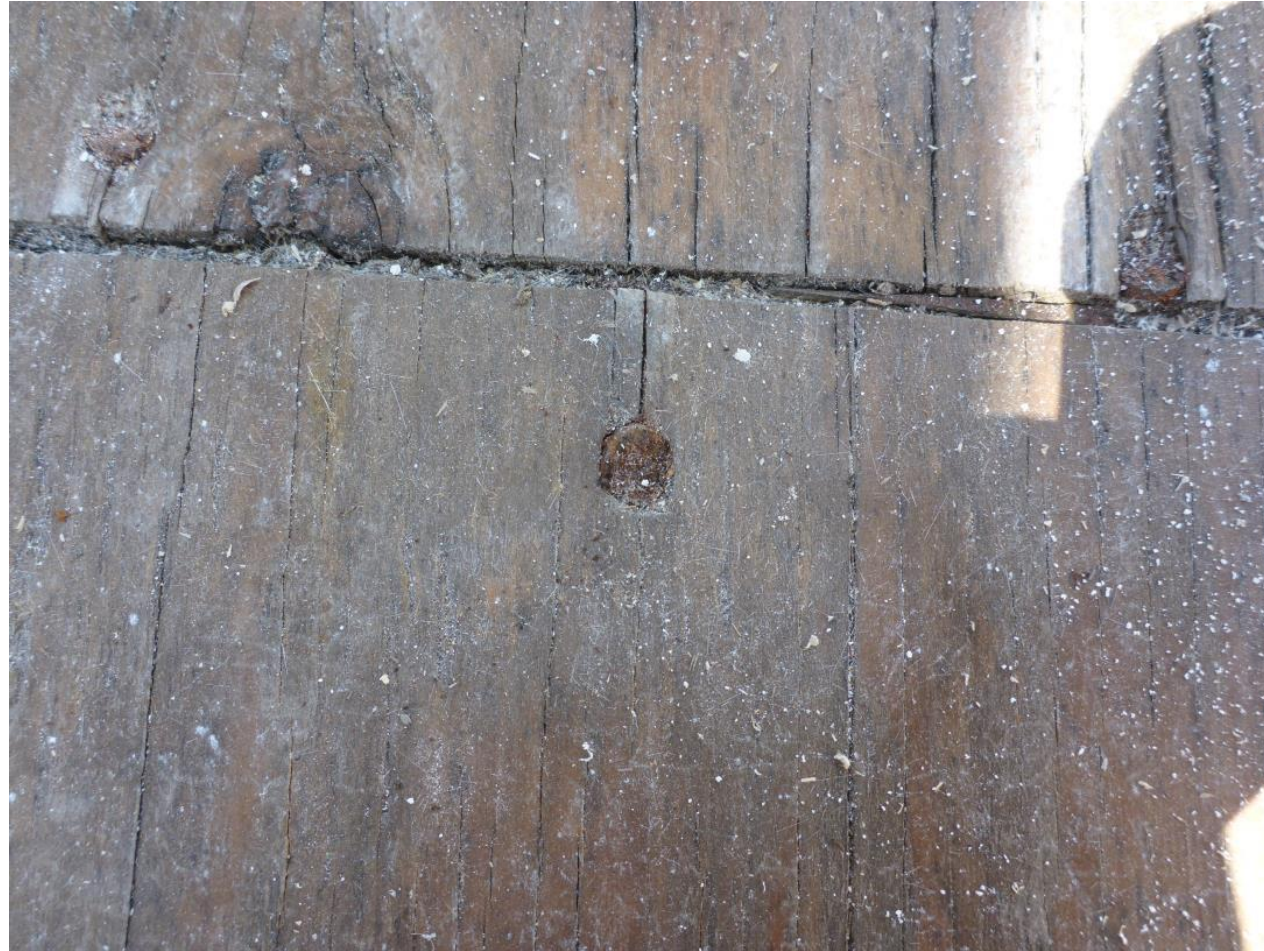
Weathered Sheathing and Rusted Fasteners

Destructive Test Cut #1b

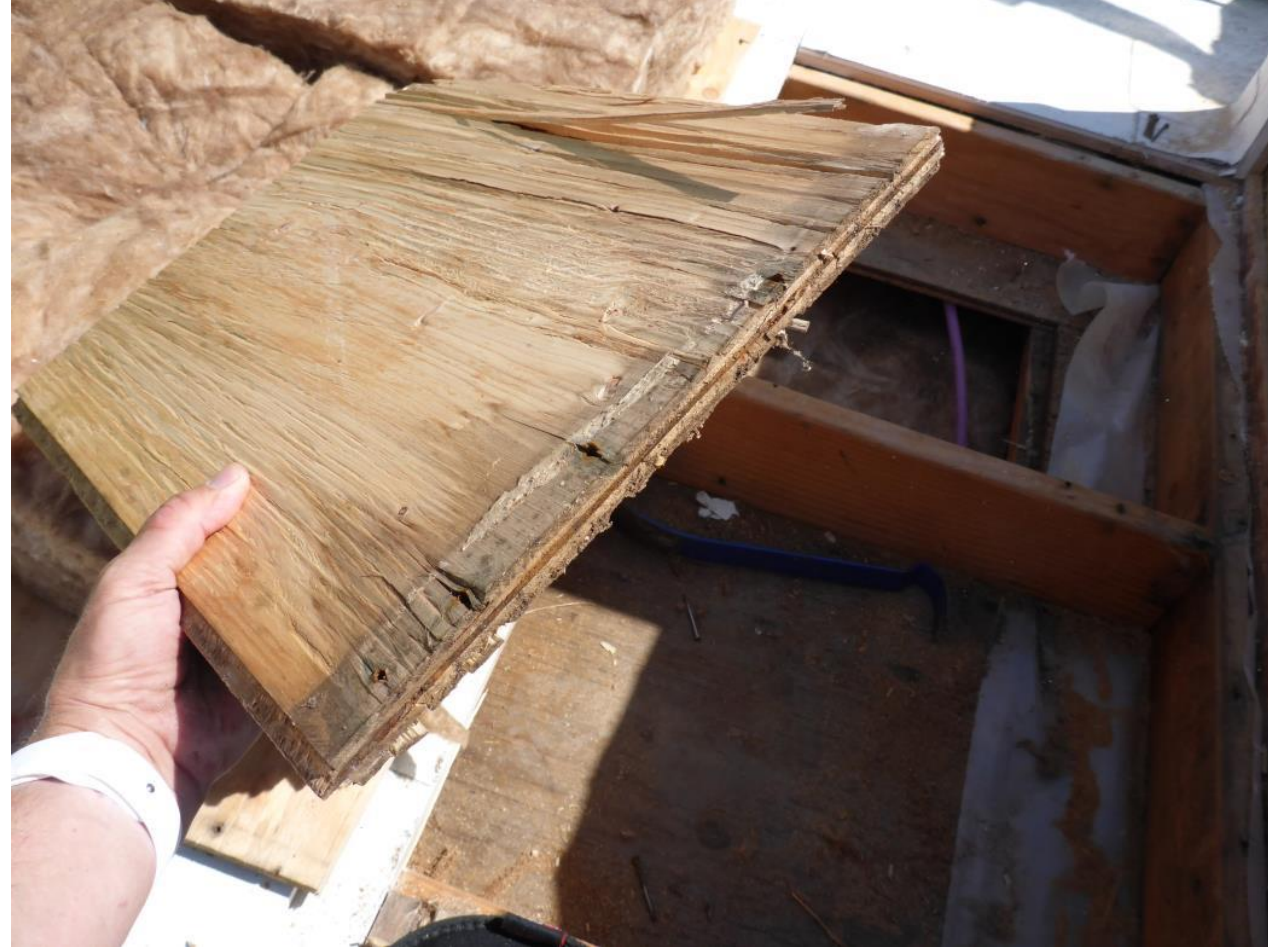
Damage Underneath the Plywood Deck Edge

Water Damage Due to Rain

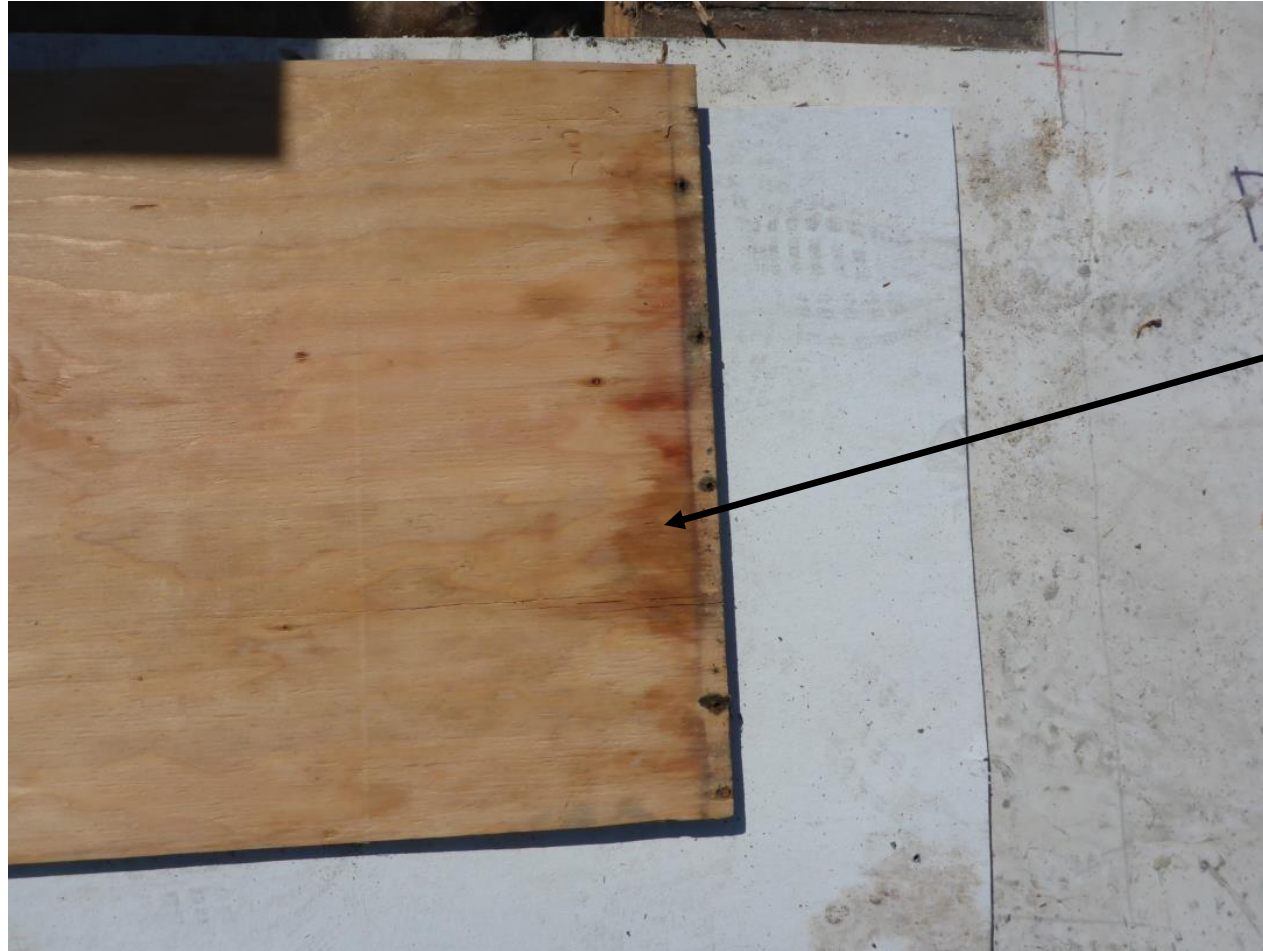
Damage Underneath Plywood Cricket

Destructive Test Cut #1b (Bottom of Structural Roof Sheathing)

Damage was at the top, water soaked through the T&G joints

Roofing Repair Action

- Demolition and replacement of 100% of cricket plywood and framing
- Selective replacement of structural sheathing where damaged
- Replacement of 100% of the roofing and flashings
- Replacement of 100% the sheet metal roofing coping caps
