Building Envelope

Curtain Wall Failures

Karim Allana, PE, RRC, RWC

Allana Buick & Bers, Inc.

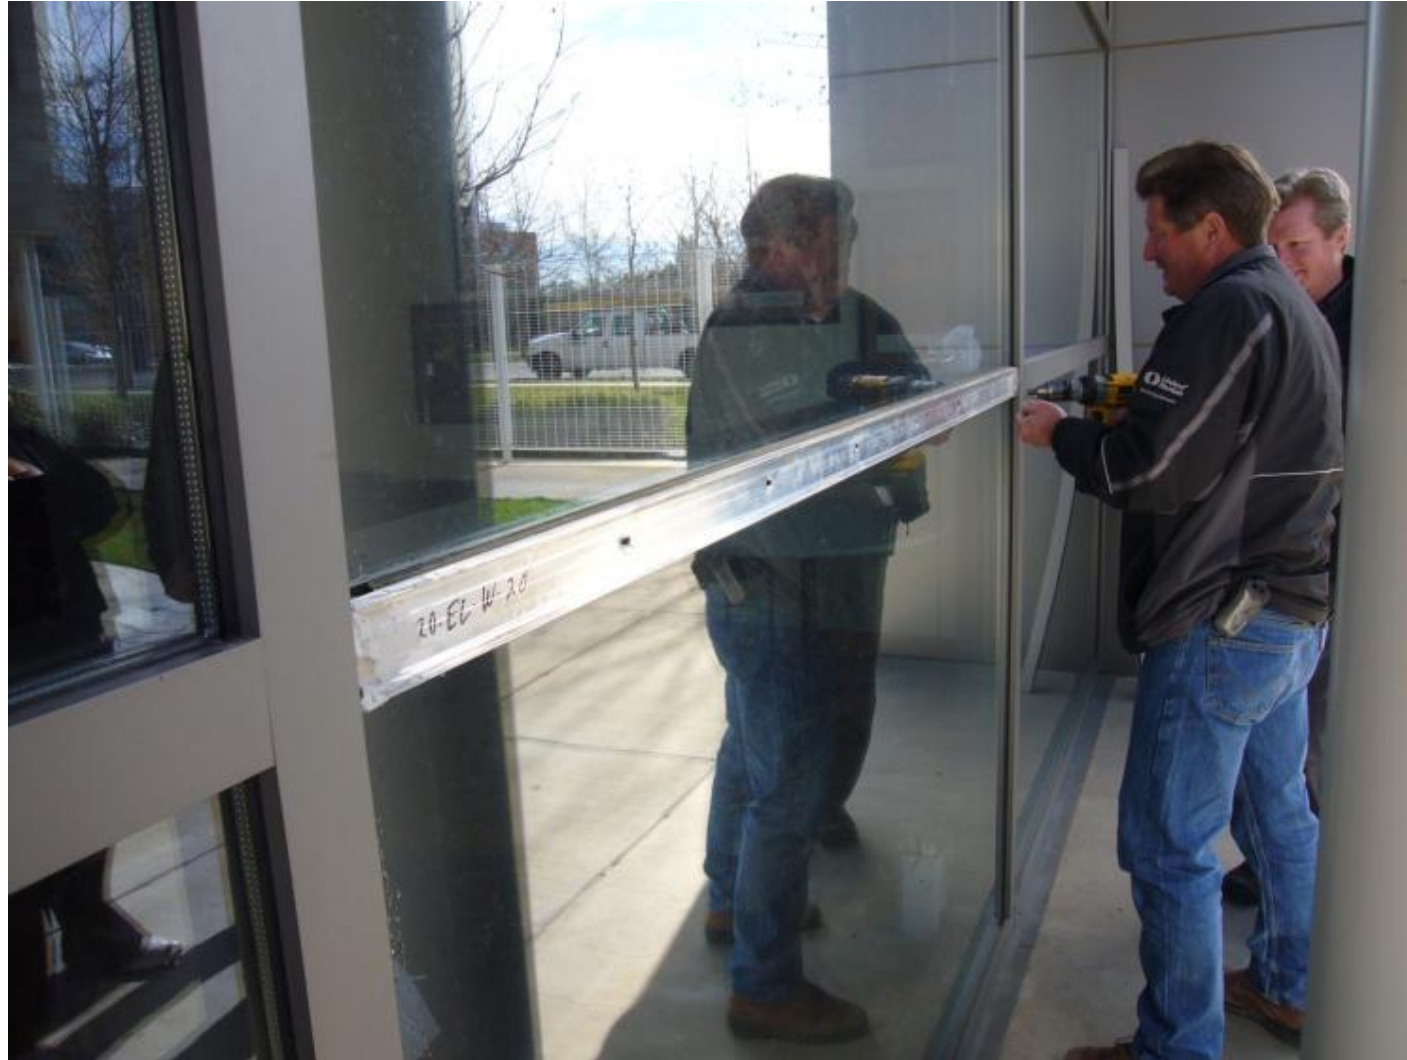
Mondavi Gasket Shrinkage / Failure

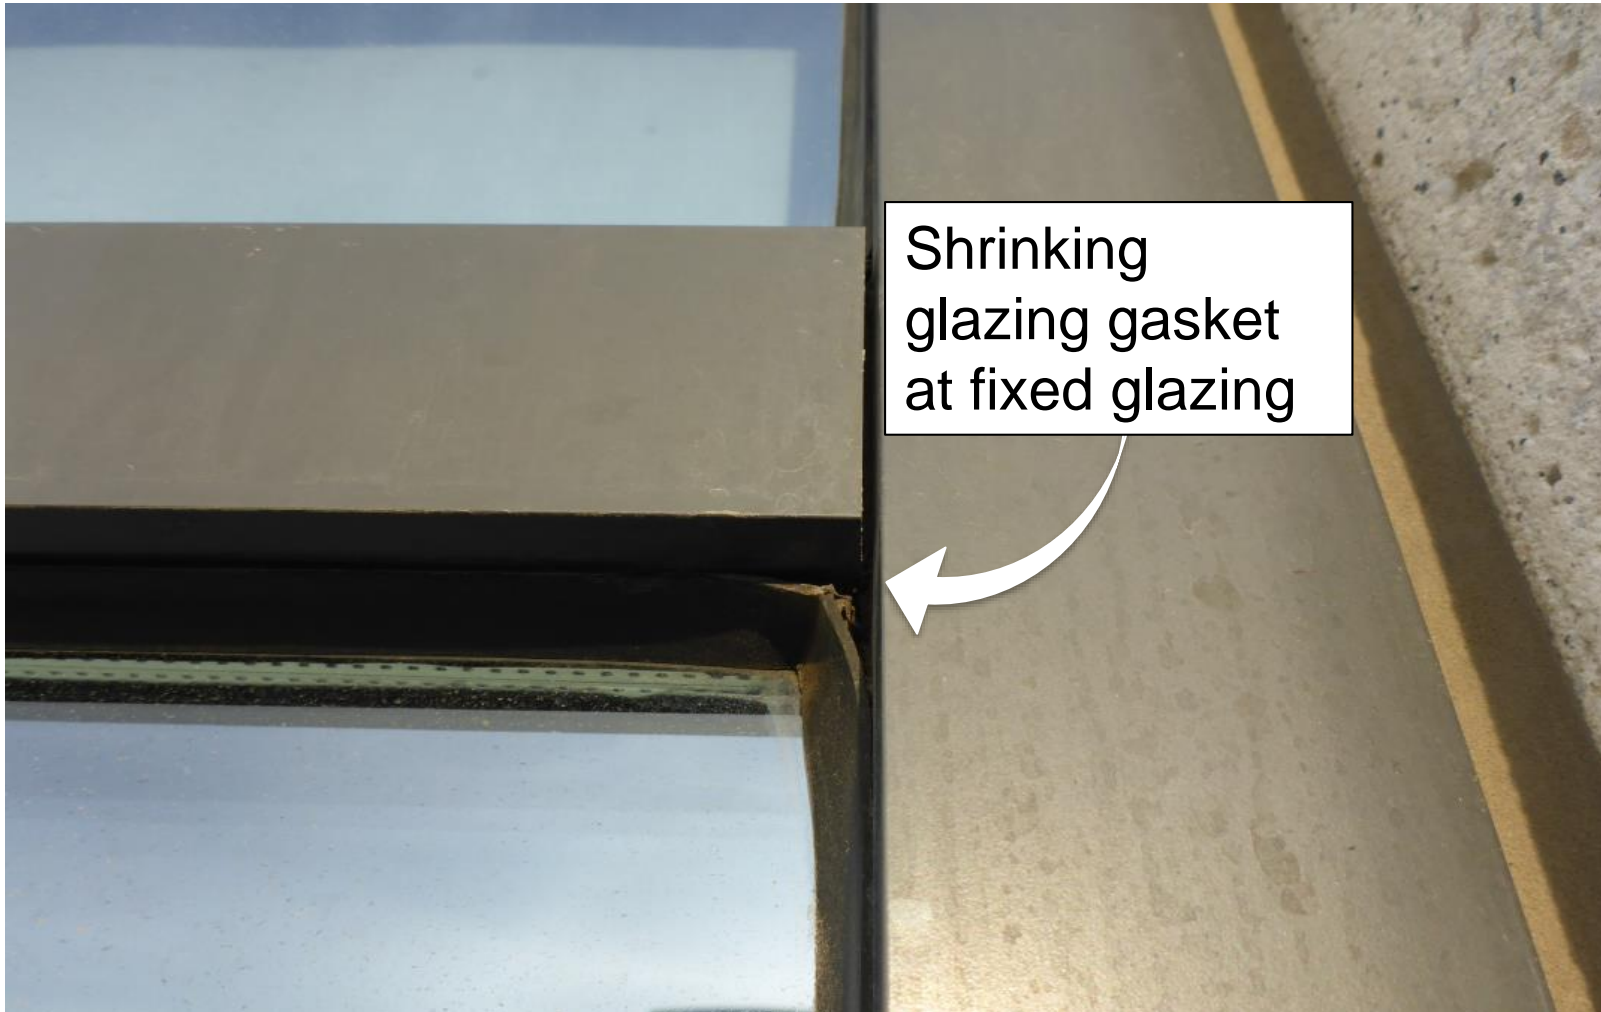
Gasket Failure - San Jose Condo

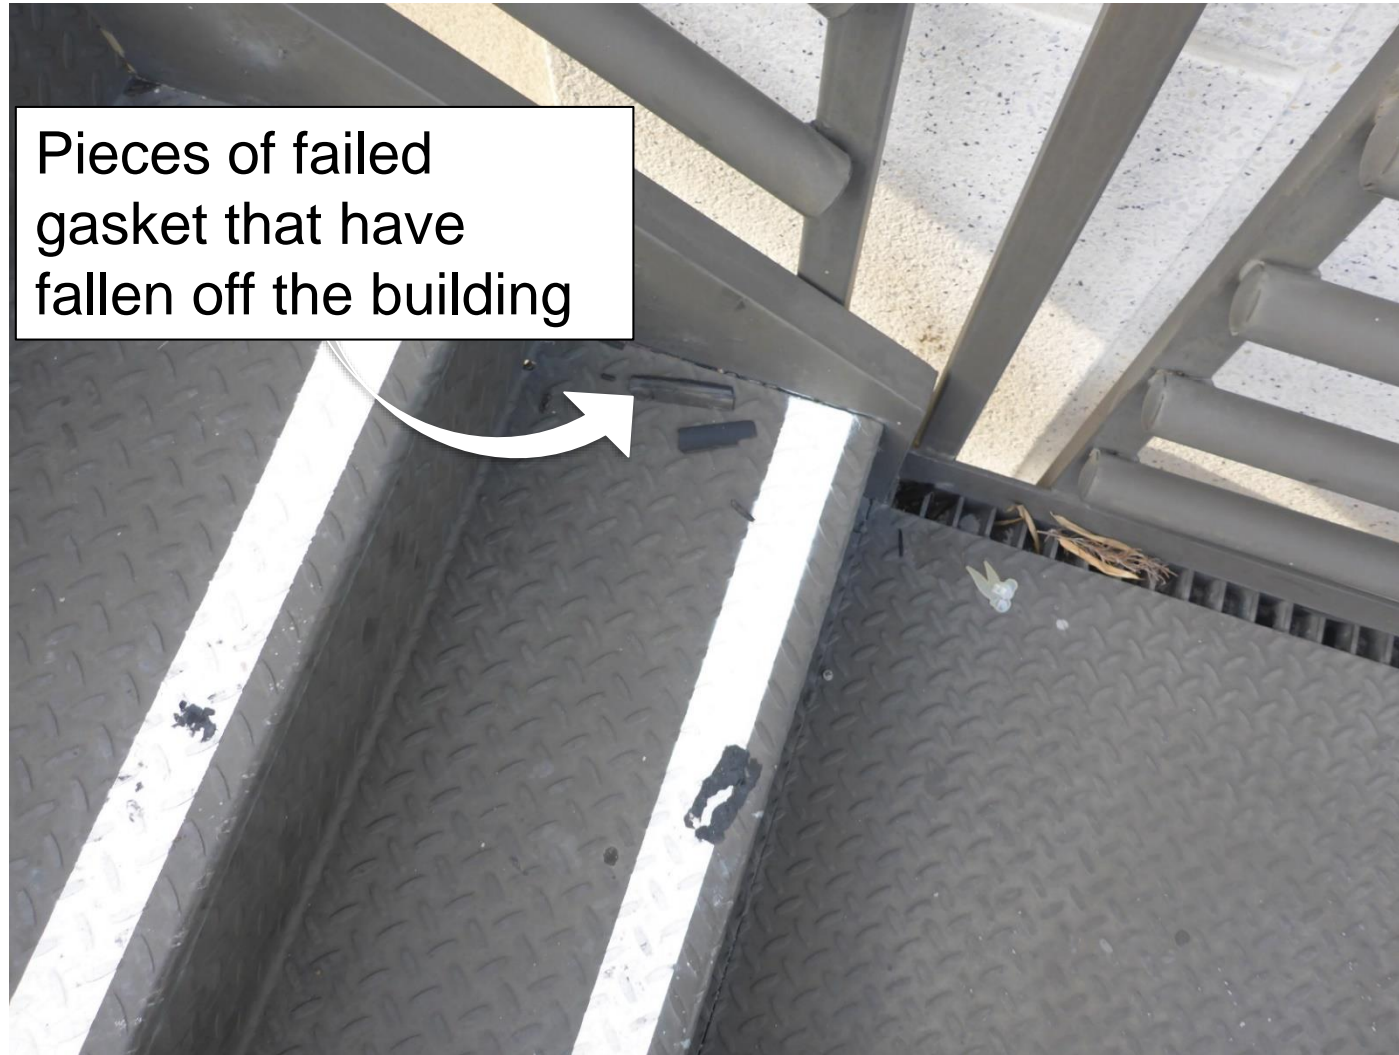
Gasket Failure- San Jose Condo

Pieces of failed
gasket that have
fallen off the building

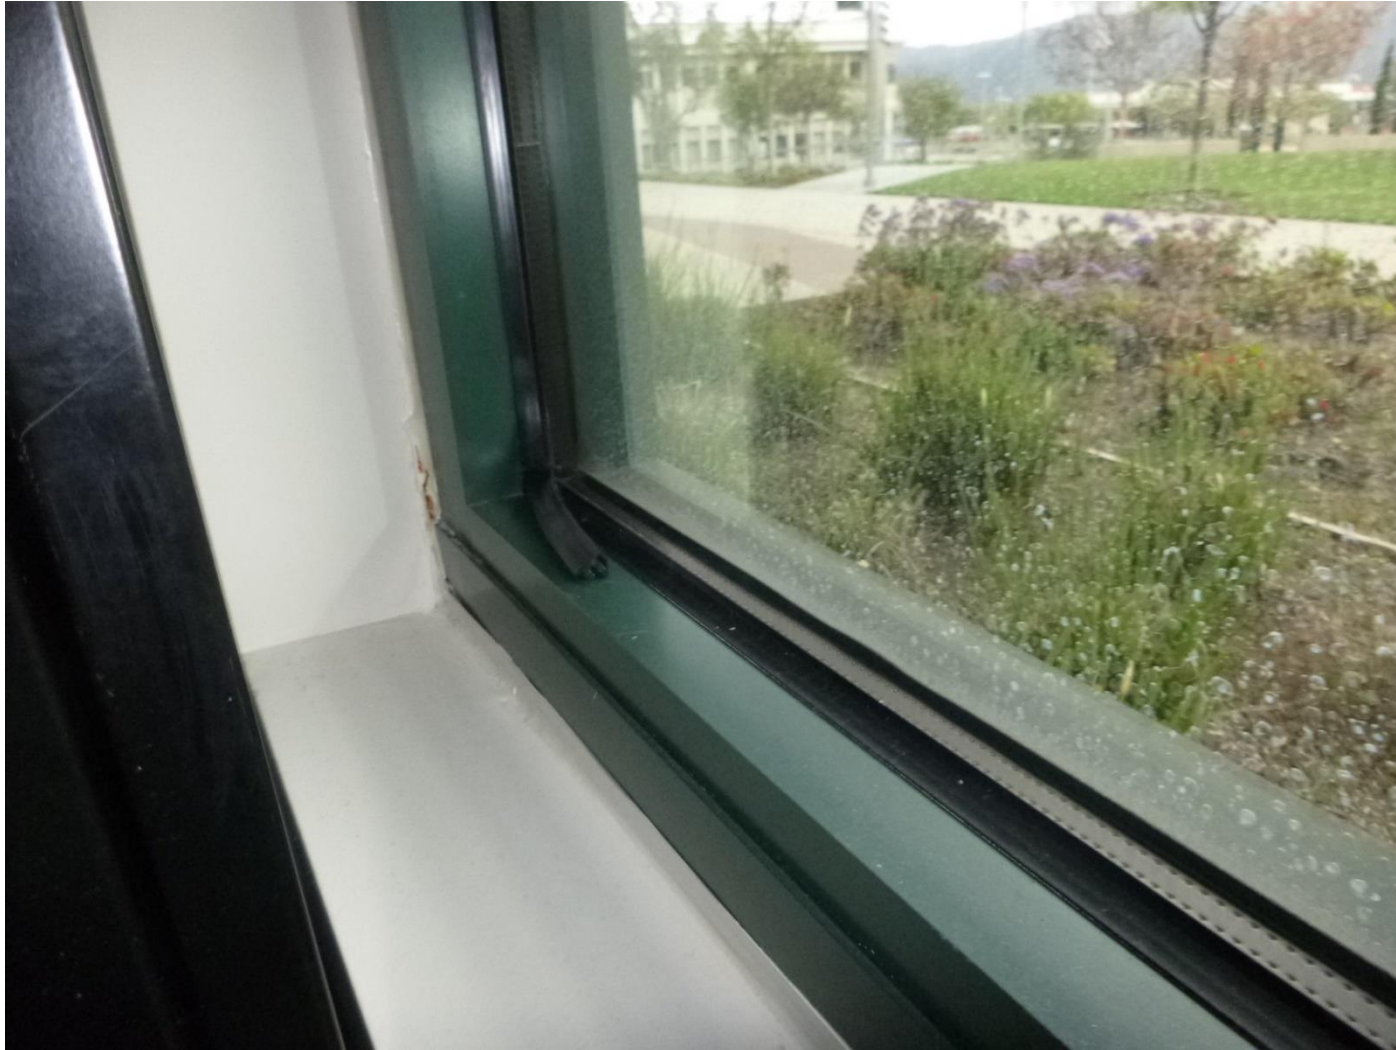
Gasket Failure- SM College Library

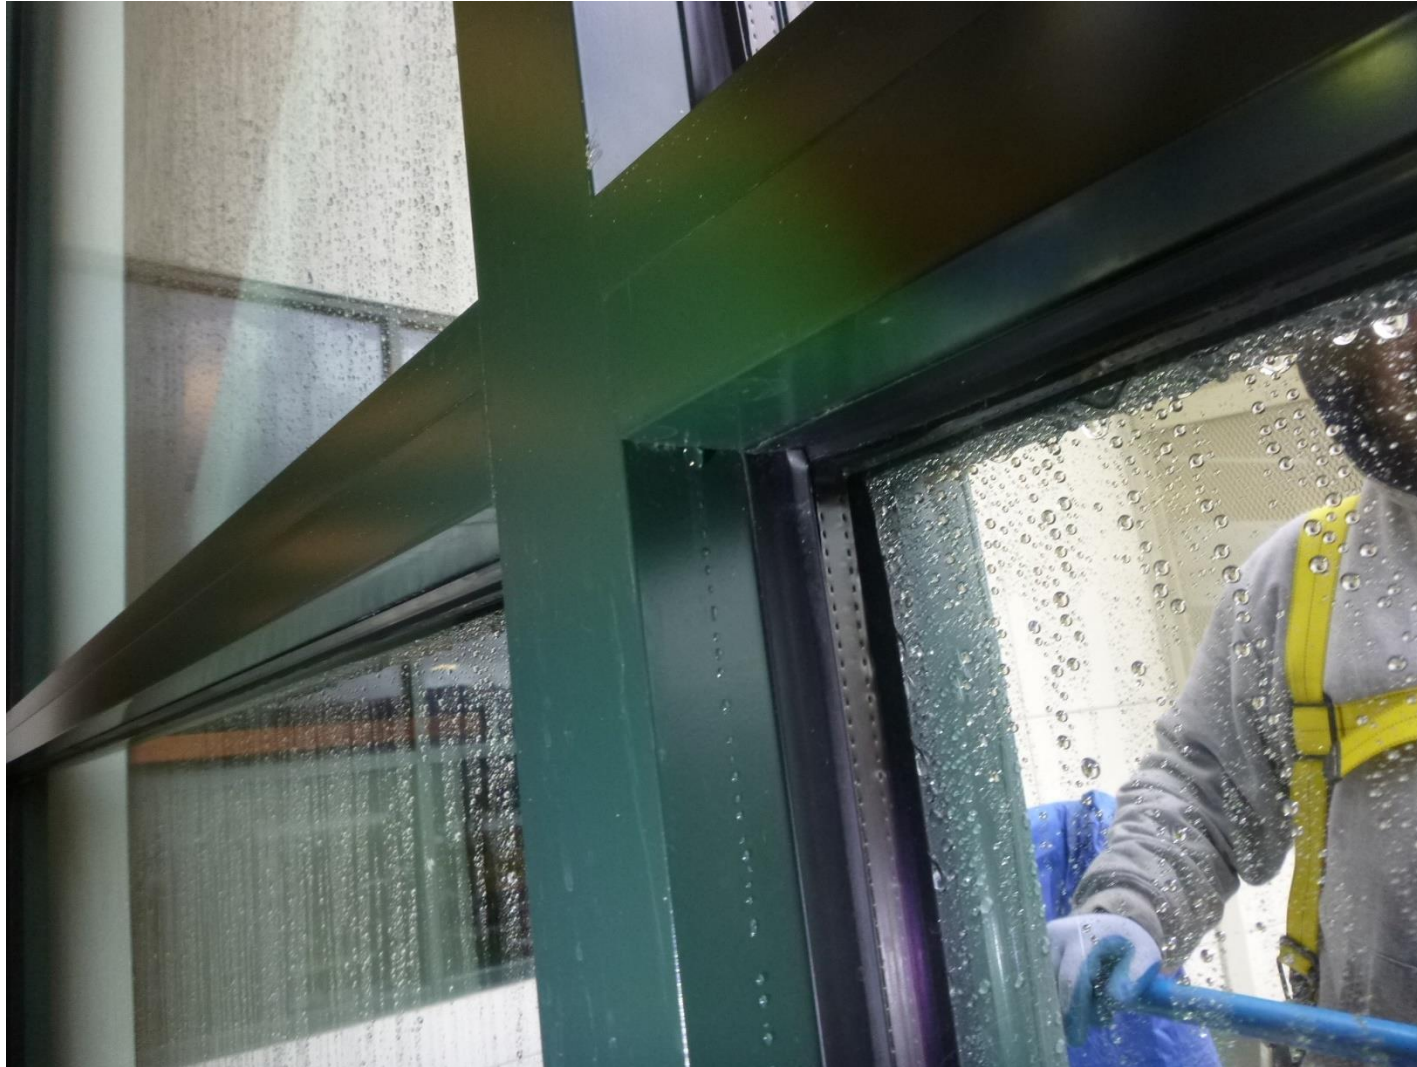
Gasket Failure- Causing Leaks

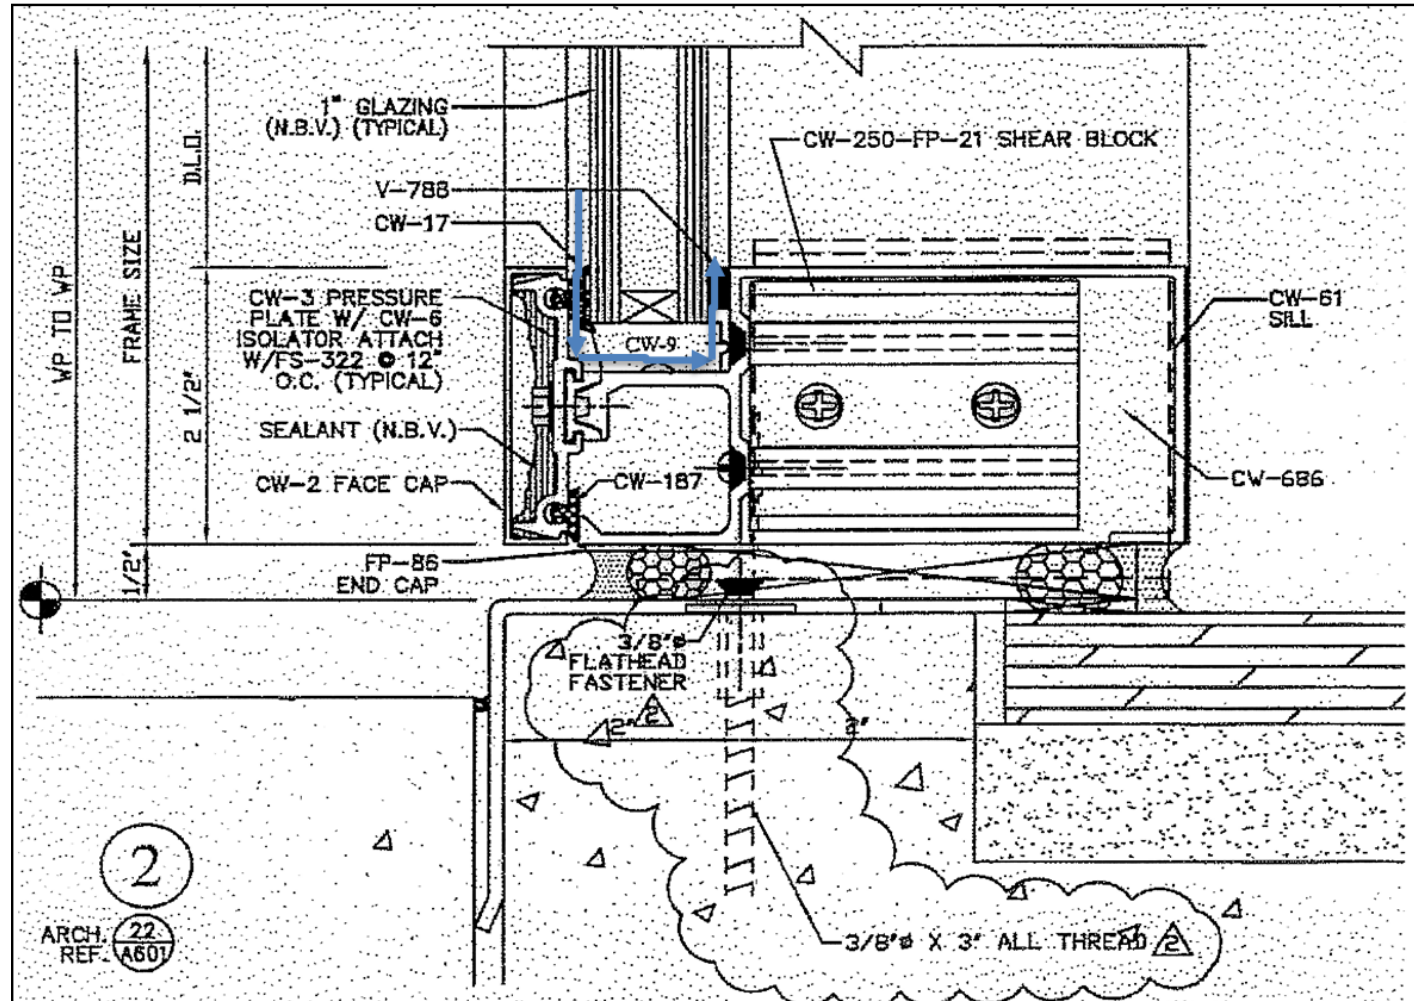
Typical EPDM Mullion Gasket Shrinkage

15/16" glazing installed produces a loose seal and leaks

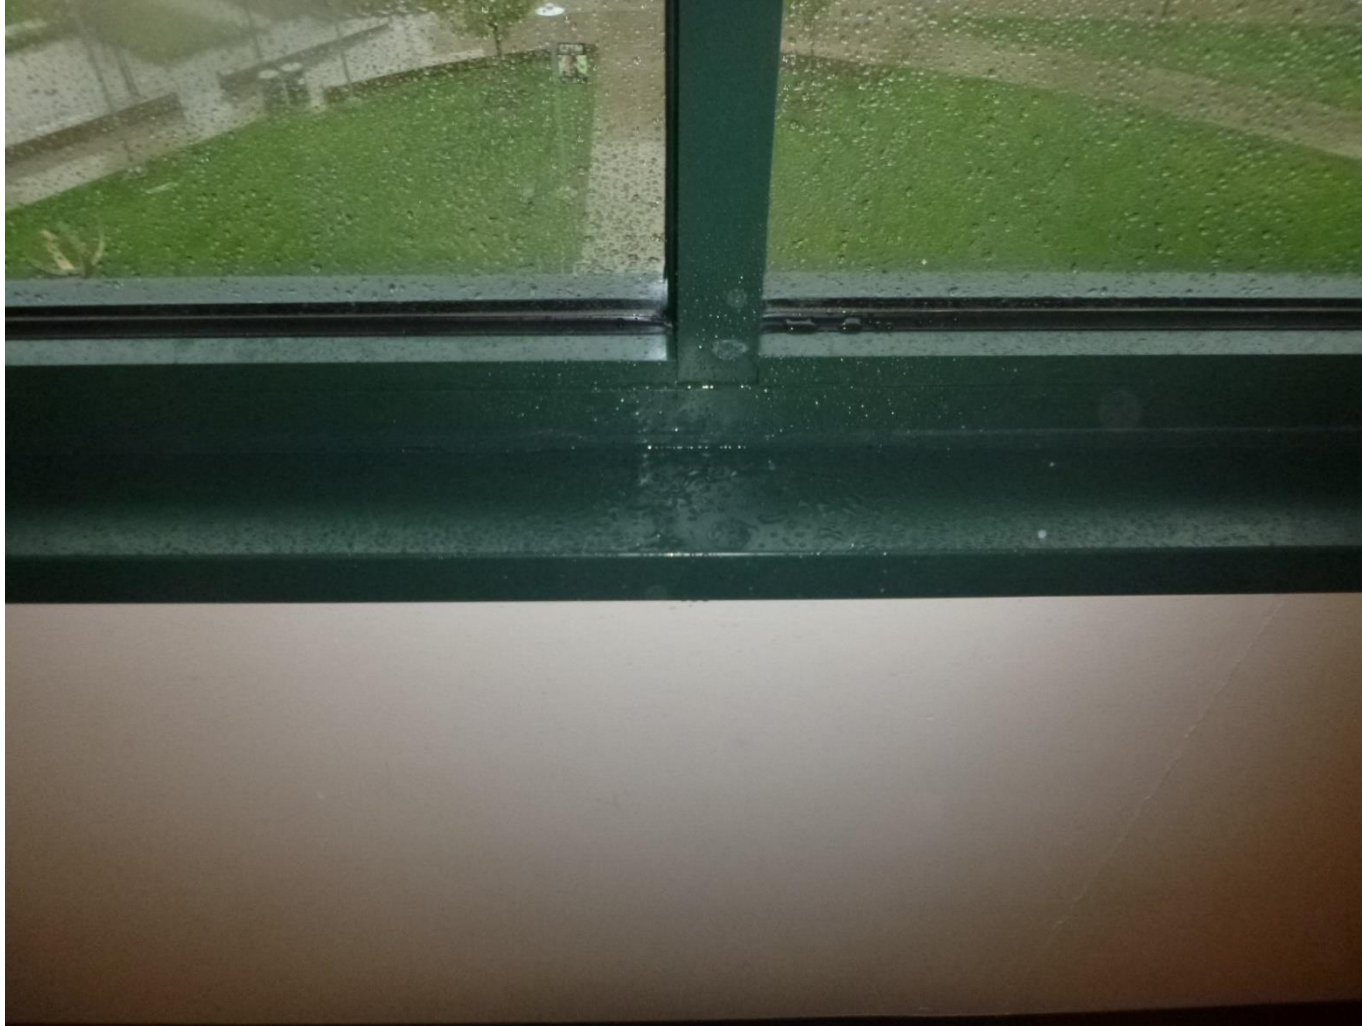
Gasket Shrinkage Water Intrusion

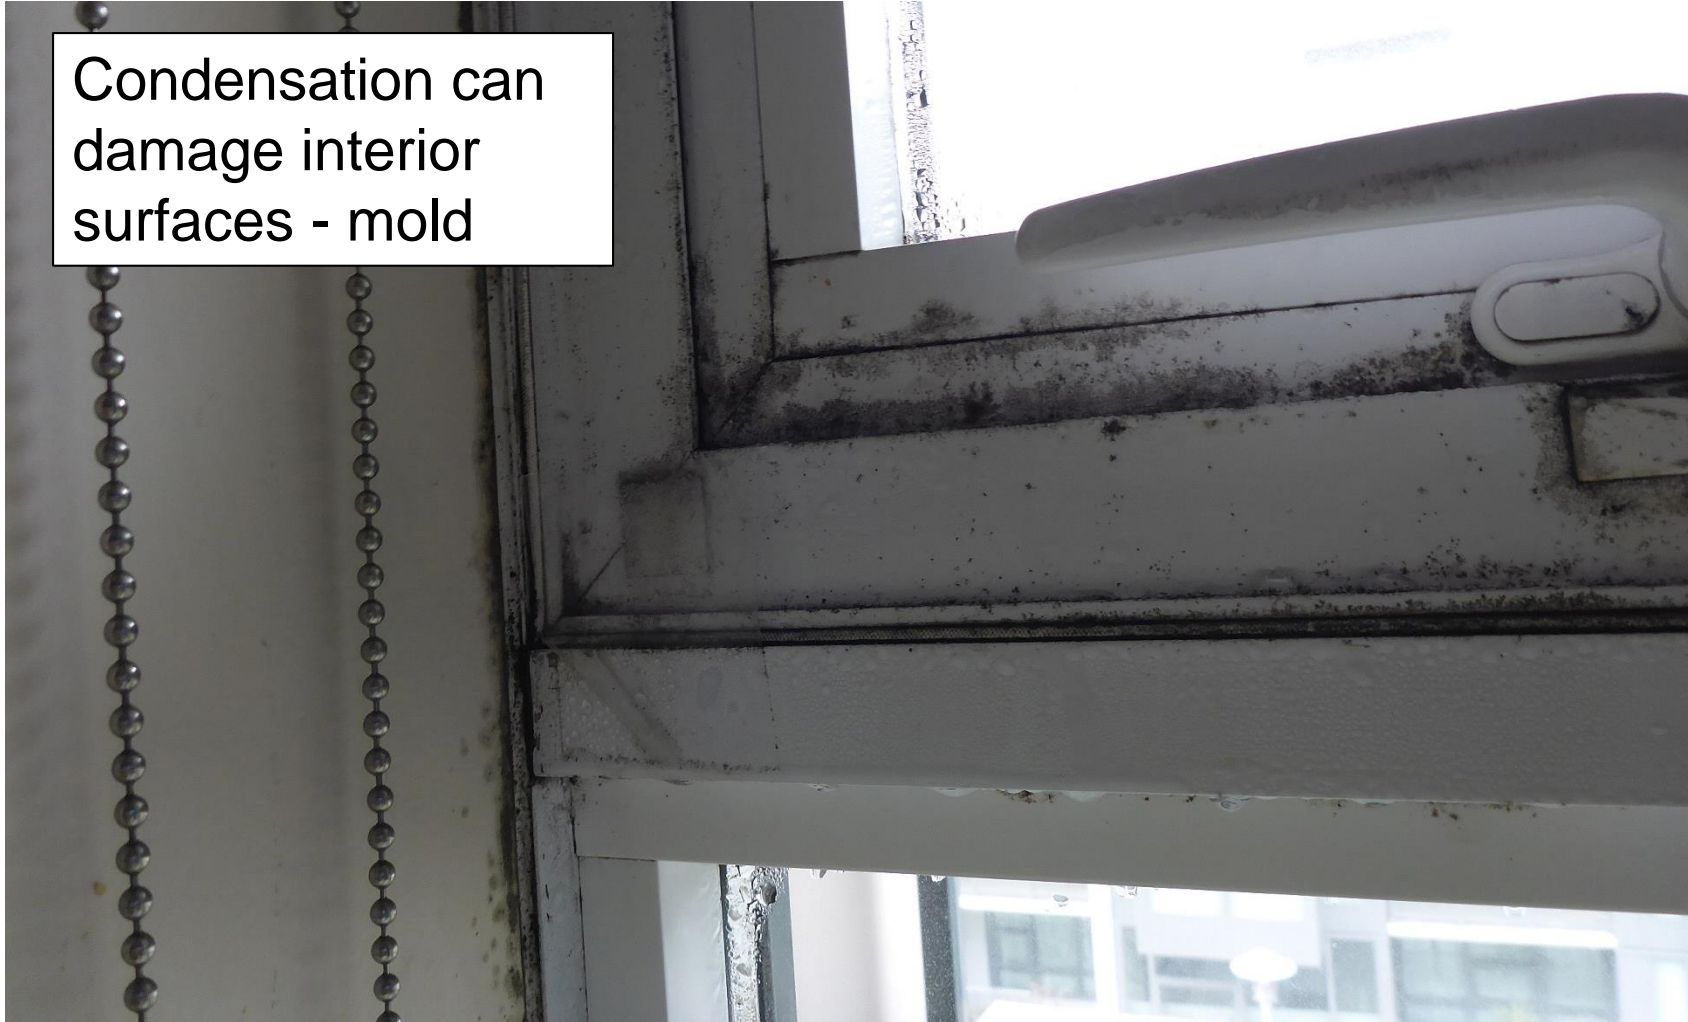
Condensation Due to Gasket Shrinkage

Condensation can
damage interior
surfaces - mold

- Specifying high quality gasketing materials
- Quality control testing/commissioning to check for specified materials
- Using wet seals on inside in conjunction with gaskets

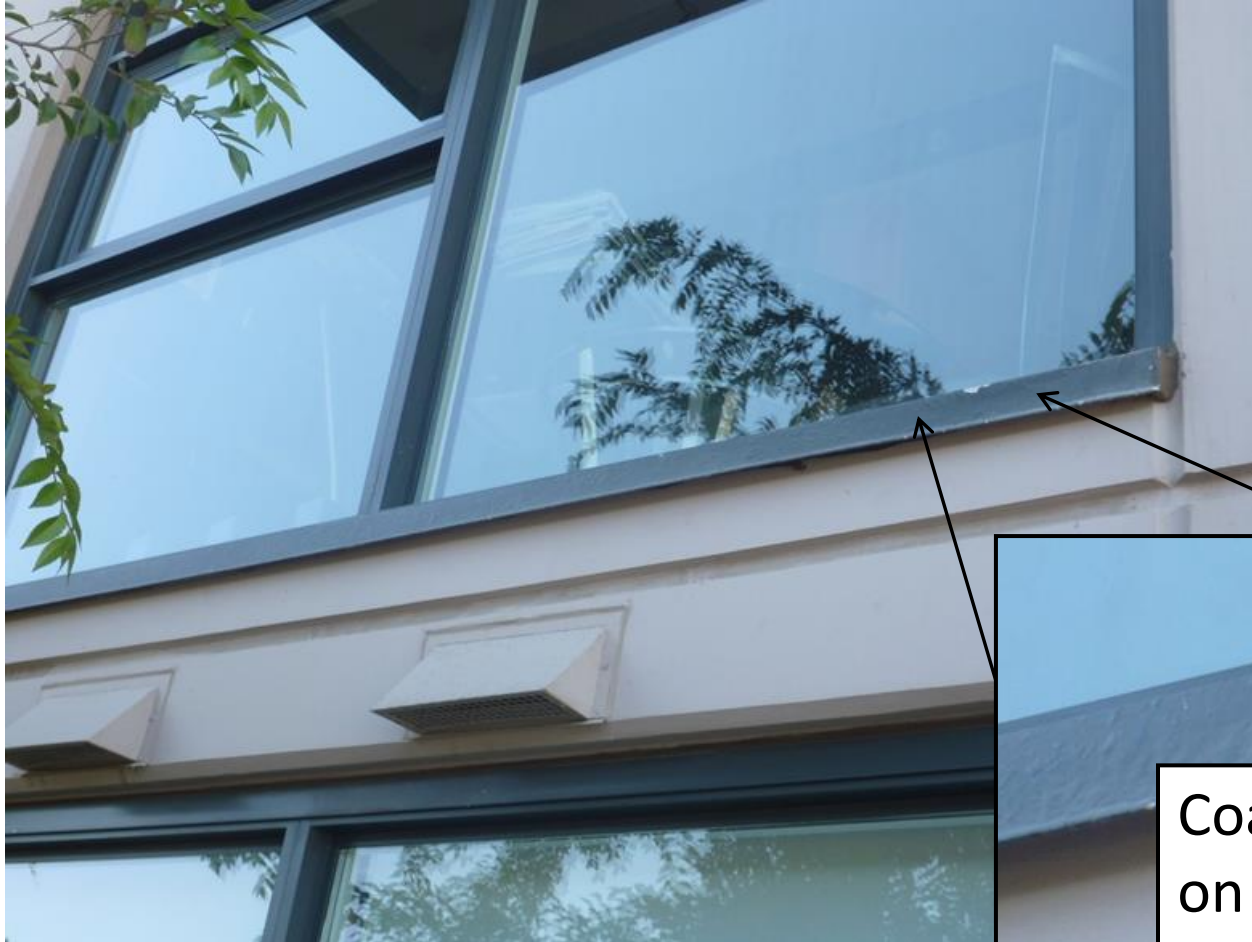
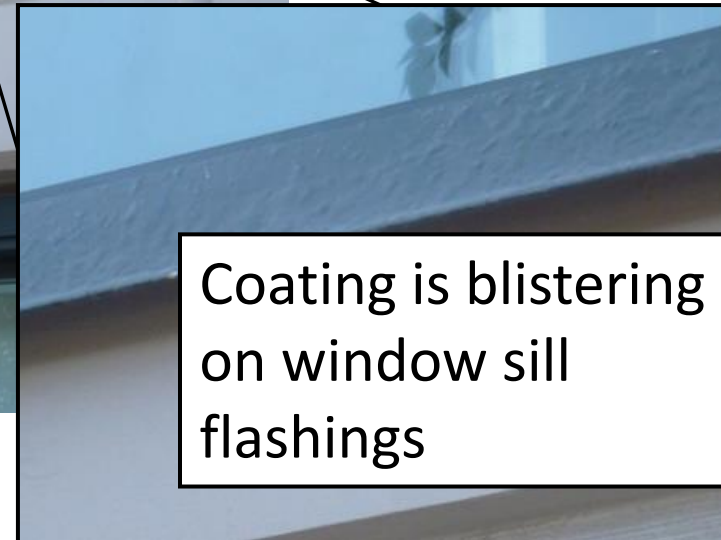
Aluminum Coating Failure

Coating is blistering
on window sill
flashings

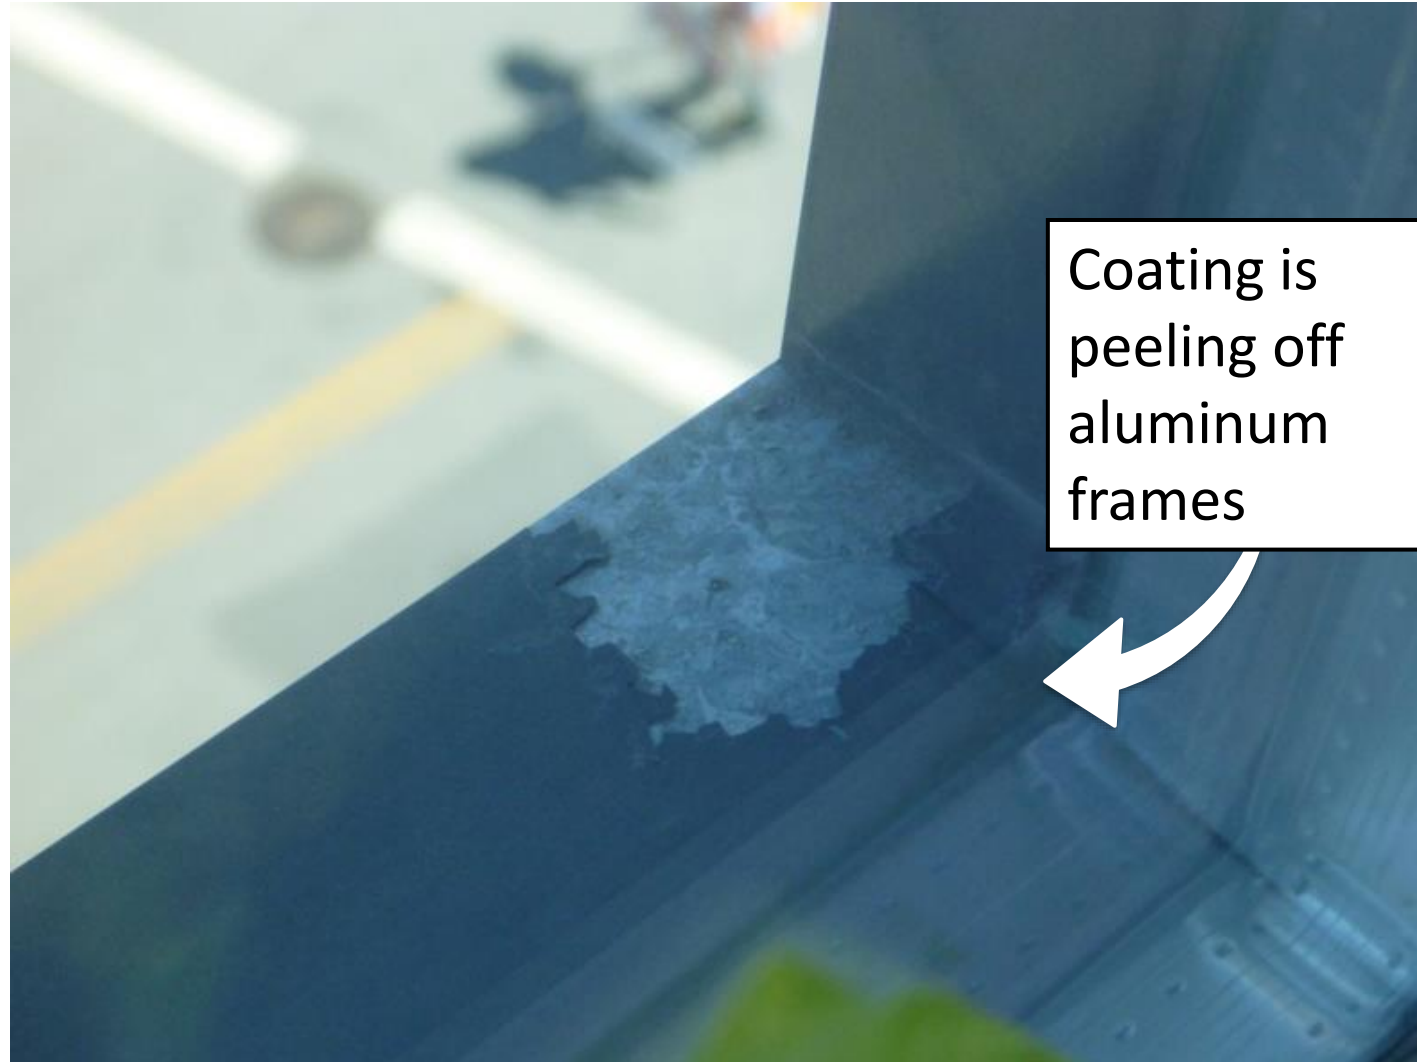
Aluminum Coating Failure

Coating is
peeling off
aluminum
frames

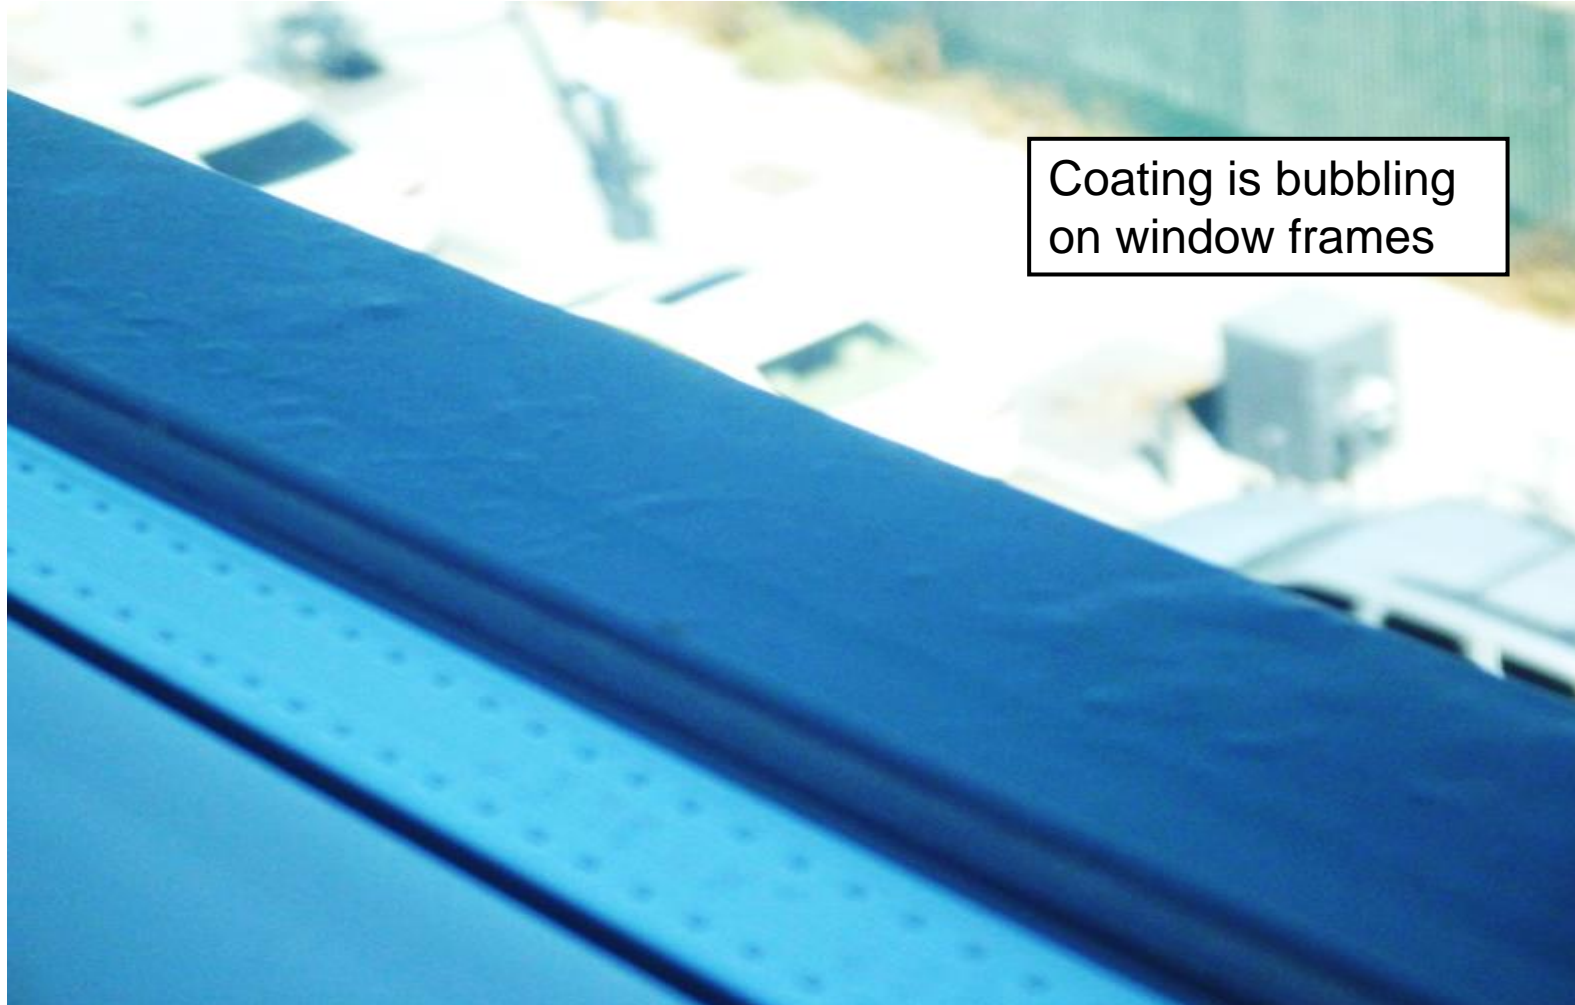
San Francisco Condo #1

Coating is bubbling
on window frames

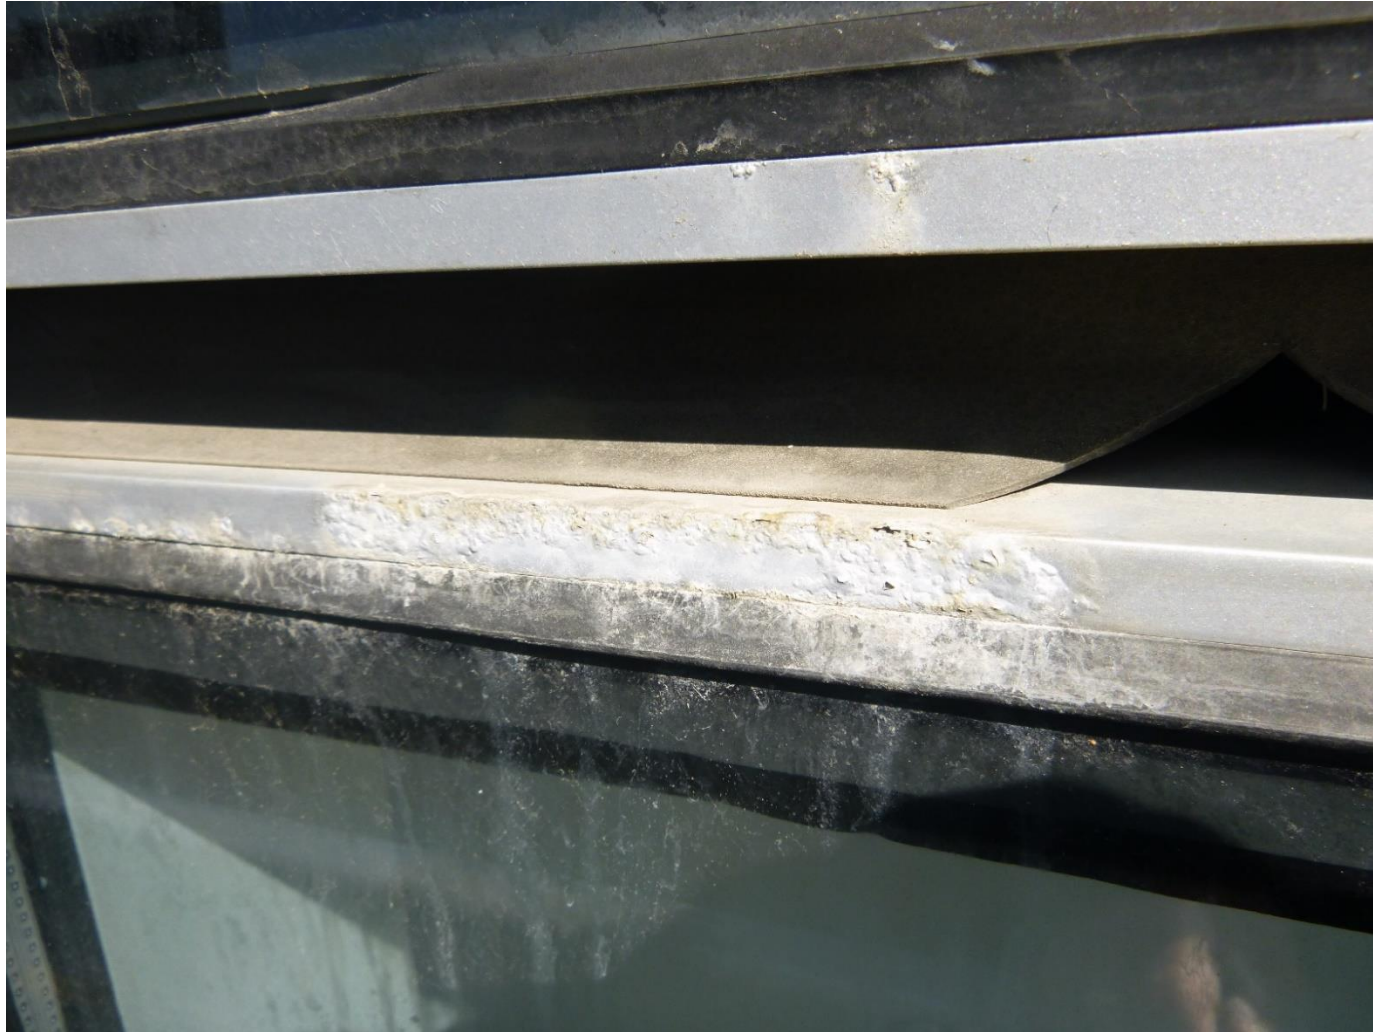
Coating Failure Causing Pitting

- Proper surface preparation and pre-treatments are not followed
 - Missing primer
- Coating requirements are not followed
 - Improper thickness of coating
- Lack of surface prep – leading to trapped contaminants

- Proper preparation and coating requirements must be followed
 - Surface preparation, coating thickness requirements
- Use of Fluoropolymer finishes that meet AAMA 2605 certification
- Reviewing coating submittals
- Performing factory visits and verification
- Obtaining samples from factory runs and send for independent testing

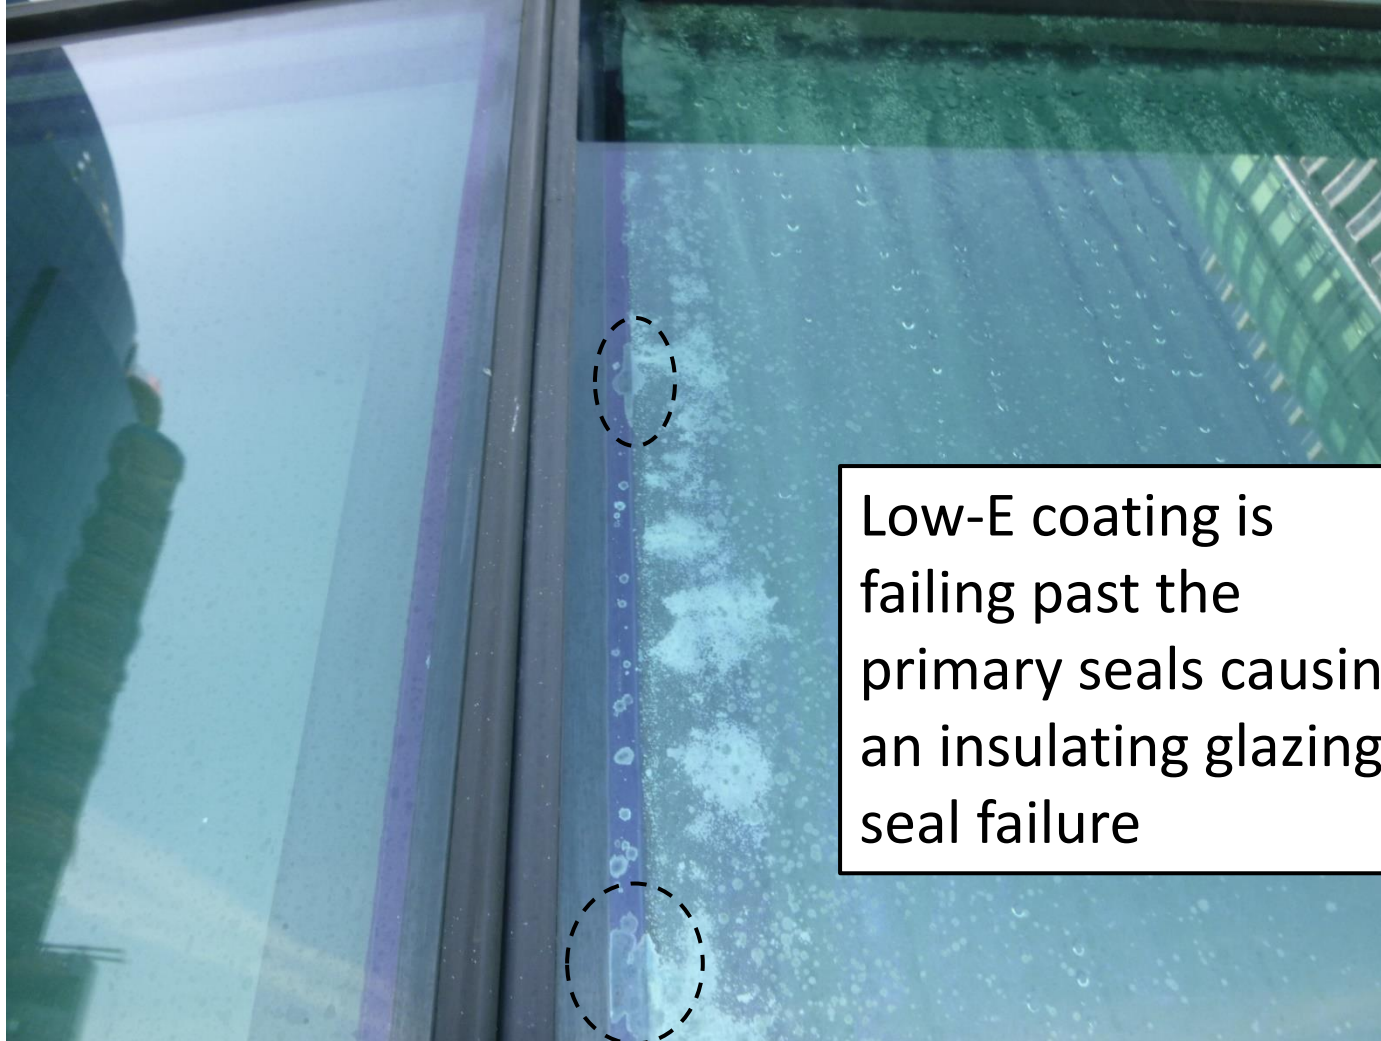
Tarnishing of Low-E Silver Coatings

Low-E coating is failing past the primary seals causing an insulating glazing seal failure

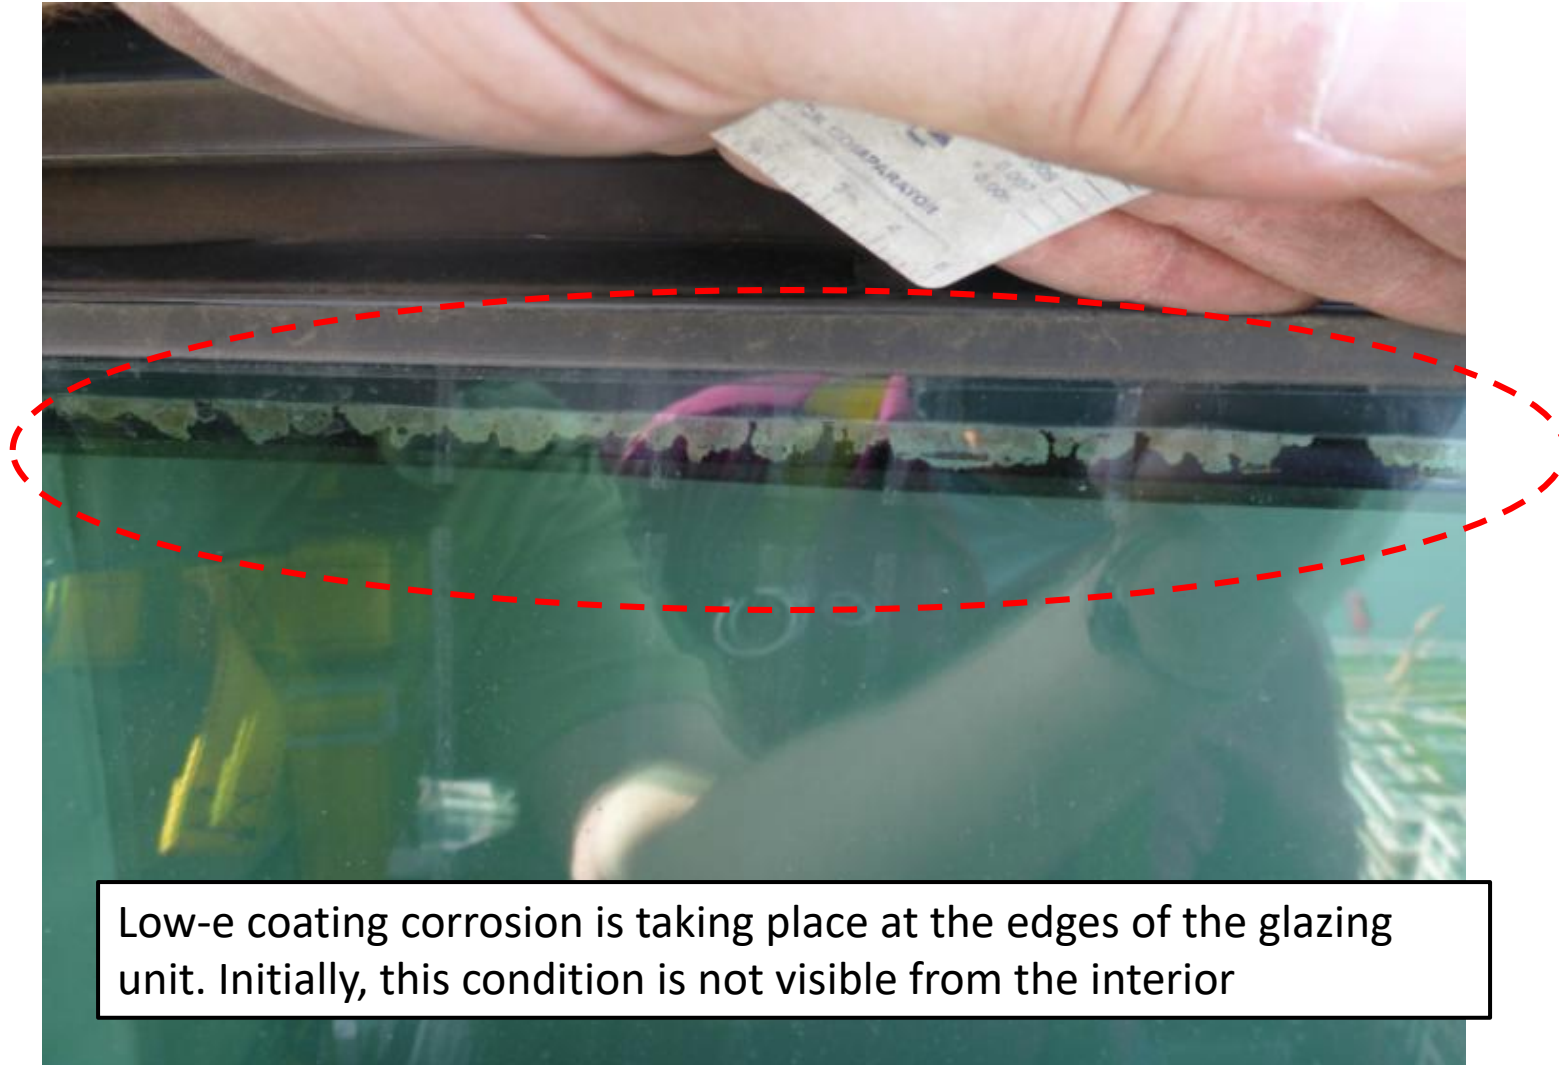
Start of Low-E Coating Corrosion

Low-e coating corrosion is taking place at the edges of the glazing unit. Initially, this condition is not visible from the interior
