Building Envelope

Curtain Wall Failures

Karim Allana, PE, RRC, RWC

Allana Buick & Bers, Inc.

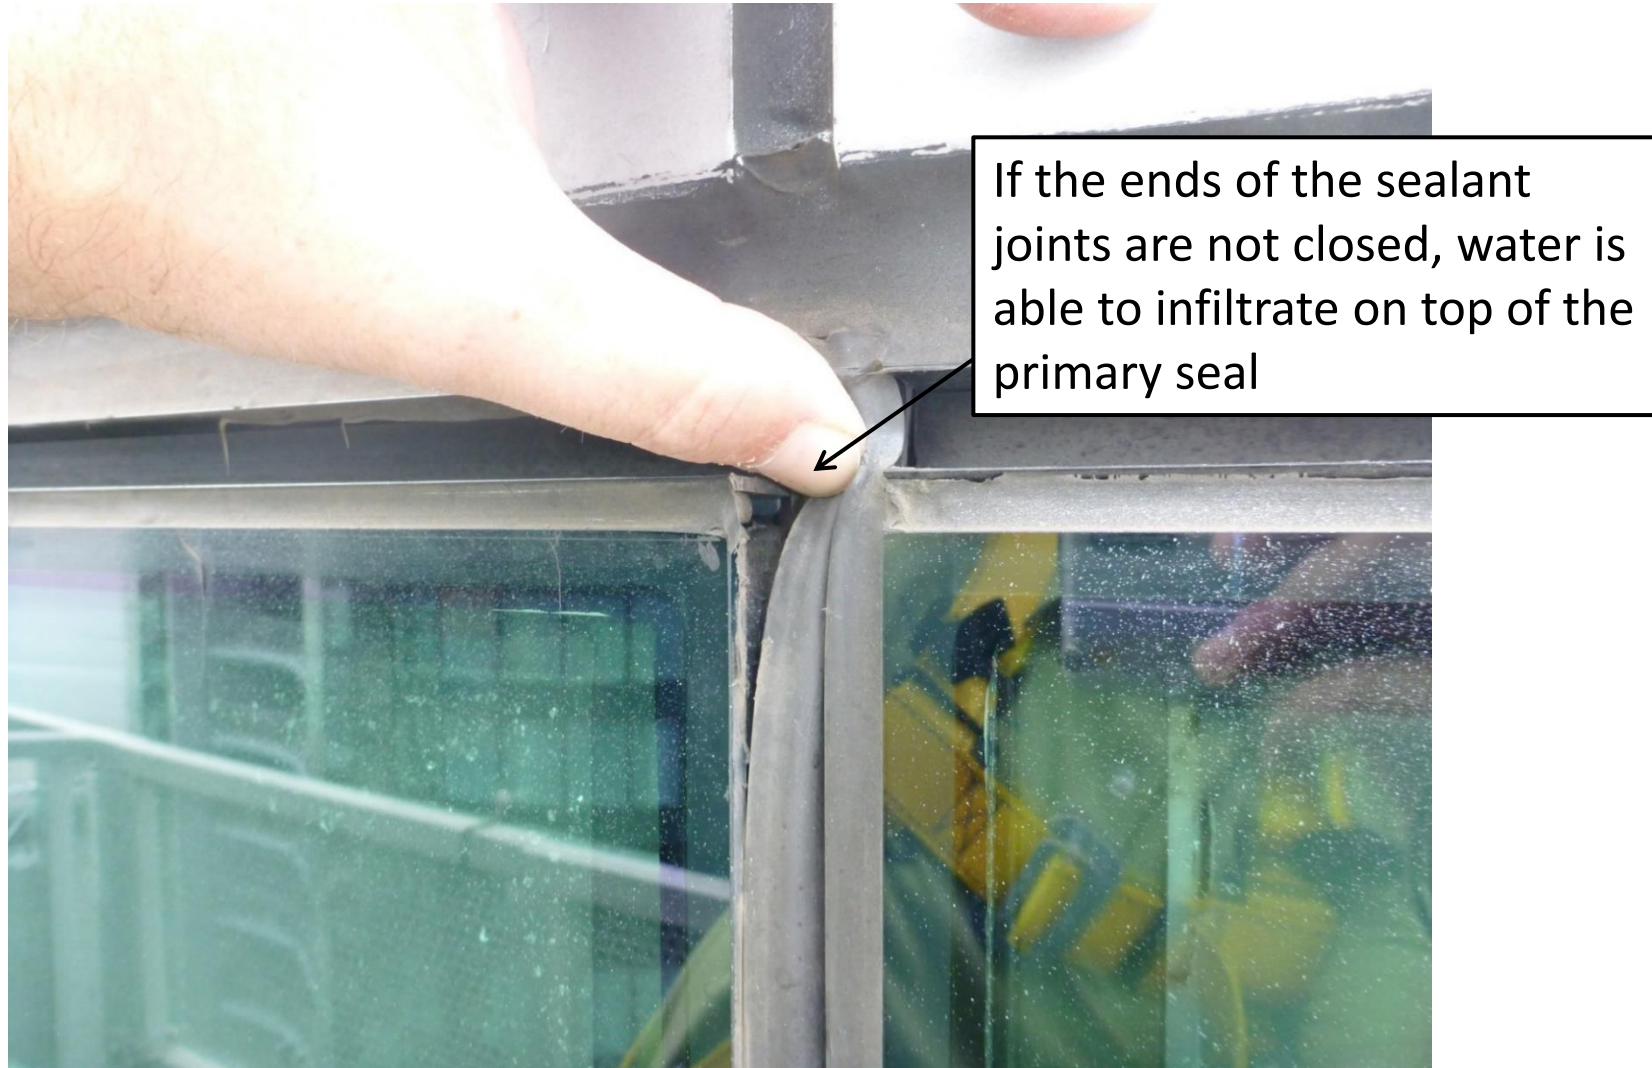
Water Infiltration at Head Stands on IGU Seal

All IG units have low-E deleted only about 3/8" but the total bond line of the PIB and silicone is about 5/8" to 3/4"

Energy dispersive X-ray spectroscopy (EDX) of the edge-delete (Table A), low-E coating under the PIB (Table B), and discolored low-E revealed that there was no corrosive materials such as chlorine, phosphorus, or sulfur in contact with any surfaces. There is evidence however, that the edge delete was not complete and left some residual low-E coating under the silicone secondary seal.

Failure is most likely the result of extended water contact due to the flexible vertical tubing retaining water, which allowed water to migrate along the tops of the IG units. It appears there is installation issues with the lack of vertical tube drainage as well as IG manufacture by not edge-deleting properly. The PIB is of good quality and could have resisted water penetration if it were not adhered to the low-E which is attacked by the water contact, resulting in bond/seal loss.

- Proper edge deletion needs to occur during the manufacturing process to ensure proper bonding of the IGU sealants
- Design of the glazing and curtain wall assembly should not allow water to stand on top of the silicone sealant because, silicone is permeable
- Design installation of glass should be on blocks and properly drained to prevent dual glazing to sit in water

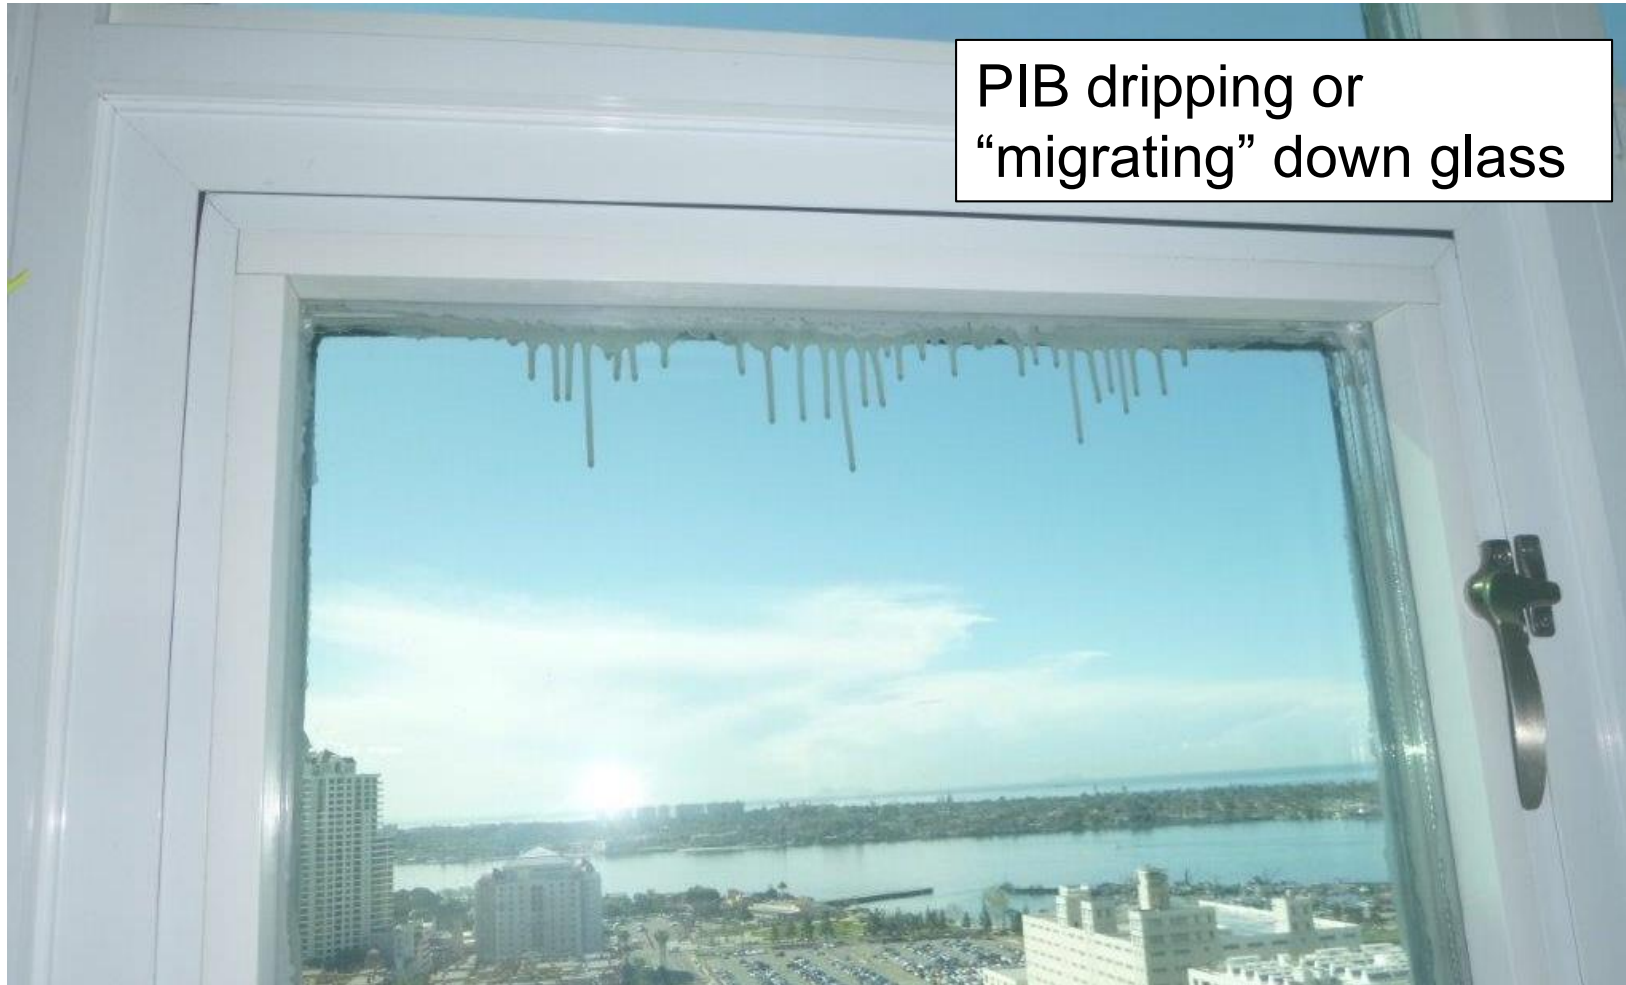
PIB Migration/Failure in IGU

- Requires glazing replacement
- Limited to gray PIB
- Gray PIB contains 64.8% polymer with plasticizers as low as 2.6%
 - PIB control samples are 97.5% polymer and 30% plasticizer

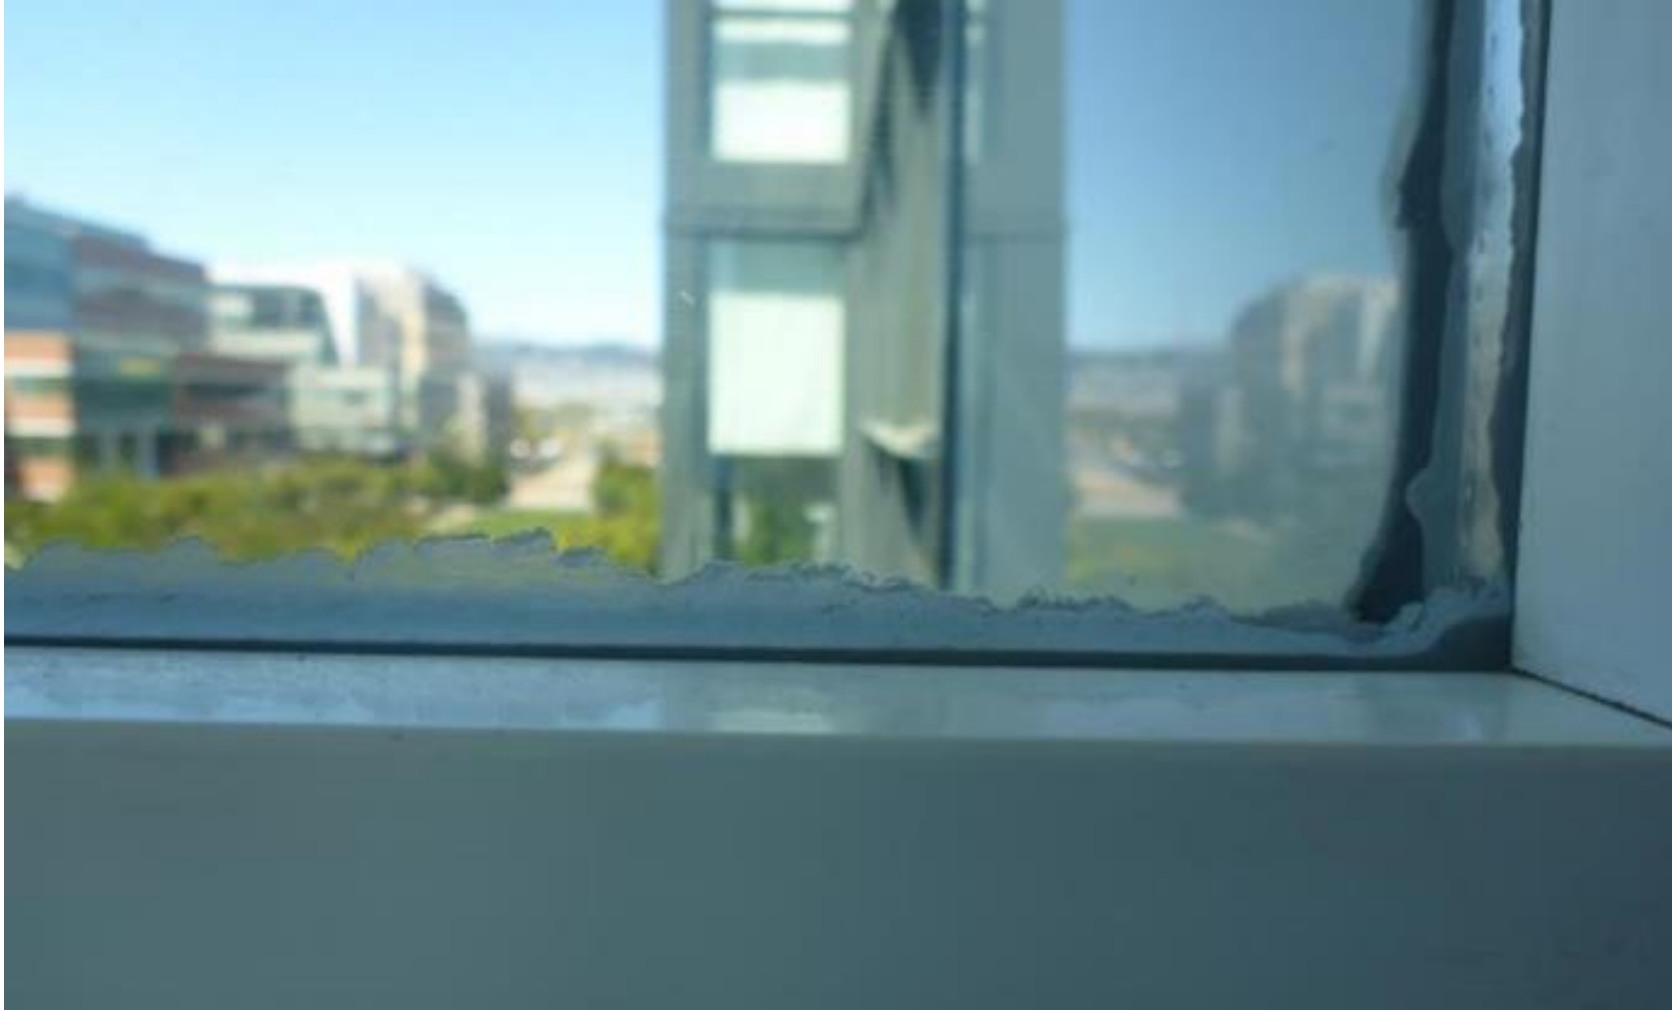
PIB Migration, Moving/Walking Up

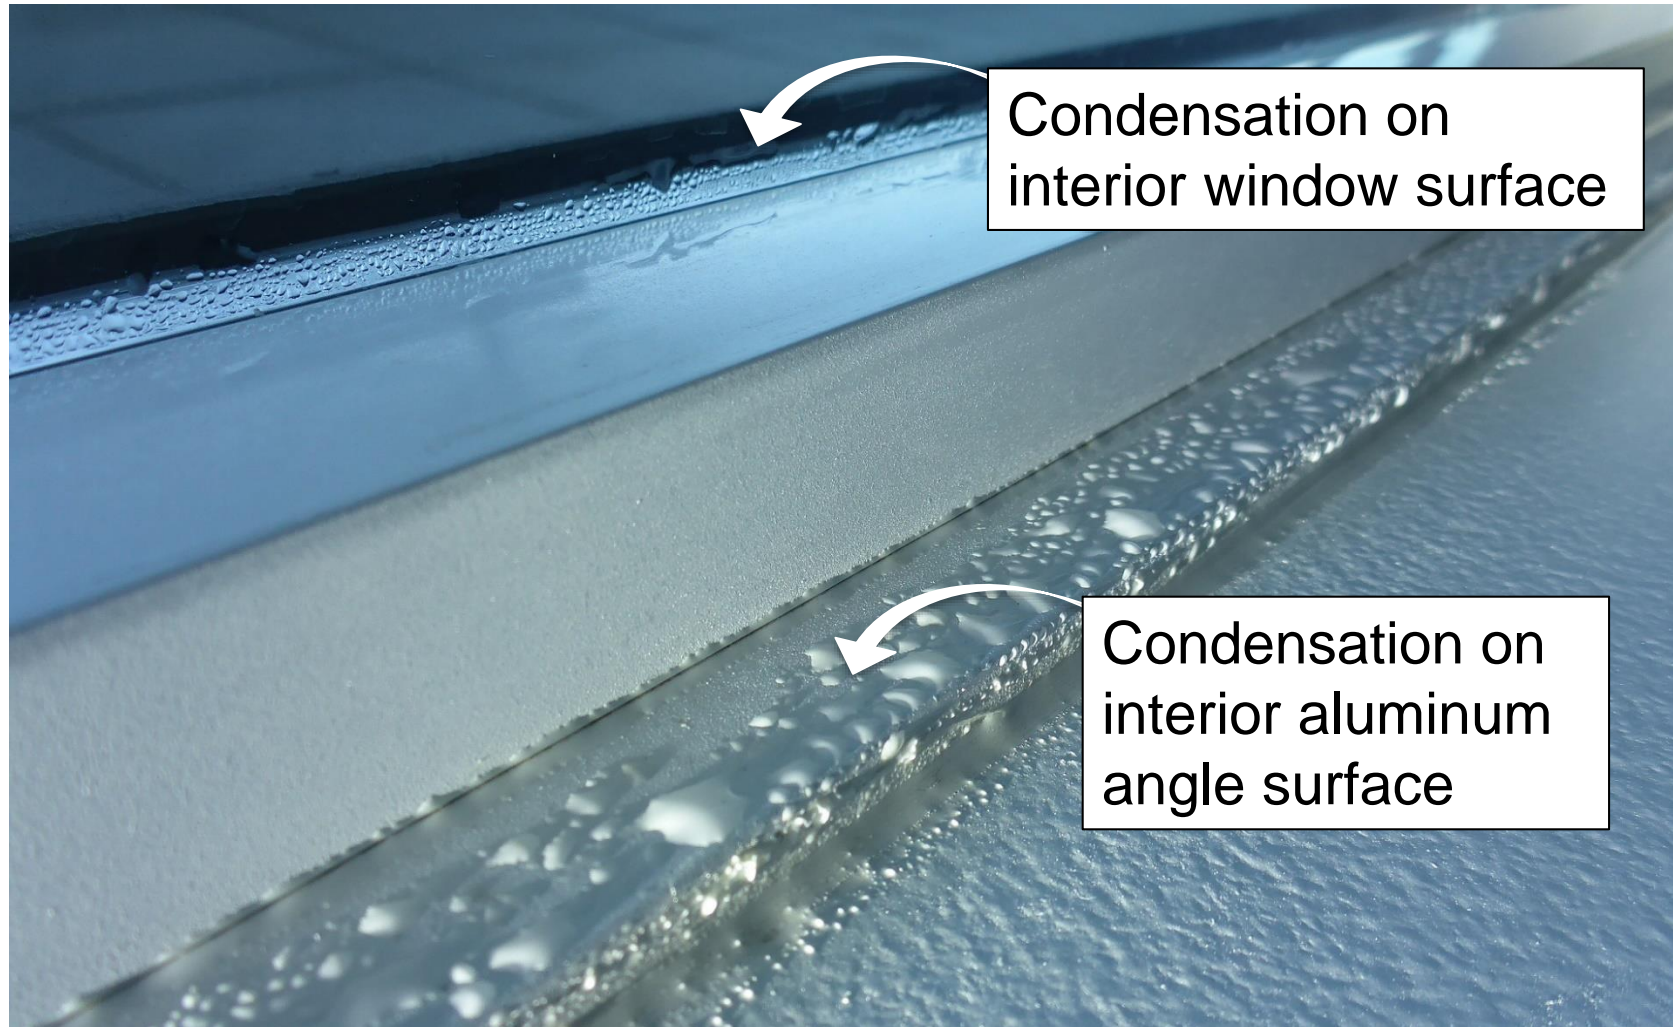
Aluminum back angle in
contact with concrete;
and in contact with back
side of aluminum frame
is a thermal bridge. Both
the angle and frame are
condensing

Condensation

- Window design should include thermally broken systems
- Design considerations include:
 - Carefully design thermal breaks in and around glazing elements and rough openings in walls
 - Hygrothermal modeling to determine CRF requirements
 - Avoiding thermal bridges in design
 - Descriptive and fully illustrated perimeter flashing conditions
