# **Building Envelope**

# Curtain Wall Failures

**Karim Allana, PE, RRC, RWC**

Allana Buick & Bers, Inc.

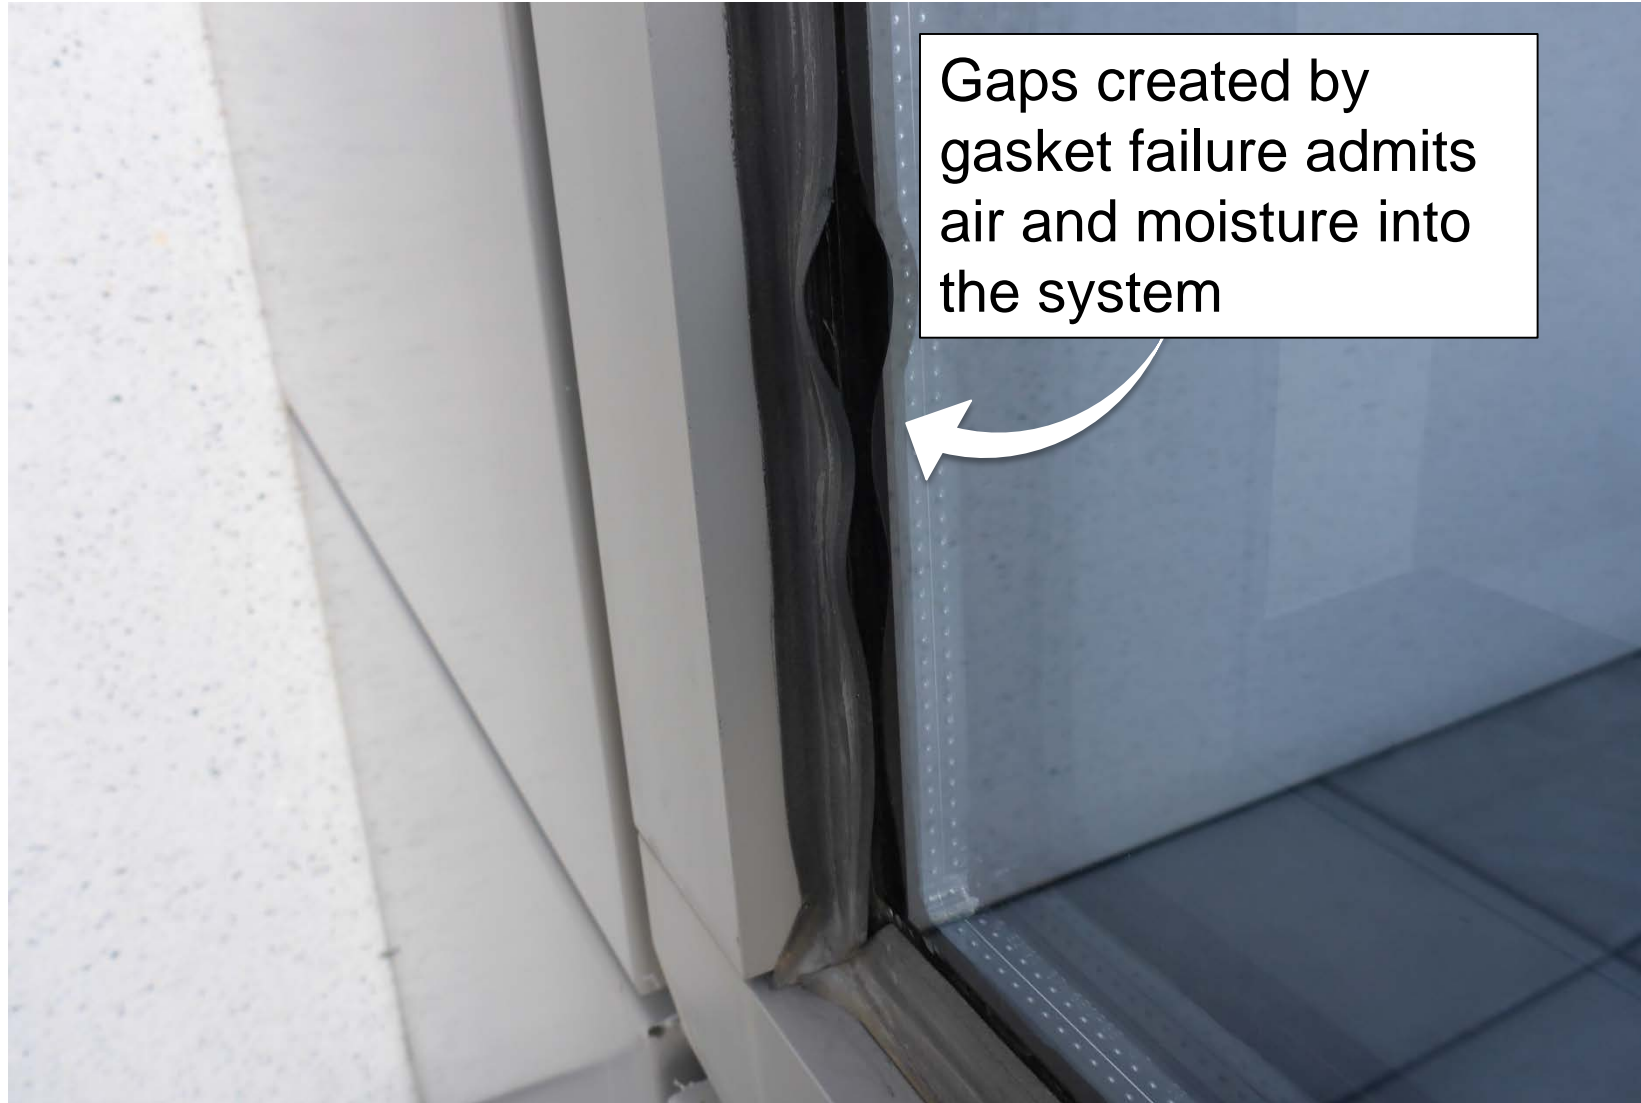
# Gasket Failure

Gaps created by gasket failure admits air and moisture into the system

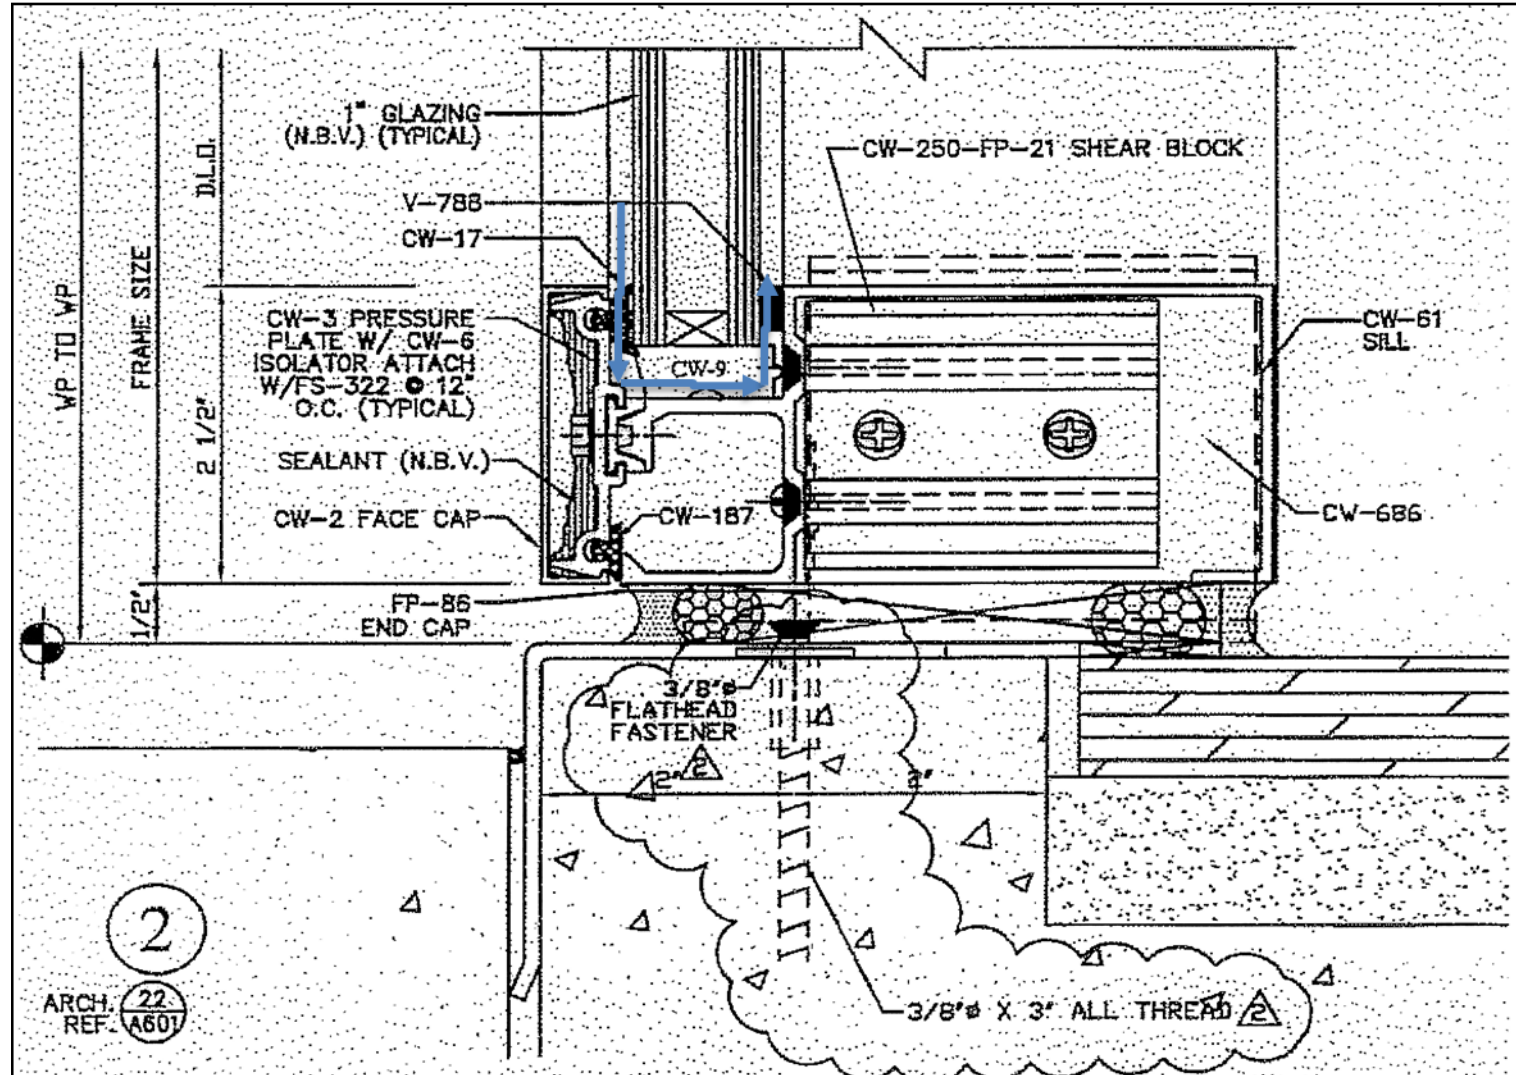
# Typical EPDM Mullion Gasket Shrinkage

15/16" glazing installed produces a loose seal and leaks

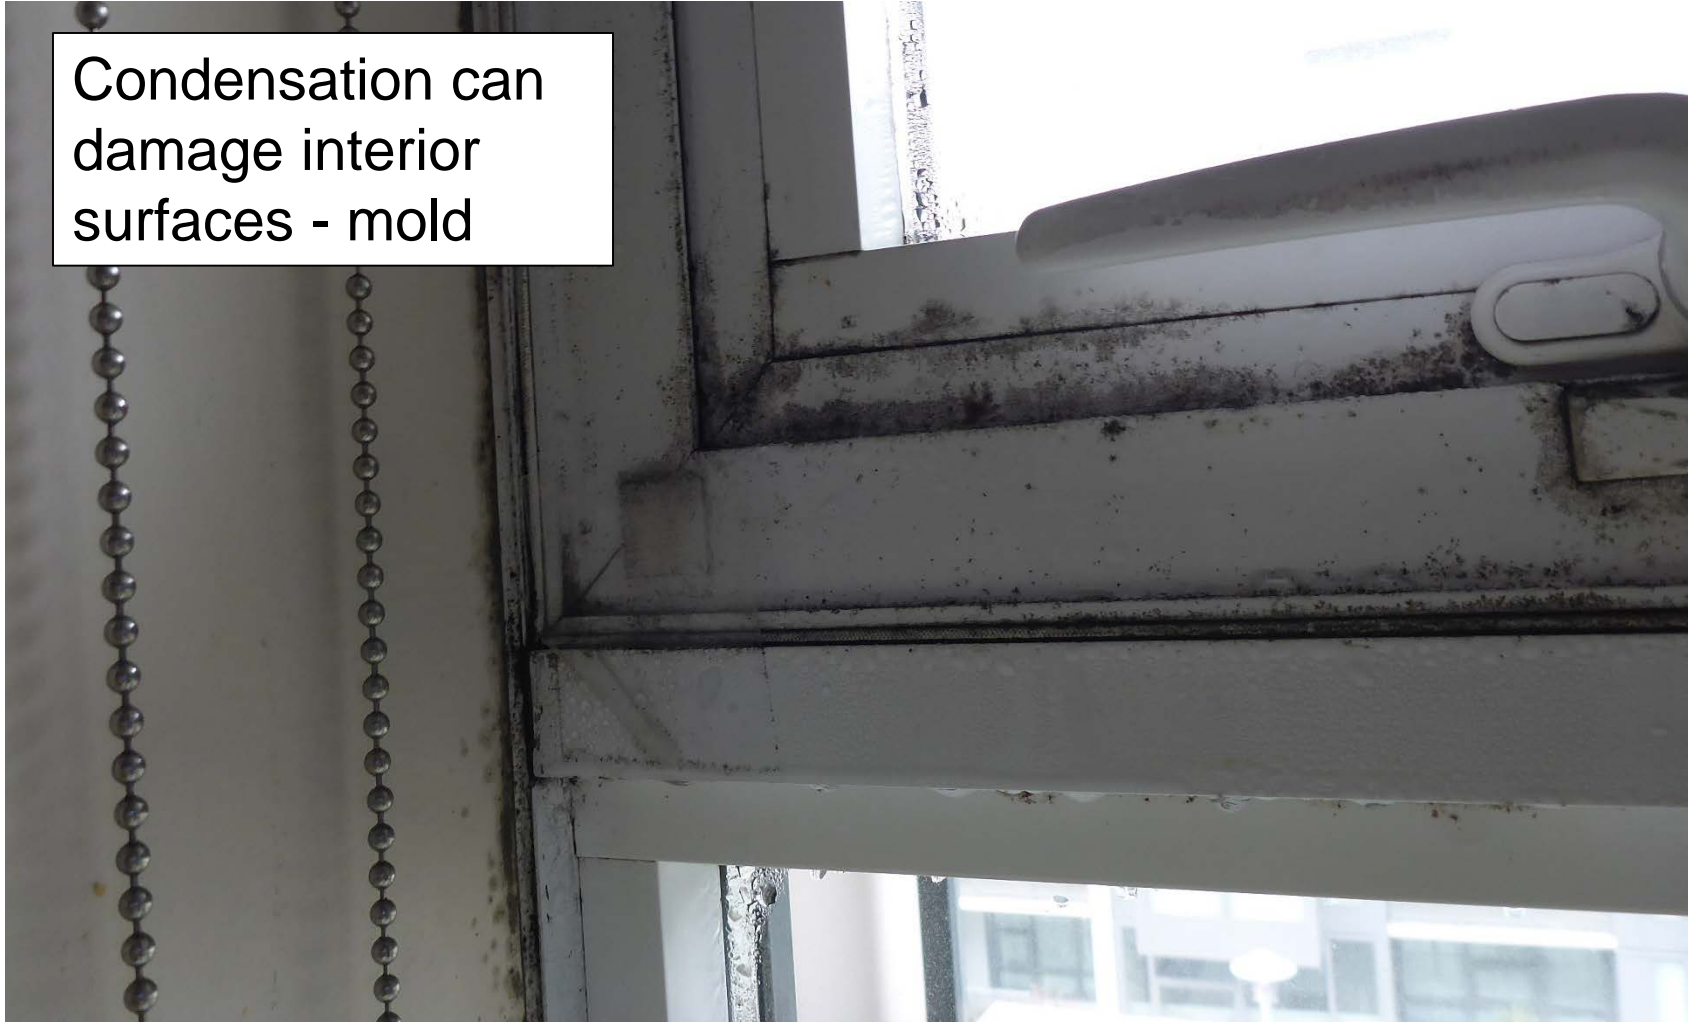
# Condensation Due to Gasket Shrinkage

Condensation can  
damage interior  
surfaces - mold

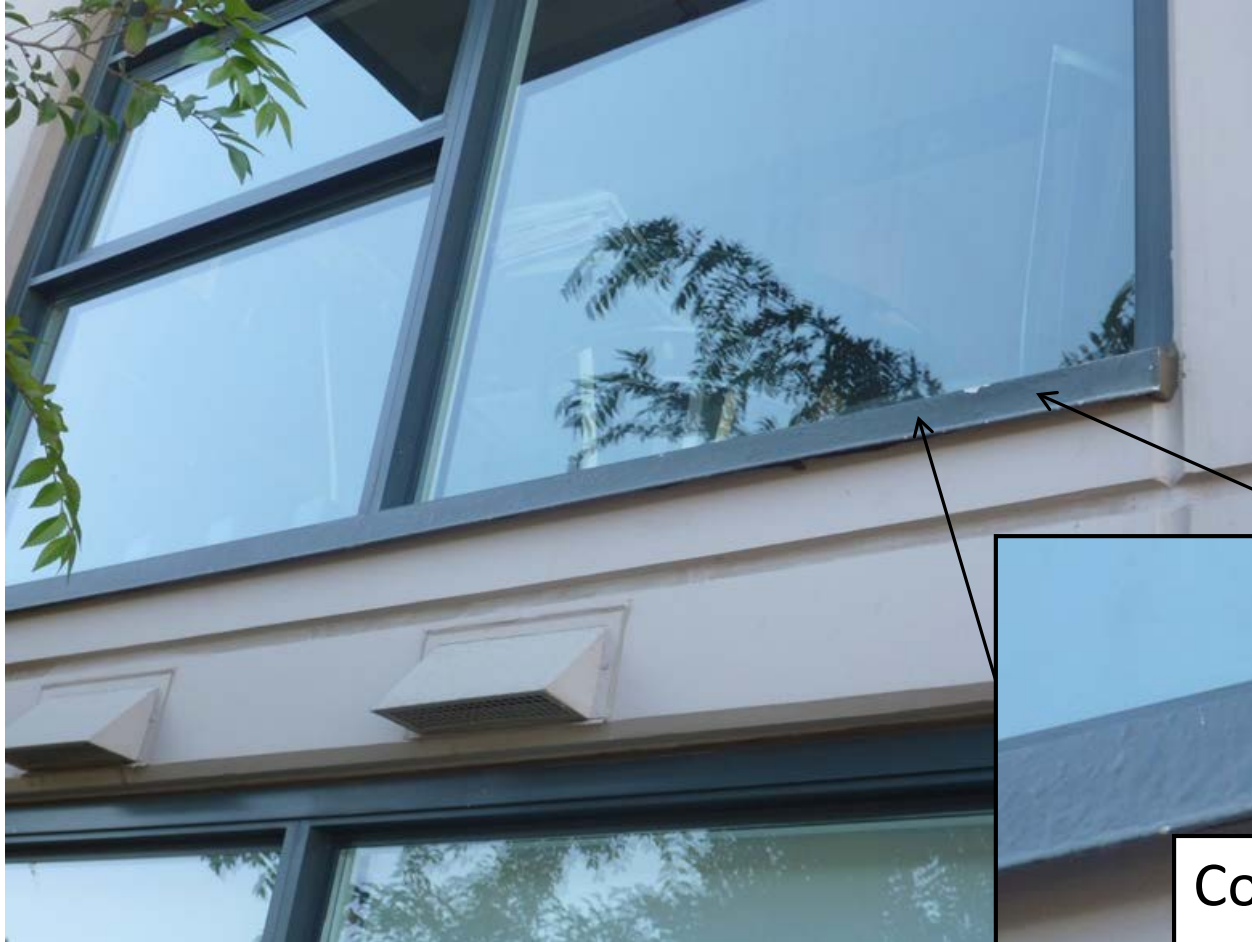
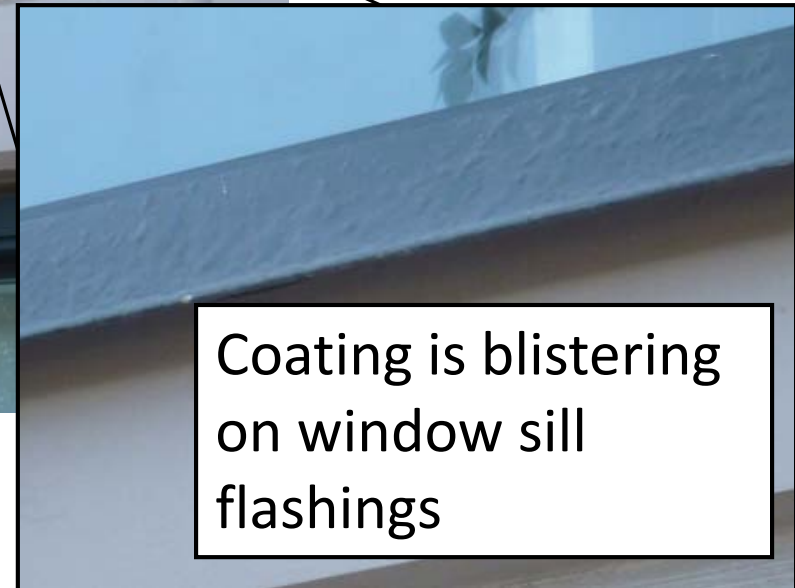
# Aluminum Coating Failure

Coating is blistering  
on window sill  
flashings

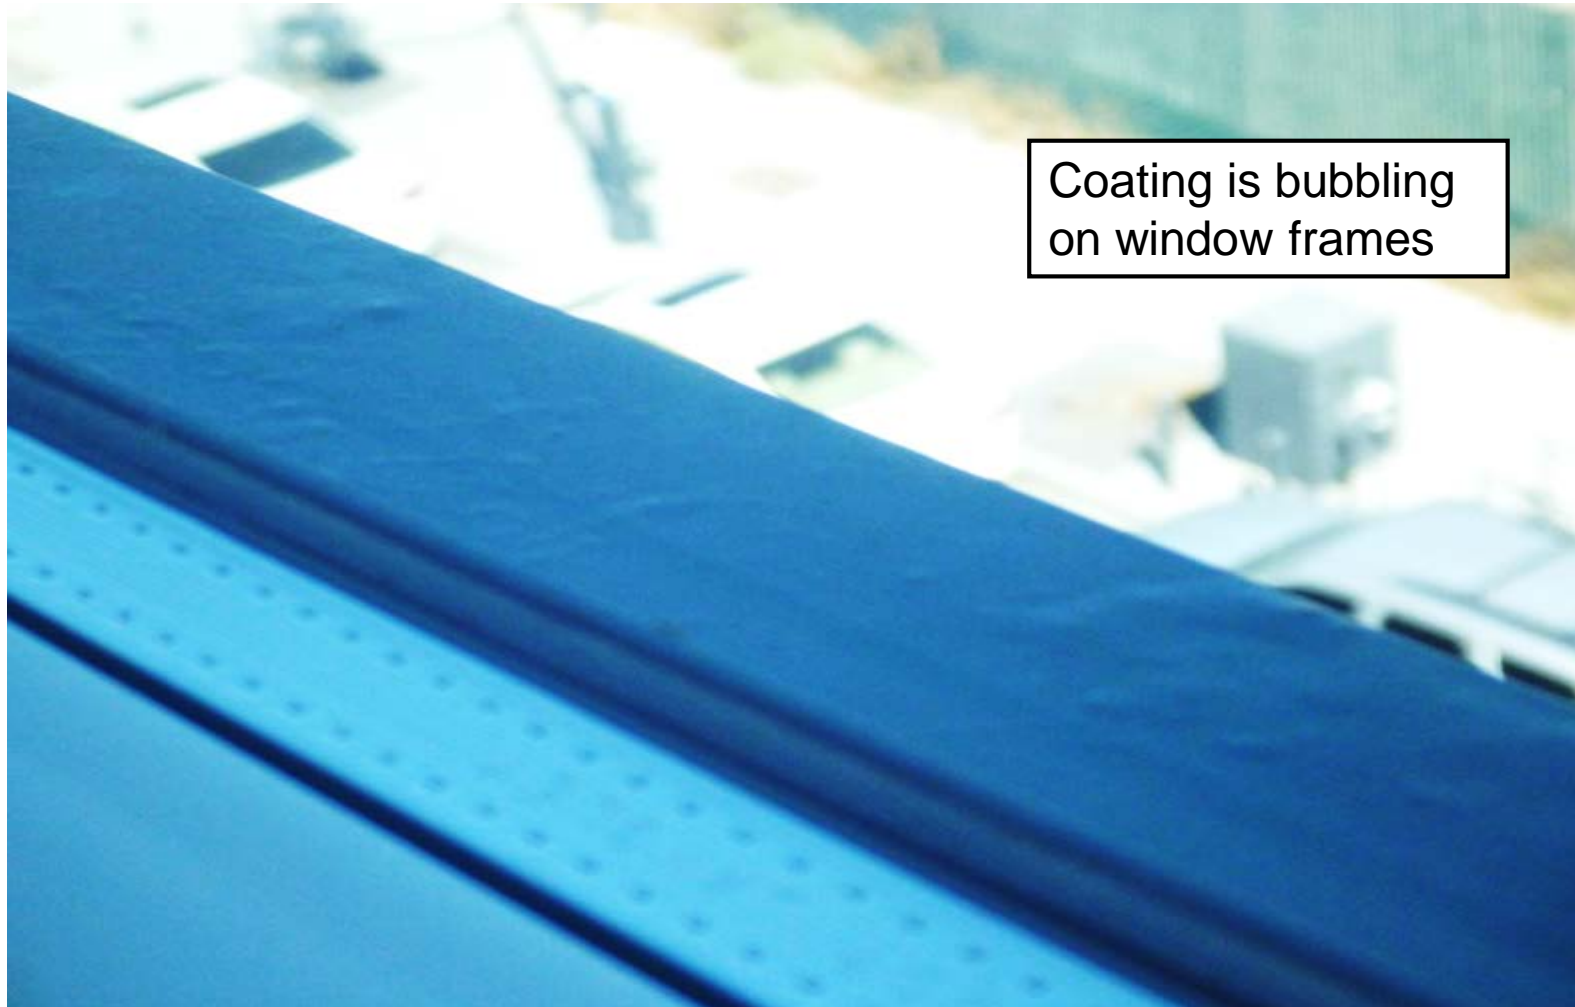
# San Francisco Condo #1

Coating is bubbling  
on window frames

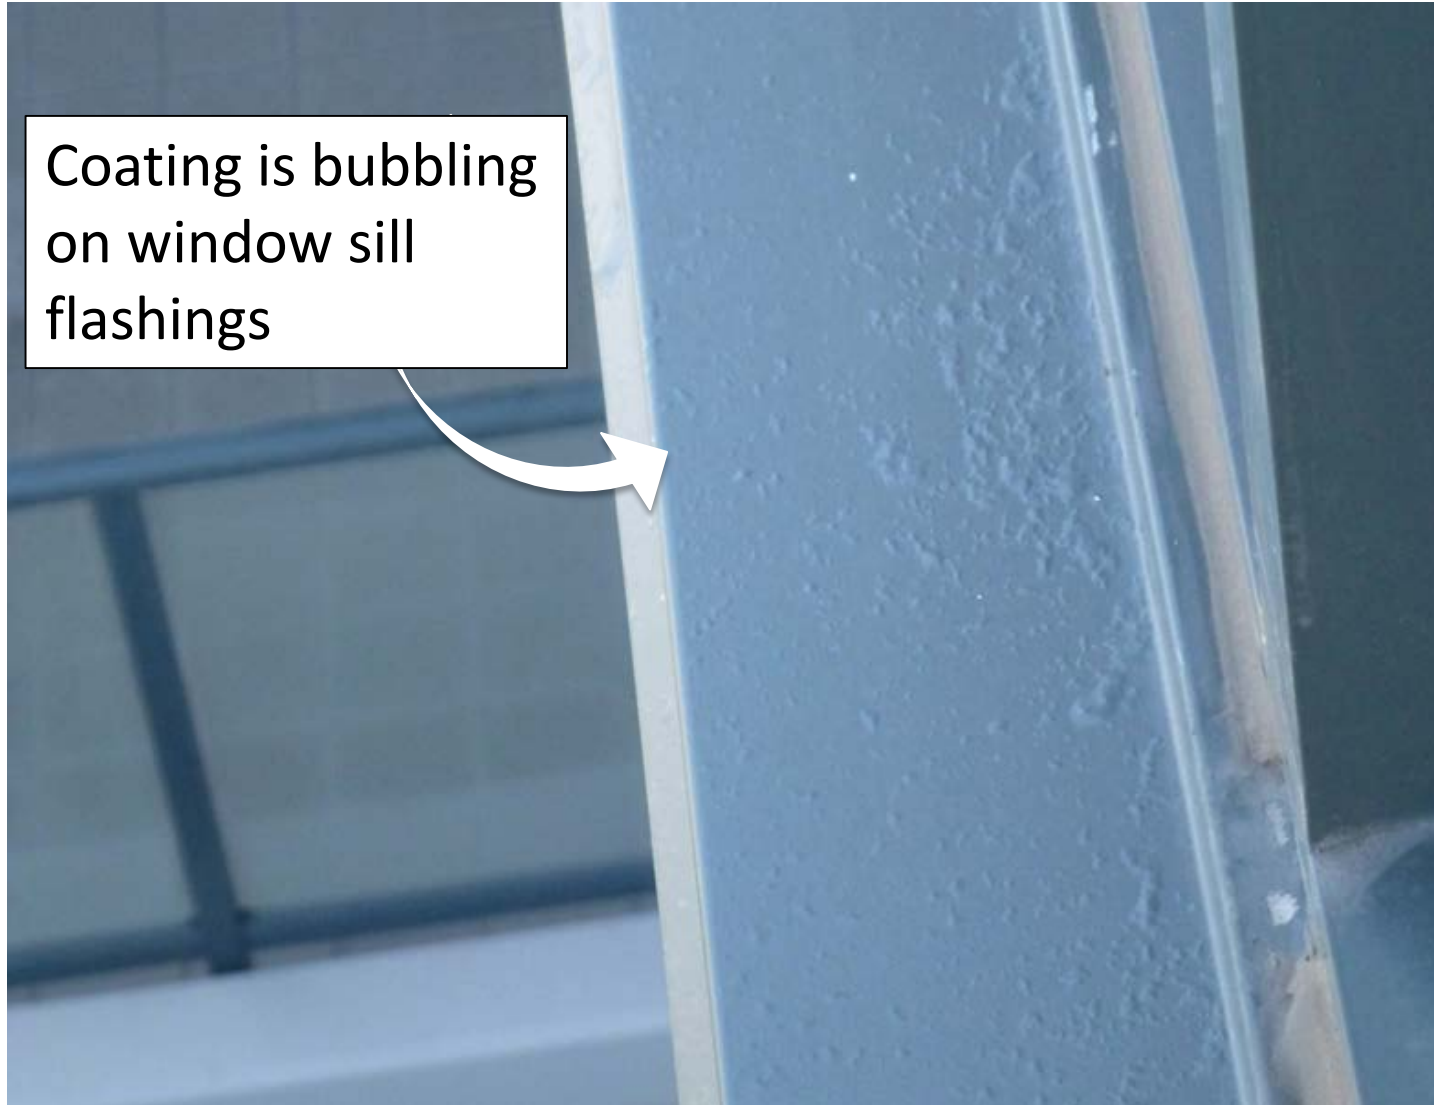
# San Francisco Condo #1

Coating is bubbling  
on window sill  
flashings

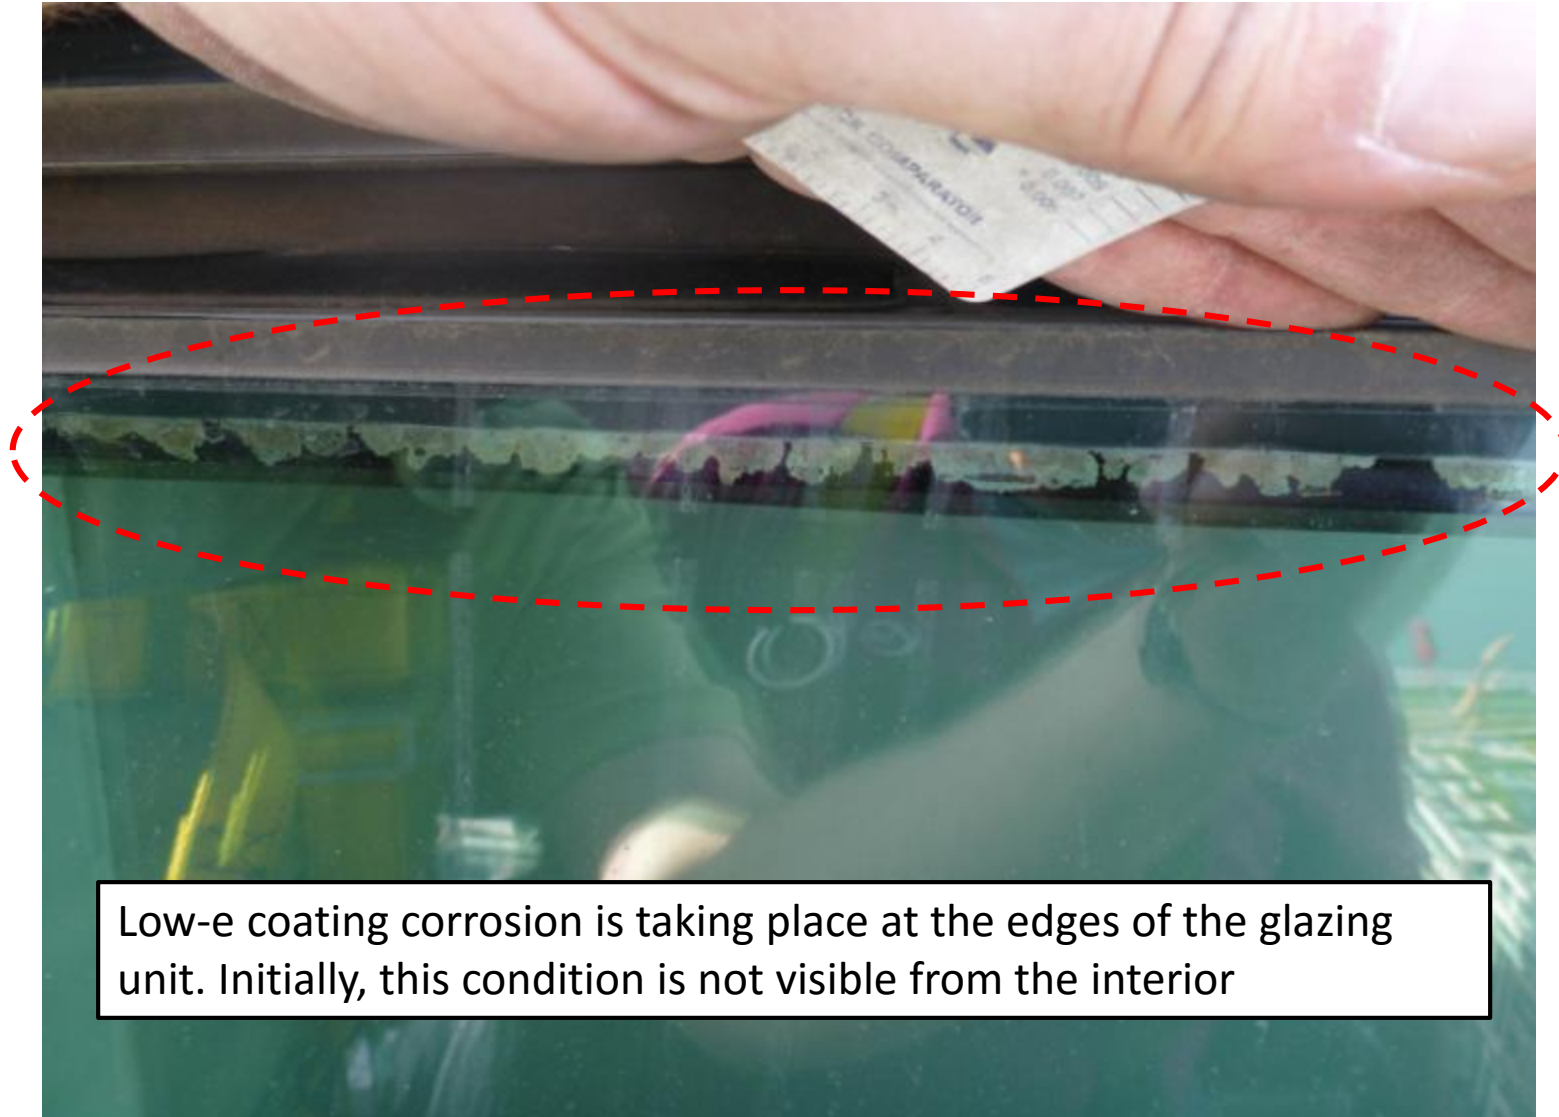
# Start of Low-E Coating Corrosion

Low-e coating corrosion is taking place at the edges of the glazing unit. Initially, this condition is not visible from the interior

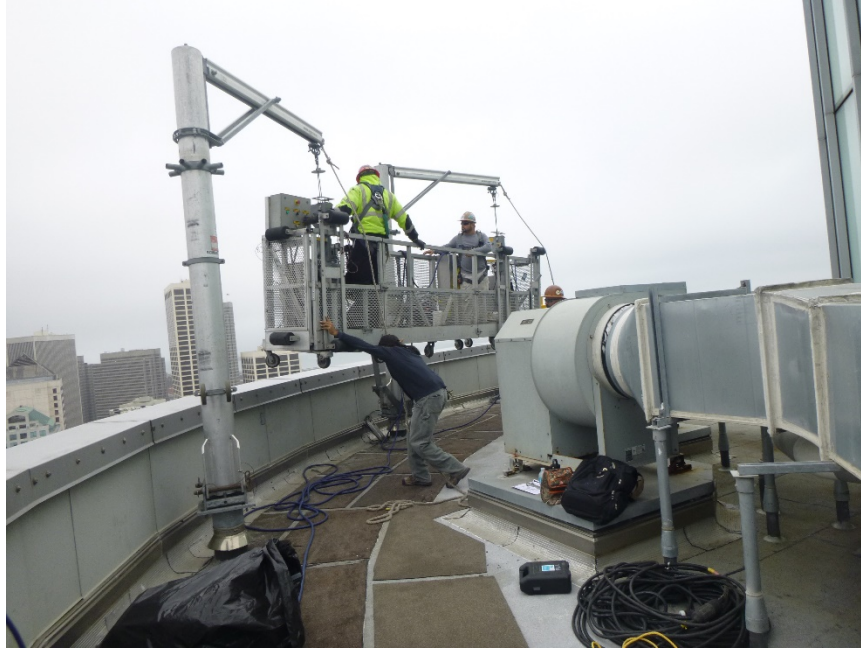
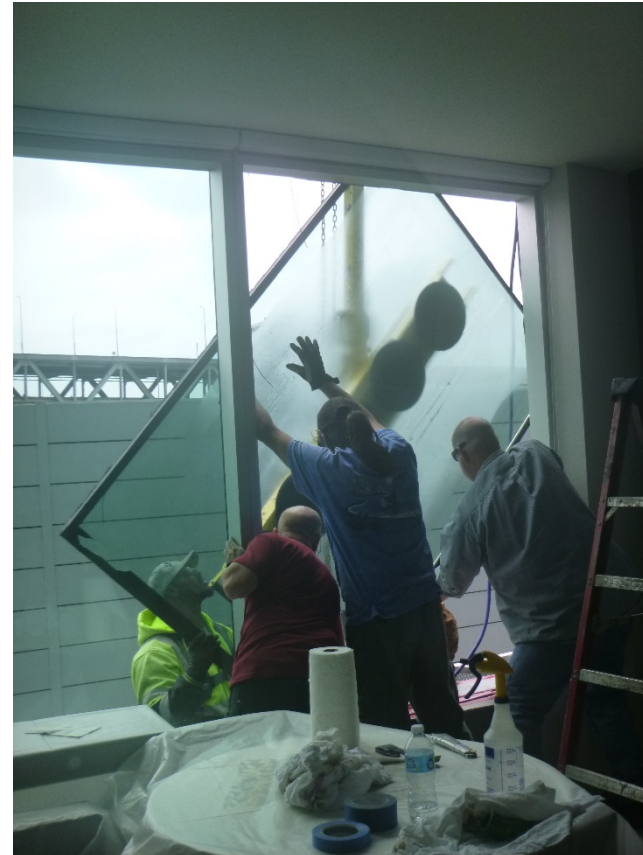
# Replacing Glass, Slow and Tedious

2 guys on window  
washing rigs

3 guys on the inside  
handling glass

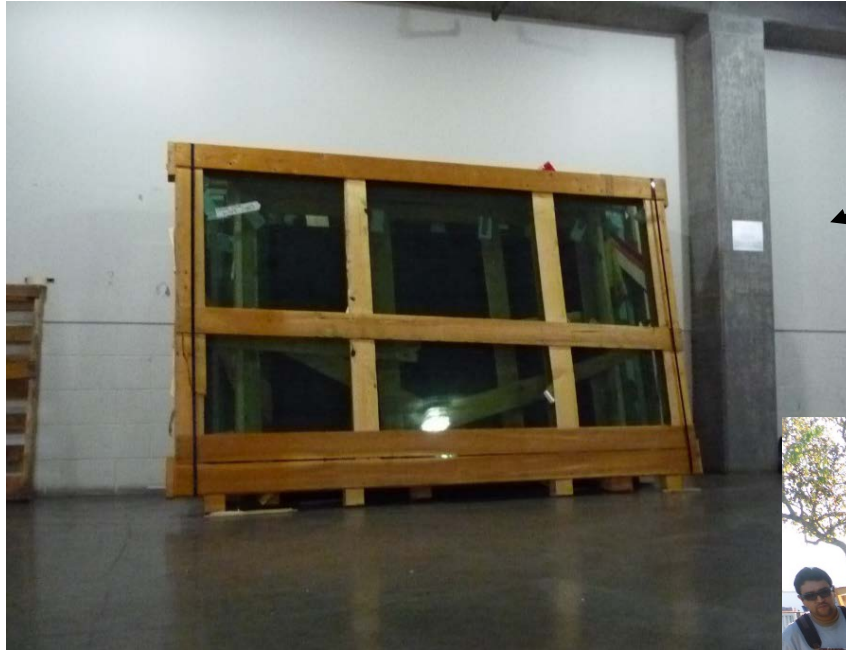
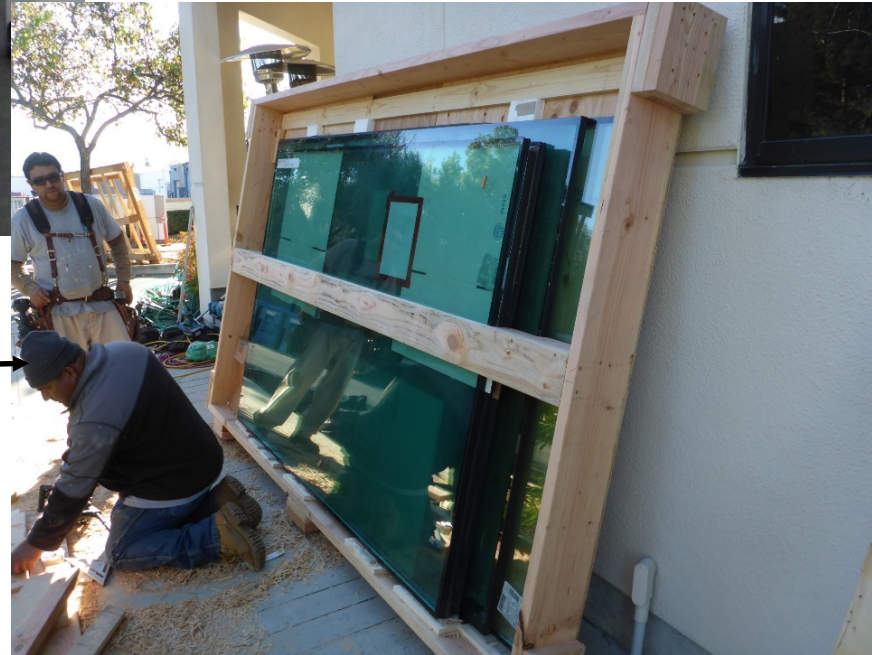
# Replacing Glass, Slow and Tedious

Removed glass  
from site

Labeled and crated,  
shipped to lab

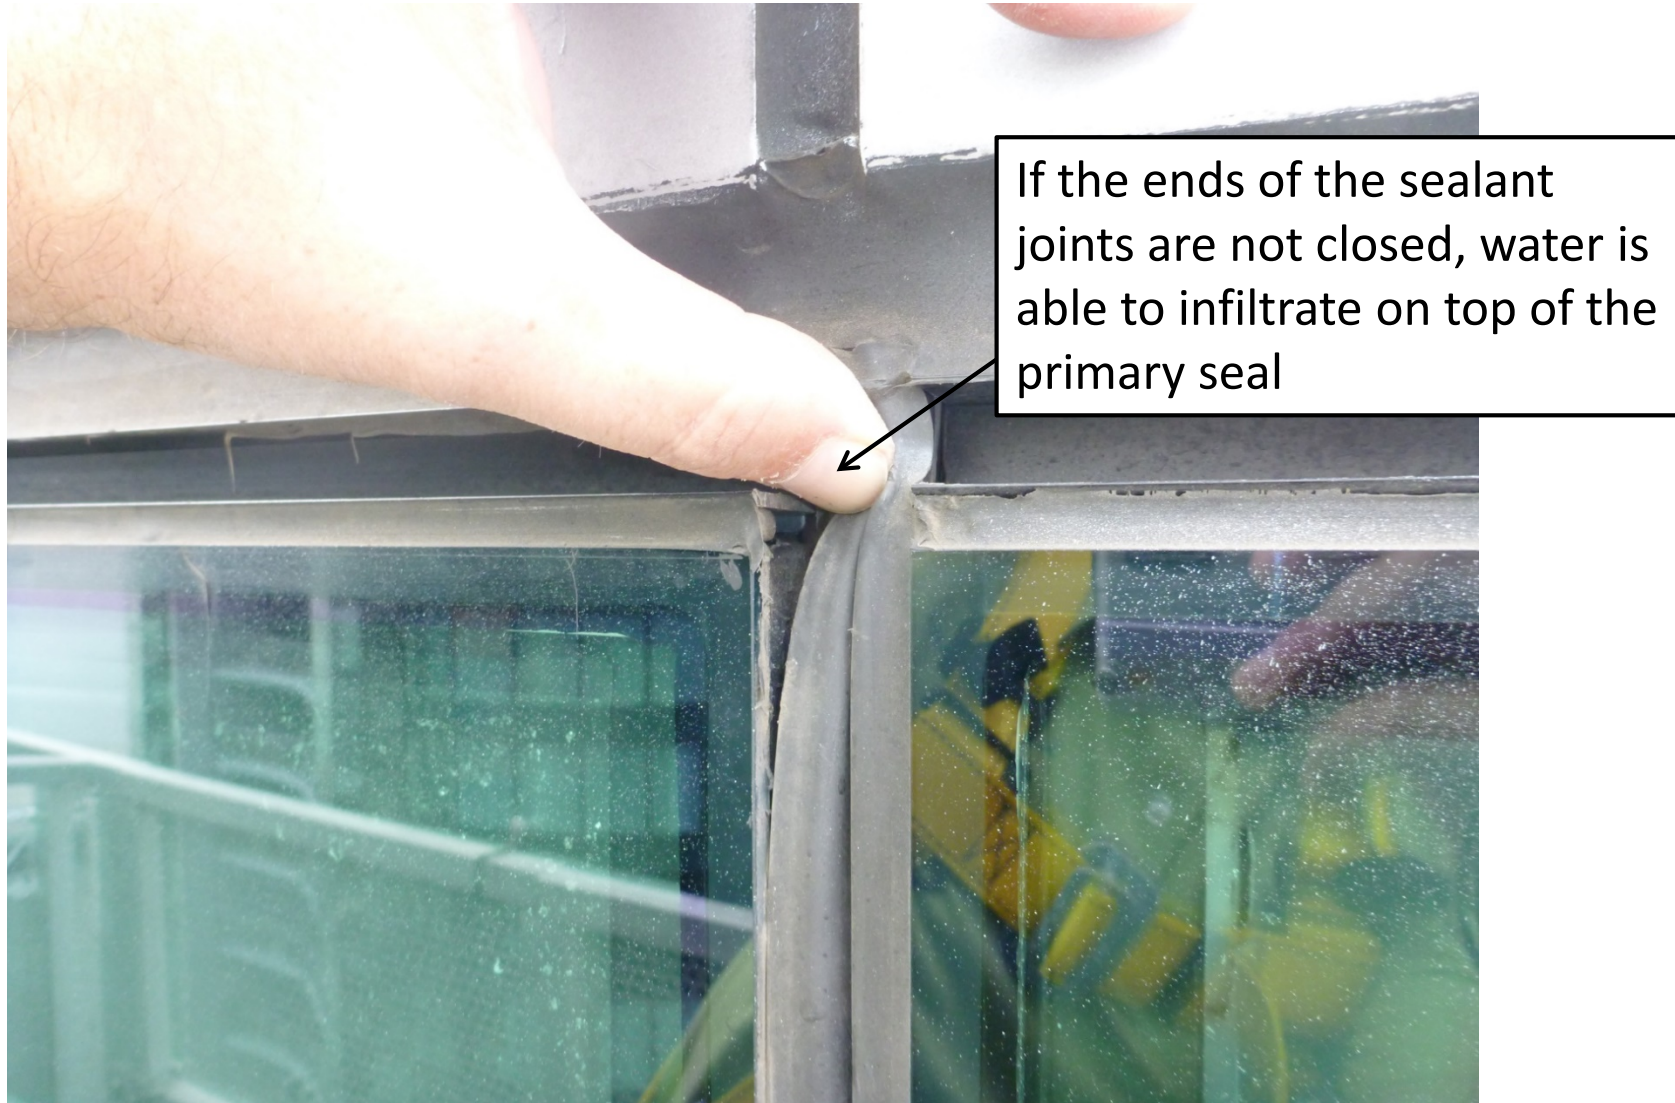
# Water Infiltration at Head Stands on IGU Seal

All IG units have low-E deleted only about 3/8" but the total bond line of the PIB and silicone is about 5/8" to 3/4"

Energy dispersive X-ray spectroscopy (EDX) of the edge-delete (Table A), low-E coating under the PIB (Table B), and discolored low-E revealed that there was no corrosive materials such as chlorine, phosphorus, or sulfur in contact with any surfaces. There is evidence however, that the edge delete was not complete and left some residual low-E coating under the silicone secondary seal.

Failure is most likely the result of extended water contact due to the flexible vertical tubing retaining water, which allowed water to migrate along the tops of the IG units. It appears there is installation issues with the lack of vertical tube drainage as well as IG manufacture by not edge-deleting properly. The PIB is of good quality and could have resisted water penetration if it were not adhered to the low-E which is attacked by the water contact, resulting in bond/seal loss.

Overall IG workmanship and material skills are satisfactory with the exception of the edge deletion

- Proper edge deletion needs to occur during the manufacturing process to ensure proper bonding of the IGU sealants
- Design of the glazing and curtain wall assembly should not allow water to stand on top of the silicone sealant because, silicone is permeable
- Design installation of glass should be on blocks and properly drained to prevent dual glazing to sit in water

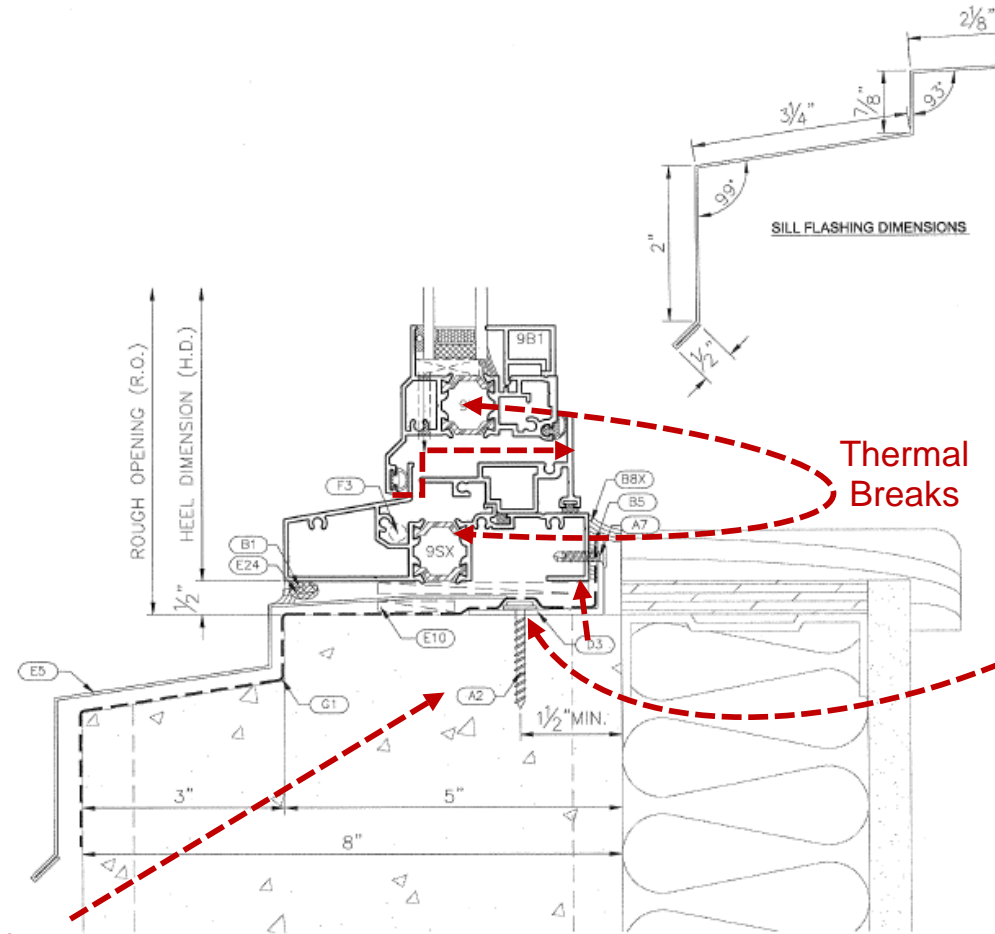
# How Condensation Can Occur

Aluminum back angle in contact with concrete; and in contact with back side of aluminum frame is a thermal bridge. Both the angle and frame are condensing

Thermal  
Path  
Through  
Concrete
