WGA Curtain Wall Failures

Learnings From Curtain Wall Failures

Common Modes of Failure

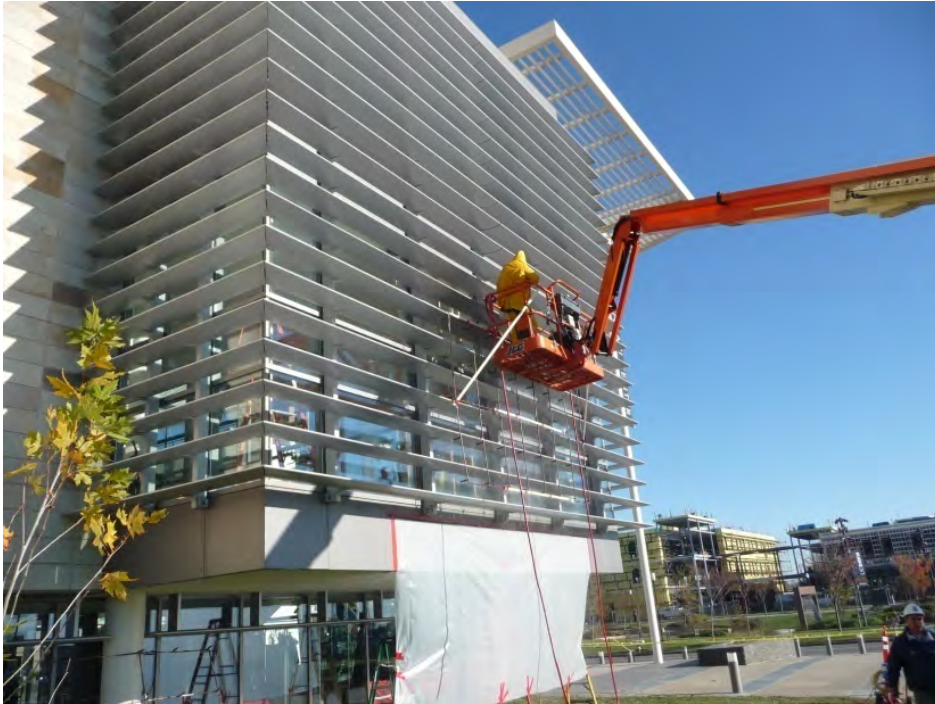
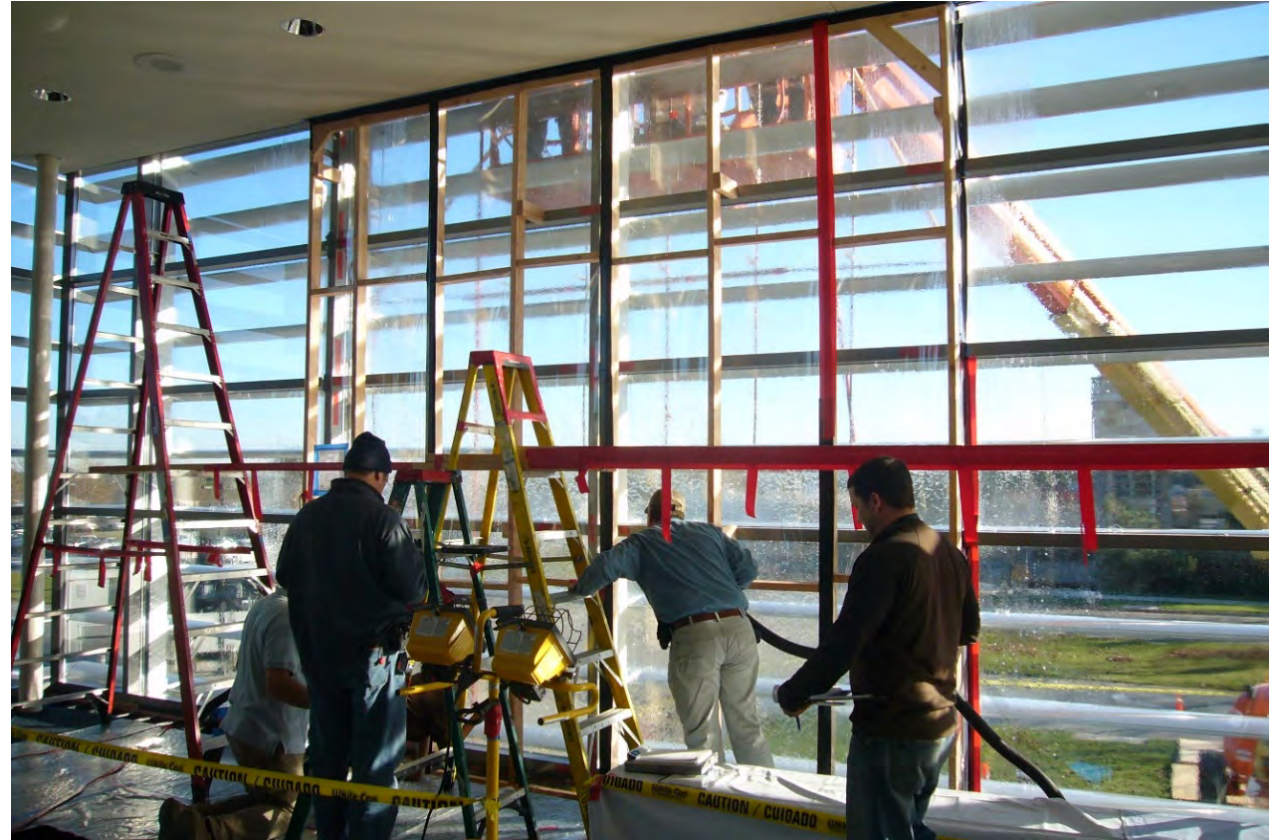
Leaks Due To Gasket Shrinkage

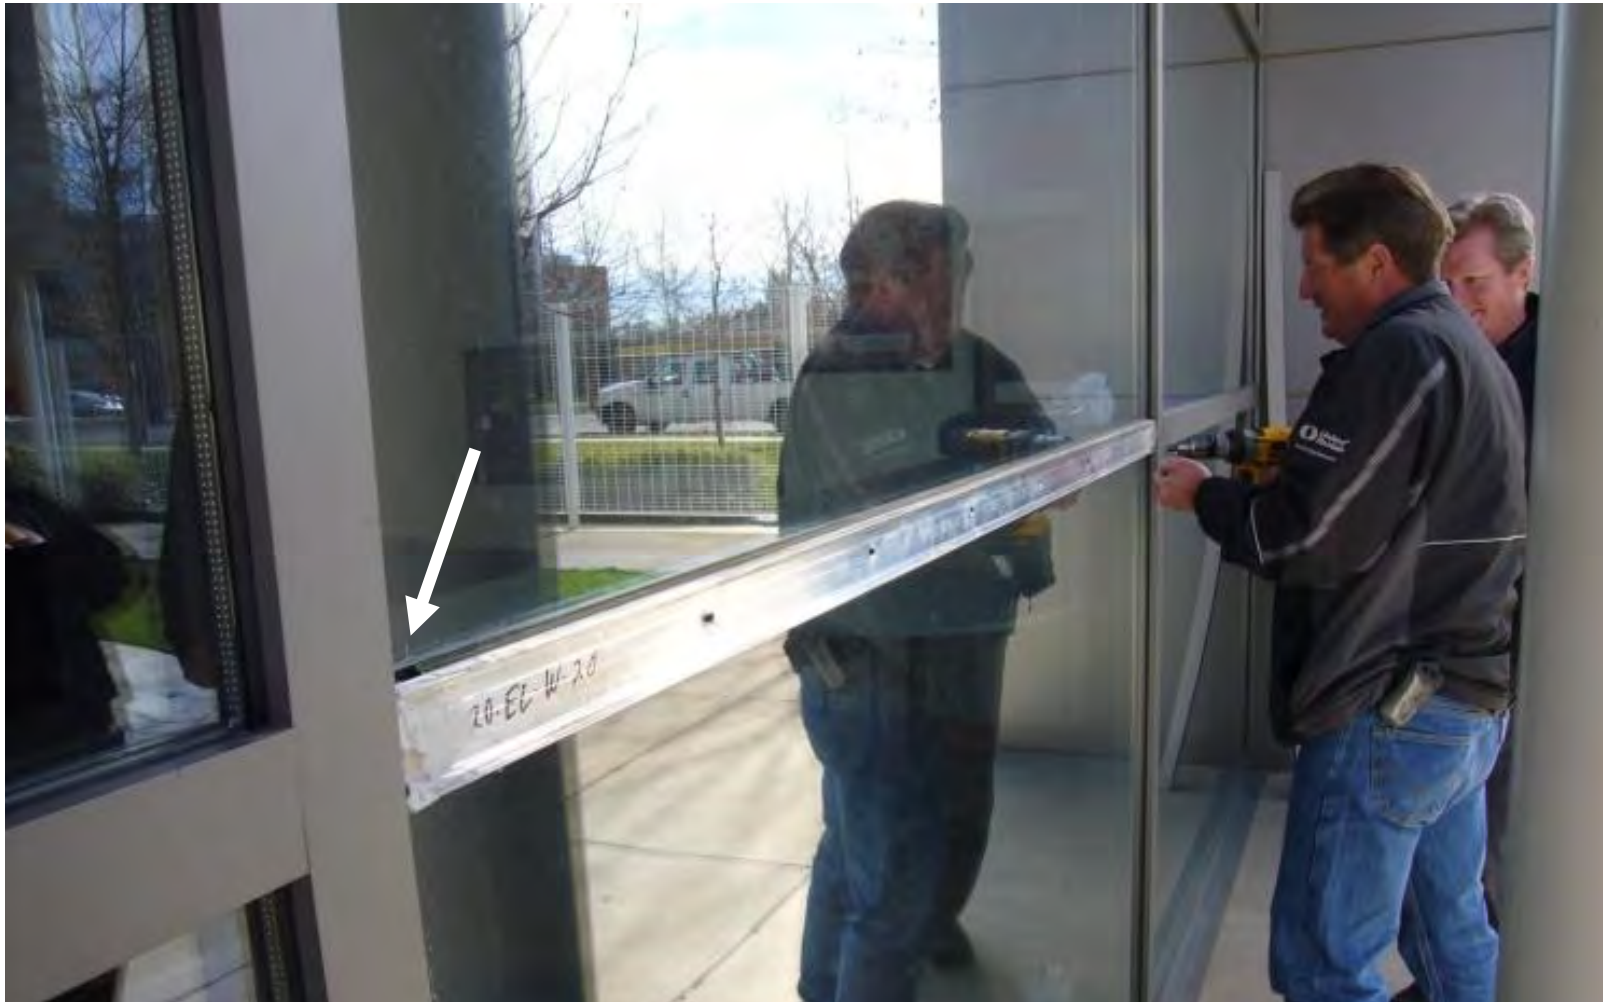
Mondavi Gasket Shrinkage / Failure

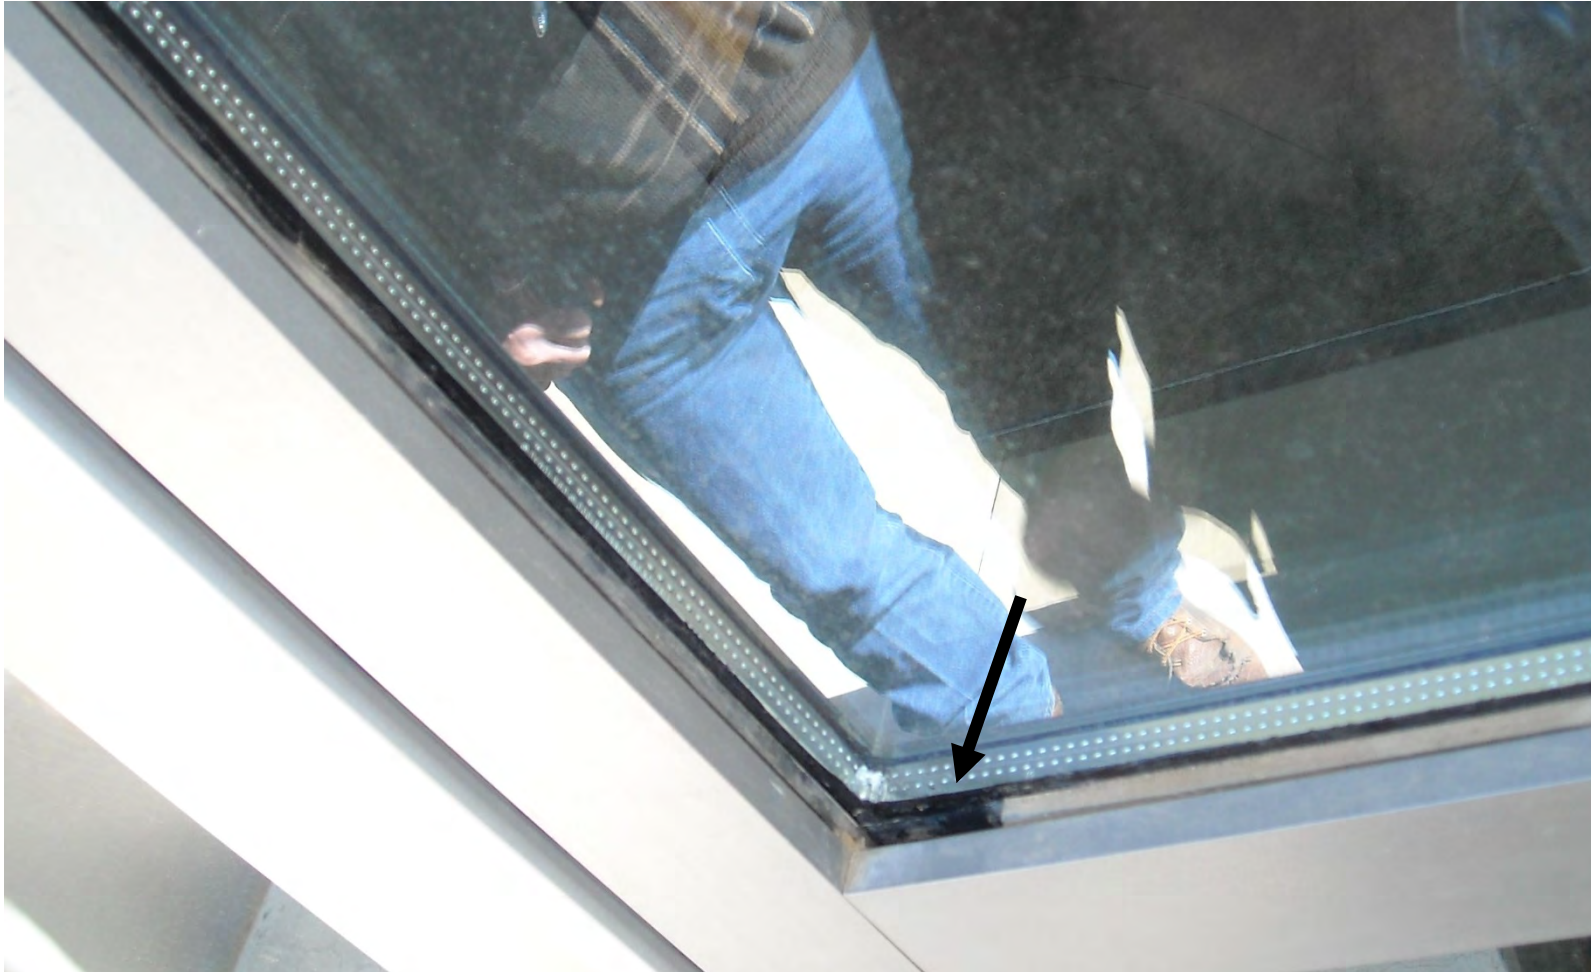
Mondavi Gasket Shrinkage / Failure

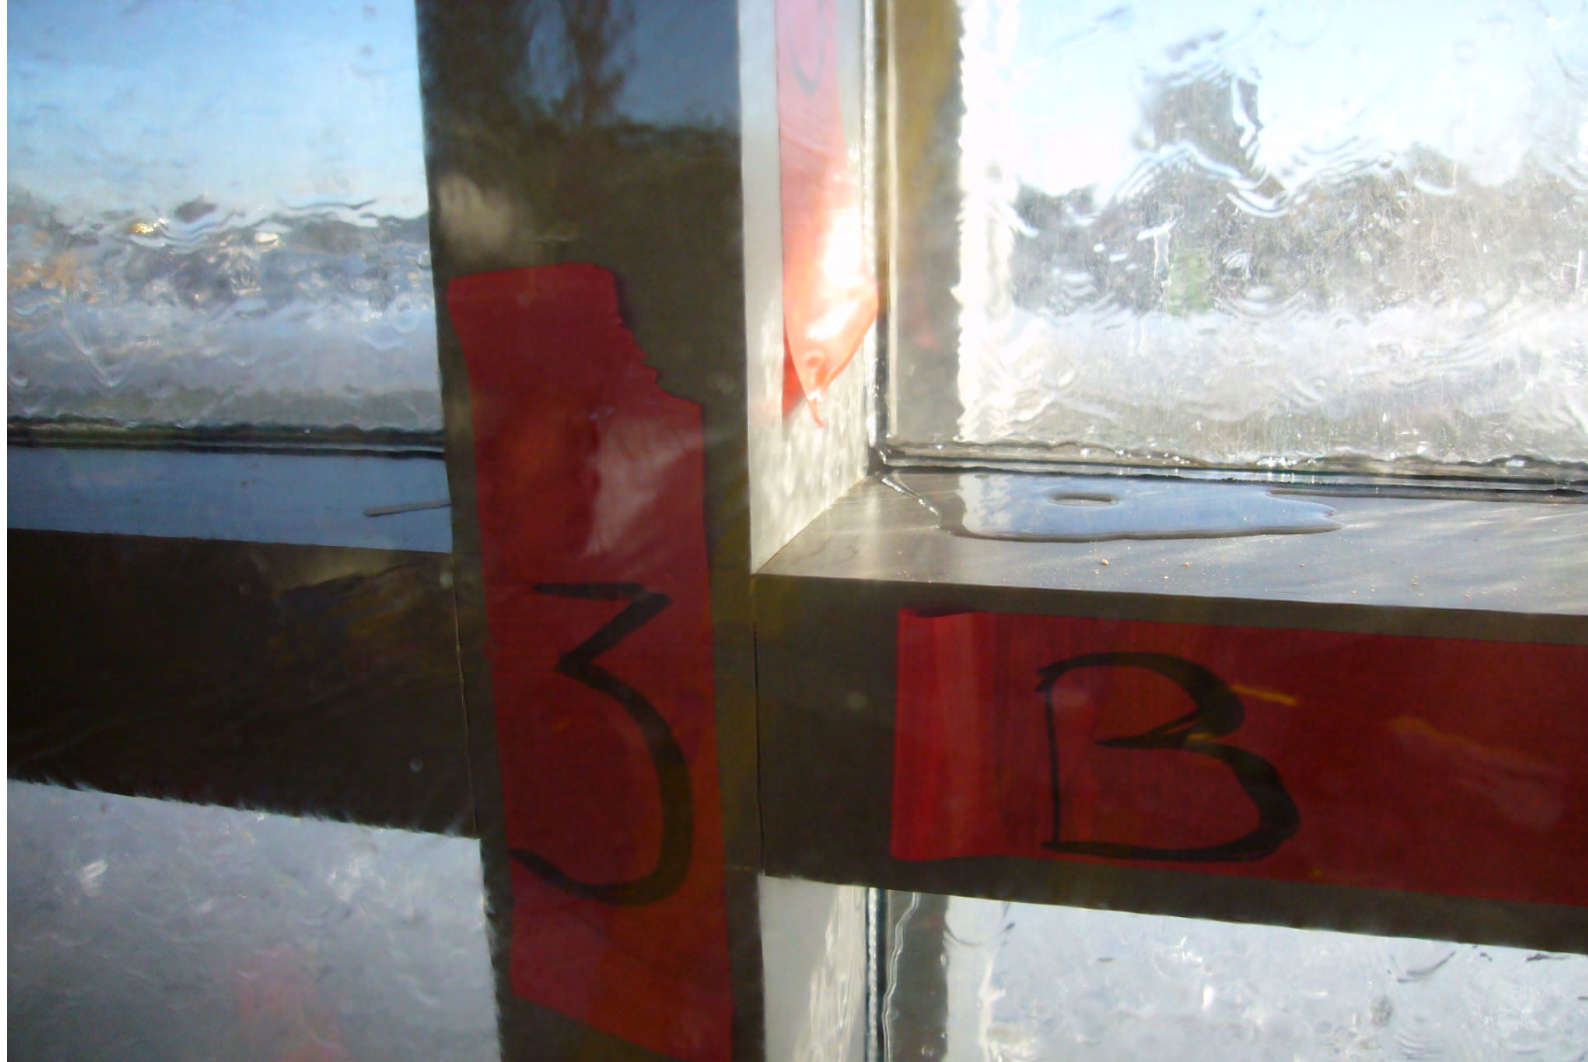
Mondavi Gasket Shrinkage / Failure

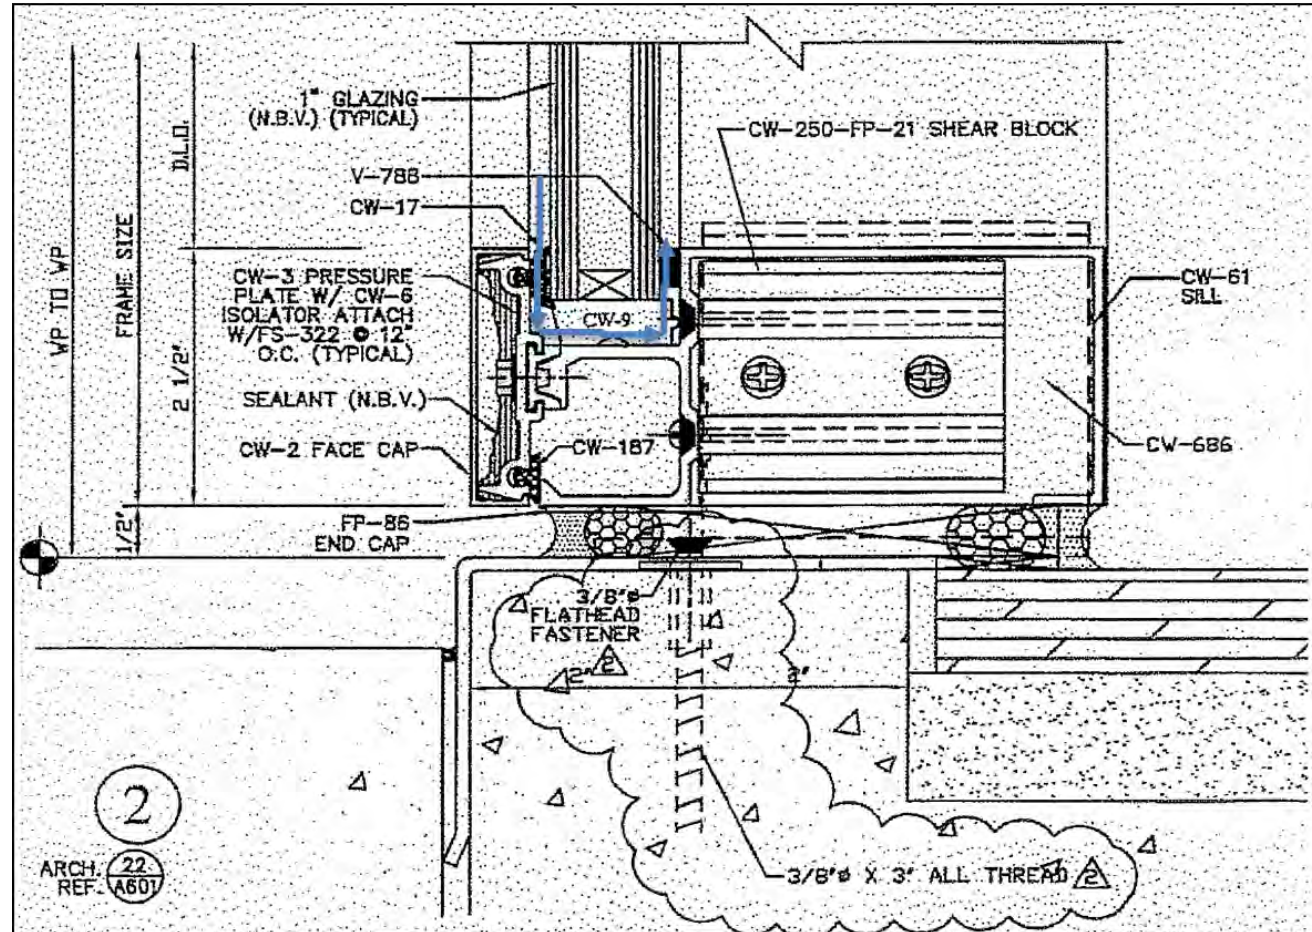
Both Exterior & Interior Gaskets Shrank

15/16" glazing installed produces a loose seal and leaks

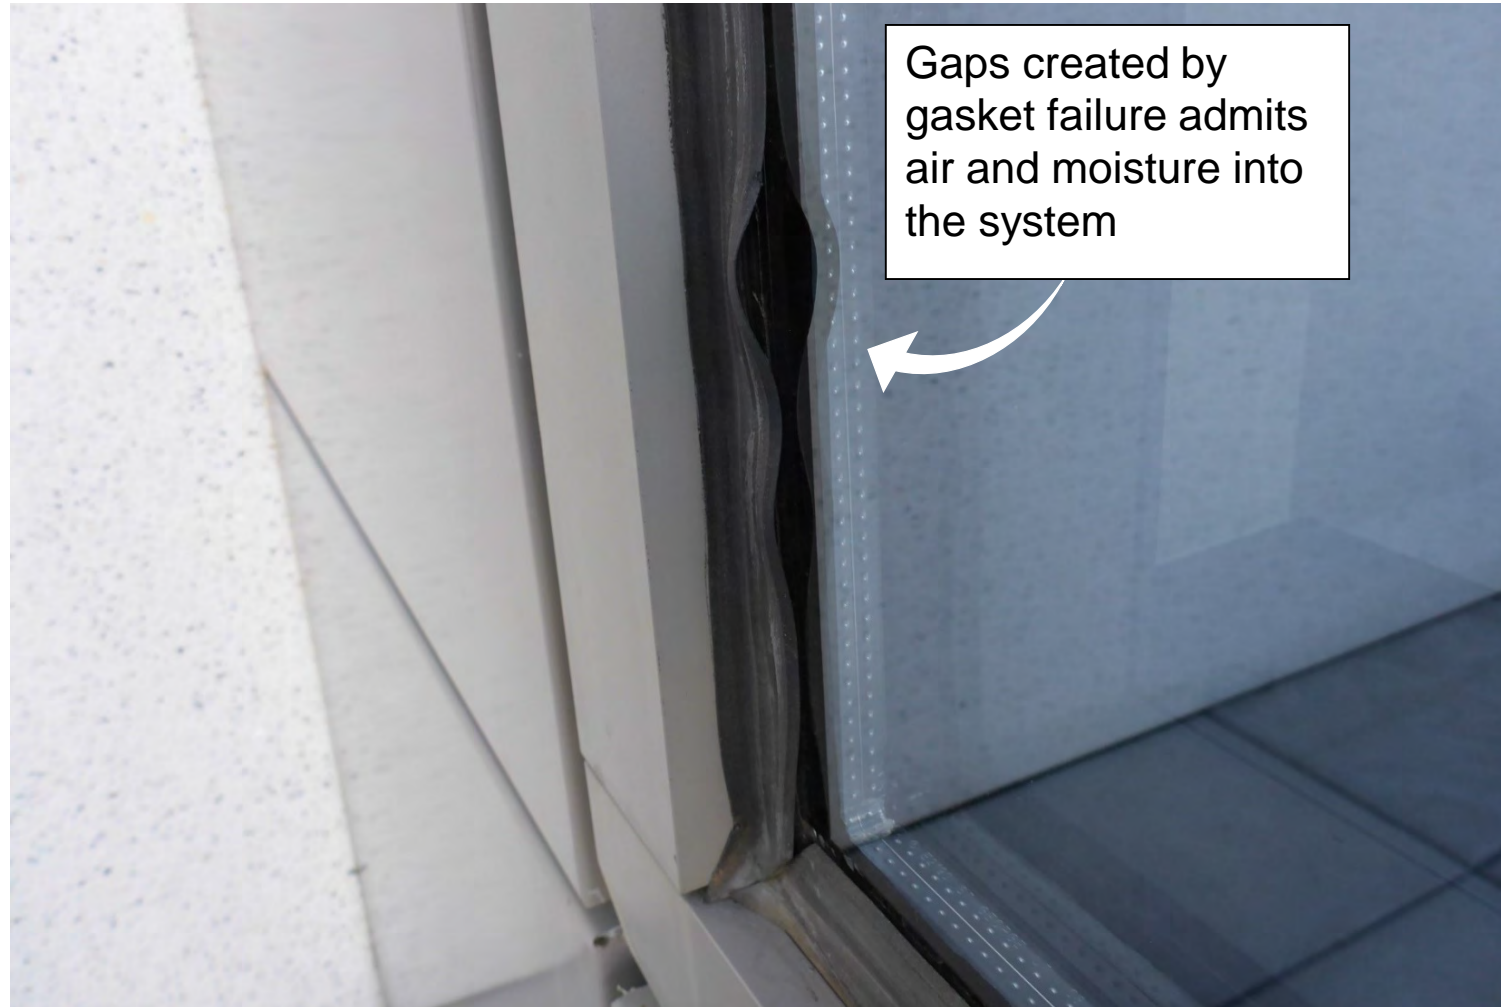
Gasket Failure

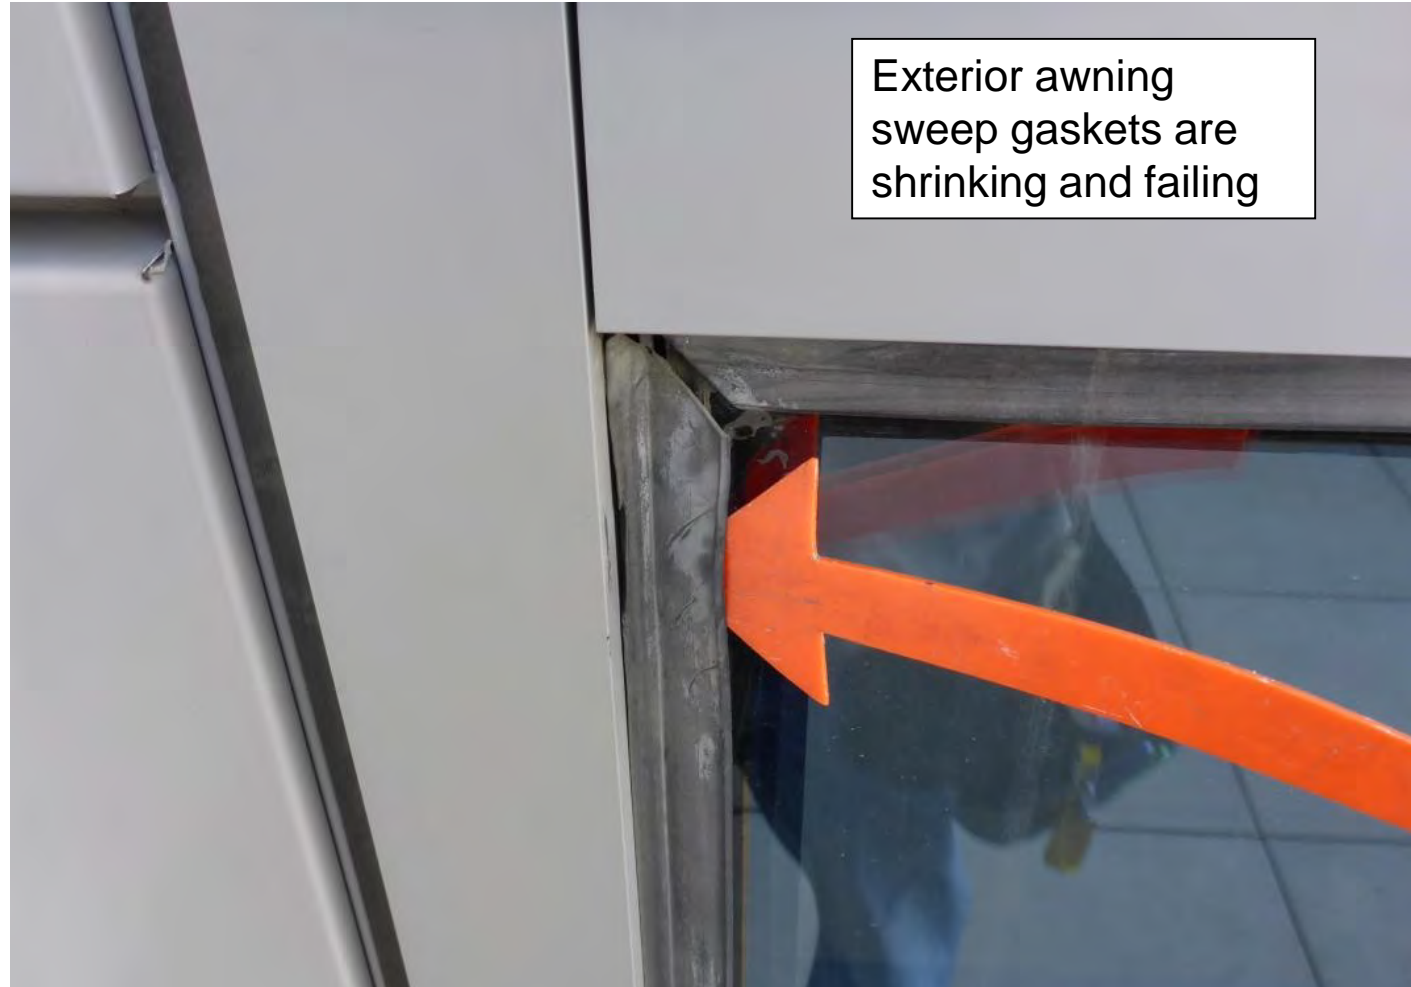
Gasket Failure - San Jose Condo

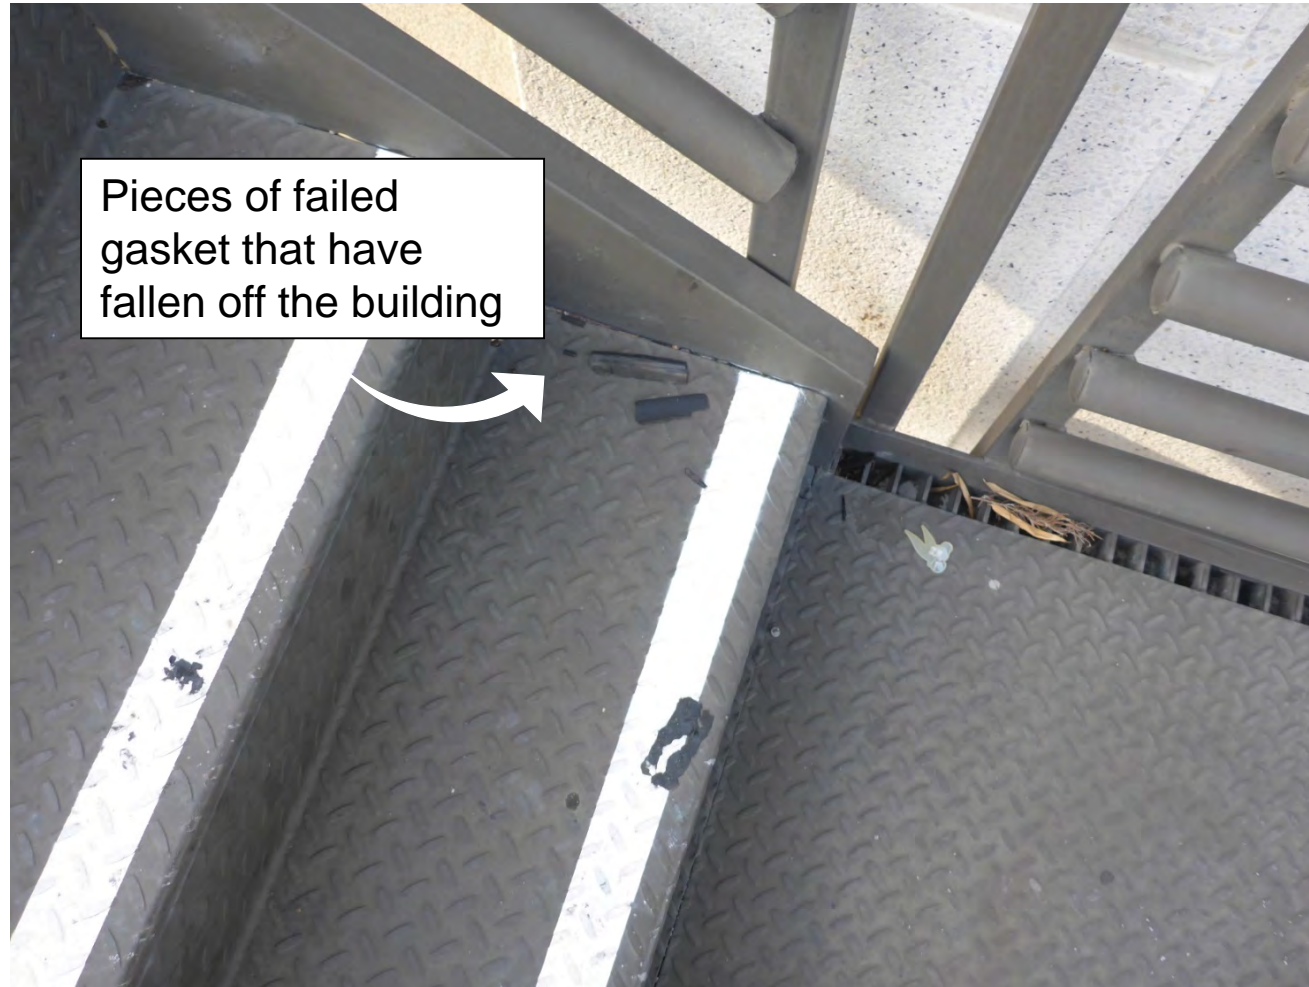
Gasket Failure- San Jose Condo

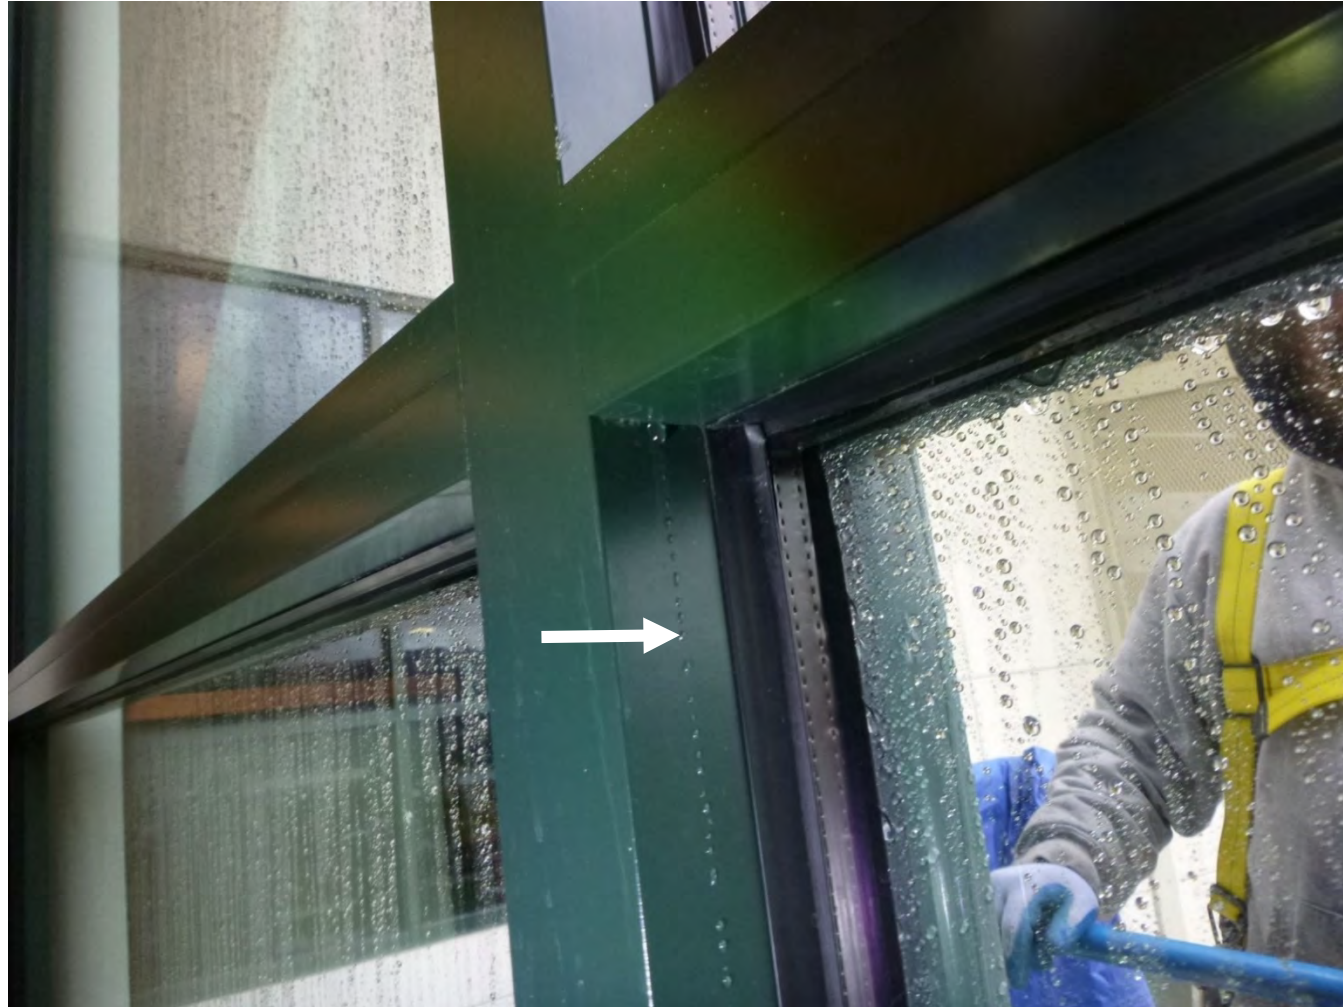
Gasket Failure - Causing Leaks

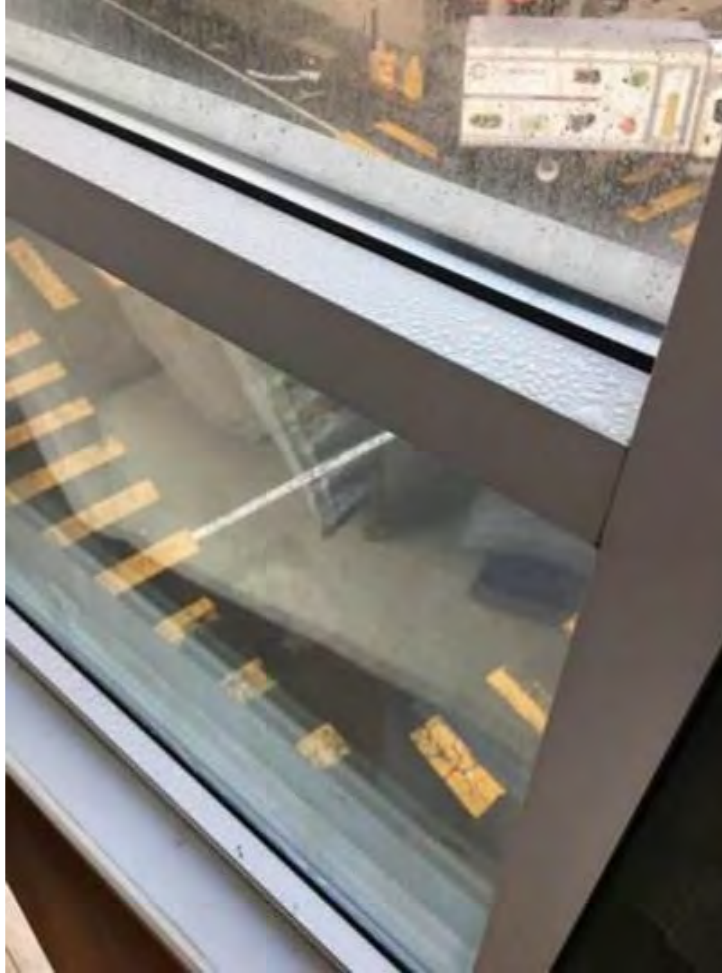
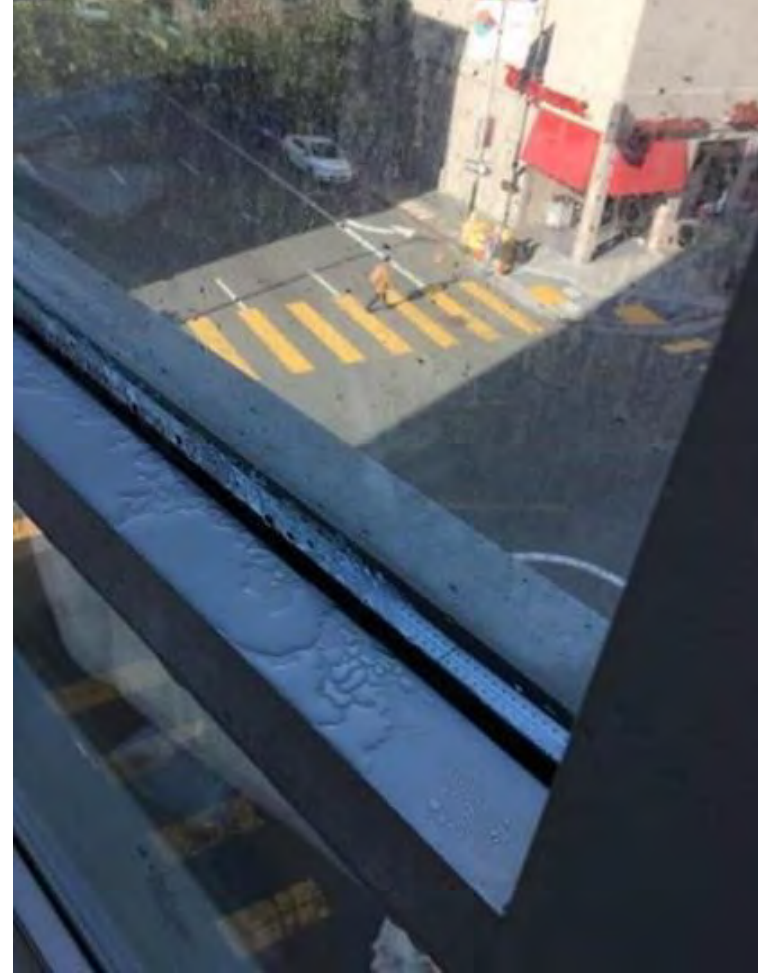
Condensation Due to Gasket Shrinkage

- Specifying silicone gaskets
- Quality control testing/commissioning to check for specified materials
- Using wet seals on inside in conjunction with gaskets

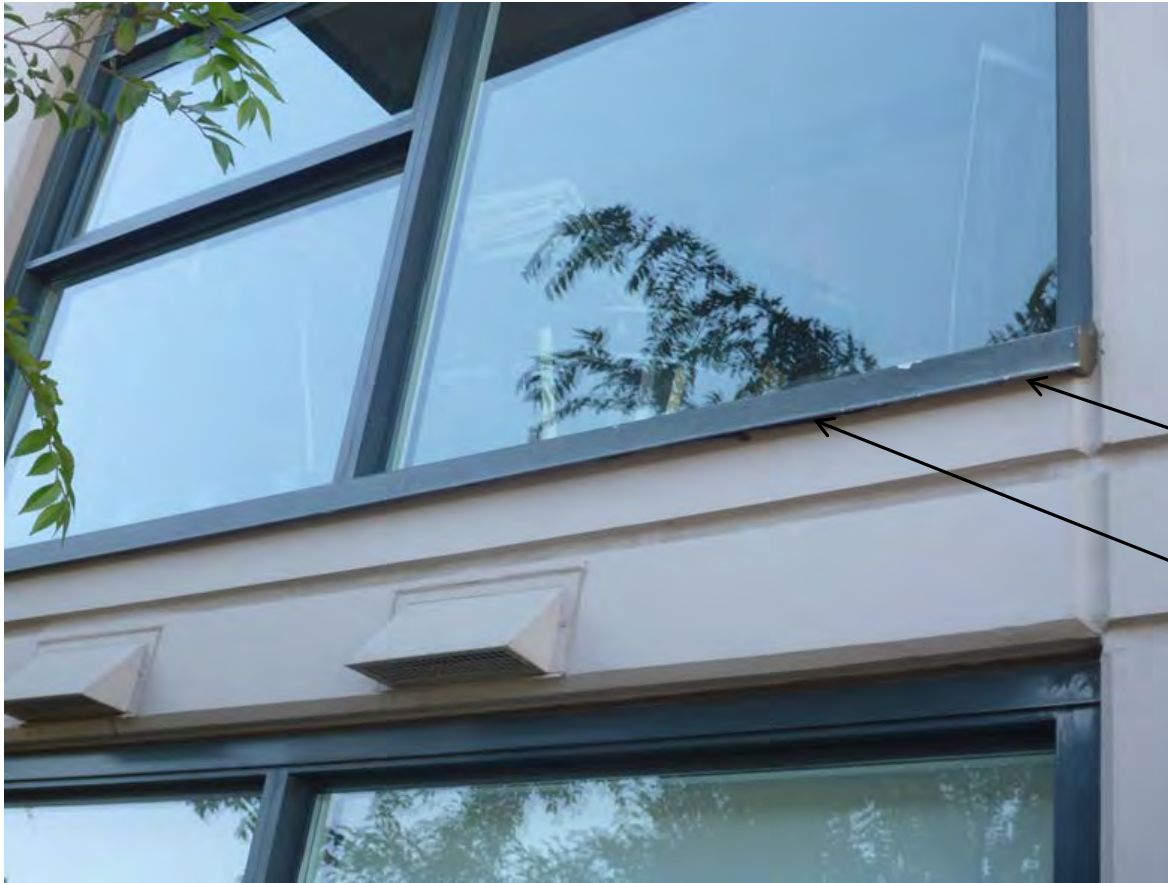
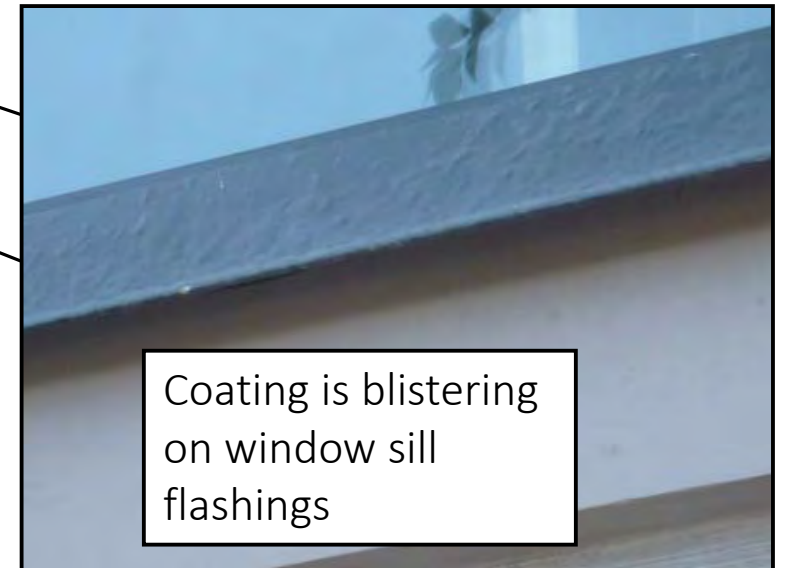
Aluminum Coating Failure

Coating is blistering
on window sill
flashings

- Proper surface preparation and pre-treatments
- Substitution of Chromimum Phosphate wash
- Coating requirements are not followed
 - Improper thickness of coating
- Lack of surface prep – leading to trapped contaminants

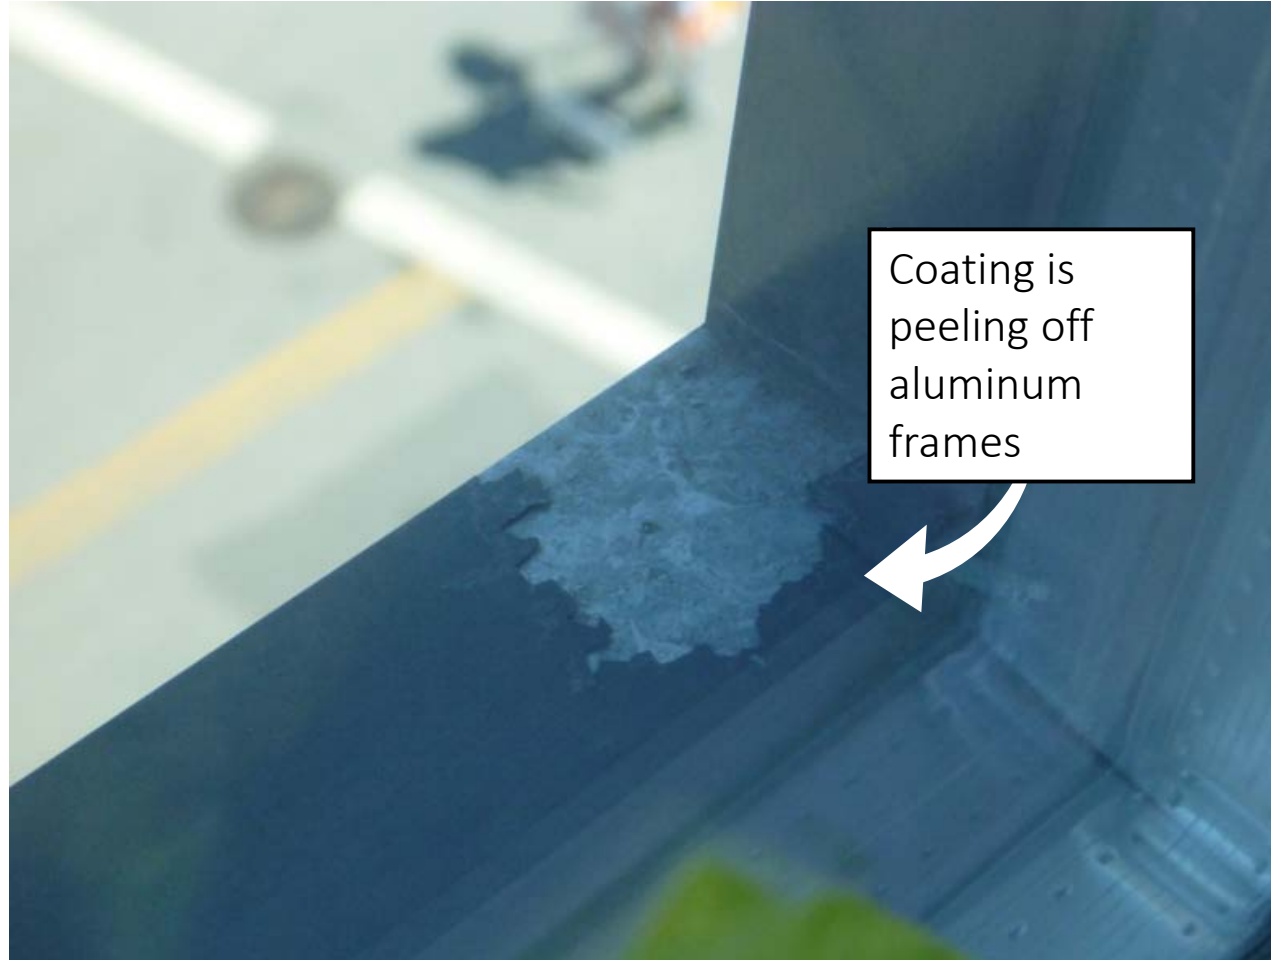
Aluminum Coating Failure

Coating is
peeling off
aluminum
frames

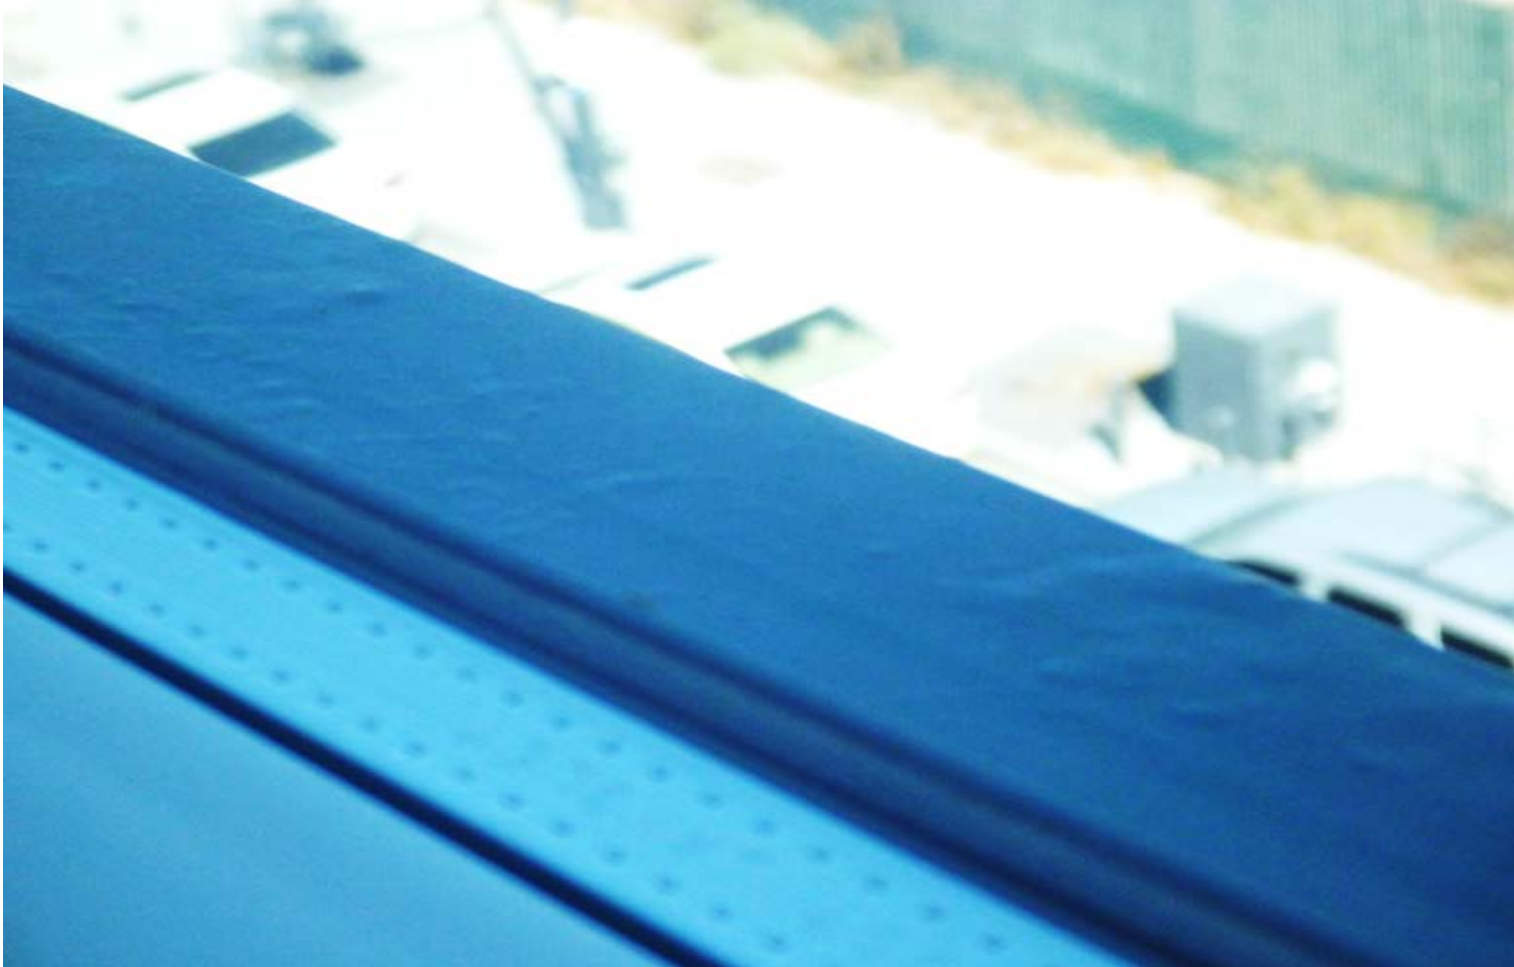
Aluminum Coating Blistering

Coating is bubbling
on window frames

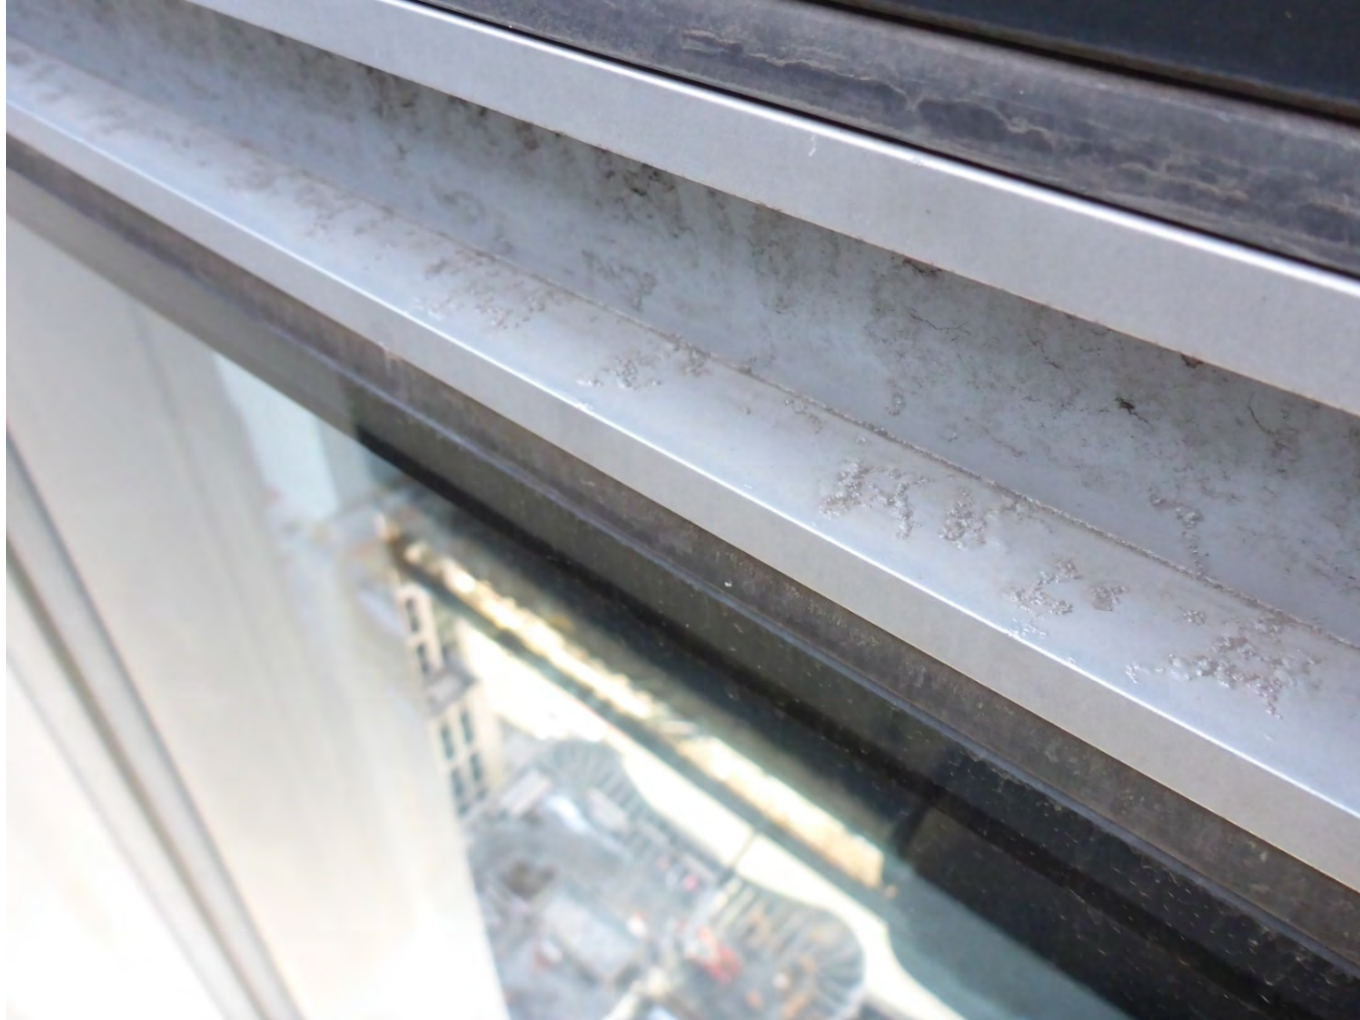
Coating Erupting and Blistering

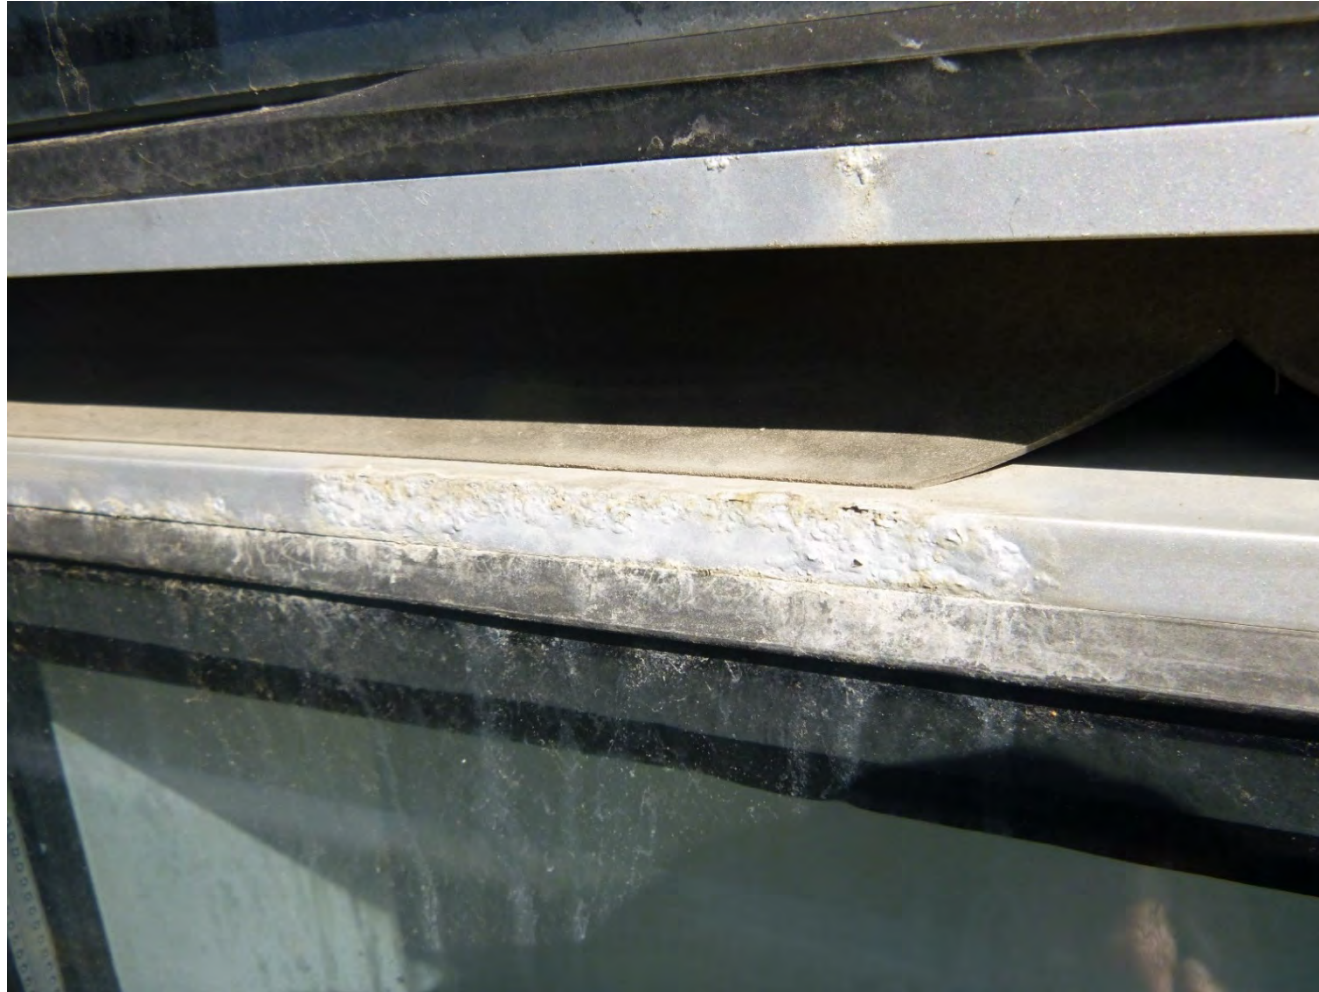
Coating Failure Causing Pitting

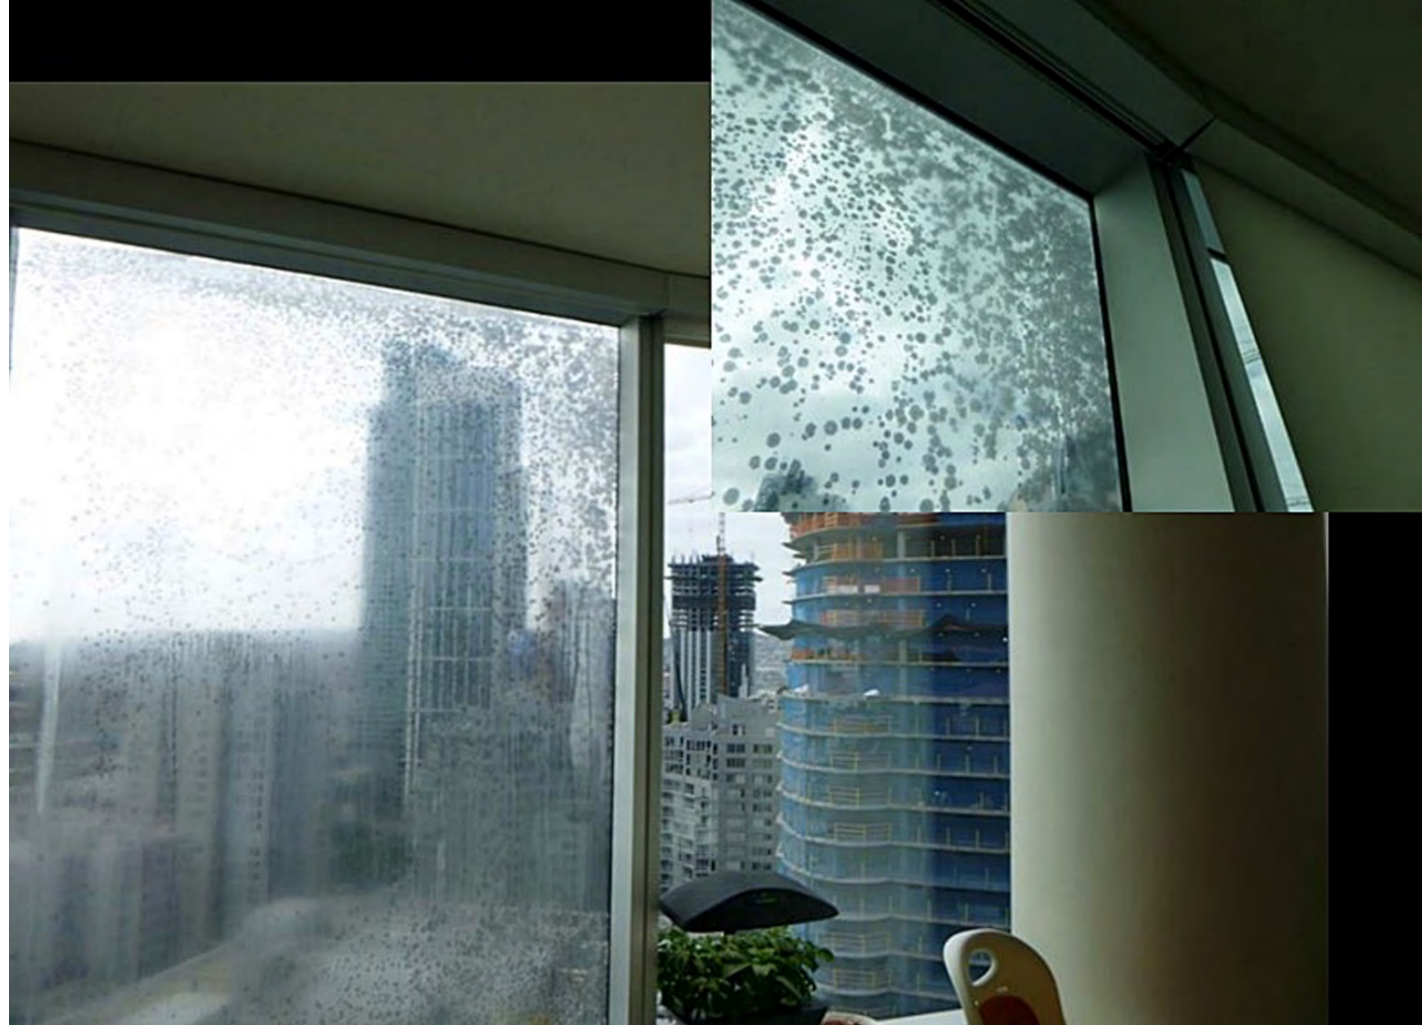
Corrosion/Tarnishing of Silver Coatings
