WGA Curtain Wall Failures

Learnings From Curtain Wall Failures

Common Modes of Failure

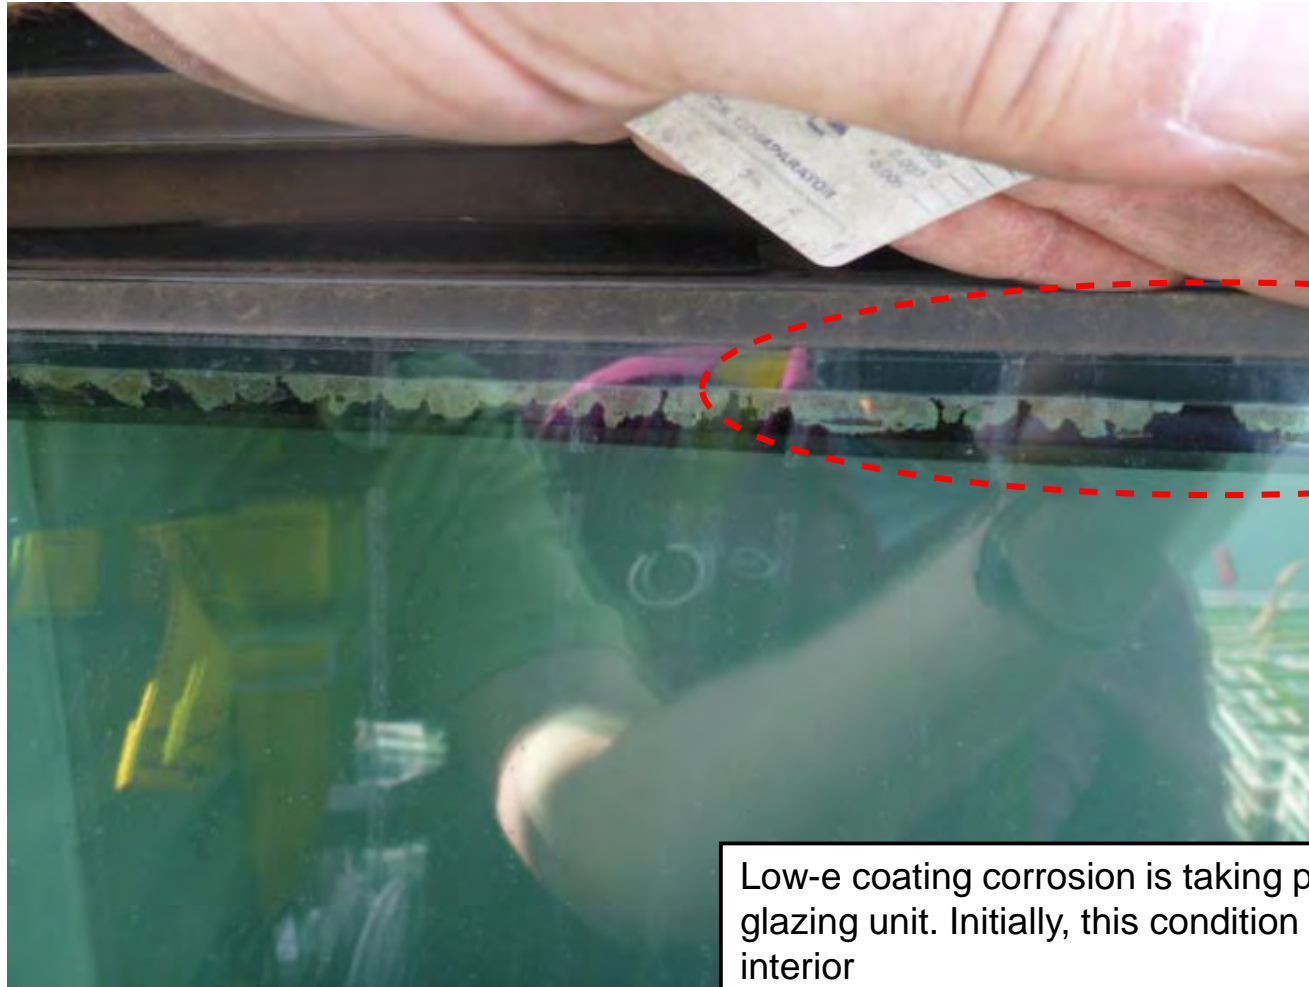
Start of Low-E Coating Corrosion

Low-e coating corrosion is taking place at the edges of the glazing unit. Initially, this condition is not visible from the interior

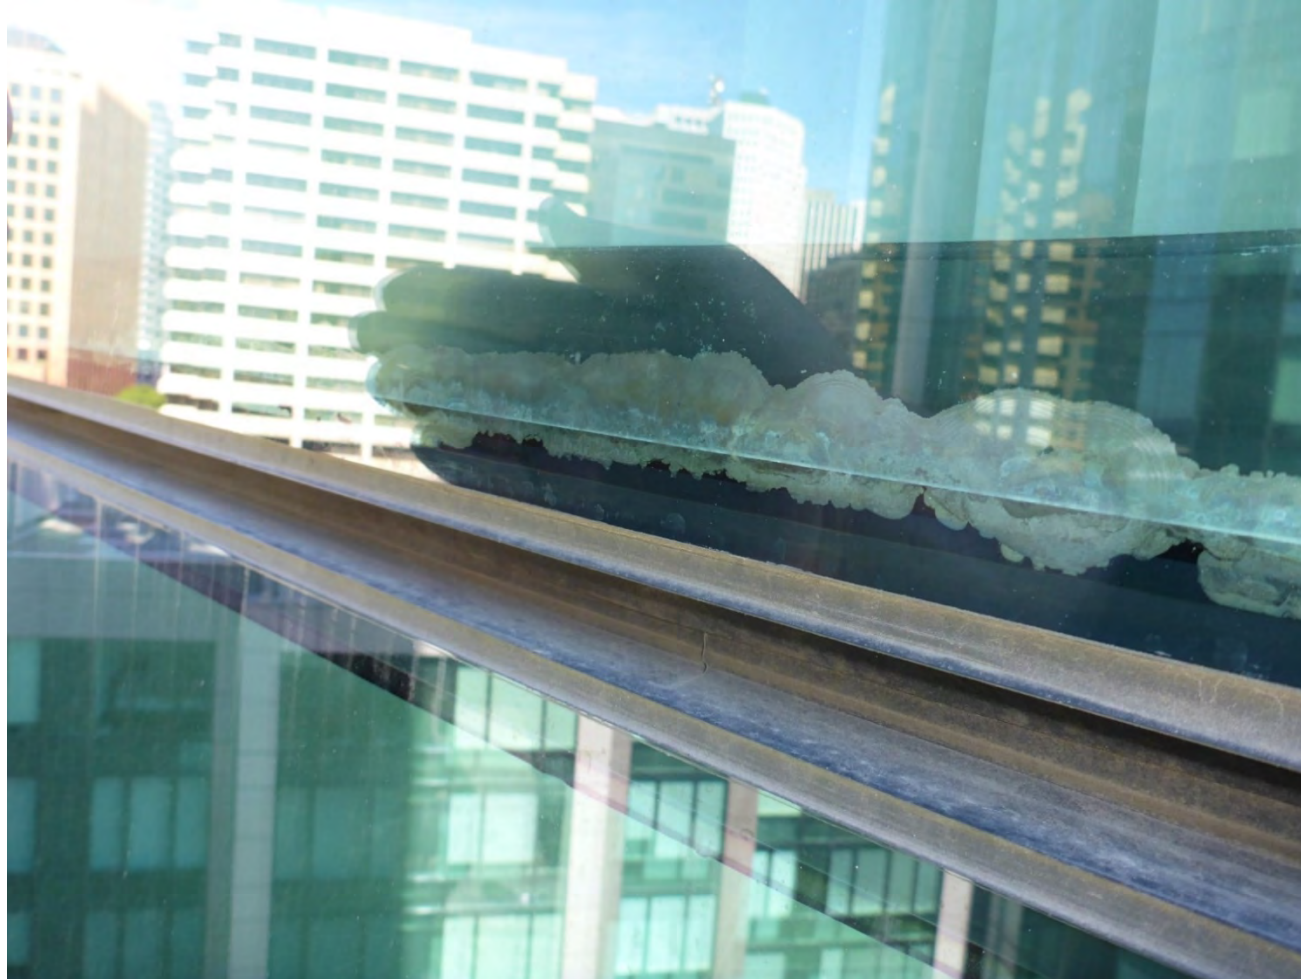
Continuing Low-E Coating Corrosion

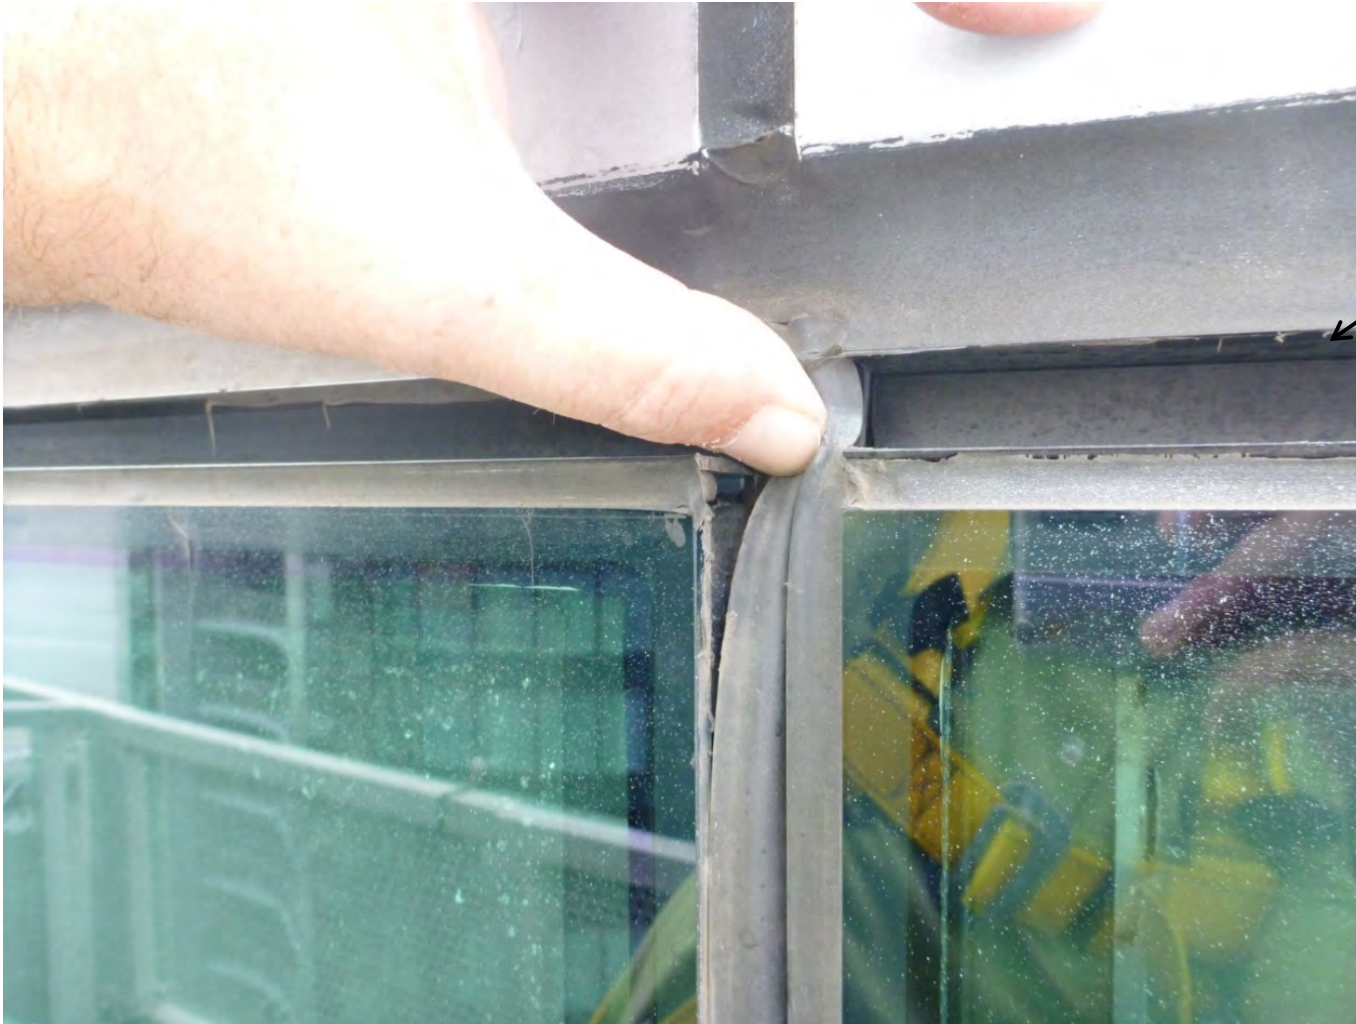
Standing Water on IGU Seals

If the ends of the sealant joints are not closed, water is able to infiltrate on top of the primary seal

- Proper edge deletion needs to occur during the manufacturing process to ensure proper bonding of the IGU sealants
- Design of the glazing and curtain wall assembly should not allow water to stand on top of the silicone sealant because silicone is permeable
- Design installation of glass should be on blocks and properly drained to prevent dual glazing to sit in water

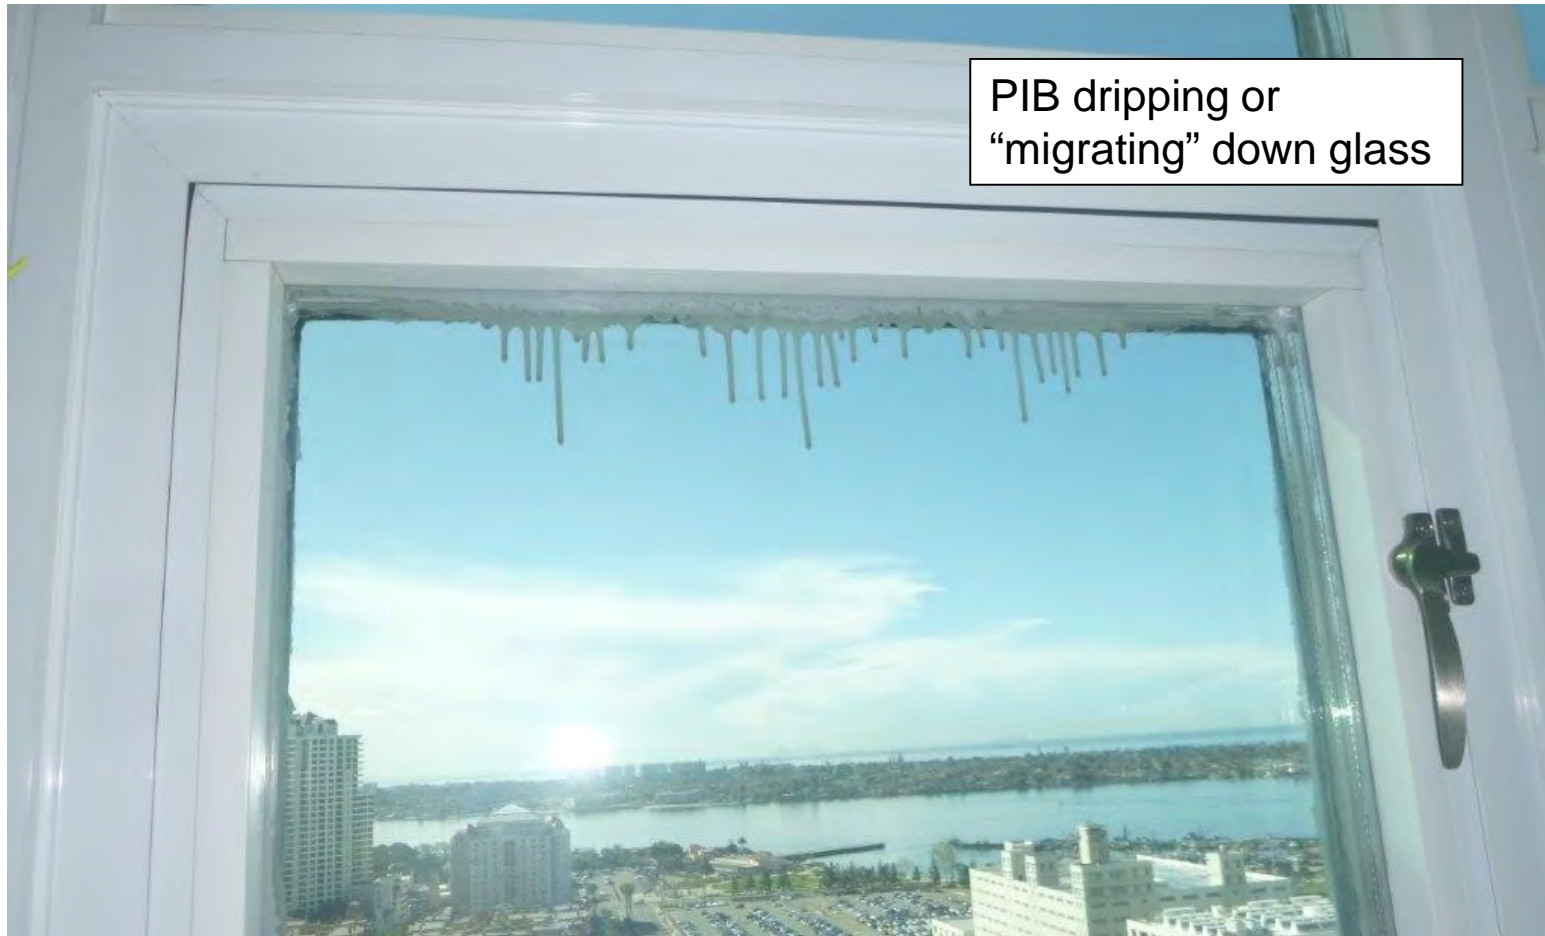
PIB Migration/Failure in IGU

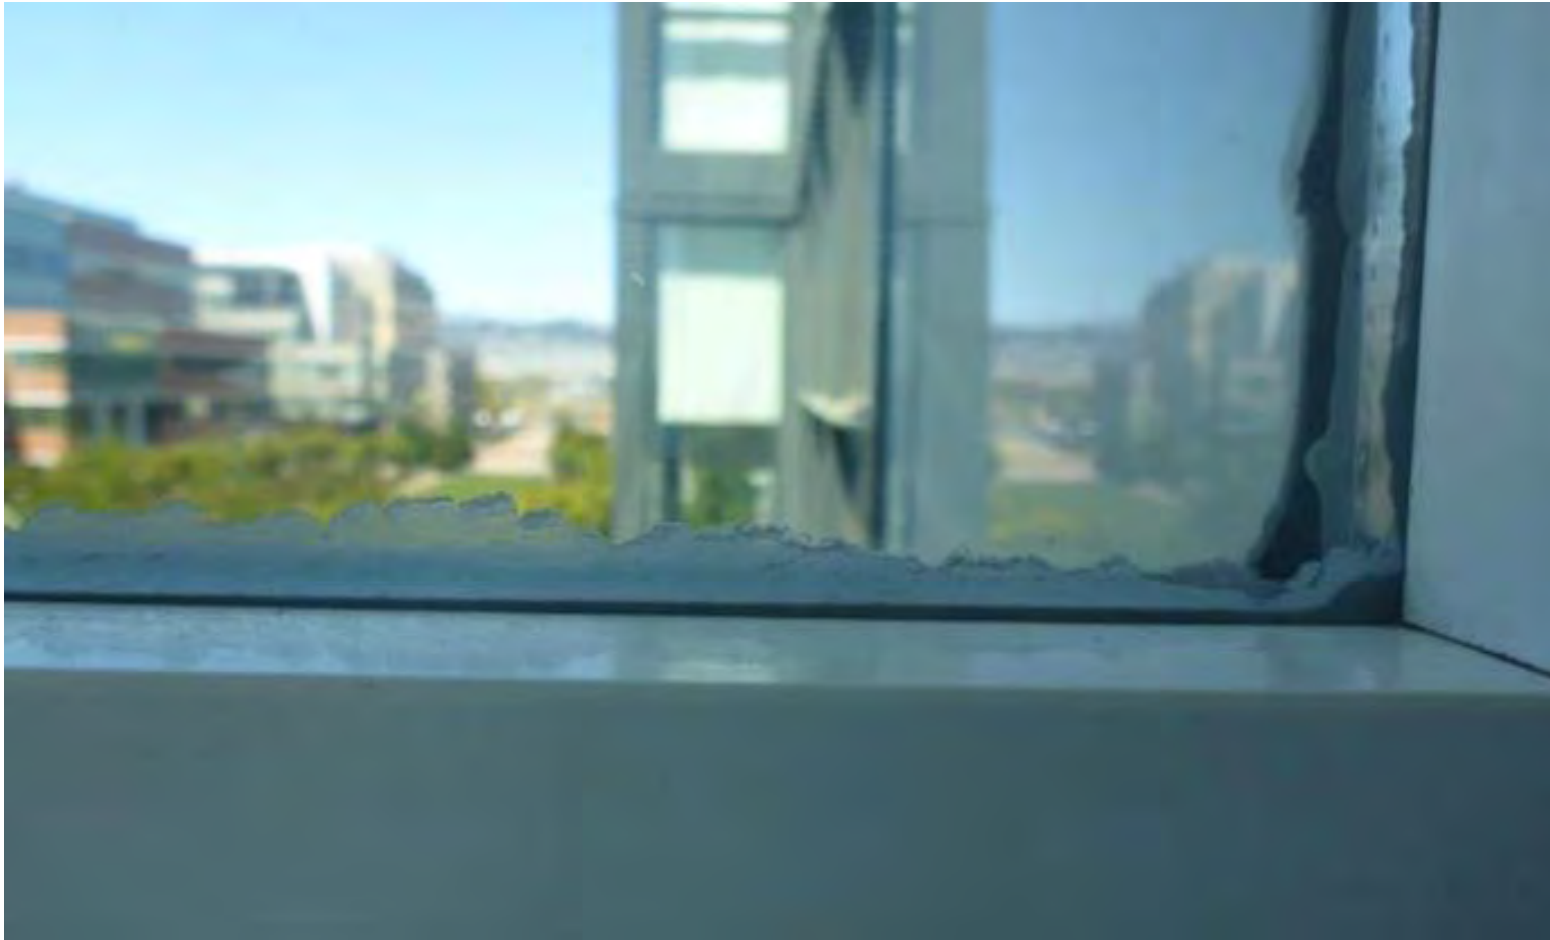
PIB Migration, Moving/Walking Up

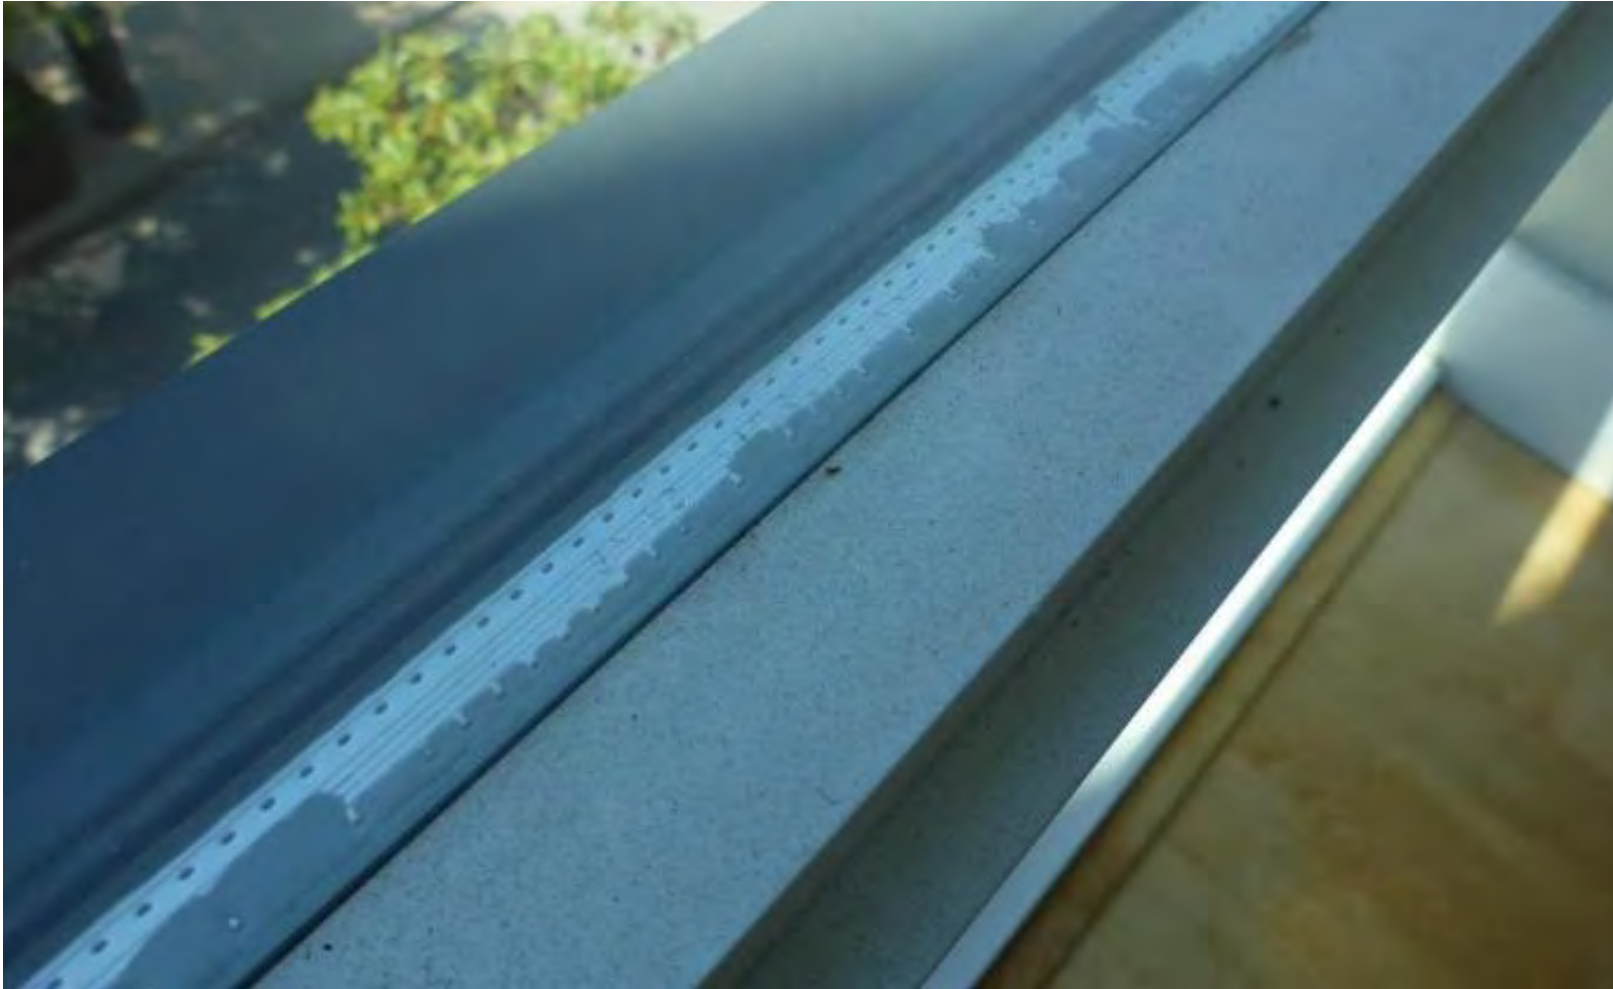
PIB Migration

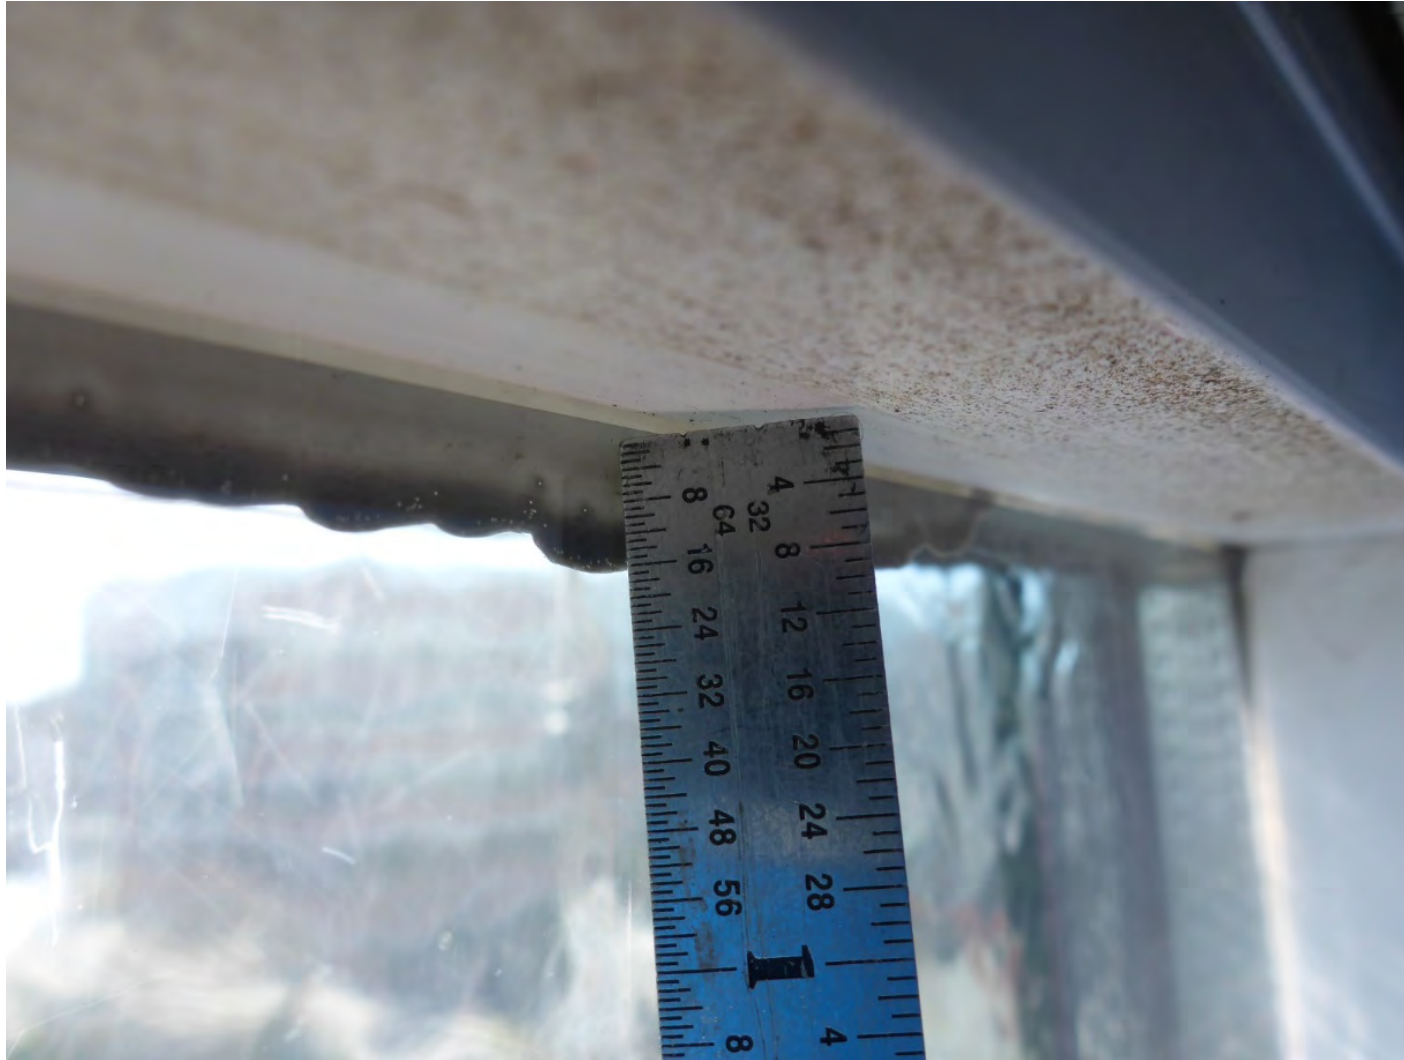
Case Study- SF Condo w/ PIB Migration

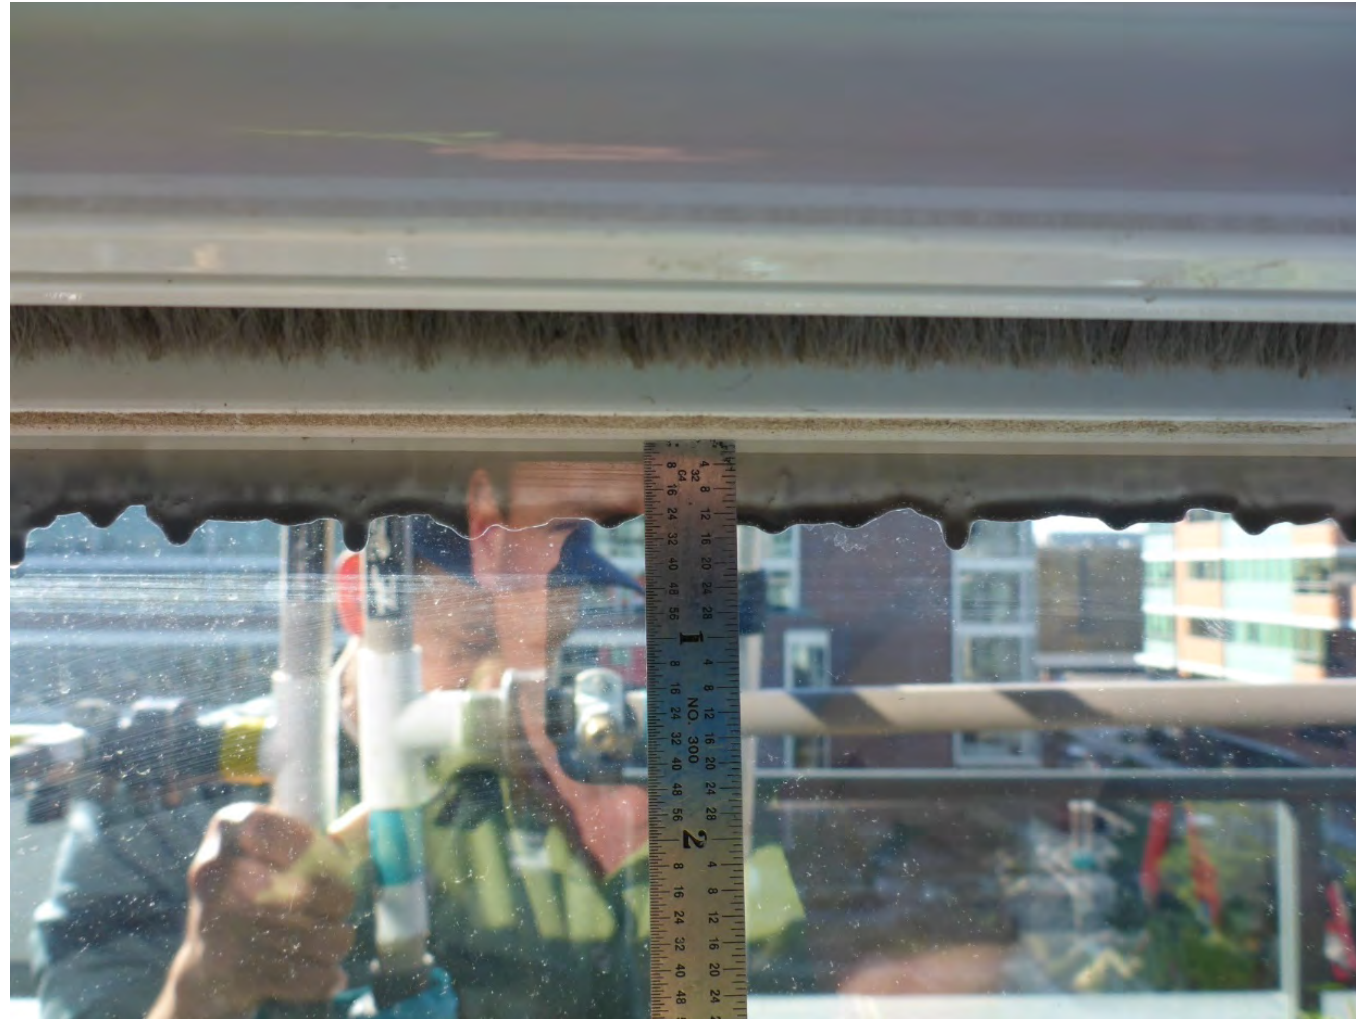
Case Study- SF Condo w/ PIB Migration

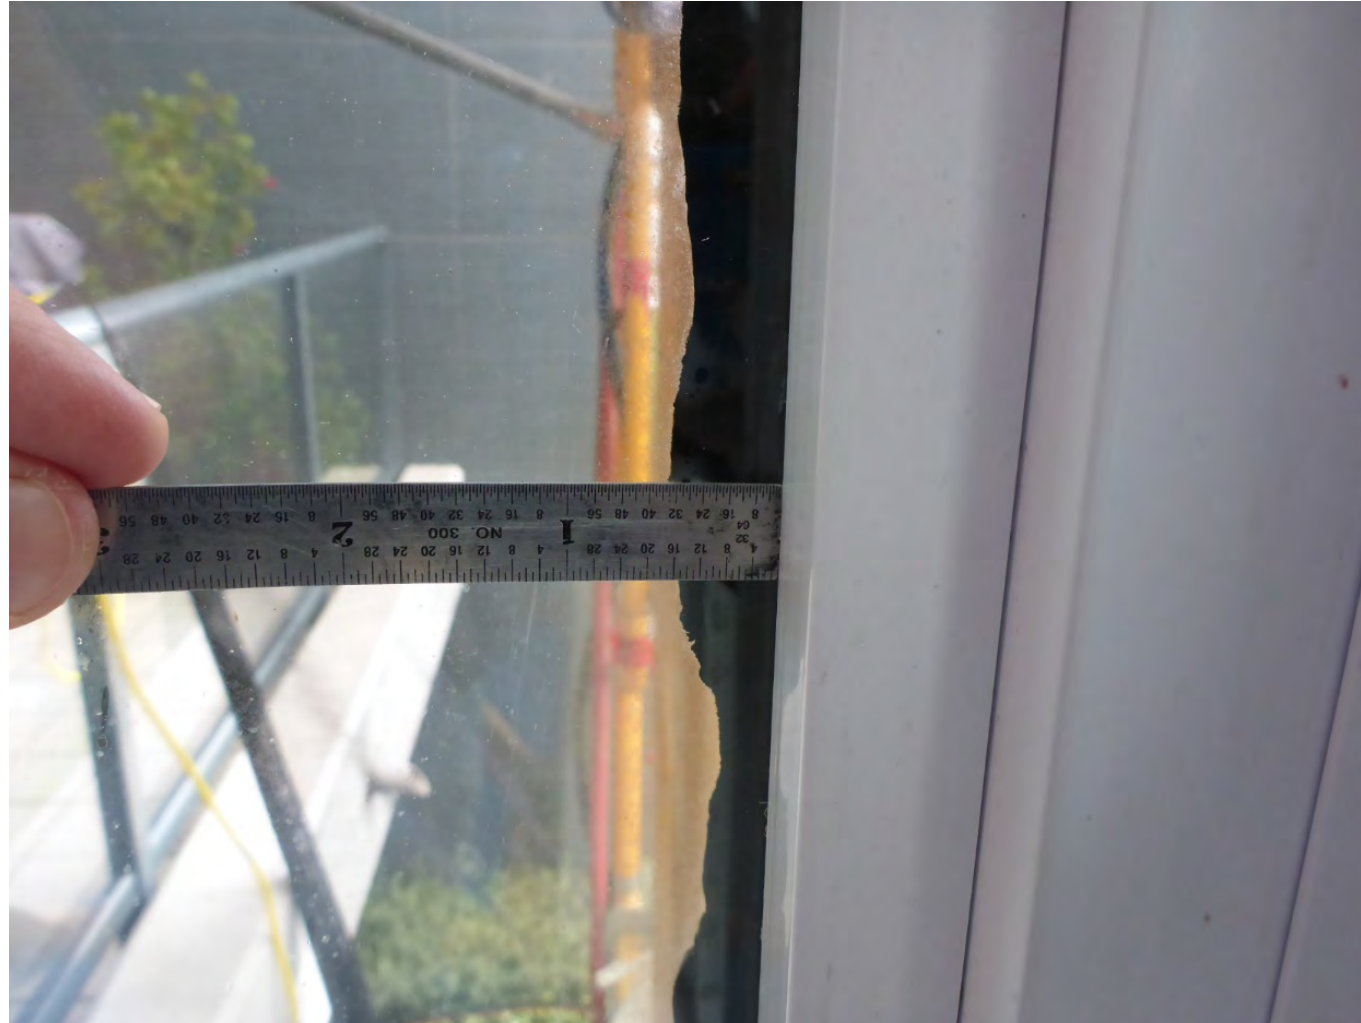
Case Study- SF Condo w/ PIB Migration

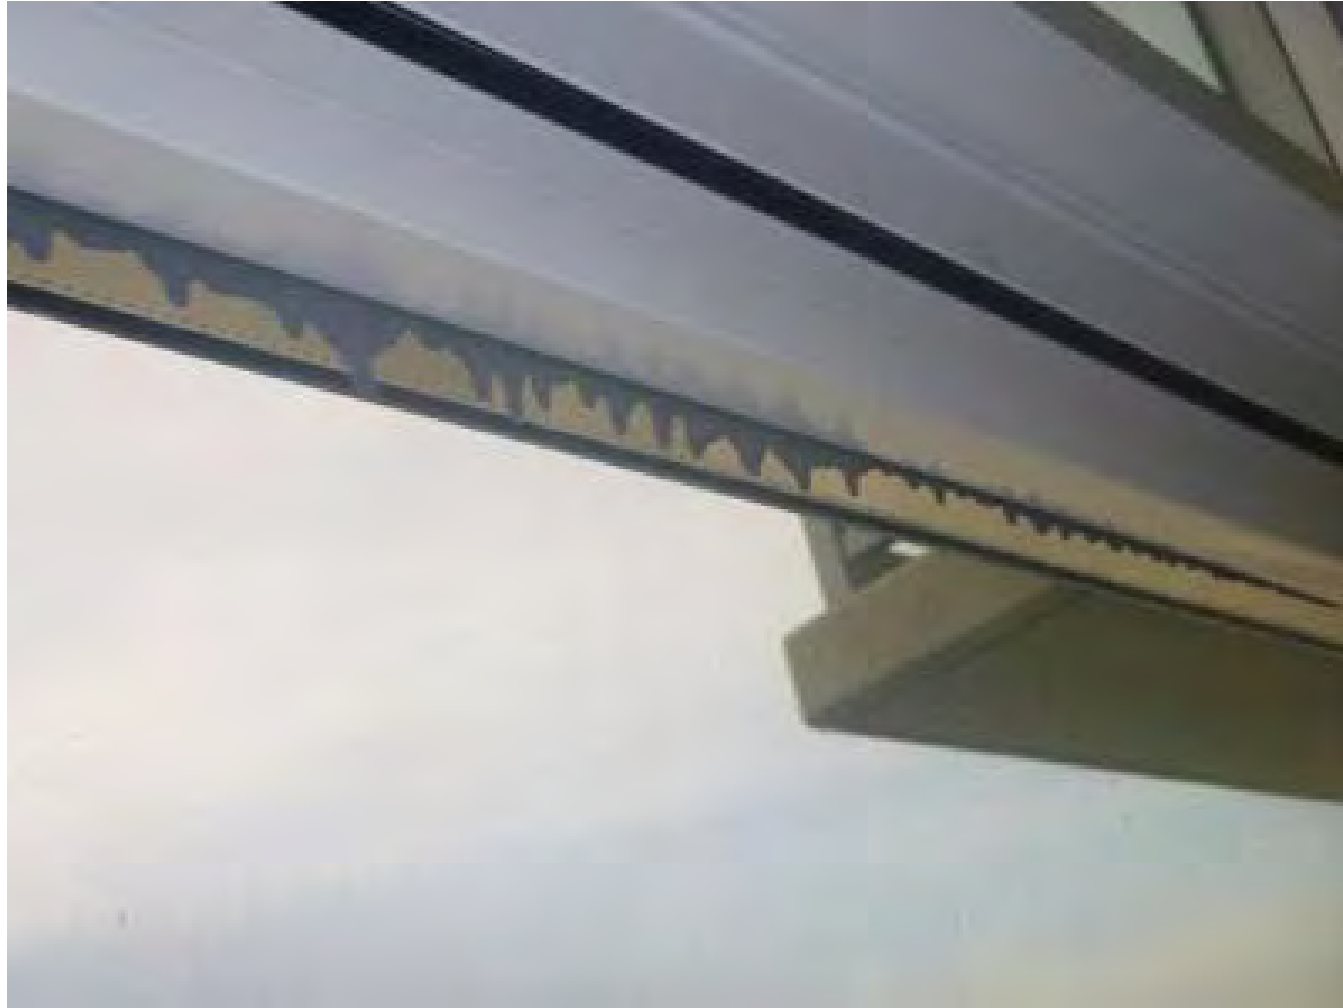
Case Study- San Pedro Condo w/ PIB Migration

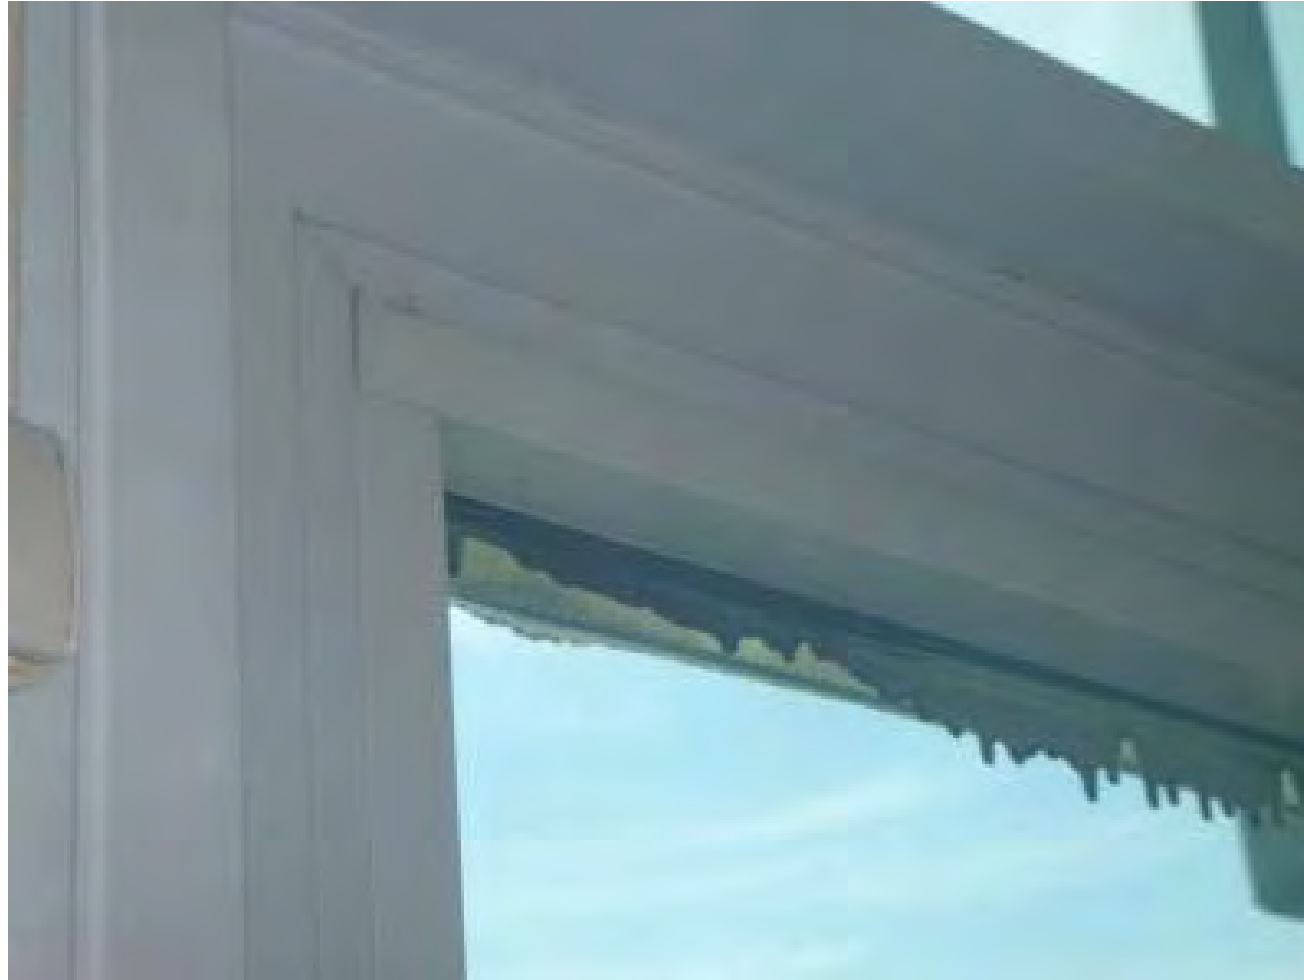
Case Study- San Pedro Condo w/ PIB Migration

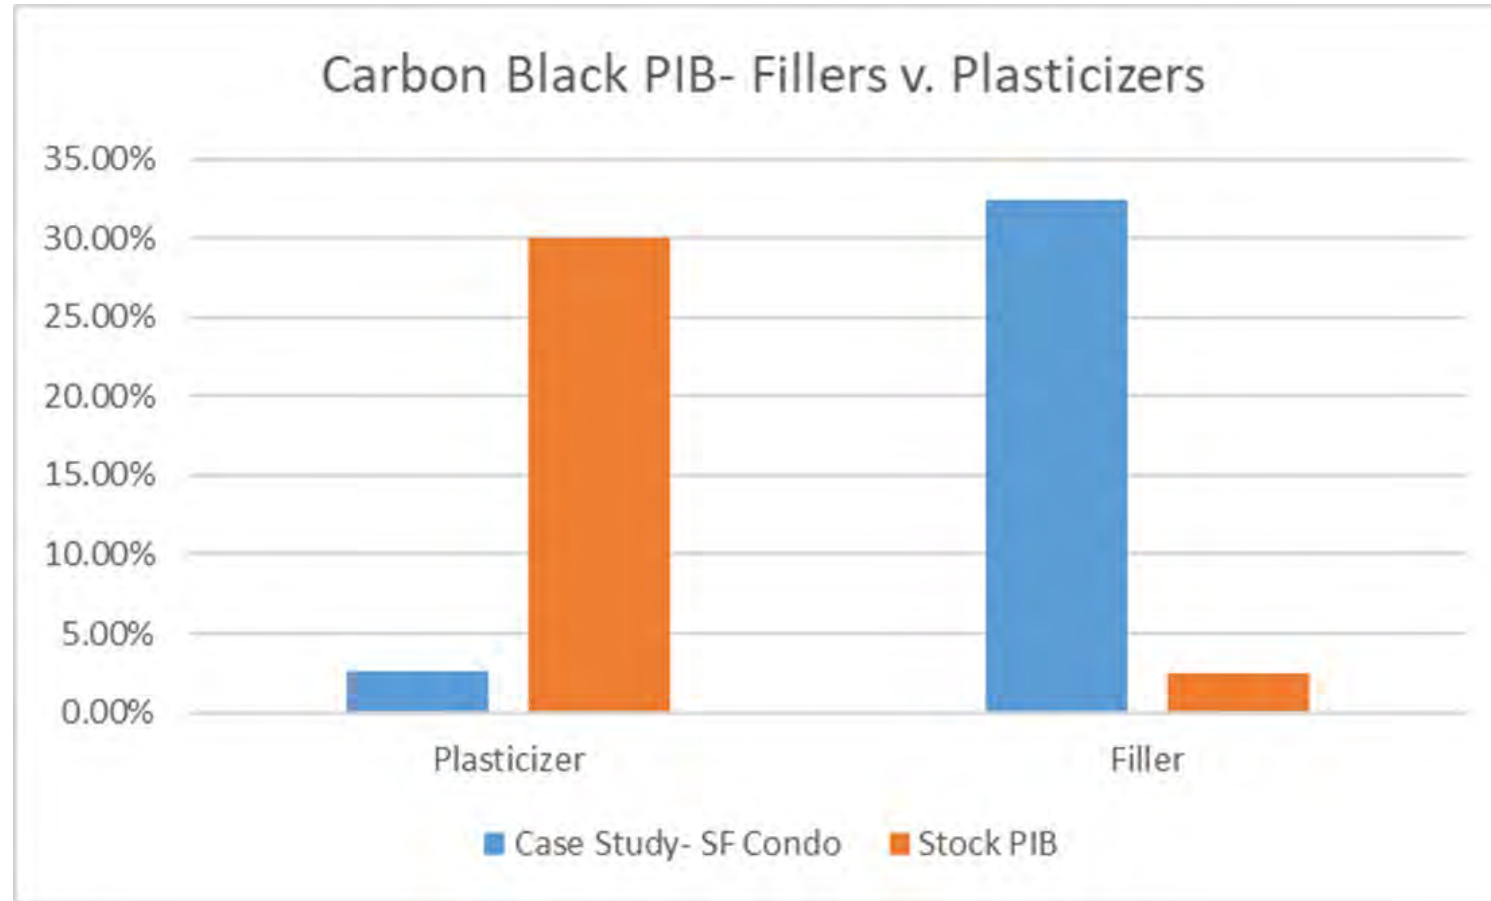
Case Study- SF Condo w/ PIB Migration
