33RD RCI INTERNATIONAL CONVENTION & TRADE SHOW

Avoiding Condensation in Low-Slope Roofing Assemblies

Case Study

San Francisco Apartment

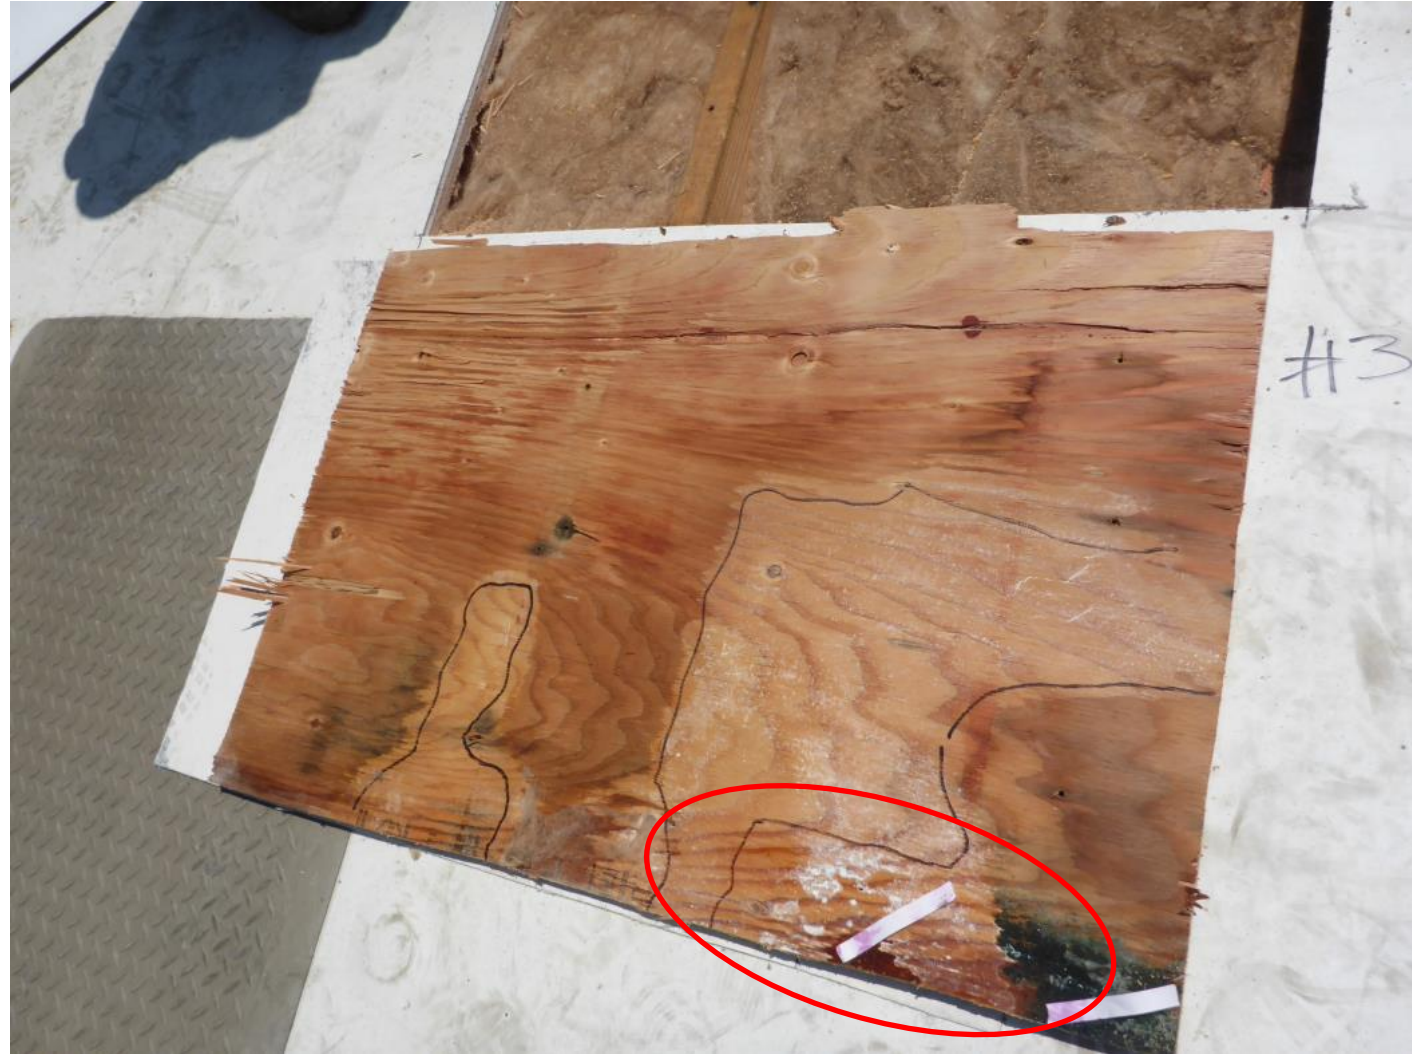
Destructive Test
Cut #3b

Damage on Backside of Plywood Cricket

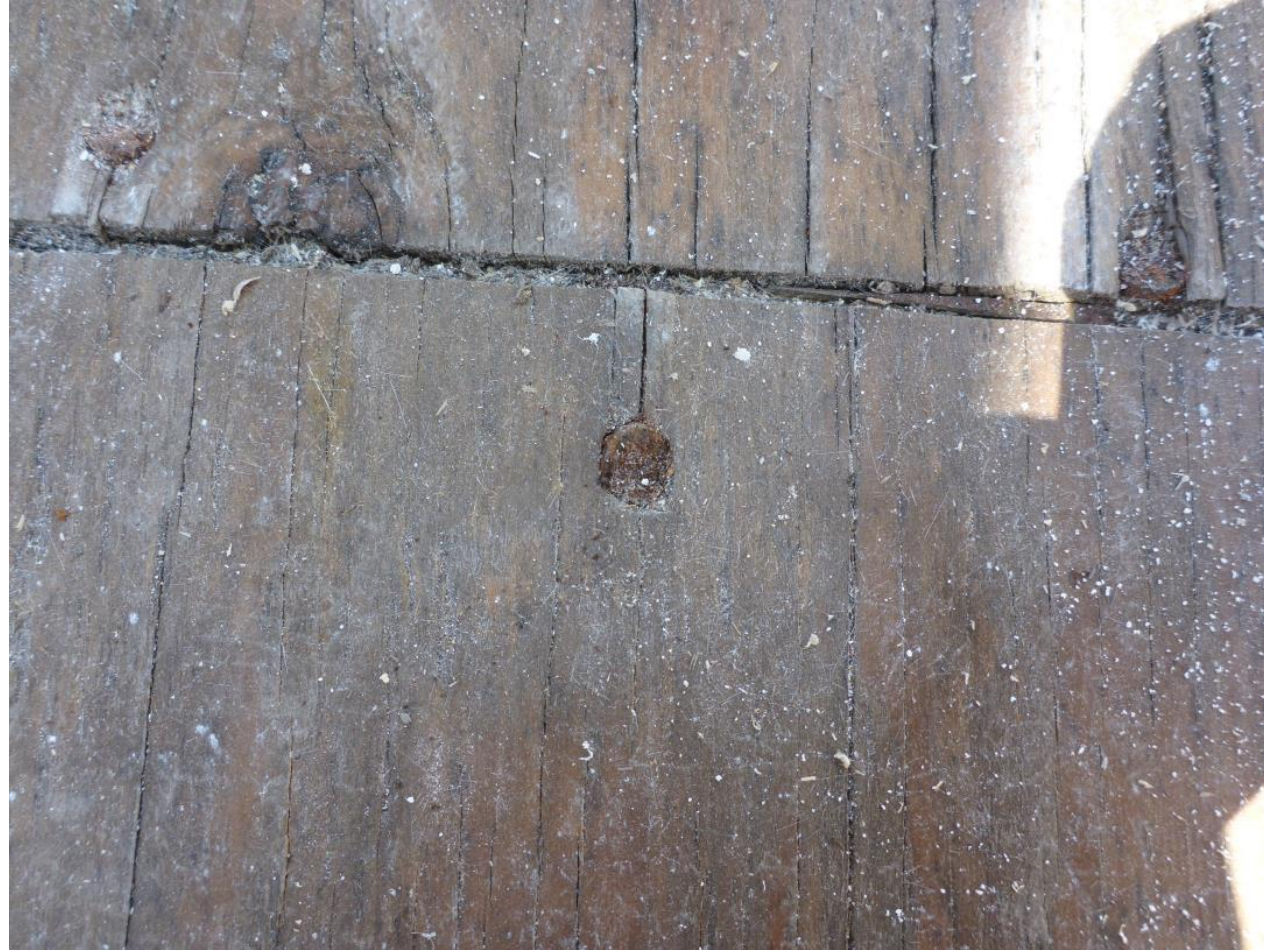
Destructive Test Cut #1b

Weathered Sheathing and Rusted Fasteners

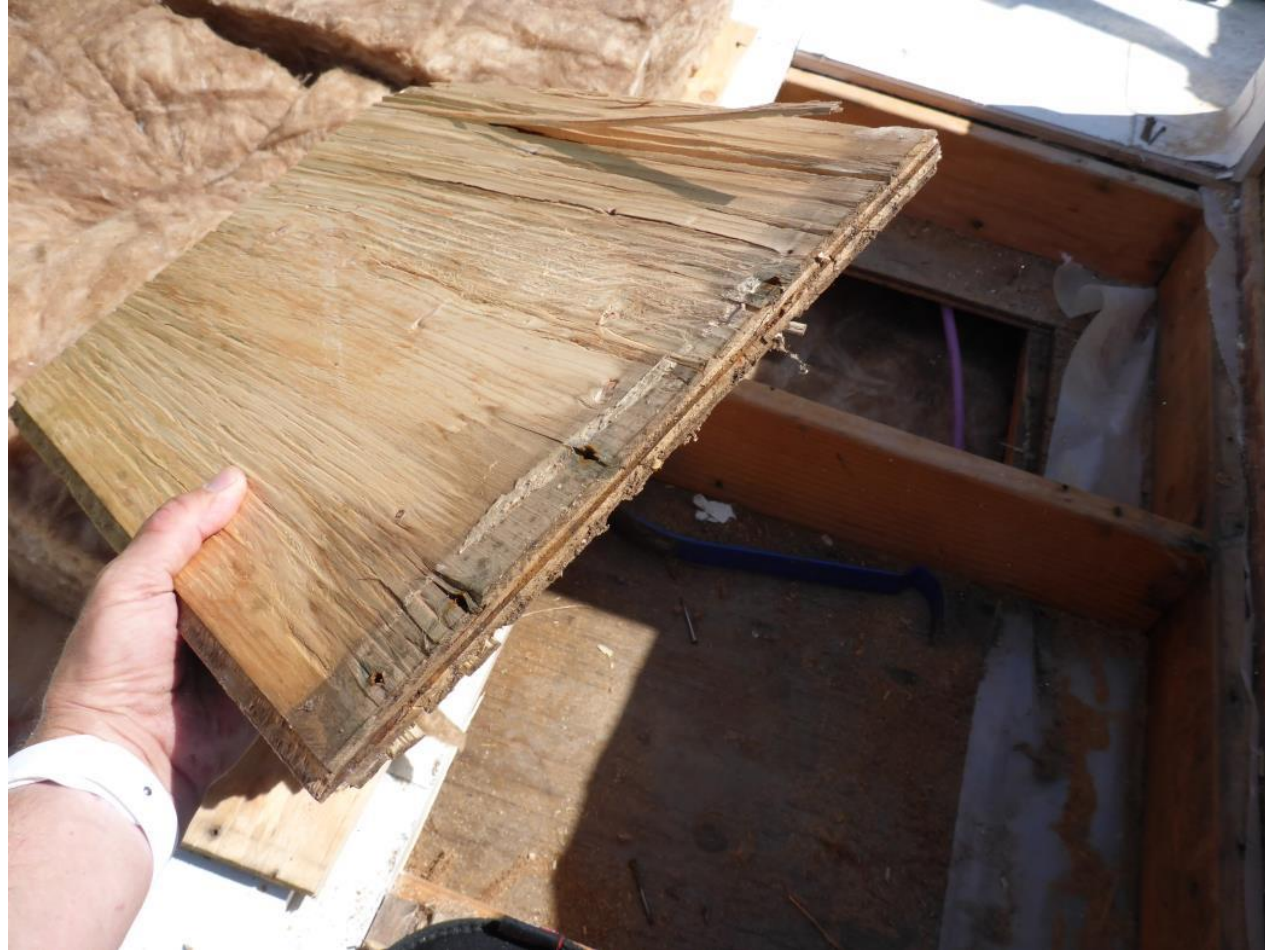
Damage Underneath the Plywood Deck Edge

Water Damage Due to Rain
