# Building Skin Failures

**Karim Allana, PE, RRC, RWC**

Allana Buick & Bers, Inc.

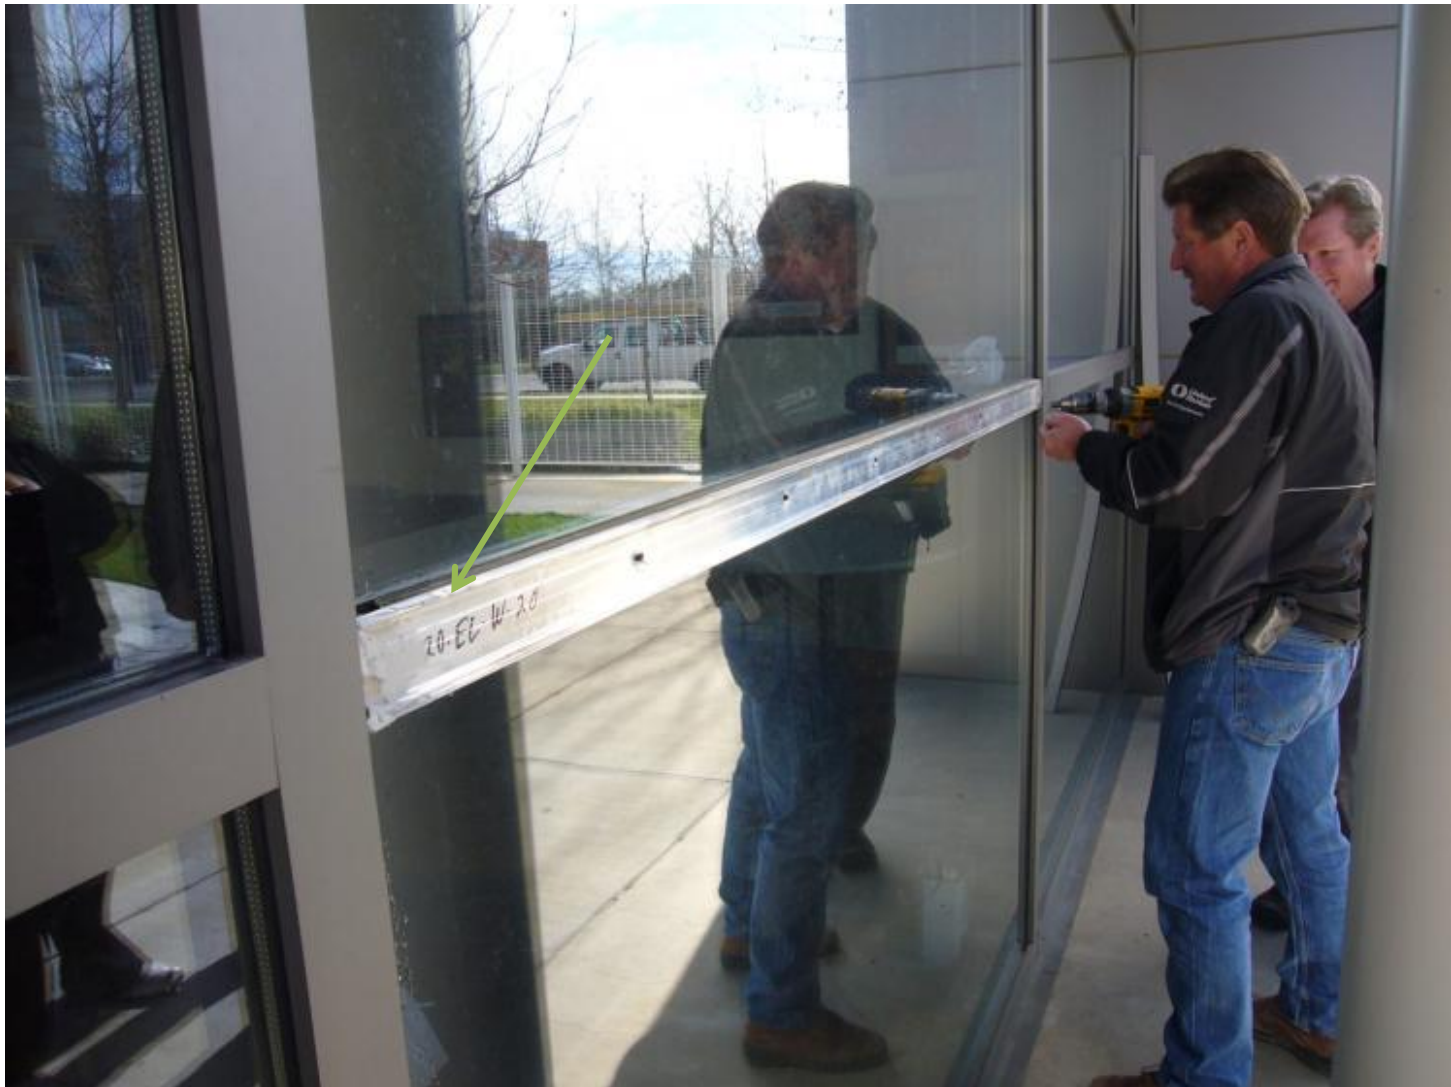
# Mondavi Gasket Shrinkage / Failure

- Drying out, shrinking and cracking
- Exposure to UV radiation
- Exposure to freeze-thaw cycles
- Improper maintenance
- Failures experienced in 4-6 years

# Avoiding Gasket Failure

- Specifying high quality gasketing materials
- Quality control testing/commissioning to check for specified materials
- Using wet seals on inside in conjunction with gaskets

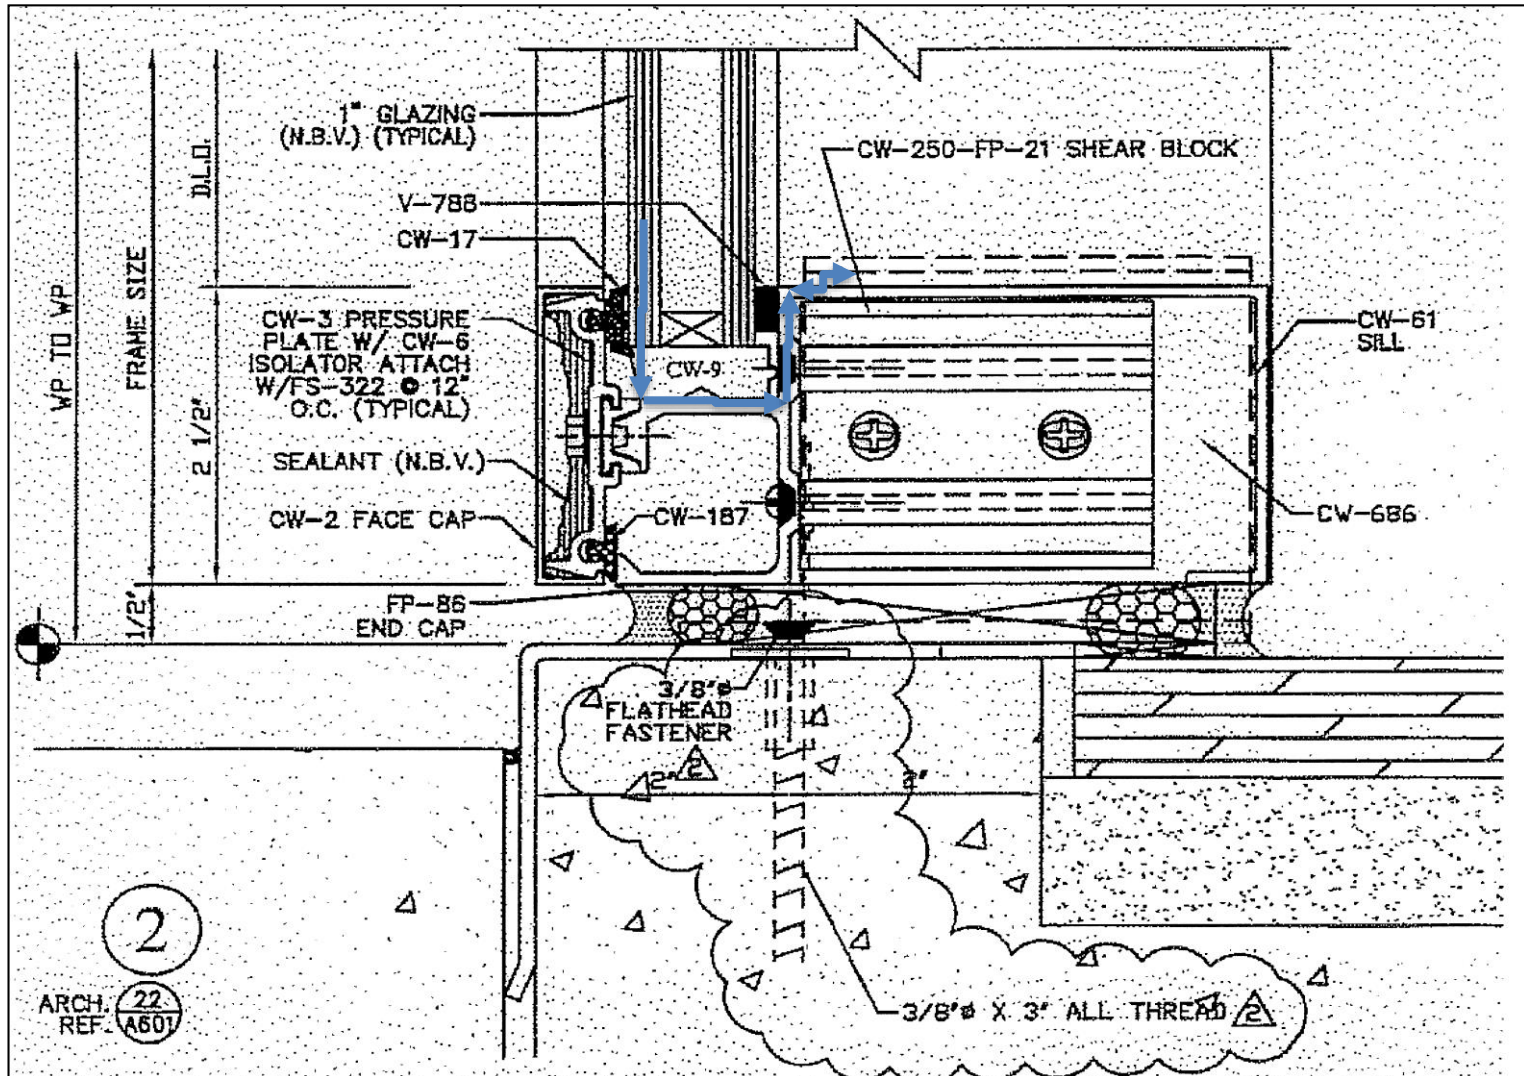
# Typical EPDM Mullion Gasket Shrinkage

15/16" glazing installed produces a loose seal and leaks

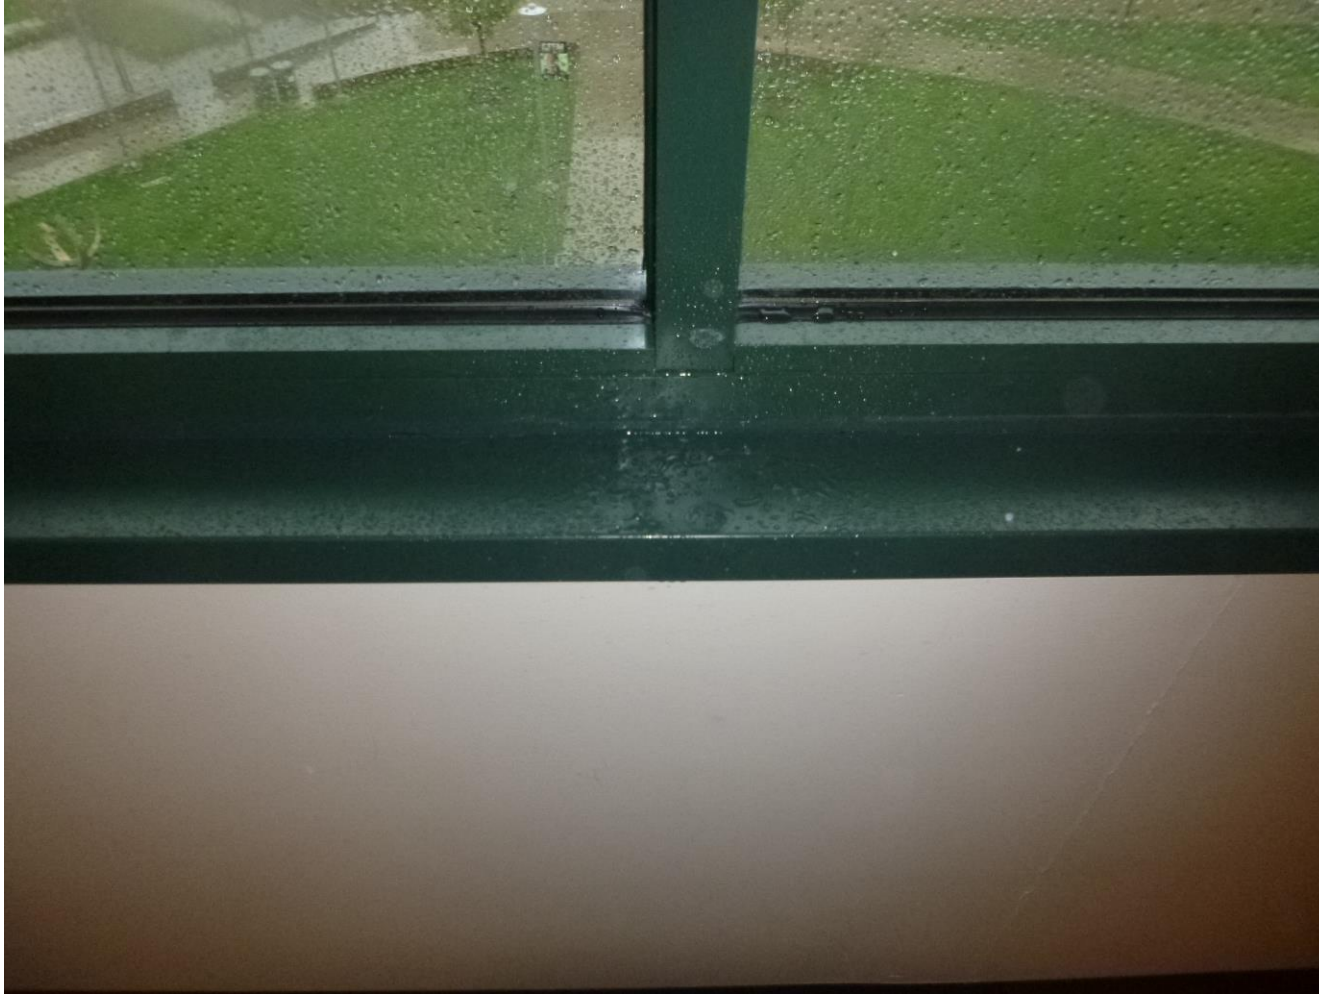
# Gasket Shrinkage Water Intrusion

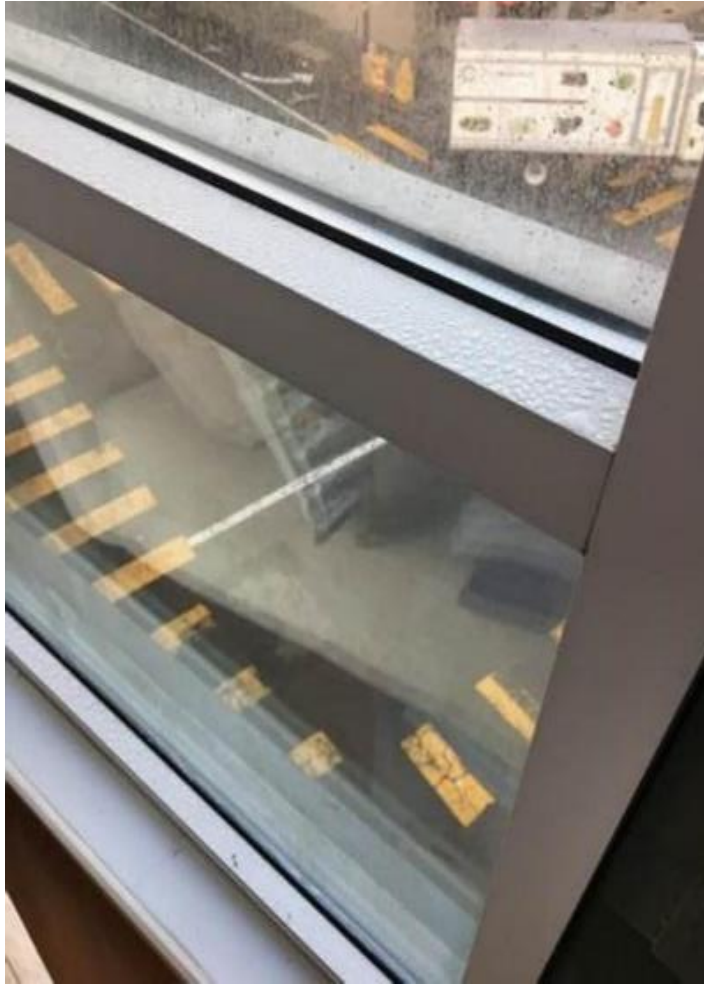
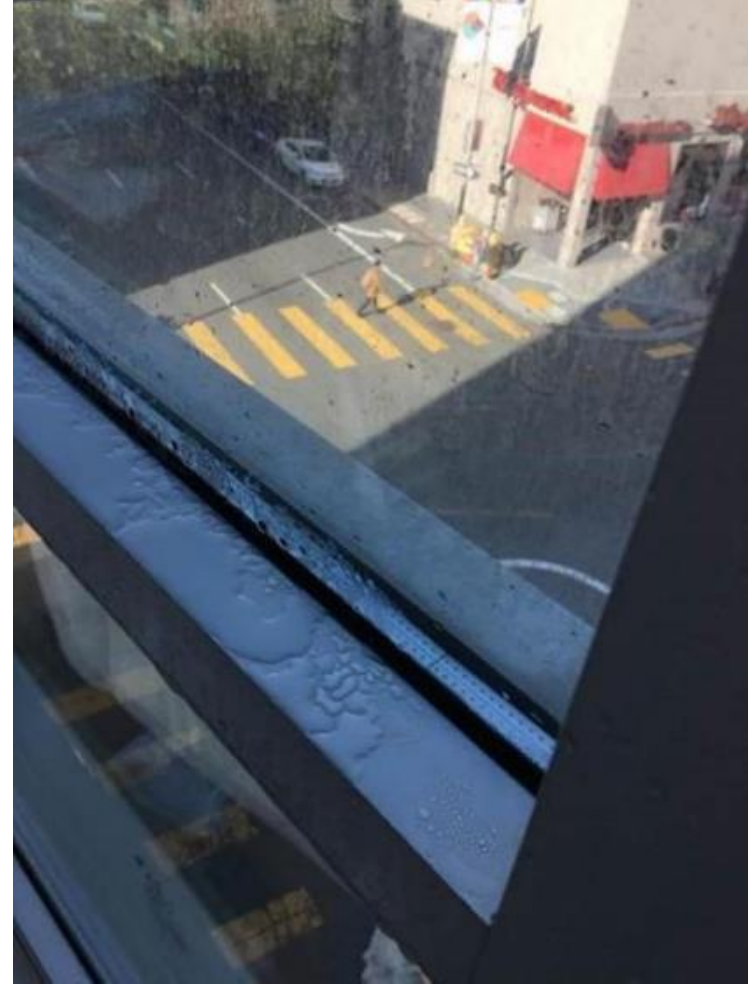
# Condensation Due to Air Leakage

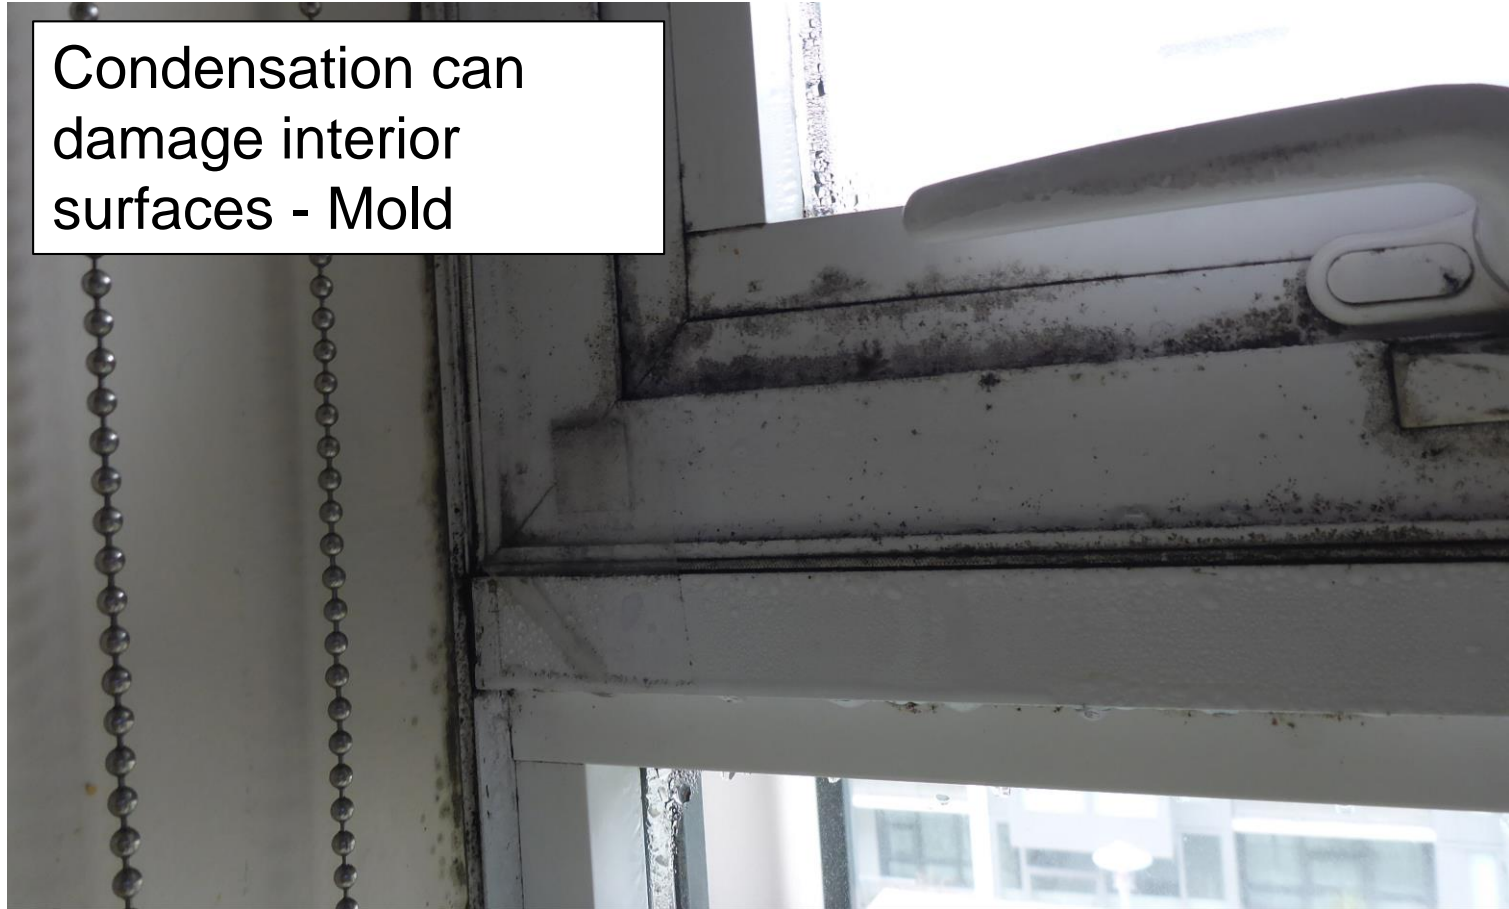
# Condensation Due to Gasket Failure

Condensation can  
damage interior  
surfaces - Mold

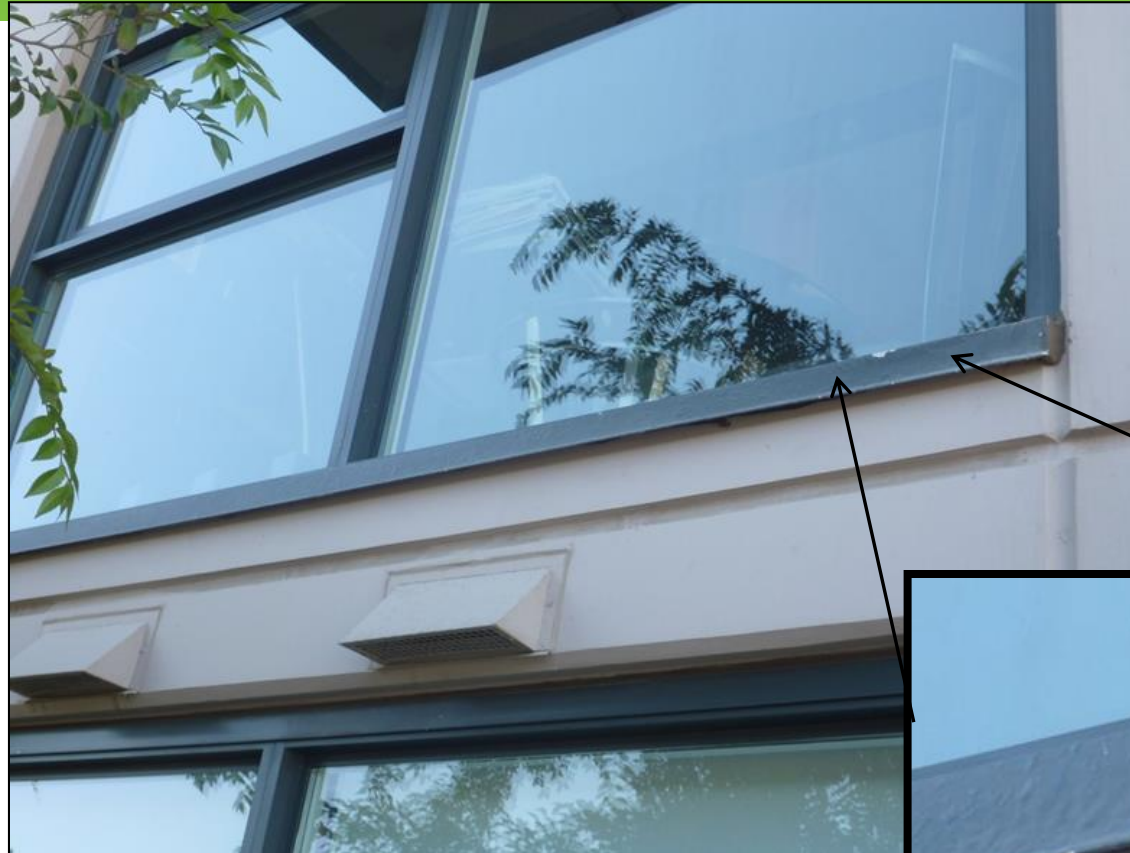
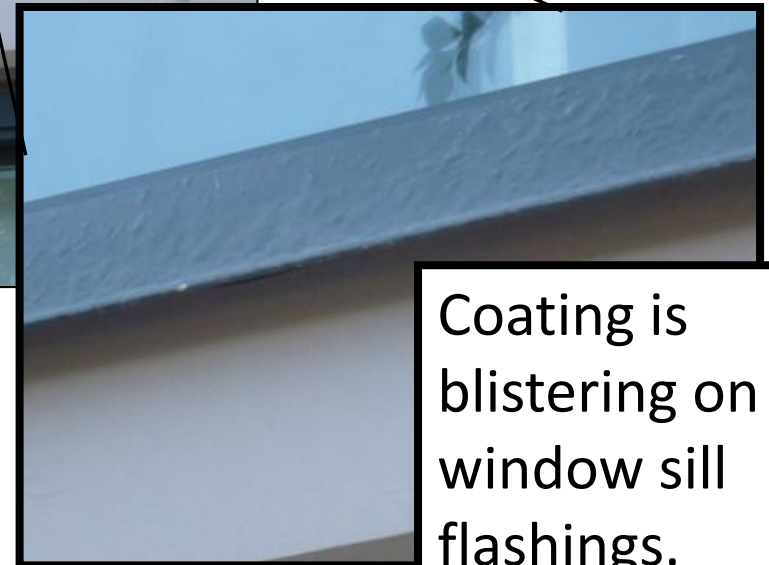
Coating is  
blistering on  
window sill  
flashings.

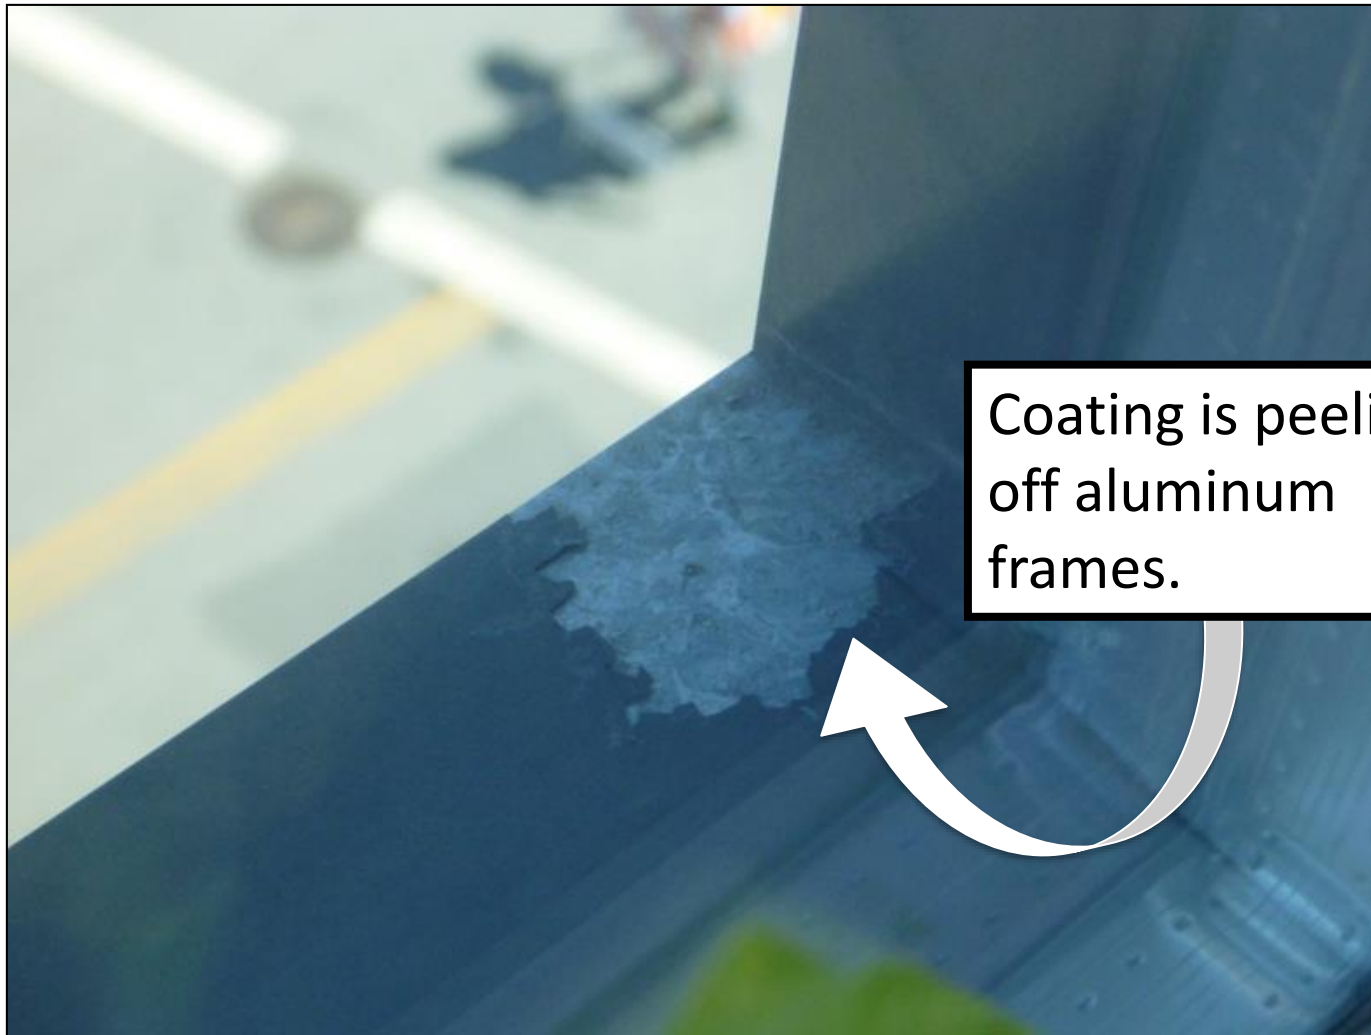
Coating is peeling off aluminum frames.

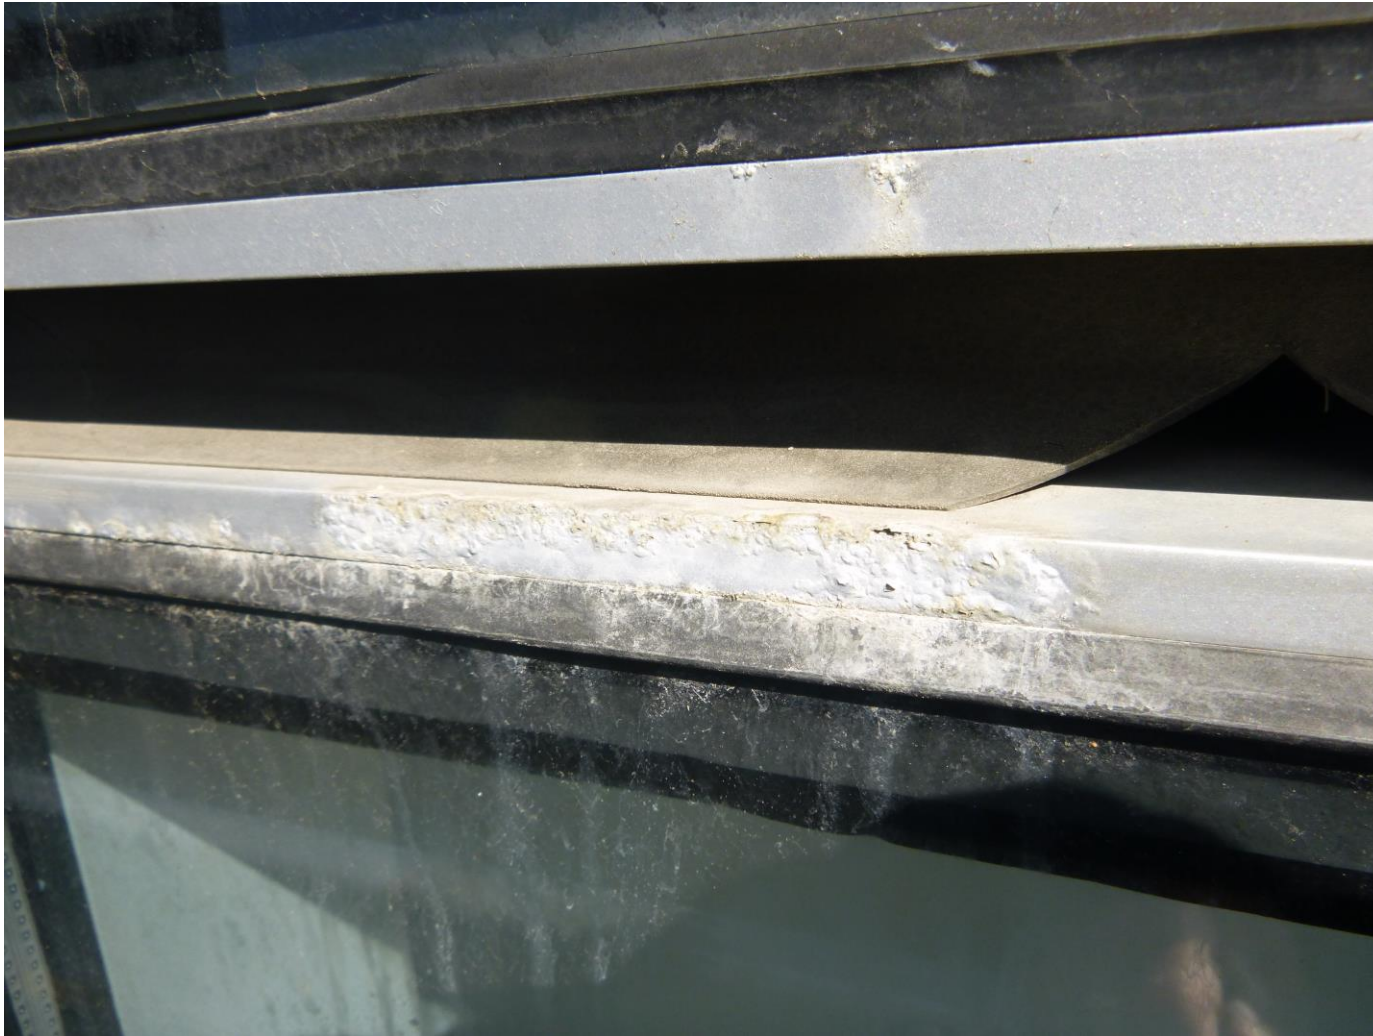
# Coating Failure Causing Pitting

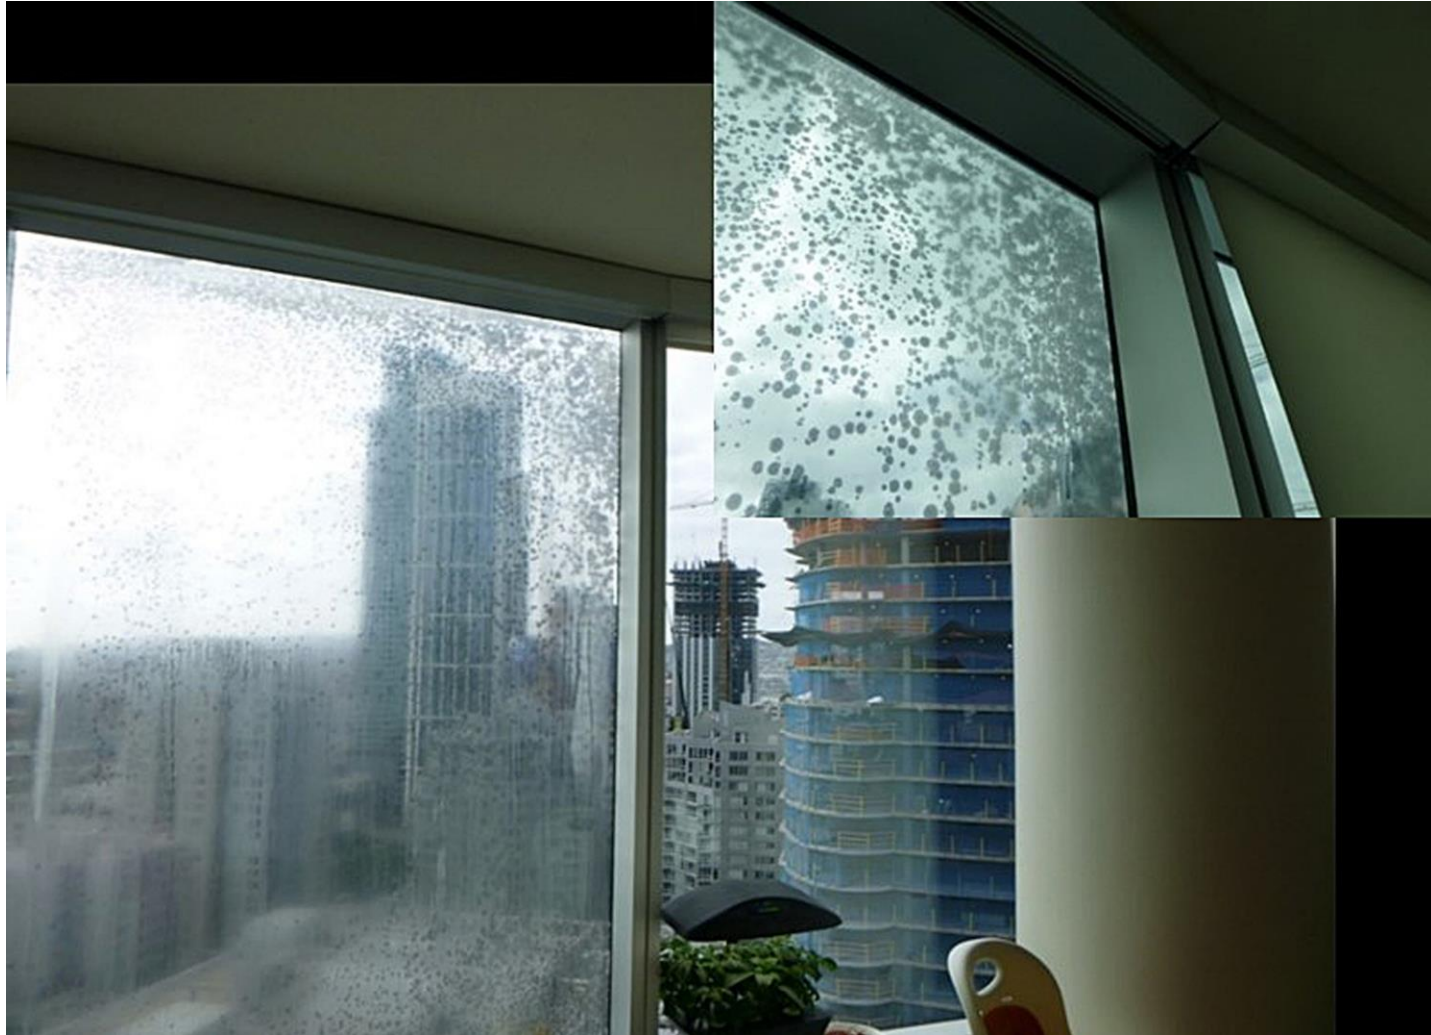
# Corrosion/Tarnishing of Silver Coatings

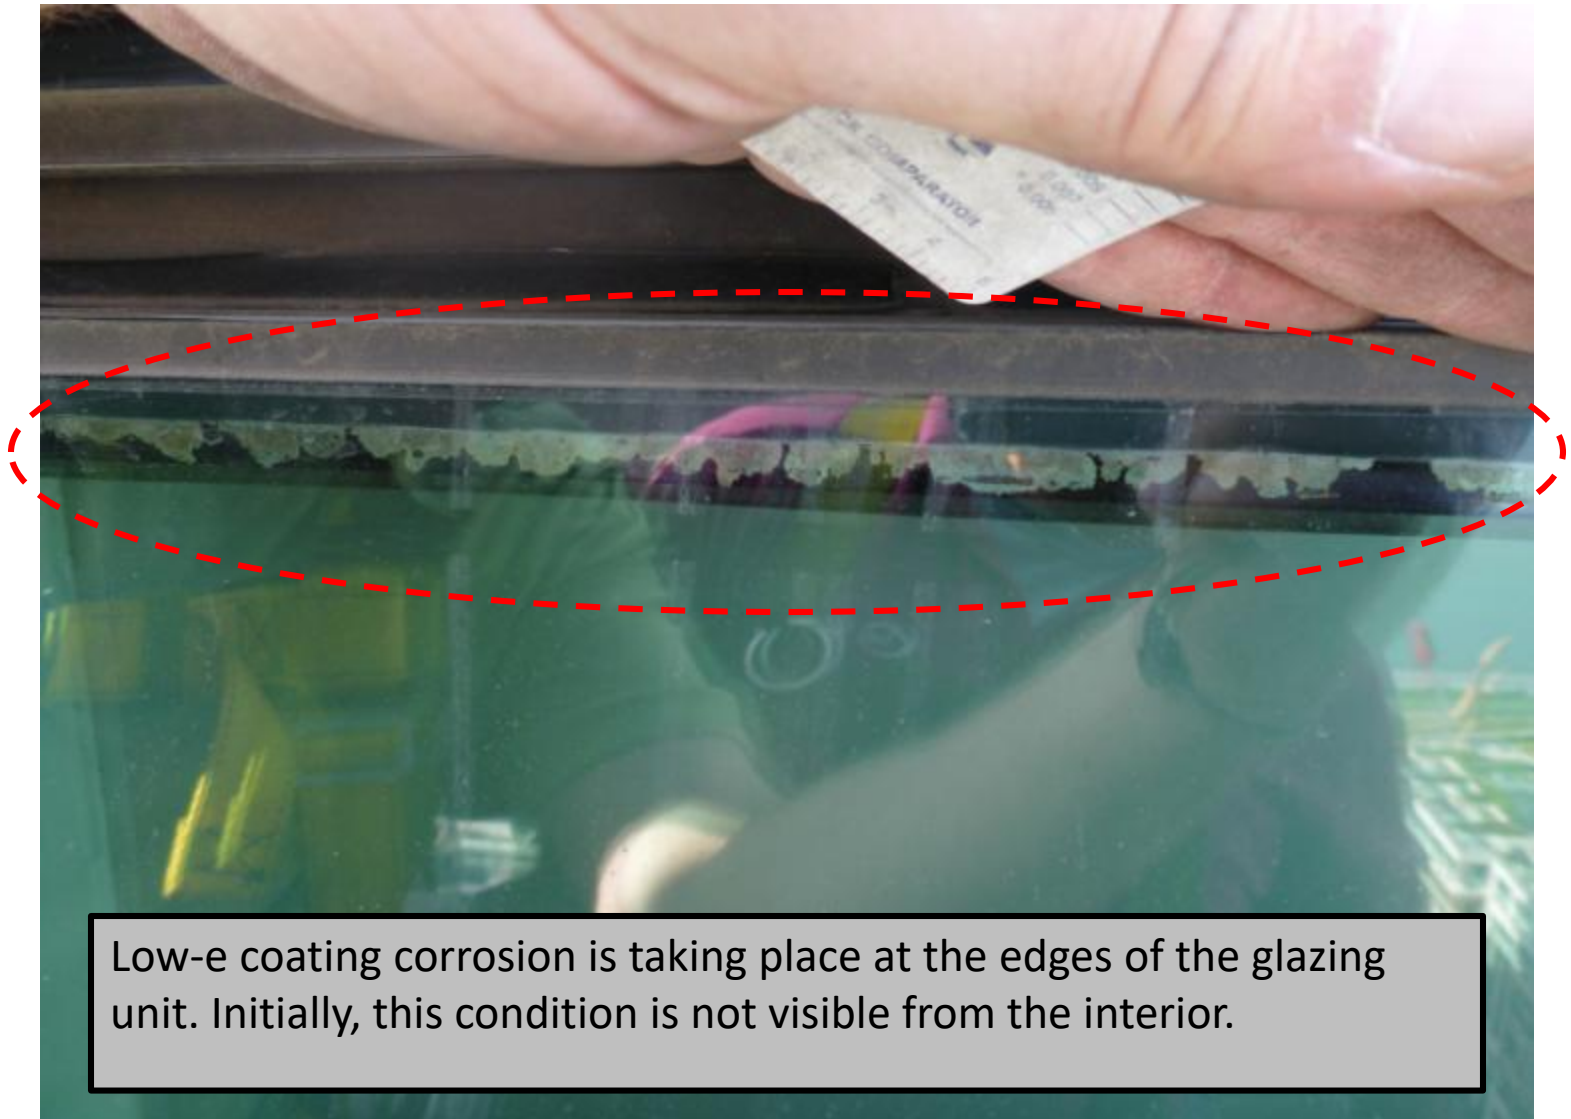
Low-e coating corrosion is taking place at the edges of the glazing unit. Initially, this condition is not visible from the interior.

- Low-E coating needs to be edge deleted. If not edge deleted, the exposed edge could start corrosion and spread to inside.
- Once corrosion starts, it breaks down the seals causing overall unit failure

- Proper edge deletion needs to occur during the manufacturing process to ensure moisture does not attack edge of coating
- Design of the glazing and curtain wall assembly should not allow water to stand on top of the silicone sealant because, silicone is permeable
- Design installation of glass should be on blocks and properly drained to prevent dual glazing to sit in water

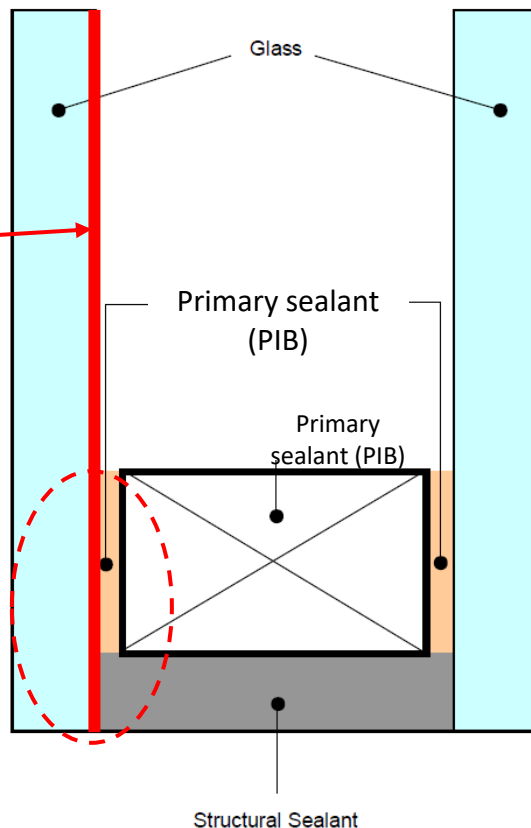
Low-E coating is not edge deleted

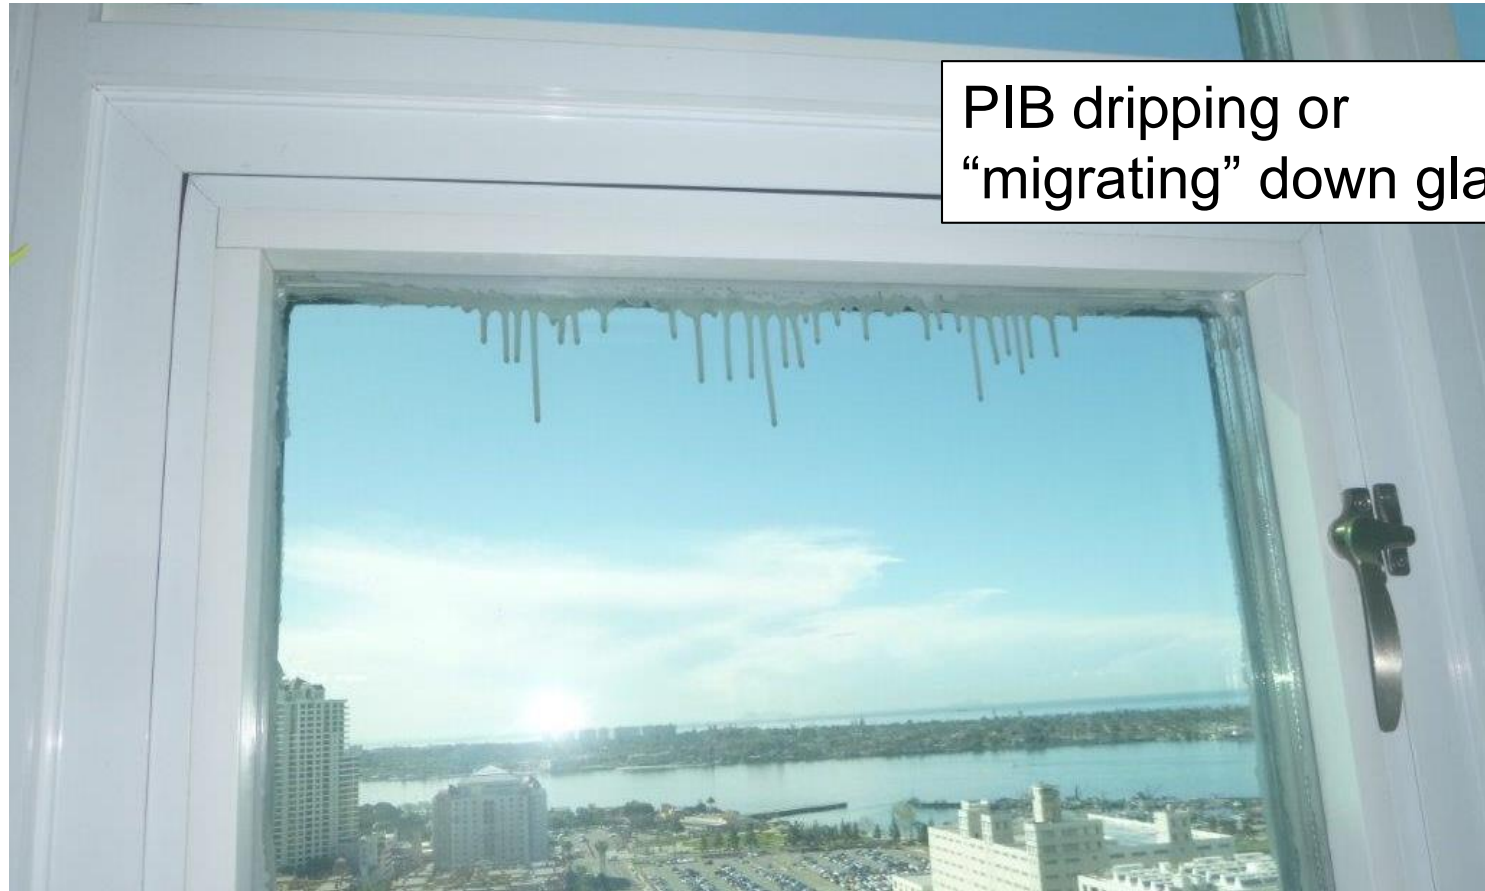
# PIB Migration/Failure in IGU

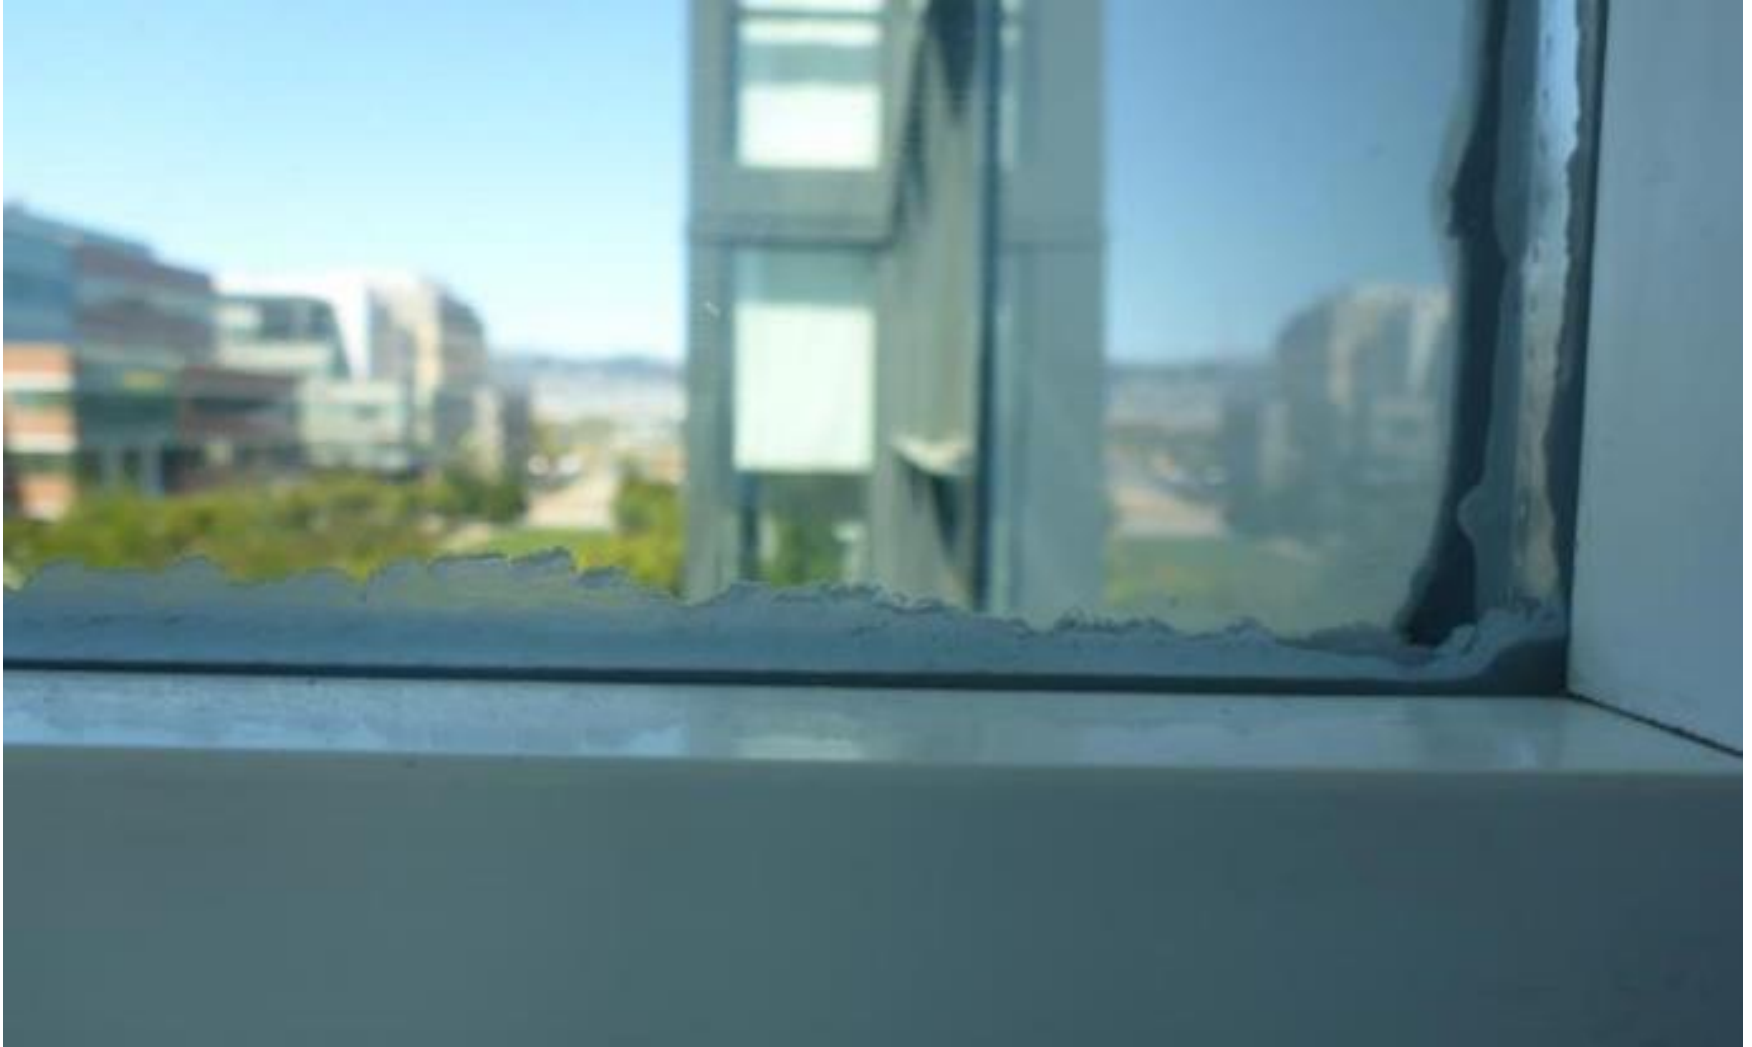
# PIB Migration, Moving/Walking Up

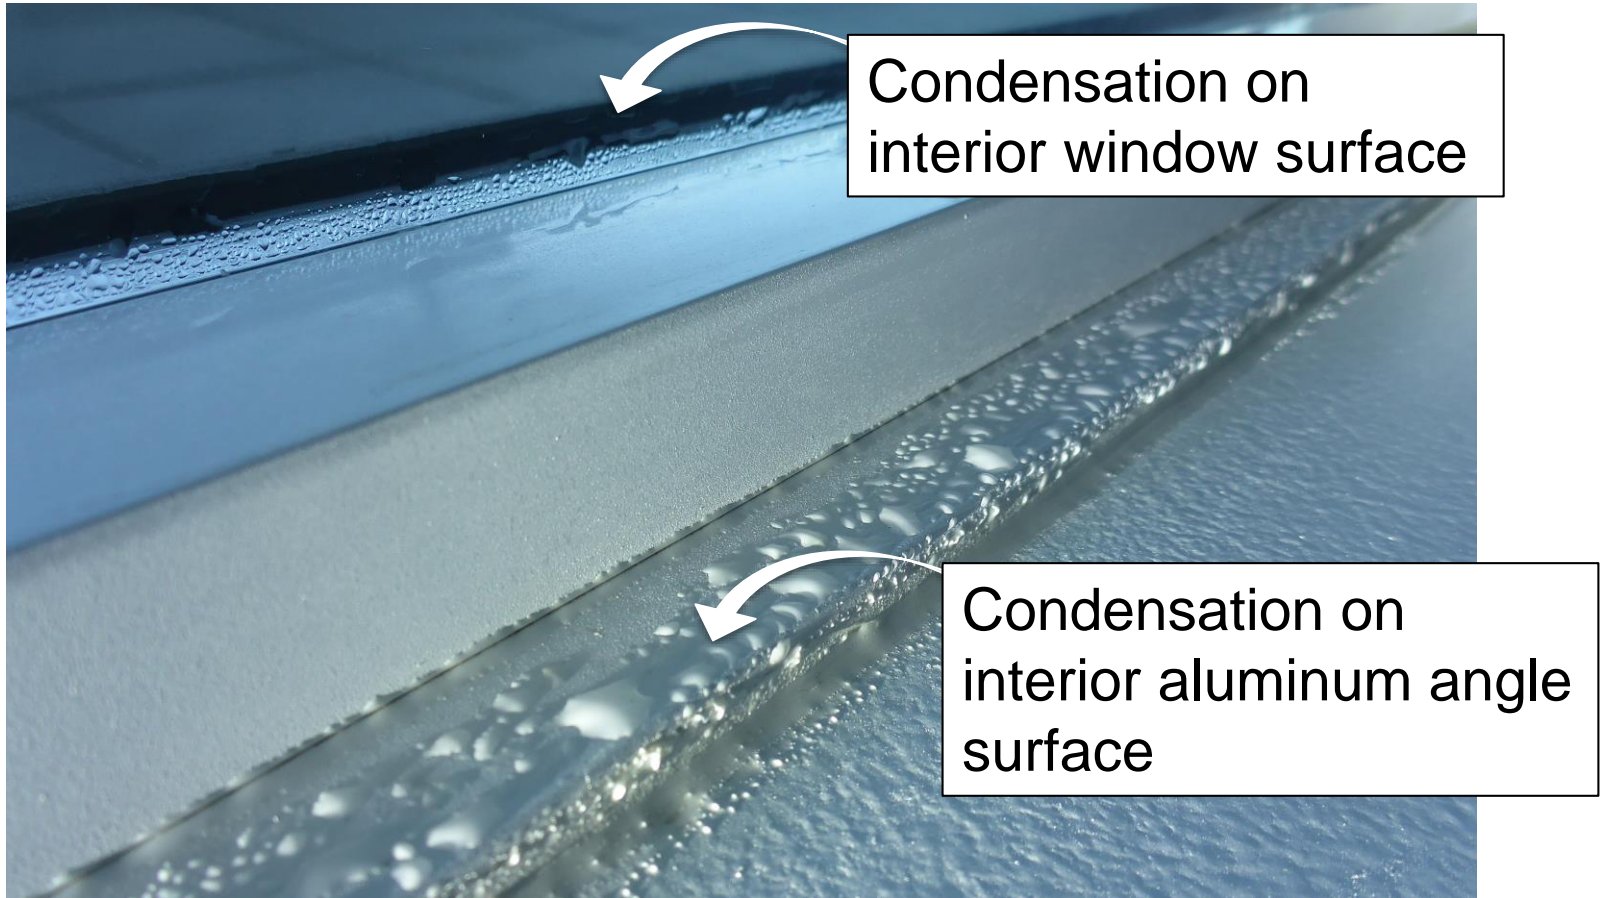
# Condensation

- Window design should include thermally broken systems
- Design considerations include:
  - Carefully design thermal breaks in and around glazing elements and rough openings in walls
  - Hygrothermal modeling to determine CRF requirements
  - Avoiding thermal bridges in design
  - Descriptive and fully illustrated perimeter flashing conditions

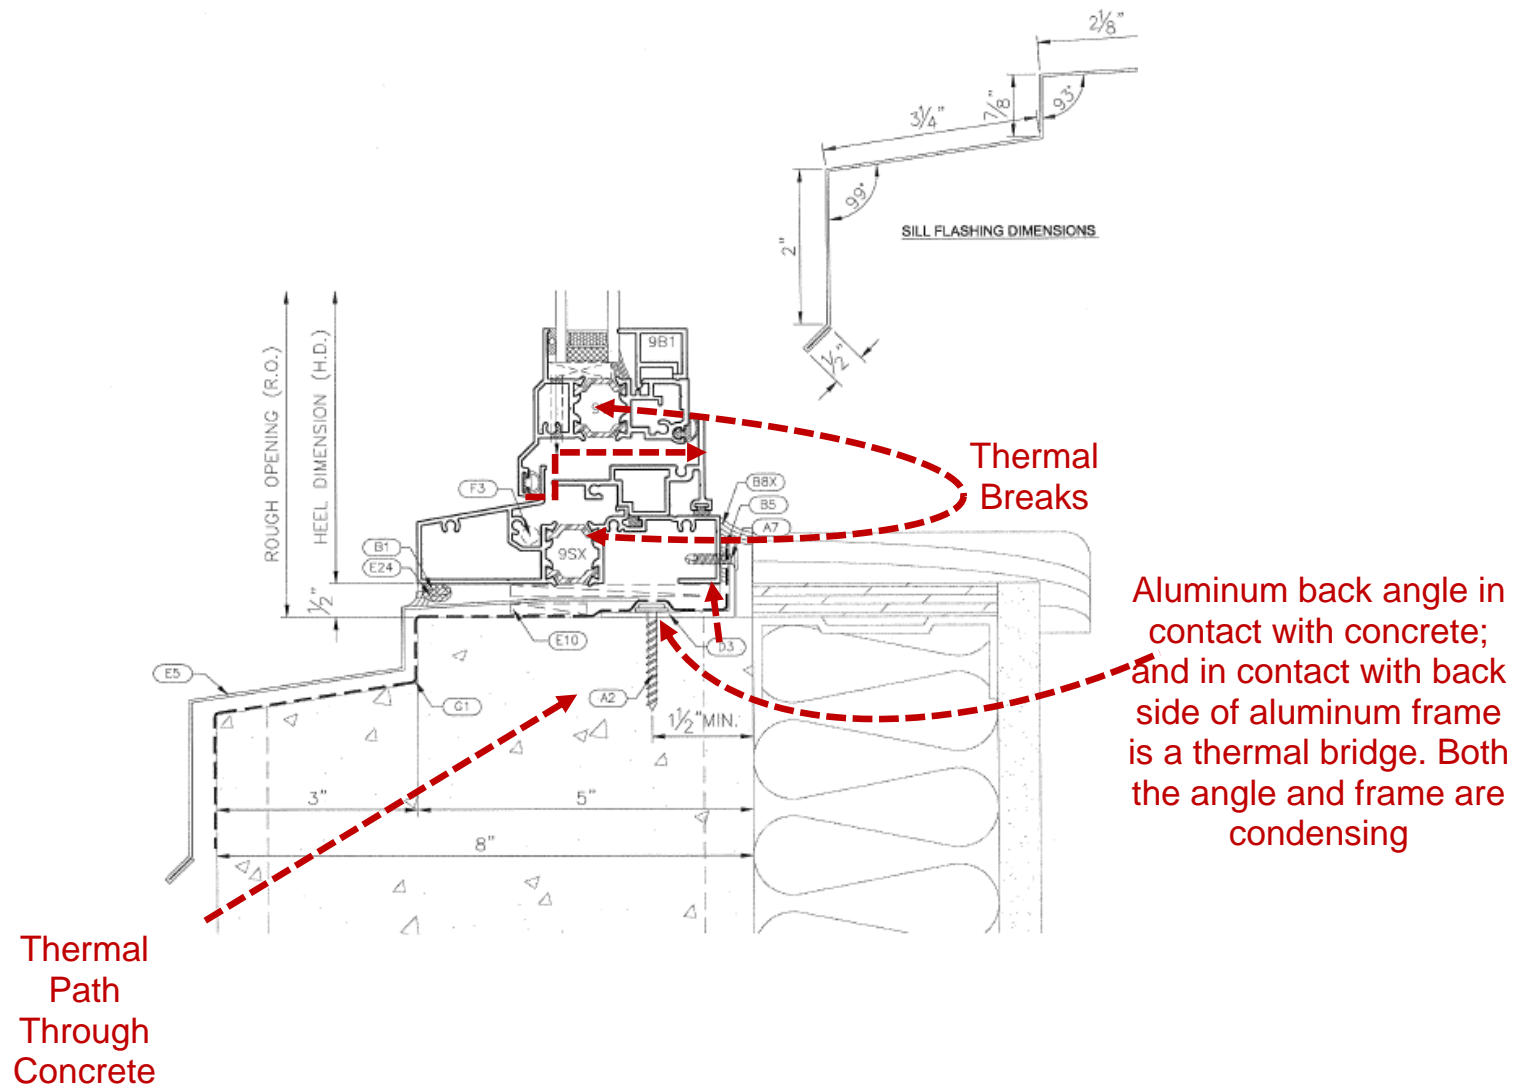
# How Thermal Break Failure Occured
