Vinyl Glazing Case Study

Some example photos and
commentary

Testing, Case Study 1

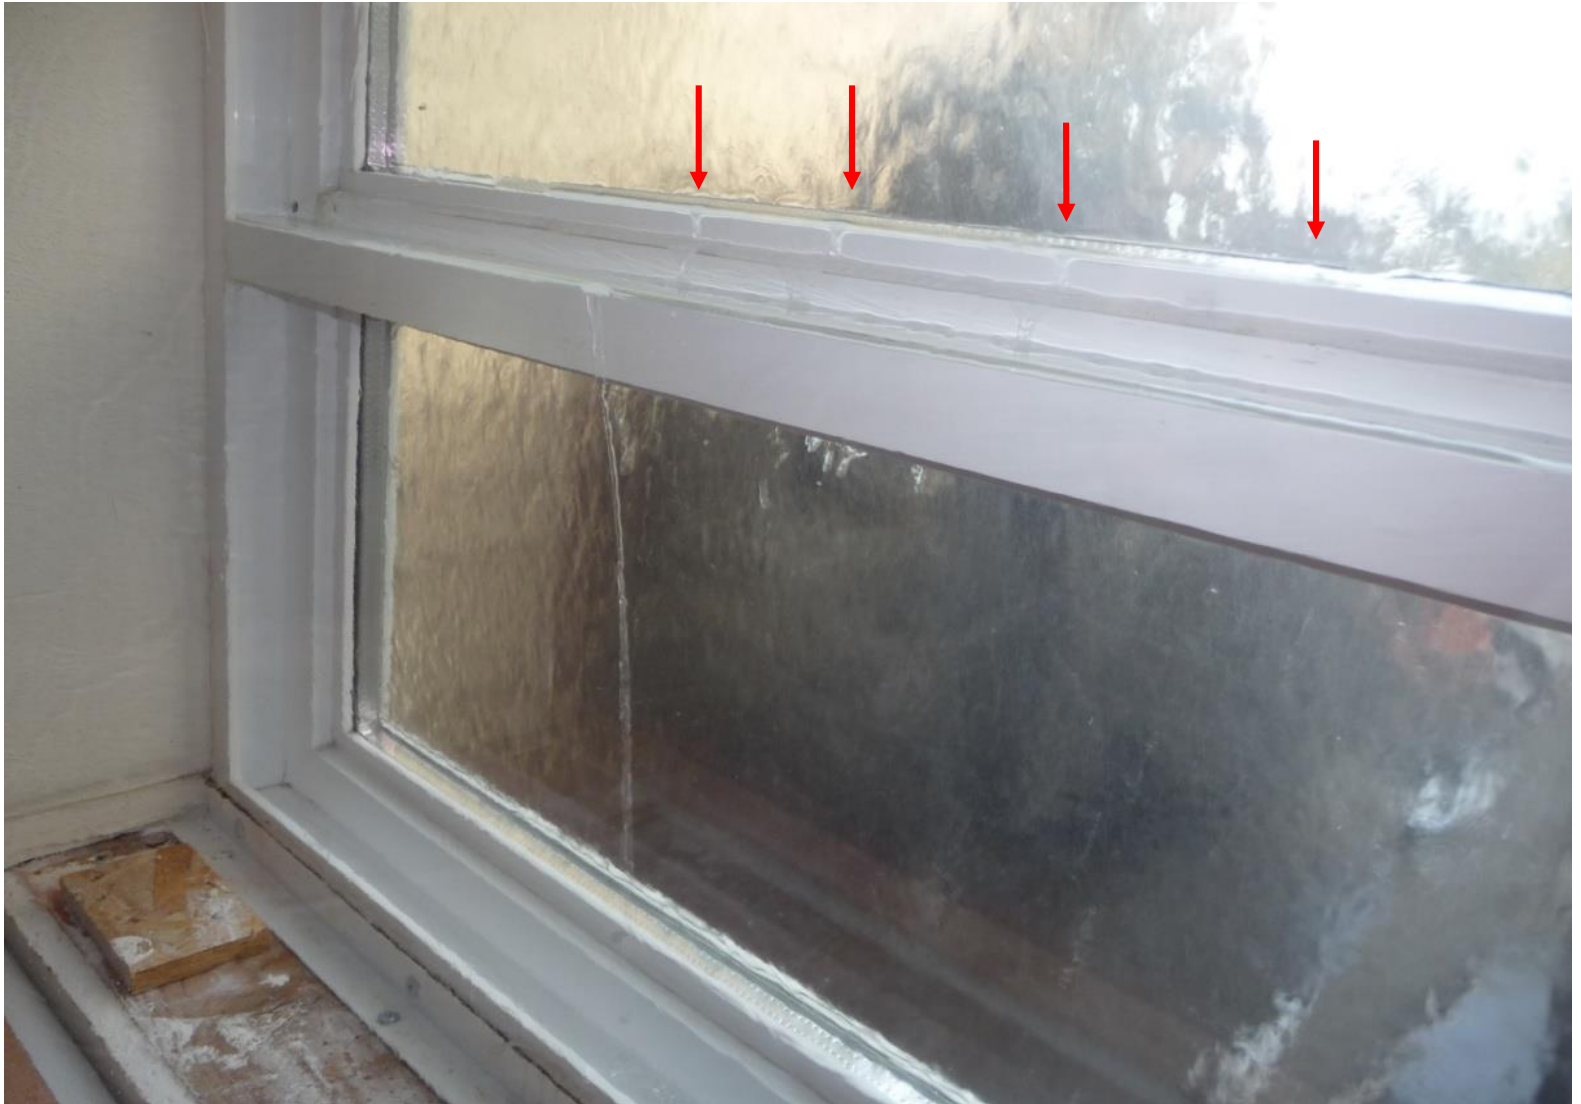
- **Several windows tested leaked at glass-to-glazing bead junctures.**
- **The windows are interior glazed and have a poor quality acrylic adhesive closed-cell foam glazing tape. These seals have failed in all windows where the glazing was tested.**
- **Water Test Failure:**
 - Windows were tested at 3.5 psf, 2/3^{rds} of the Manufacturer's stated performance standards.
 - Of the three windows that were tested without isolating the glazing, all three failed to pass. This is a 100% failure rate.

Glazing Failures And Resultant Leak.

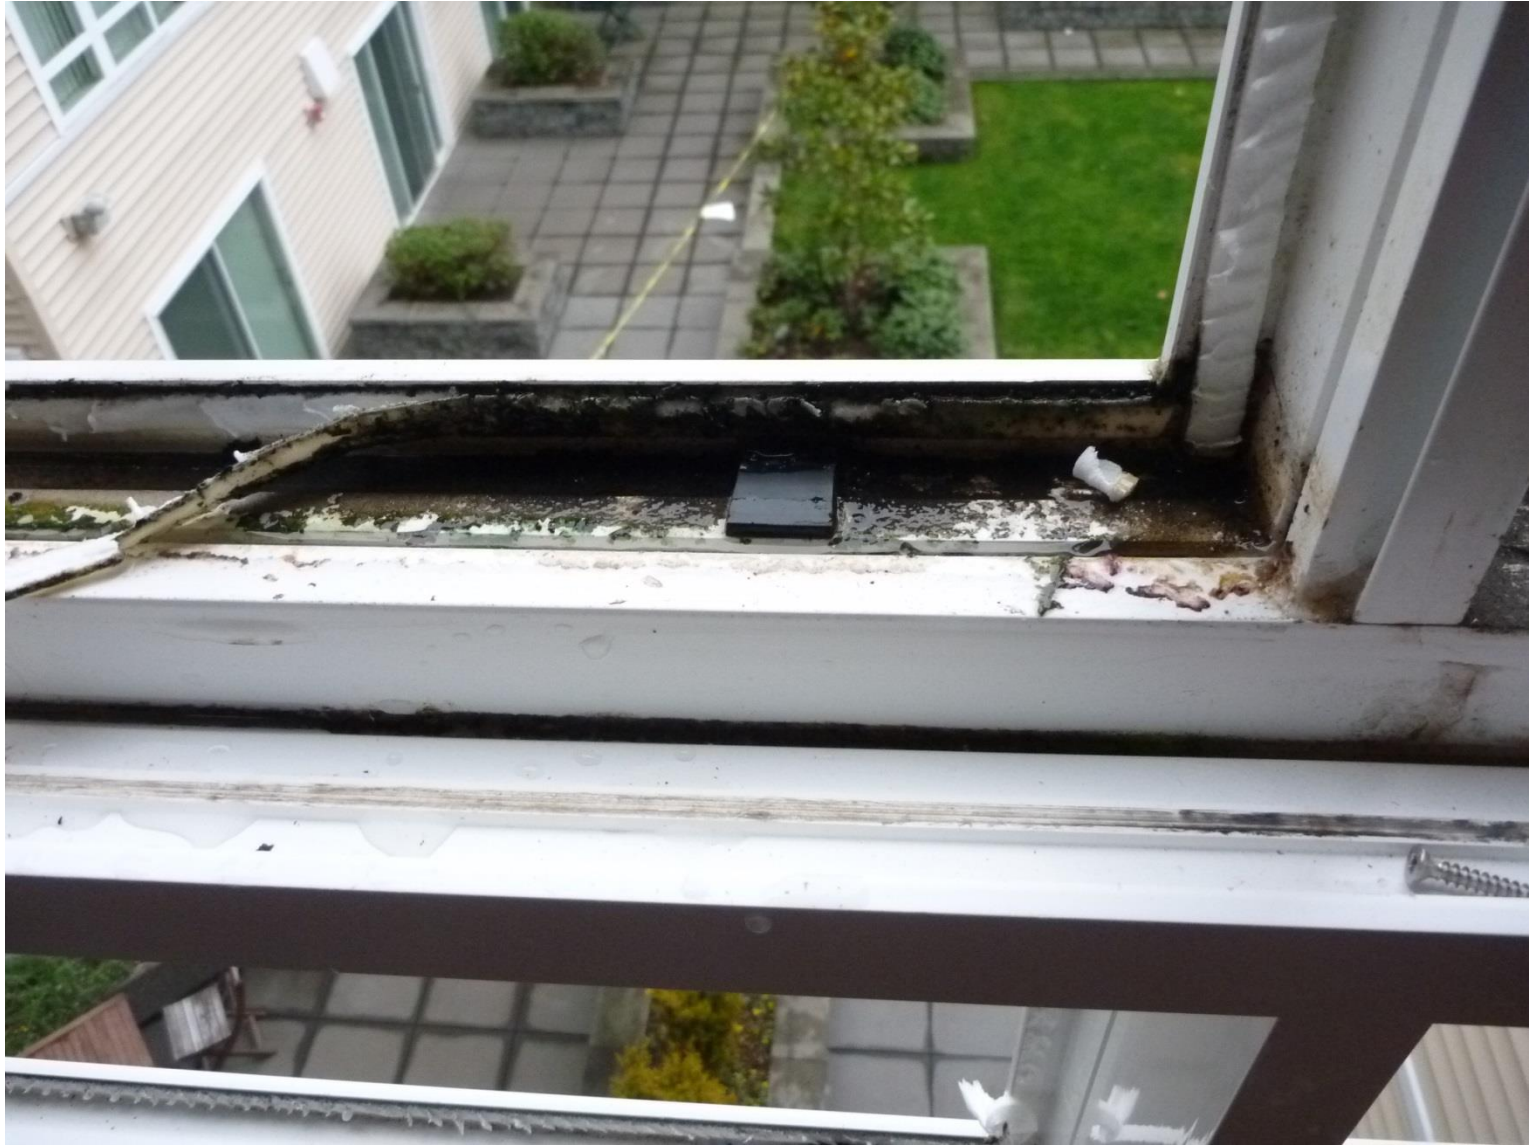
Glass Being Removed

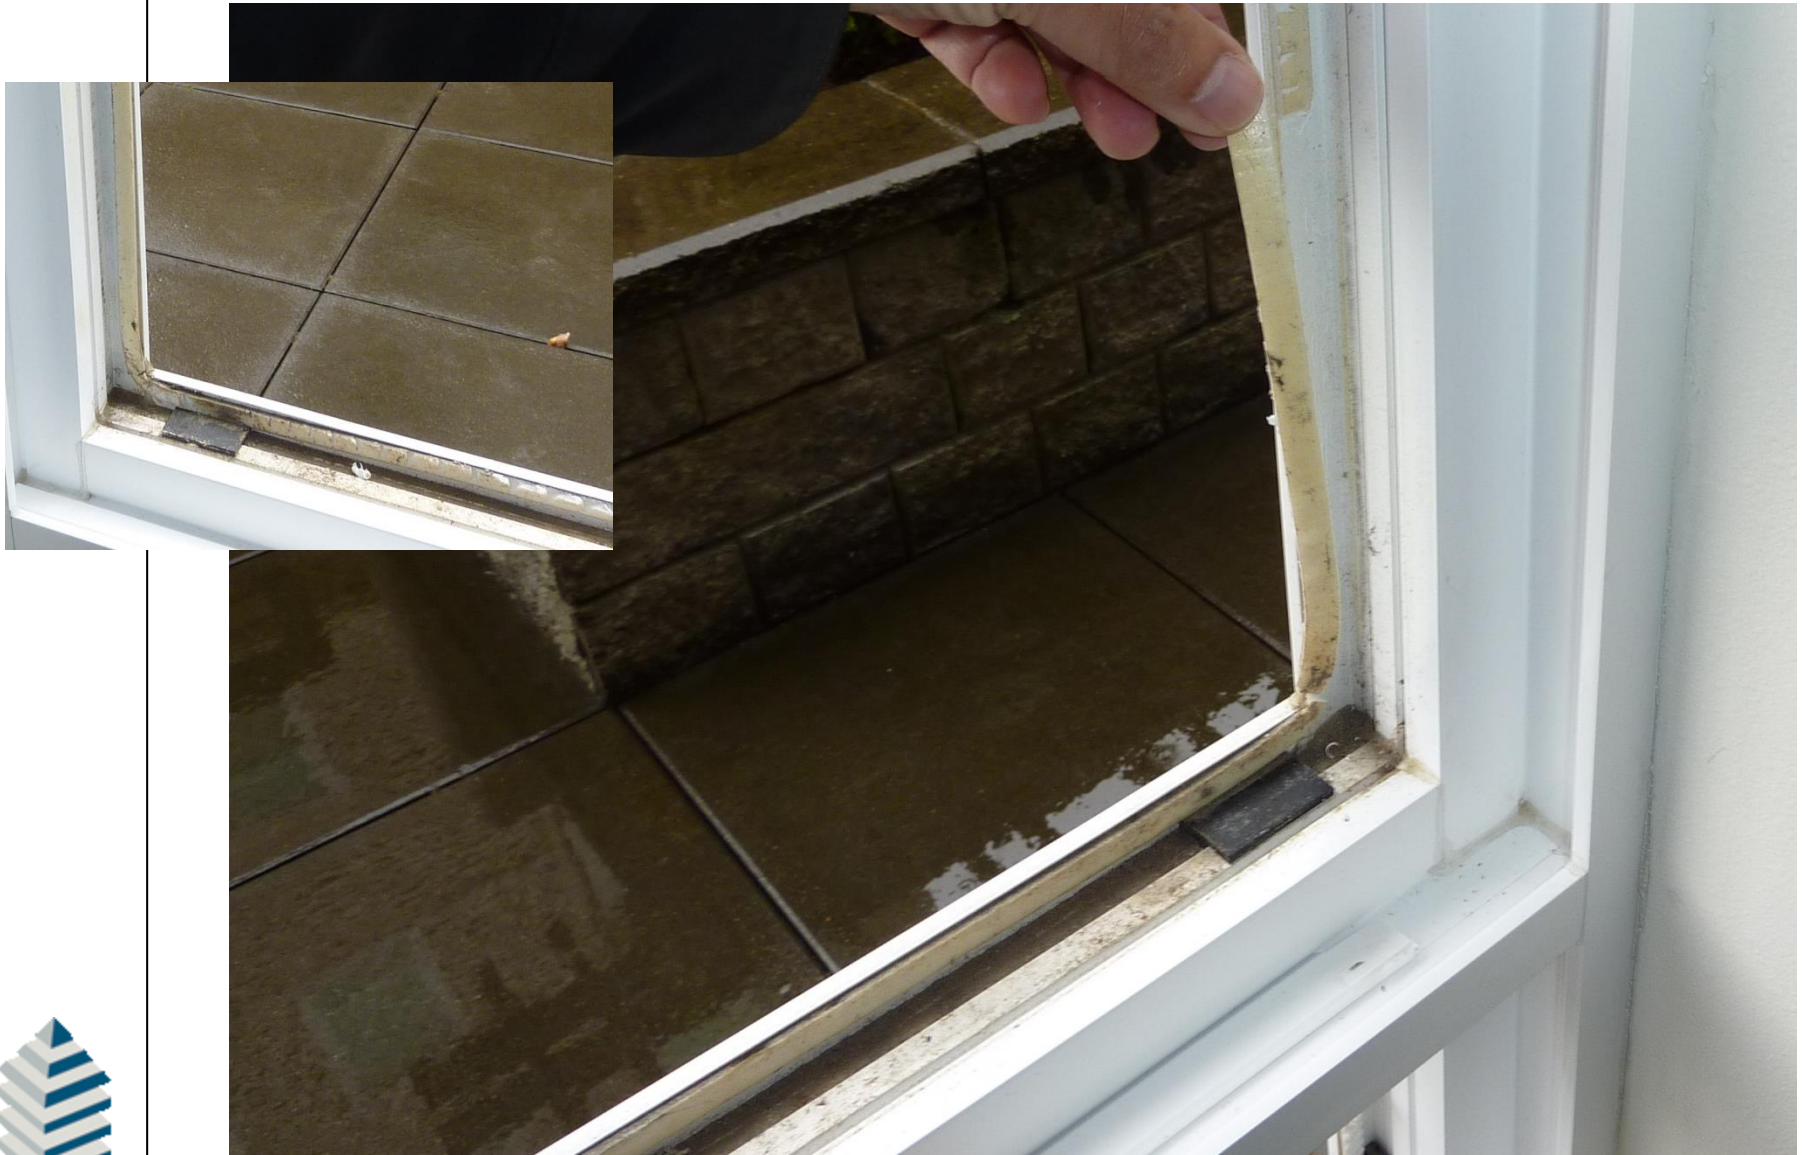
- Current glazing tape is an acrylic adhesive closed-cell foam tape that is compressed with glazing stops at the interior. In our testing, we observed that the tape did not make uniform contact with the glass thereby allowing water to bypass the tape altogether.

Glazing Tape Is Discolored And Stained From Dirt And Water

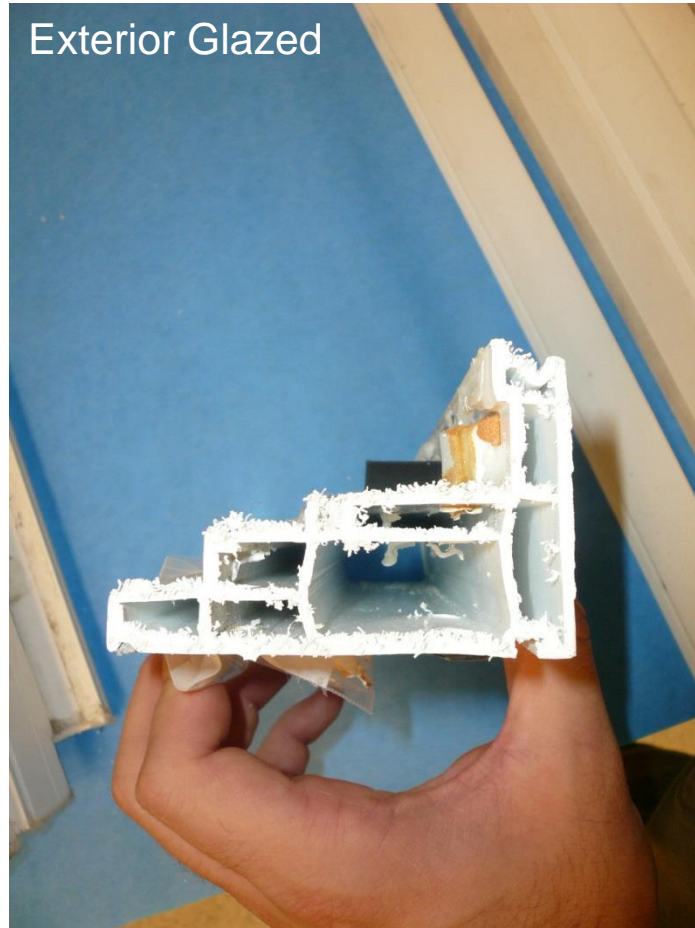
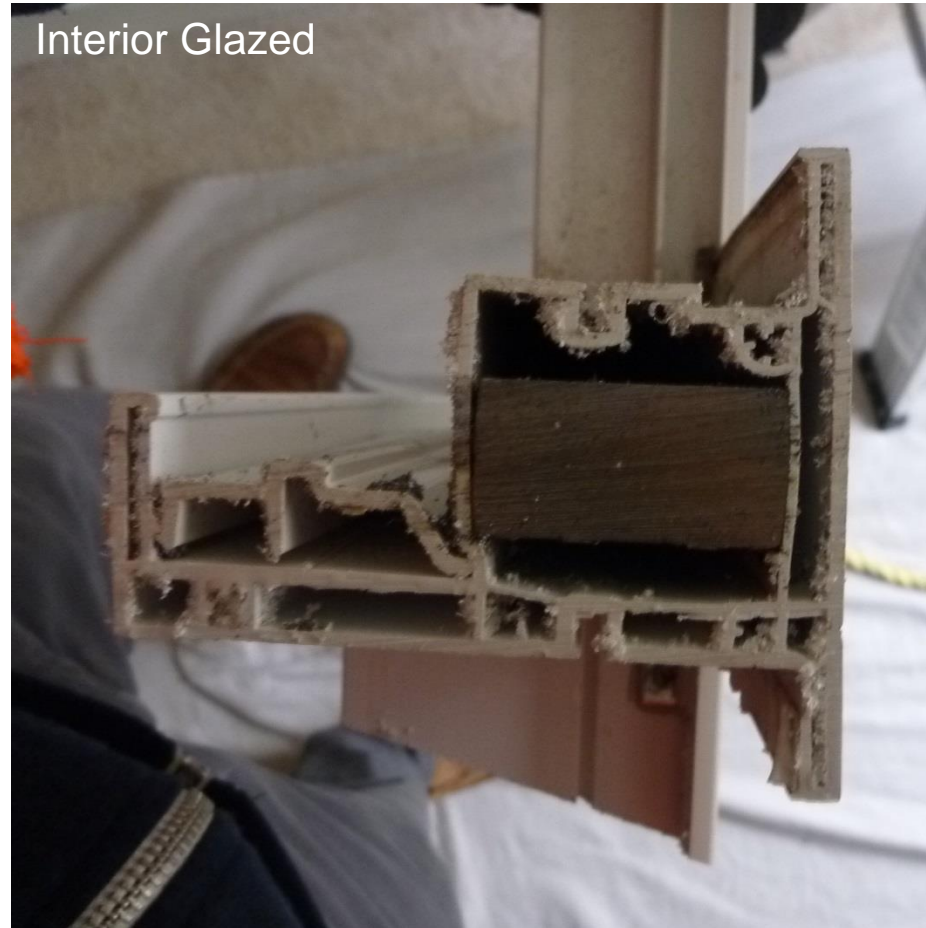
- Often the windows are internally glazed, exposing the foam gaskets to UV and water exposure

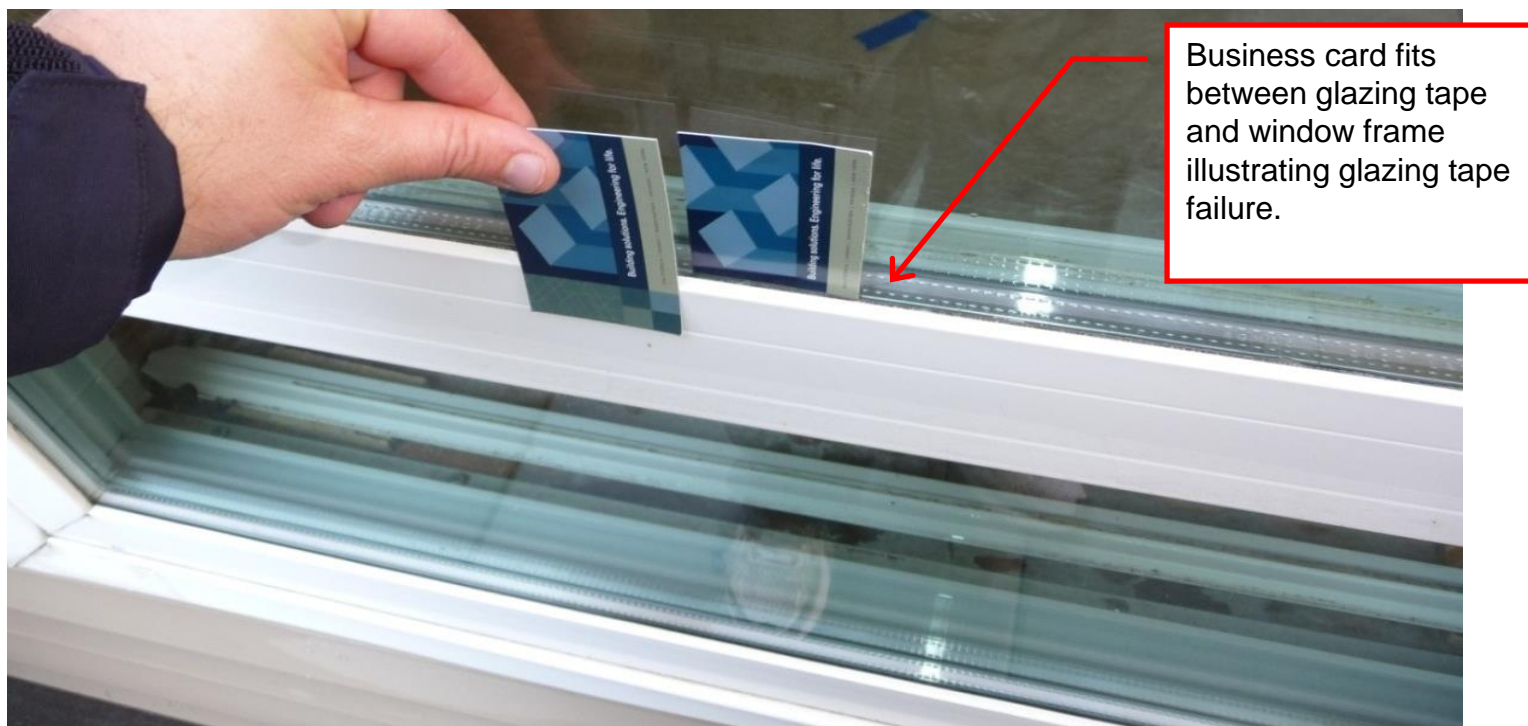
- **Glazing tape failure also causes Air-Leakage test failure:**
 - Due to failed glazing seals, windows tested (ASTM E 283-91) did not meet project specified air leakage performance standards.
 - Of the seven windows tested for air leakage all seven failed to meet the air leakage standards in Manufacturer's shop drawings. This is a 100% failure rate.

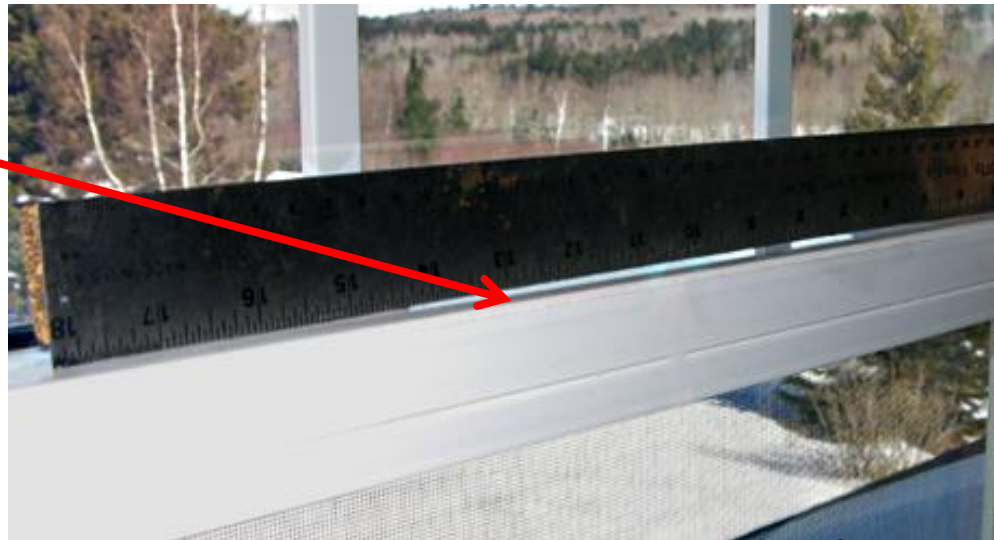
- Due to the inherent flexibility of vinyl, framing members are often reinforced with steel.
- Framing members with long spans should be designed to limit excessive bending.
- Such bending will often result in reduced performance and the misalignment can make the weather-seals and glazing gaskets non-effective causing excessive condensation, air infiltration, and water infiltration.
