Performance Issues with Vinyl Windows

Gerson Bers, LEED AP

Allana Buick & Bers, Inc.

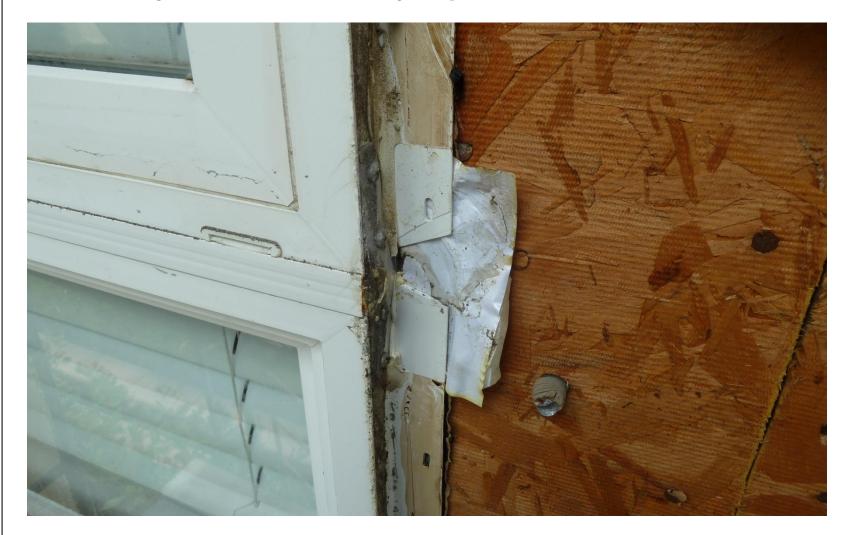
What is a Mulled Windows

Mulled joints have a beauty cap or cover

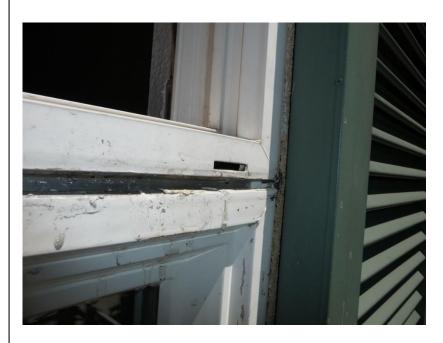
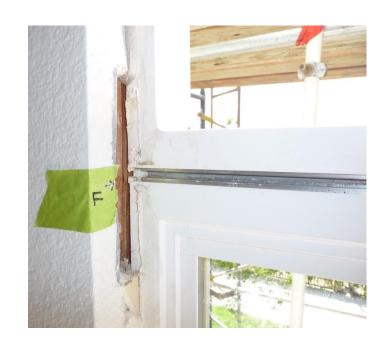
Mulled Windows

Mulled joint cap has been removed

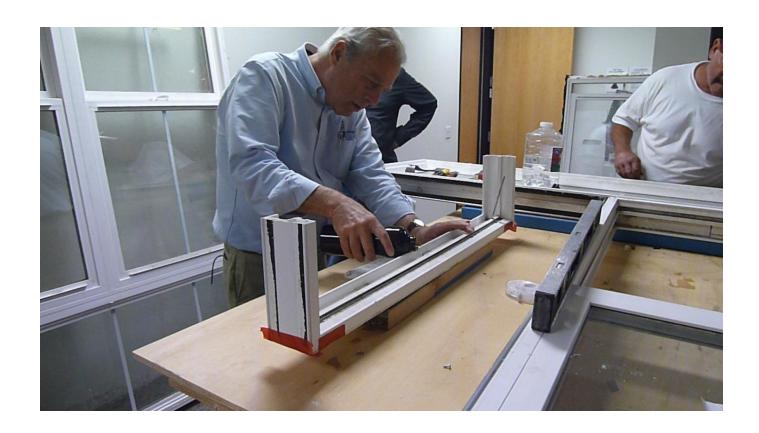
Vertical Mulled Failure

A fixed mullion is not flexible and can crack from movement during transport or due to thermal changes

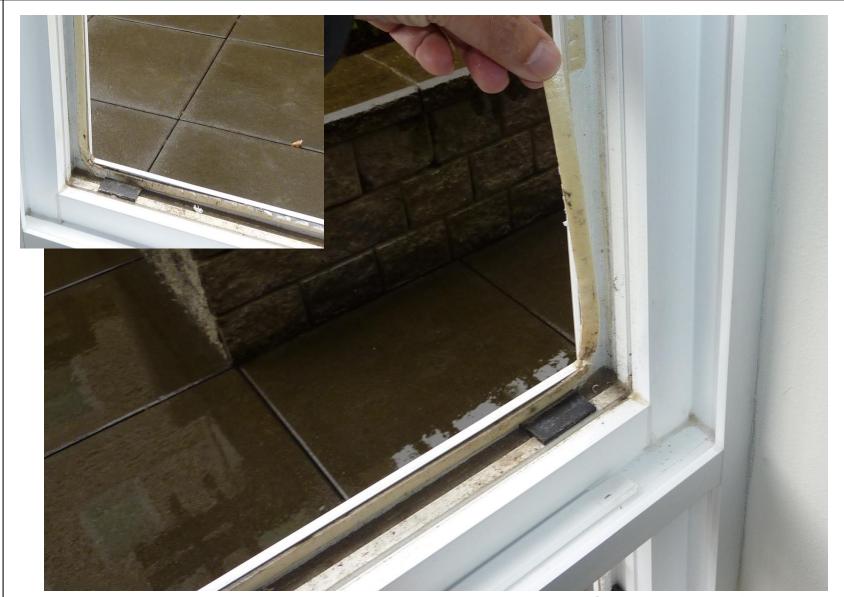
Glazing Tape Is Discolored And Stained From Dirt And Water

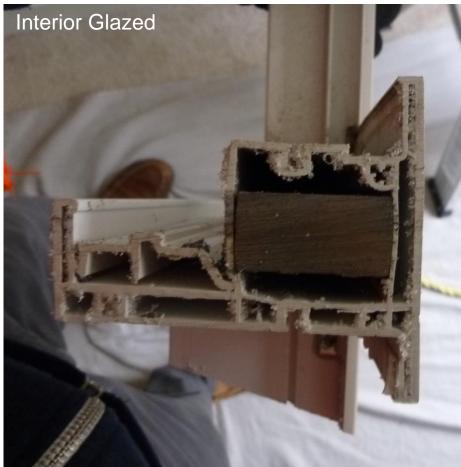
Glazing Gaskets

Often the windows are internally glazed, exposing the foam gaskets to UV and water exposure

We recommend dual seals at glazing gaskets that include foam tape or butyl tape AND wet silicone sealant

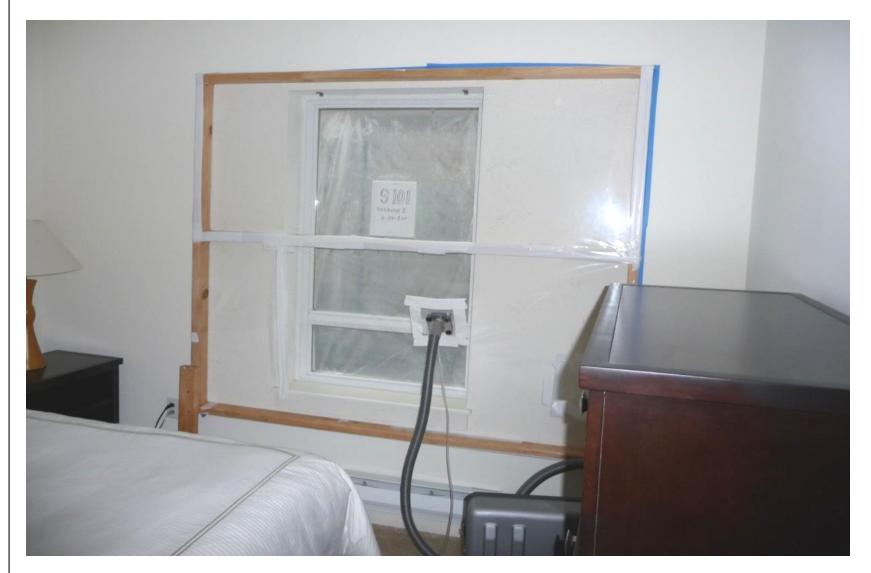
Case Study 1 In-Situ Air Leakage Test Chamber

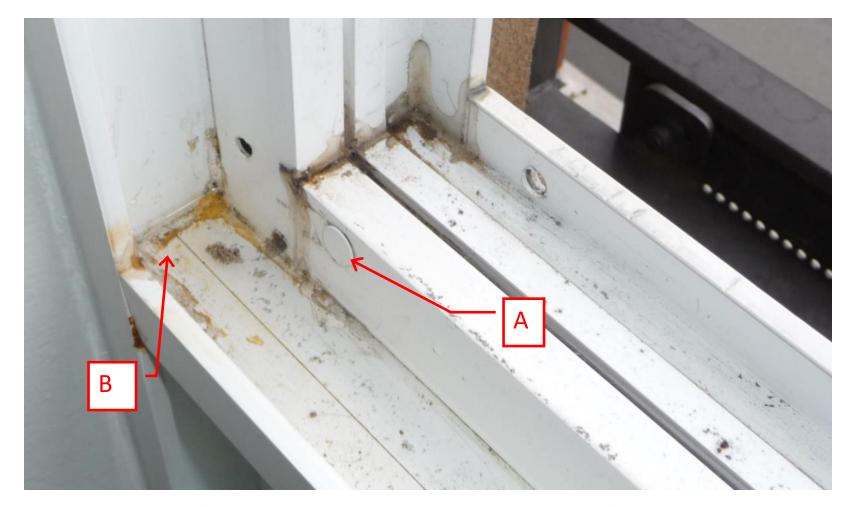
Coped Joint Failure

A = Manufacturer attempted to seal leak by pumping foam at coped joing

B = Clear silicone sealant, failed attempt to seal coped joint.

- The horizontal-to-vertical coped mullion-to-jamb extrusion joint was improperly sealed in the factory and the leaks at this juncture was not discovered until after all the windows had already been installed.
- The manufacturer responded to a warranty claim and attempted to repair this condition in the field by applying sealant and injecting foam at this juncture. The frame was sealed with silicone sealant from the exterior of the joint at the positive and negative side of the seam and a hole was drilled and expanding foam was injected blindly at this juncture.
- This method of sealing the joint was inadequate for longterm performance, had failed again resulting in more water leakage and damage to interior finishes.

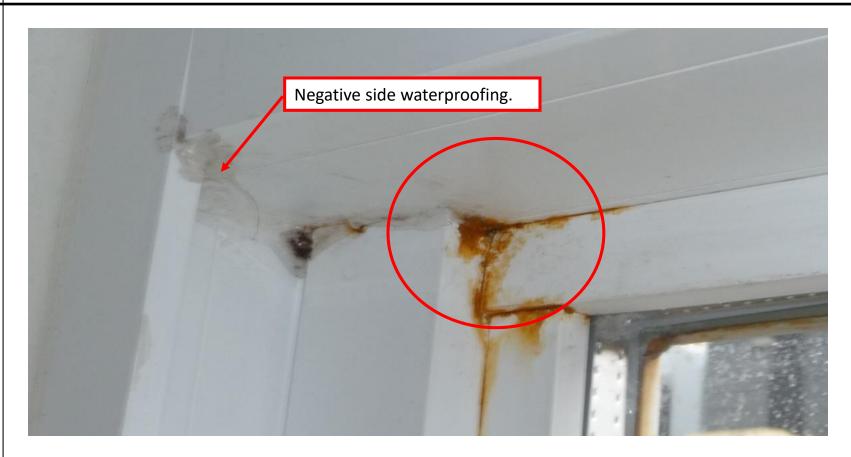
Staining From The Water In Contact With The Structural Reinforcing Causing It To Rust

Sealant is installed at underside of coped horizontal-tovertical mullion joint failed to stop leak. The leaks are rust staining from the structural steel reinforcement.

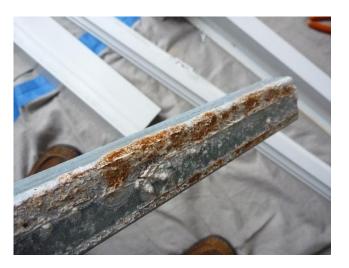
Water travels at the jambs and can rust the steel bar

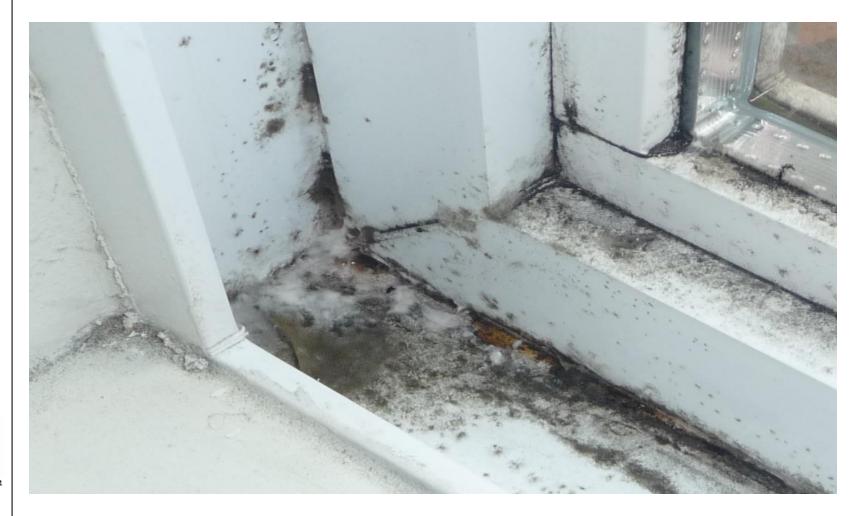
Typical Build-up Of Water in Lower Sill Track

This buildup is the result of water standing in this nondraining track.

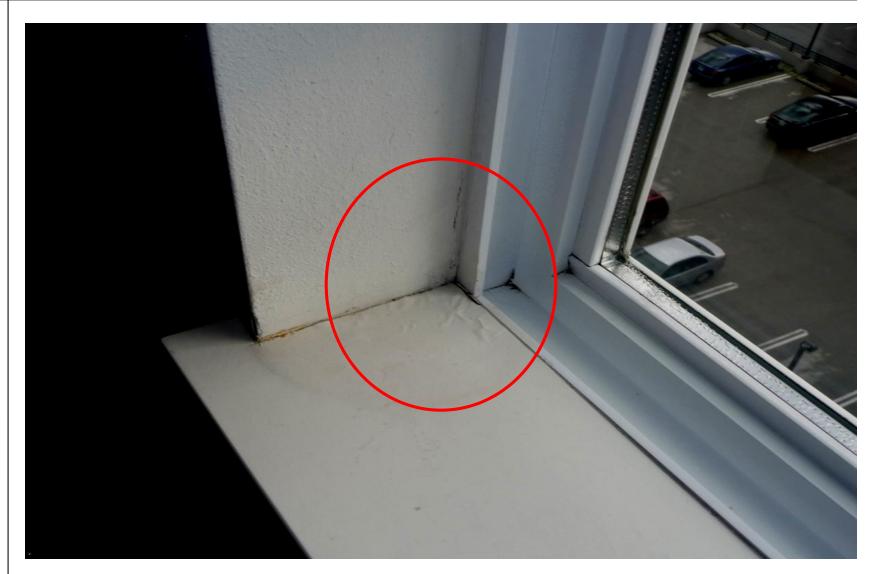
Water Intrusion-Damaged Wood Stool.
