# **Building Envelope Technology Symposium**

# **Performance of Weather Resistant Barriers in Stucco Assembly**

**Karim P. Allana, PE, RRC, RWC**

**Allana Buick & Bers, Inc.**

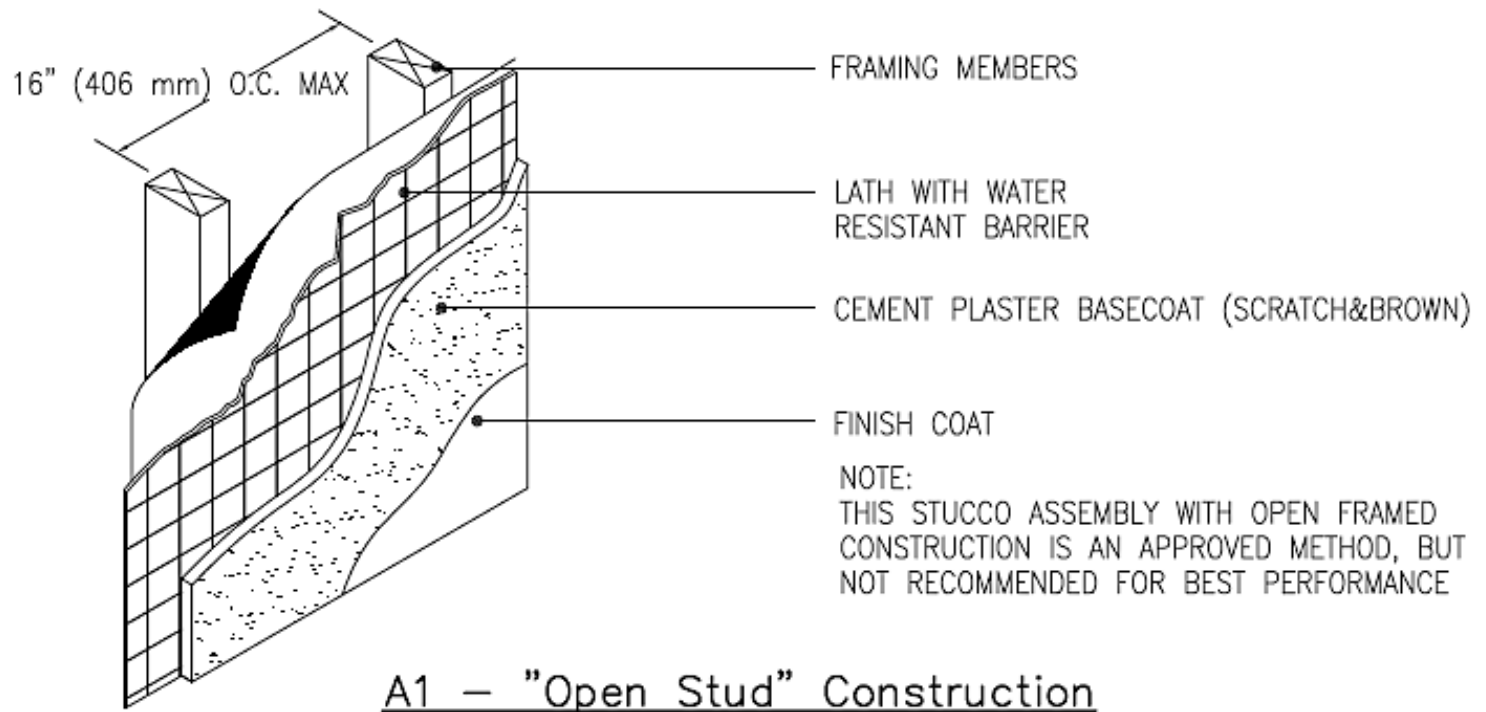
### Stucco Wall Assemblies

NOTE: THESE ASSEMBLIES INDICATE ONLY THE BASIC COMPONENTS

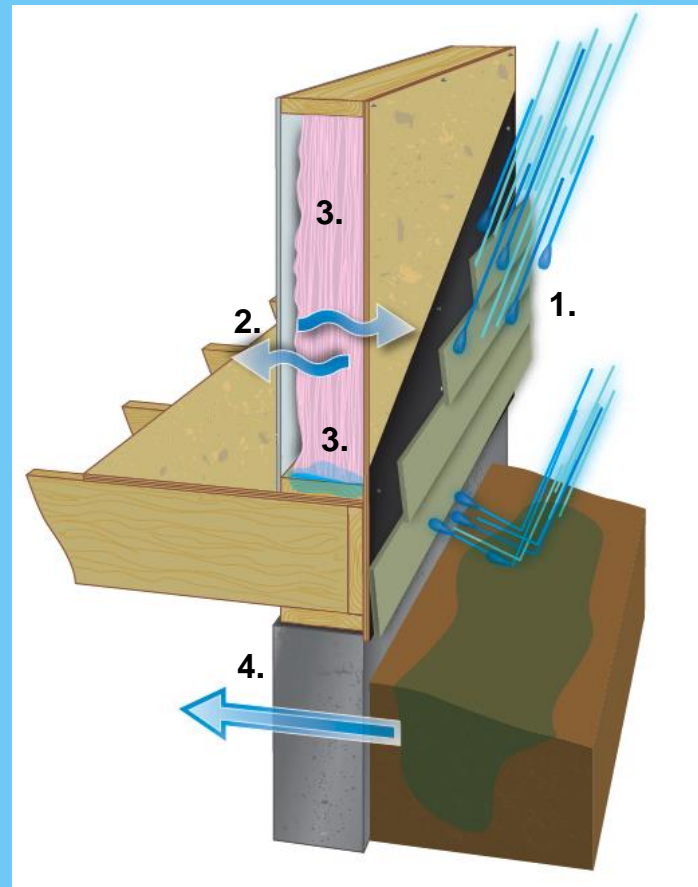
# Wall Wetting Mechanism

## Wall Wetting Mechanisms are Complex

### 1. Rain

- Absorption (wicking)
- Penetration
- Splash and drips

### 2. Water Vapor

- Diffusion
- Convection (air leaks)

### 3. Built-in Moisture

- Vapor
- Liquid/frozen

### 4. Ground Moisture

- Capillary
- Diffusion
- Liquid penetration

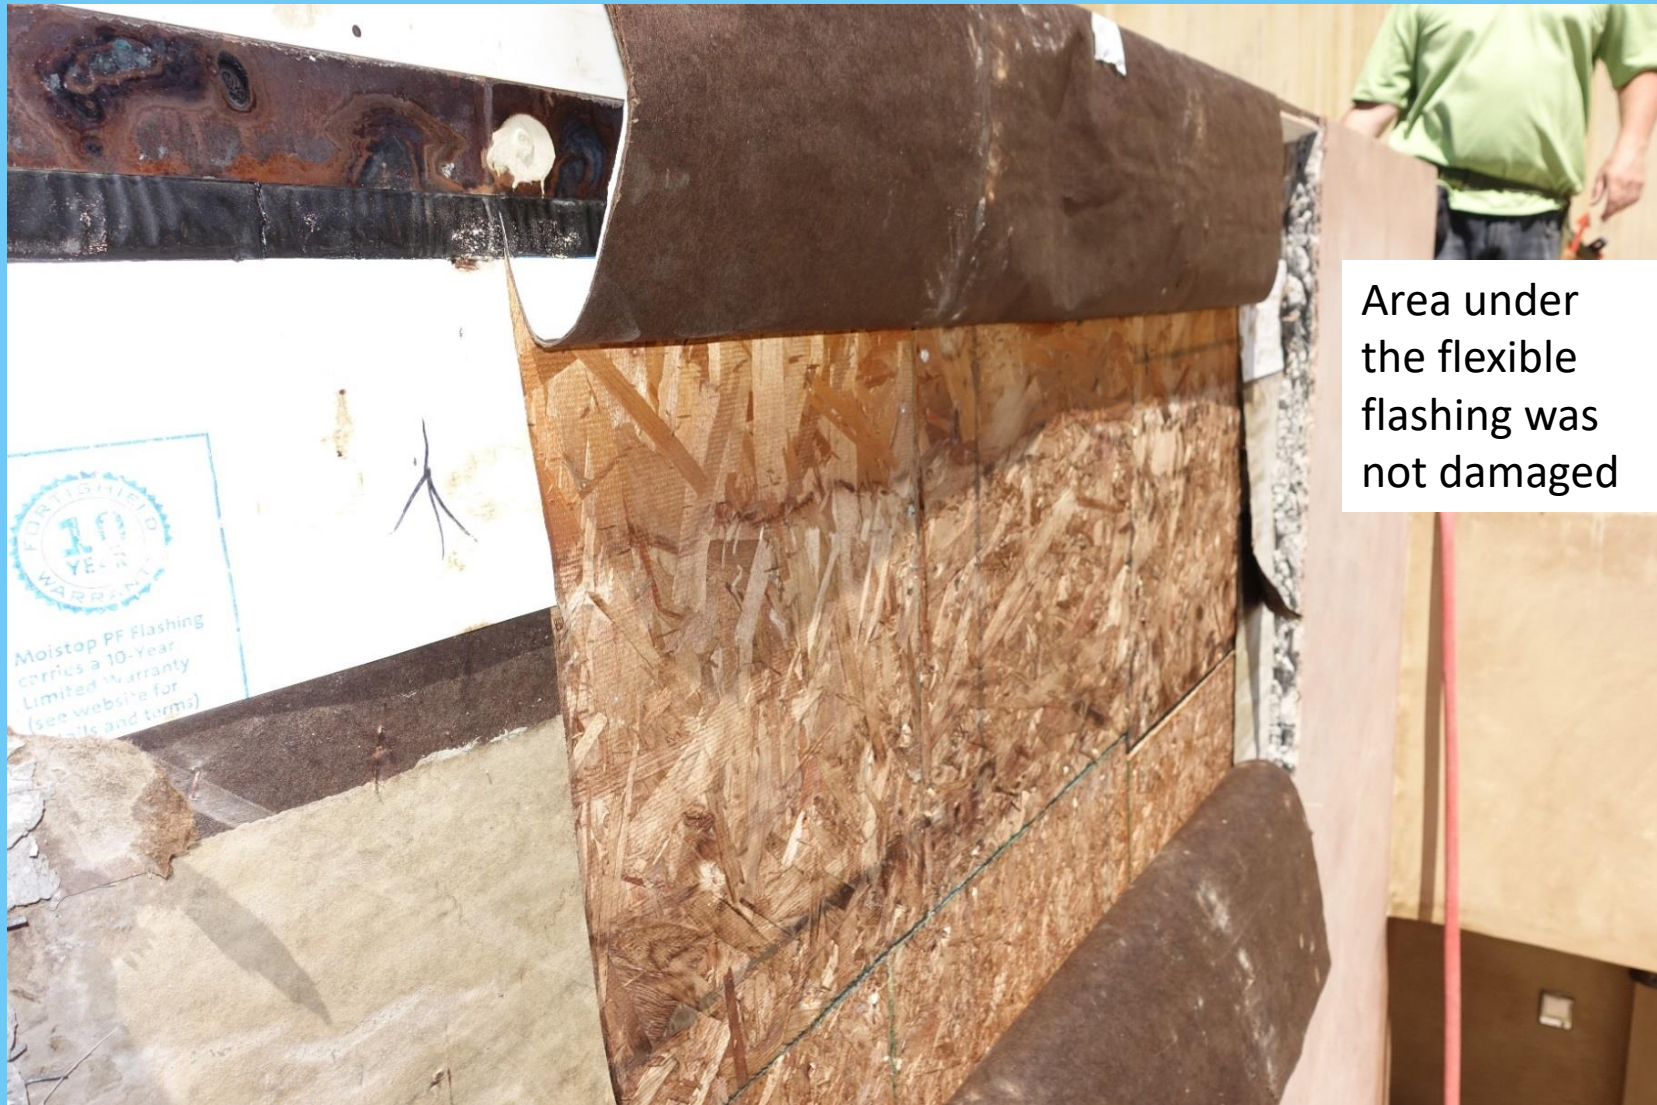
# Water Soaked Through Paper

Area under the flexible flashing was not damaged

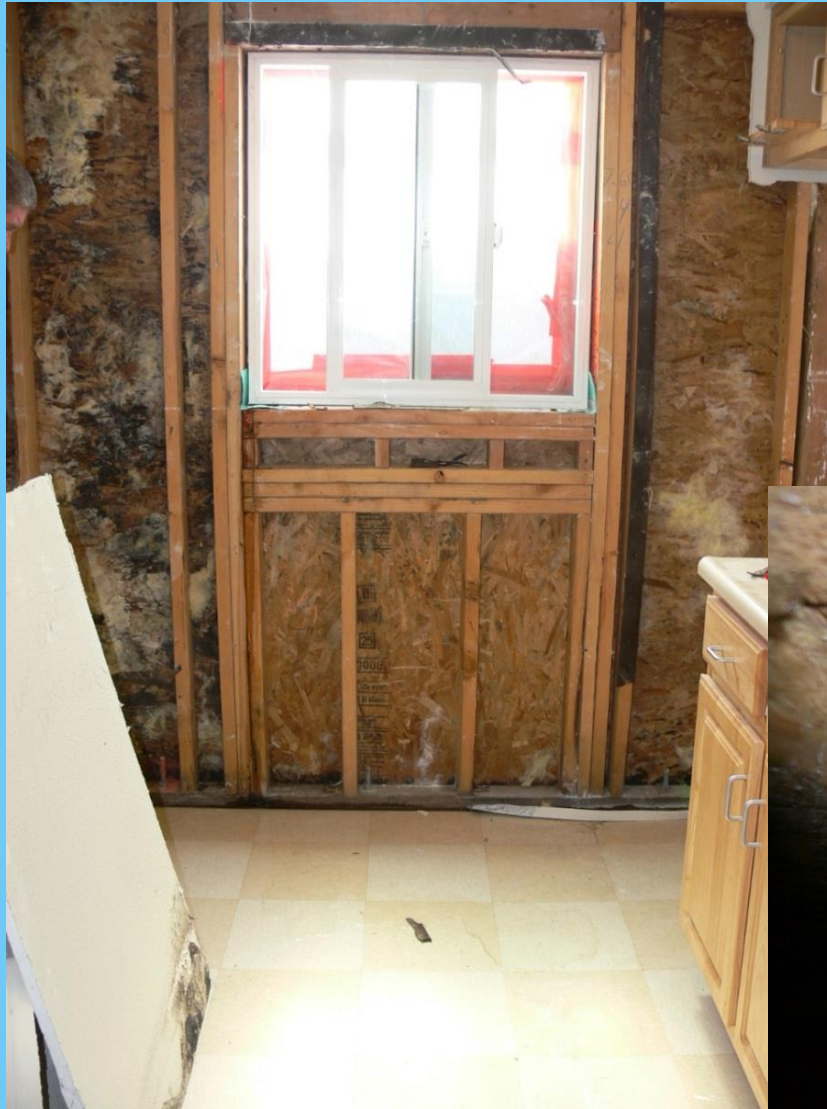
# Moisture behind Siding and Stucco

Faster (Shiner)  
corroded from  
inside

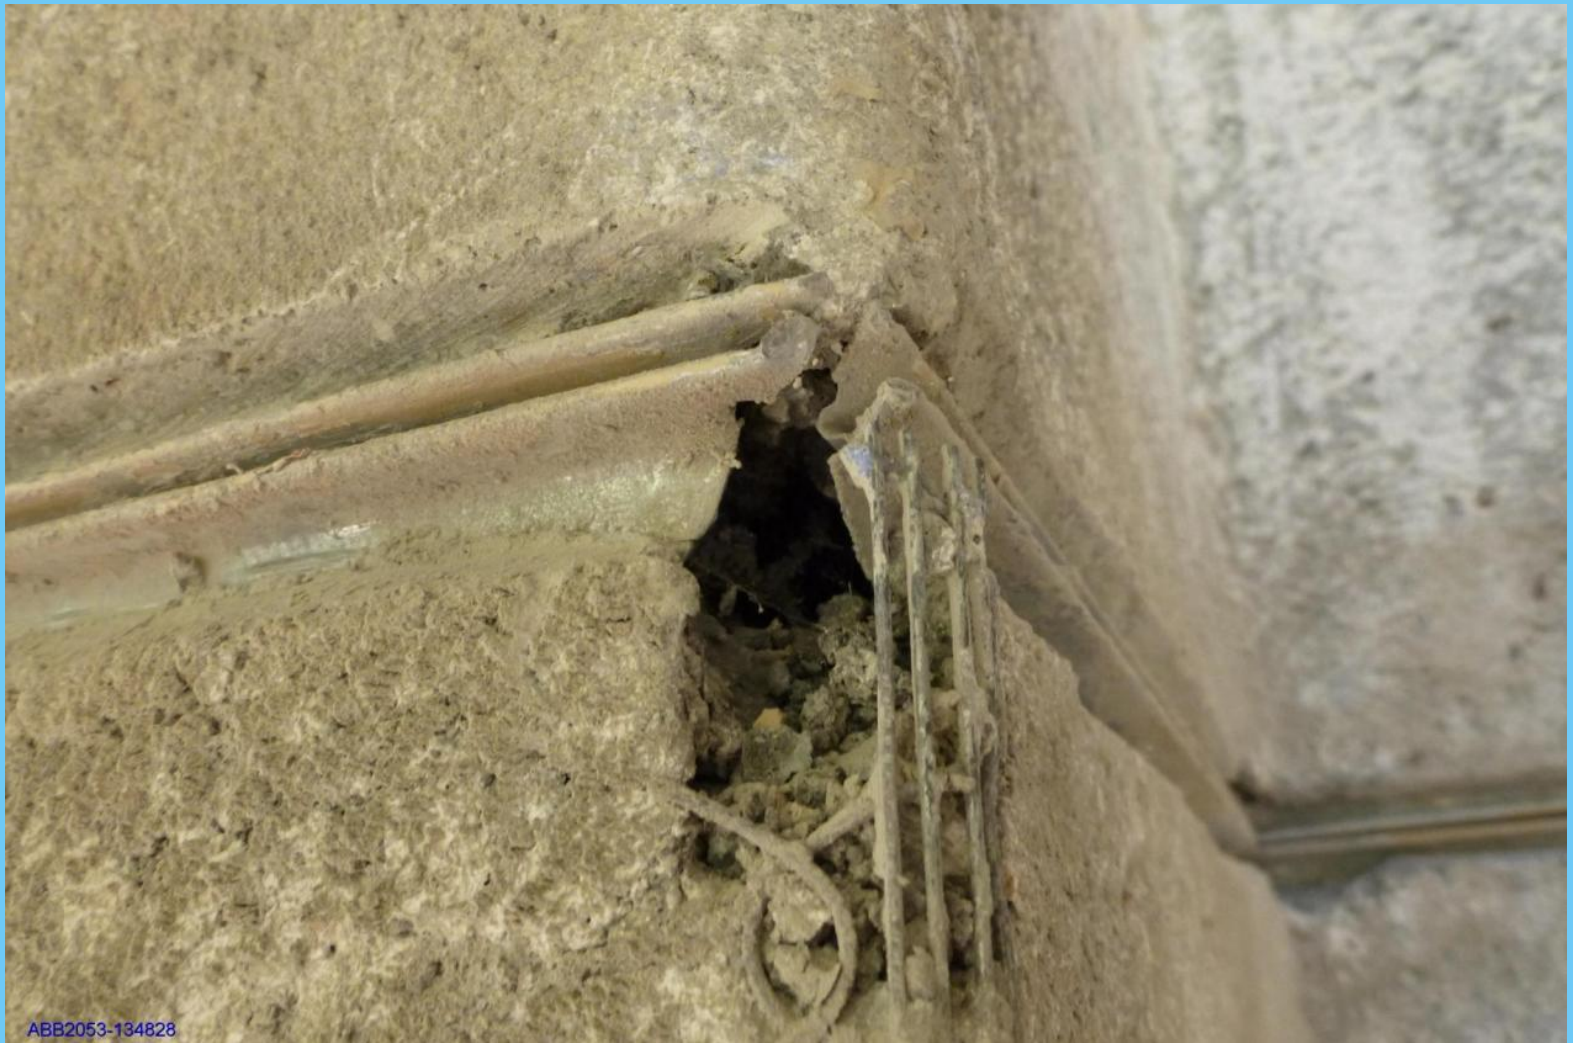
ABB2053-134828

## Sources of Water, Corners of Control Joint

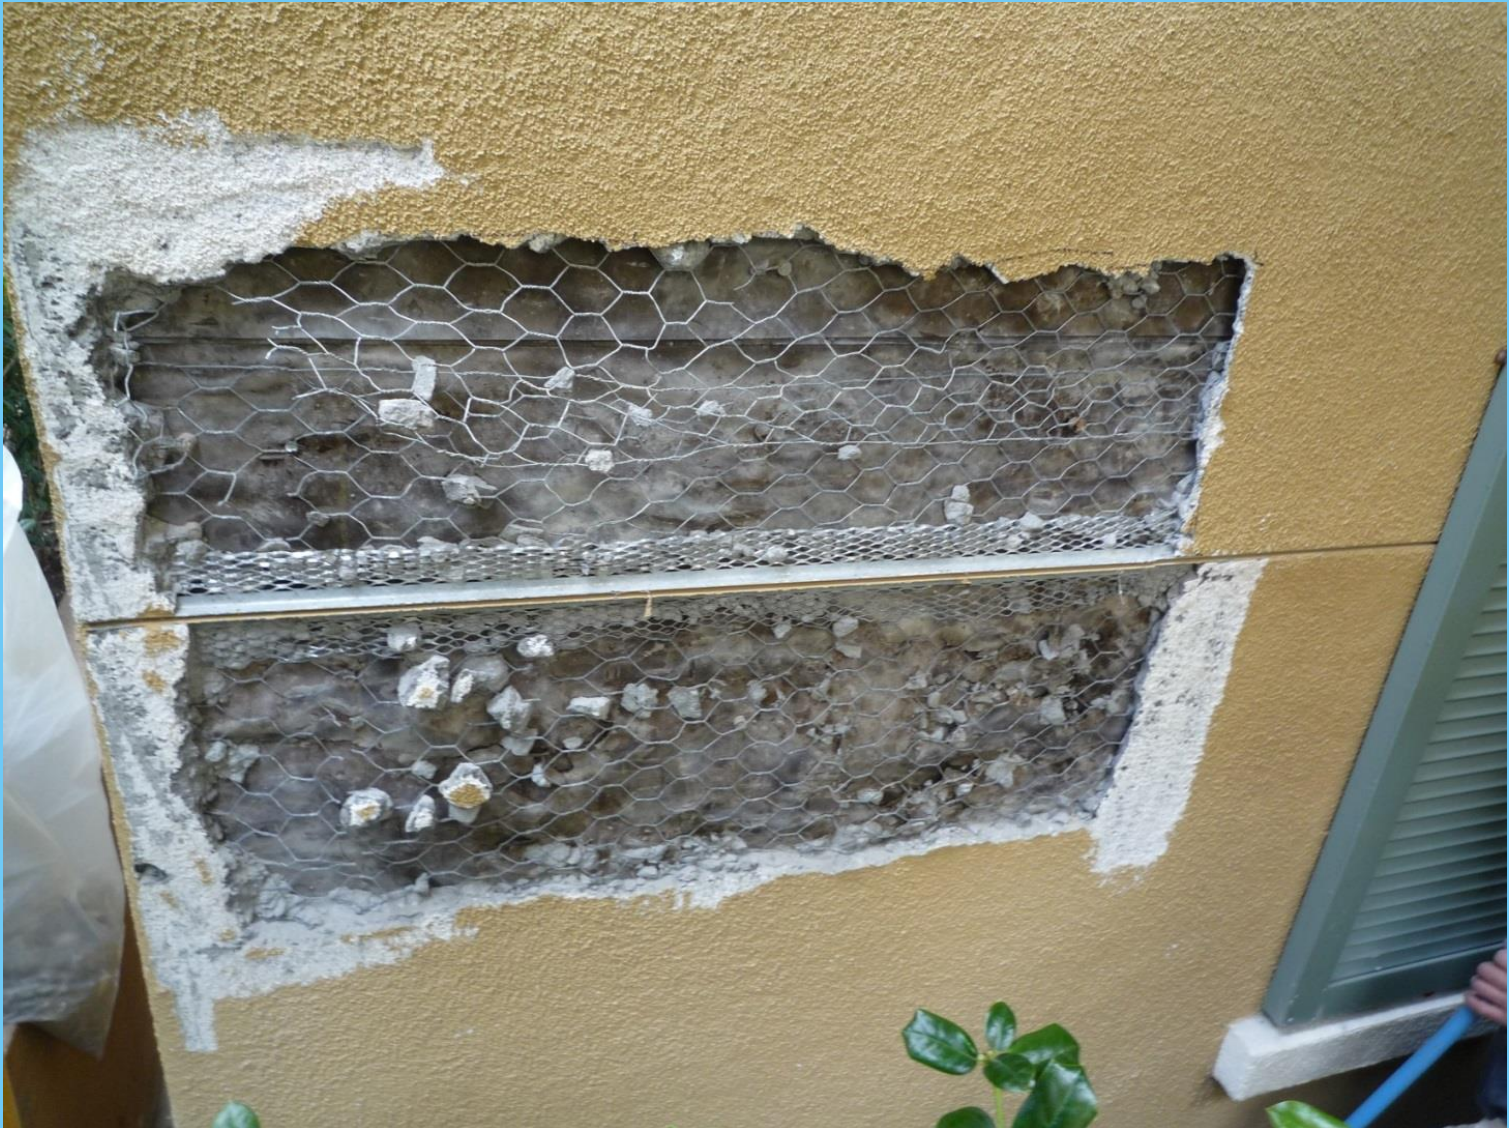
## Control Joints Nailed Tight To Paper

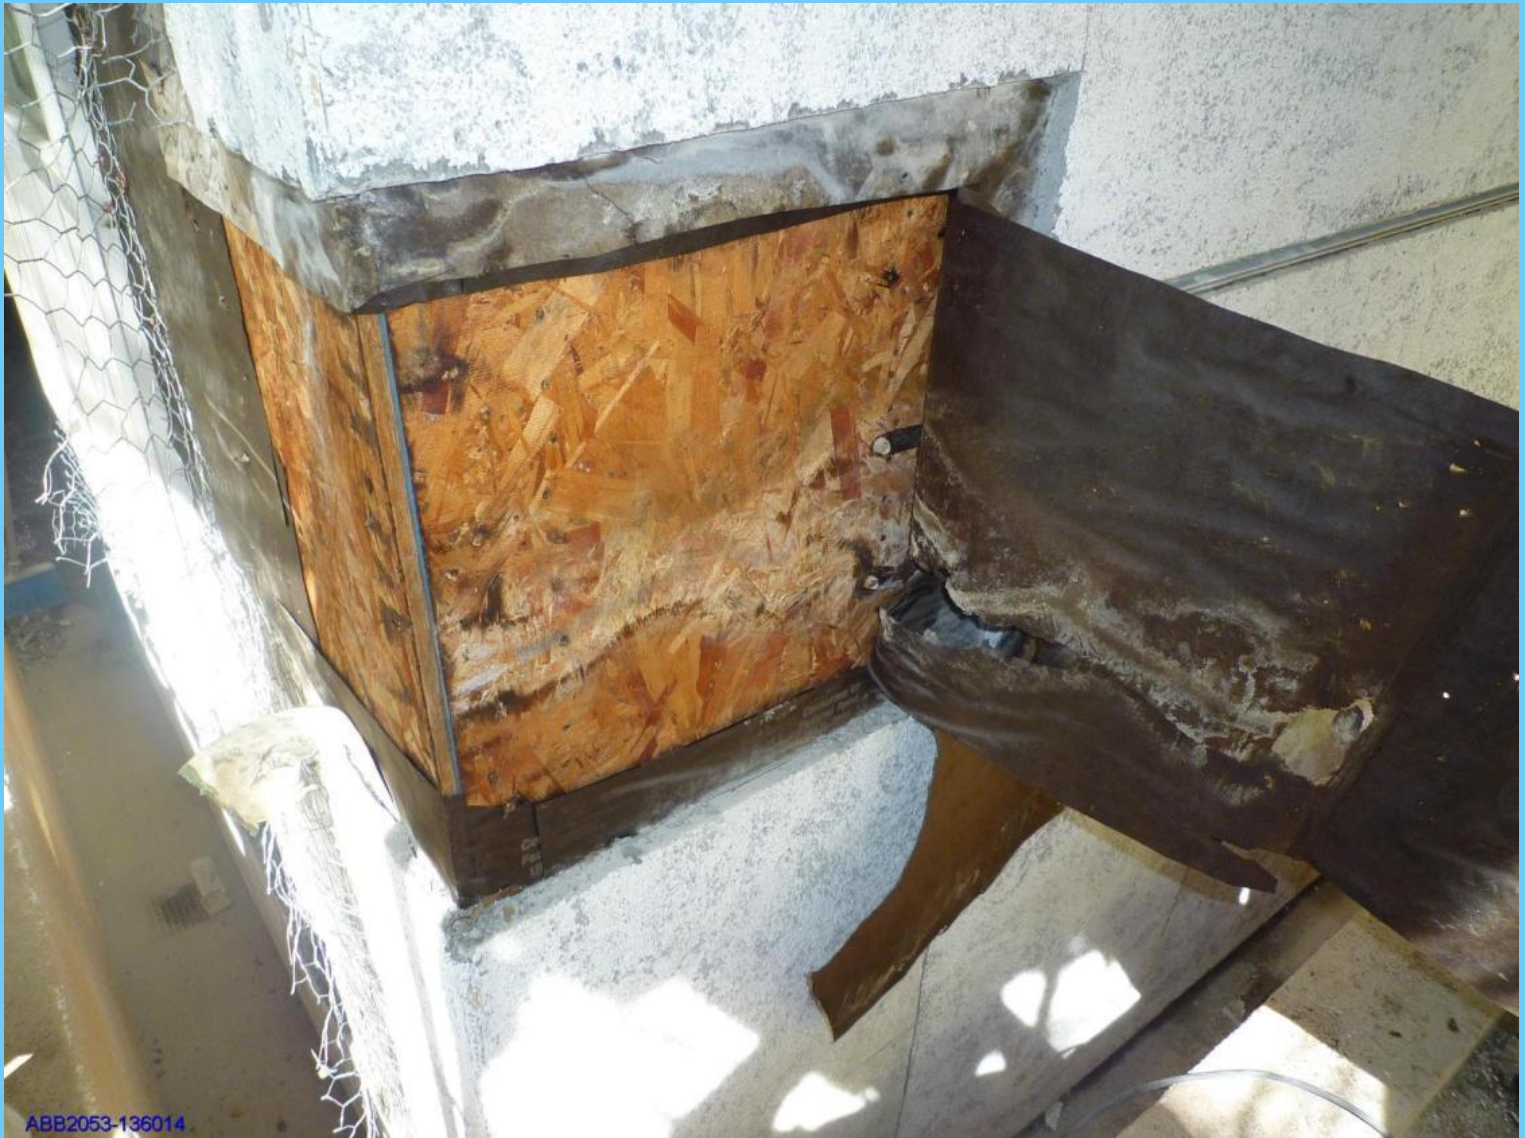
ABB2053-136014

## Sources of Water, Corner Mold at Control Joint

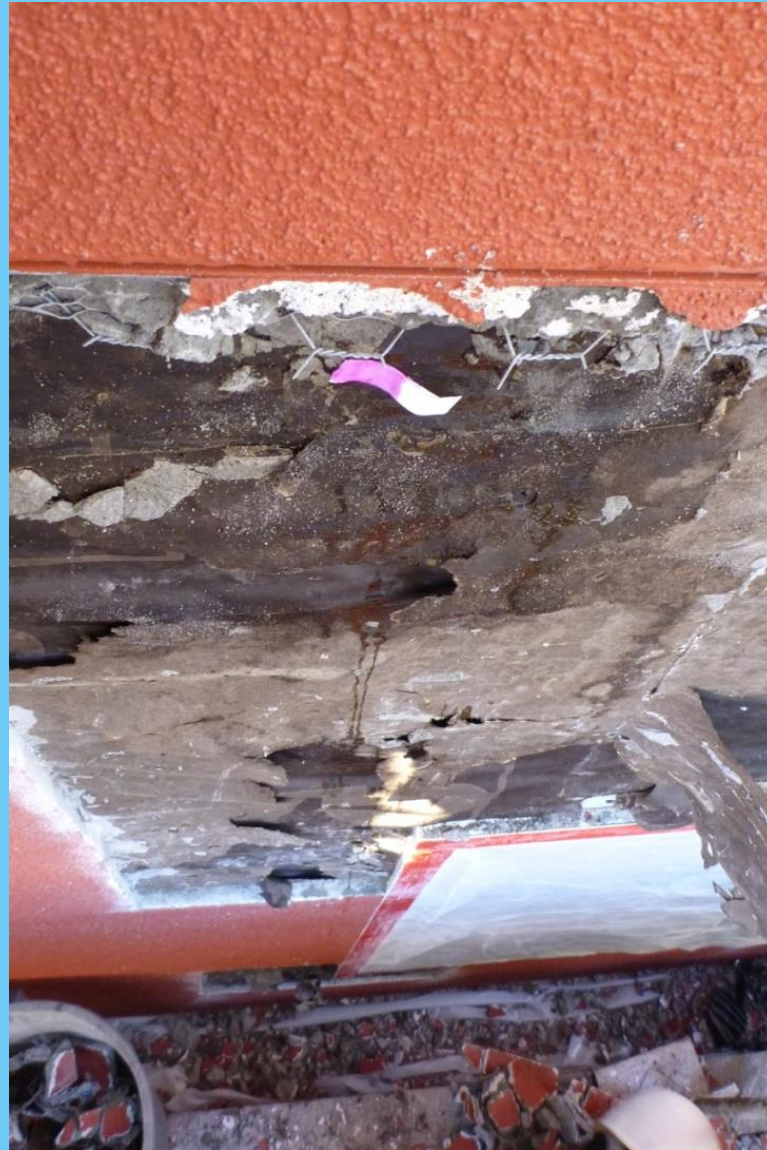
## Water Actively Dripping Under Control Joint

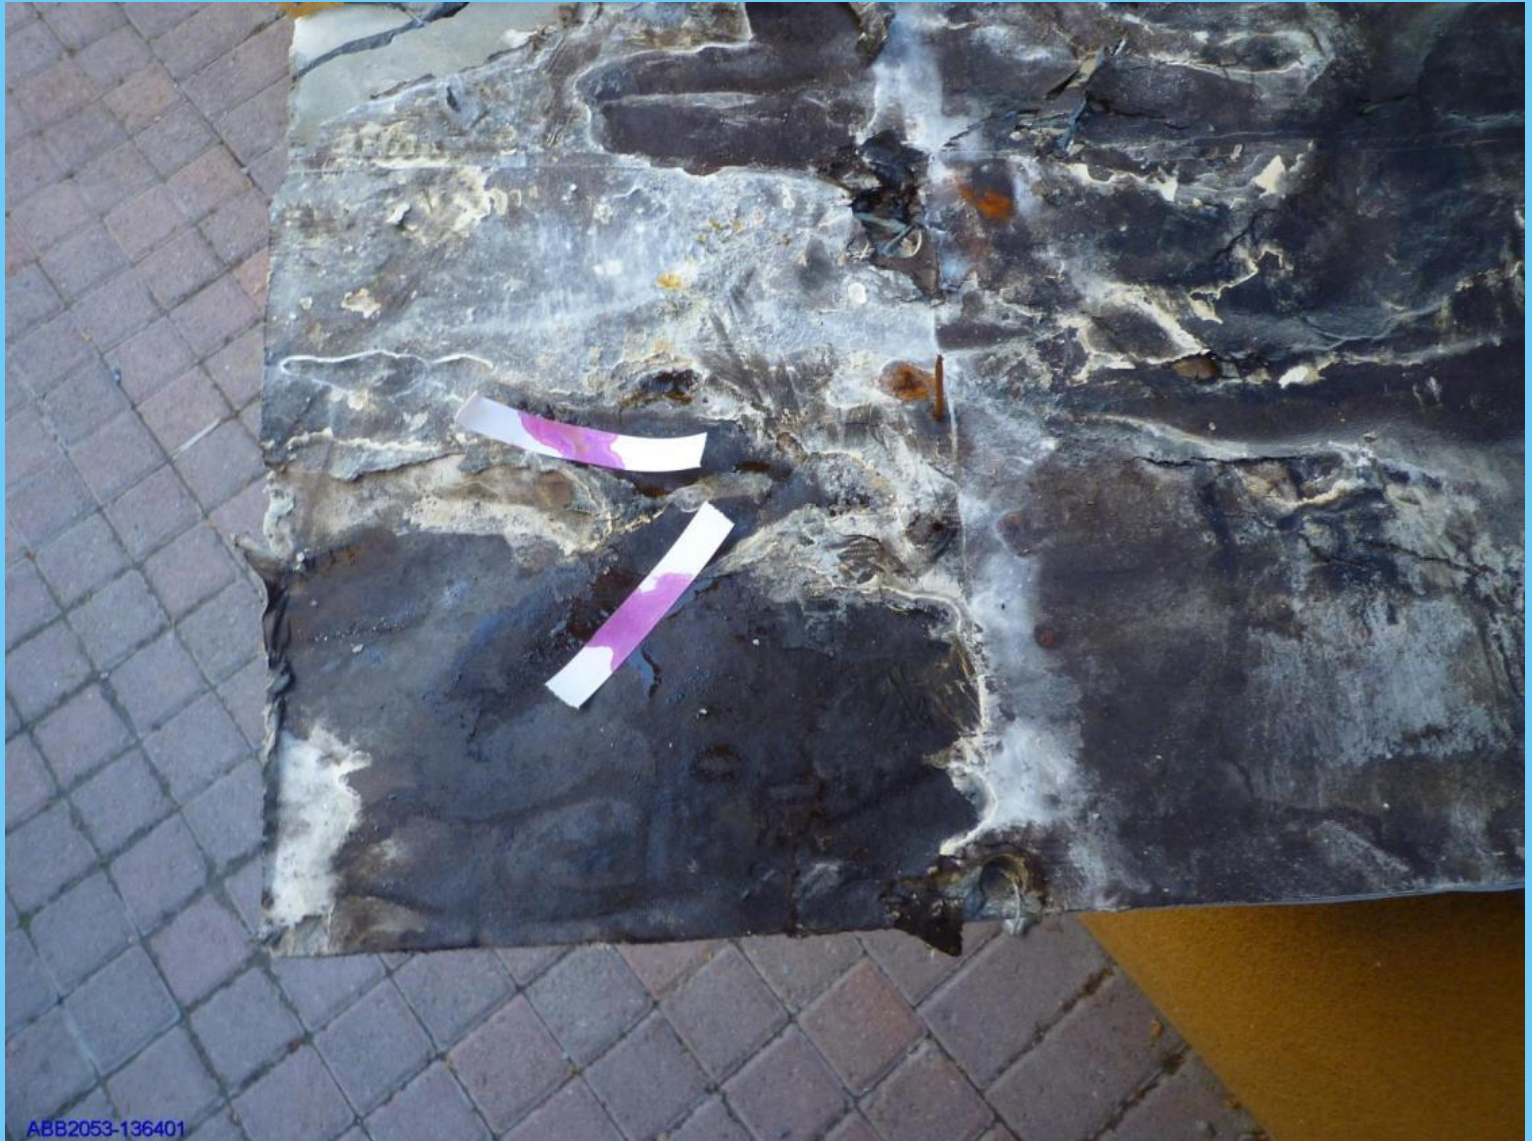
ABB2053-136401

# WRB is Completely Saturated

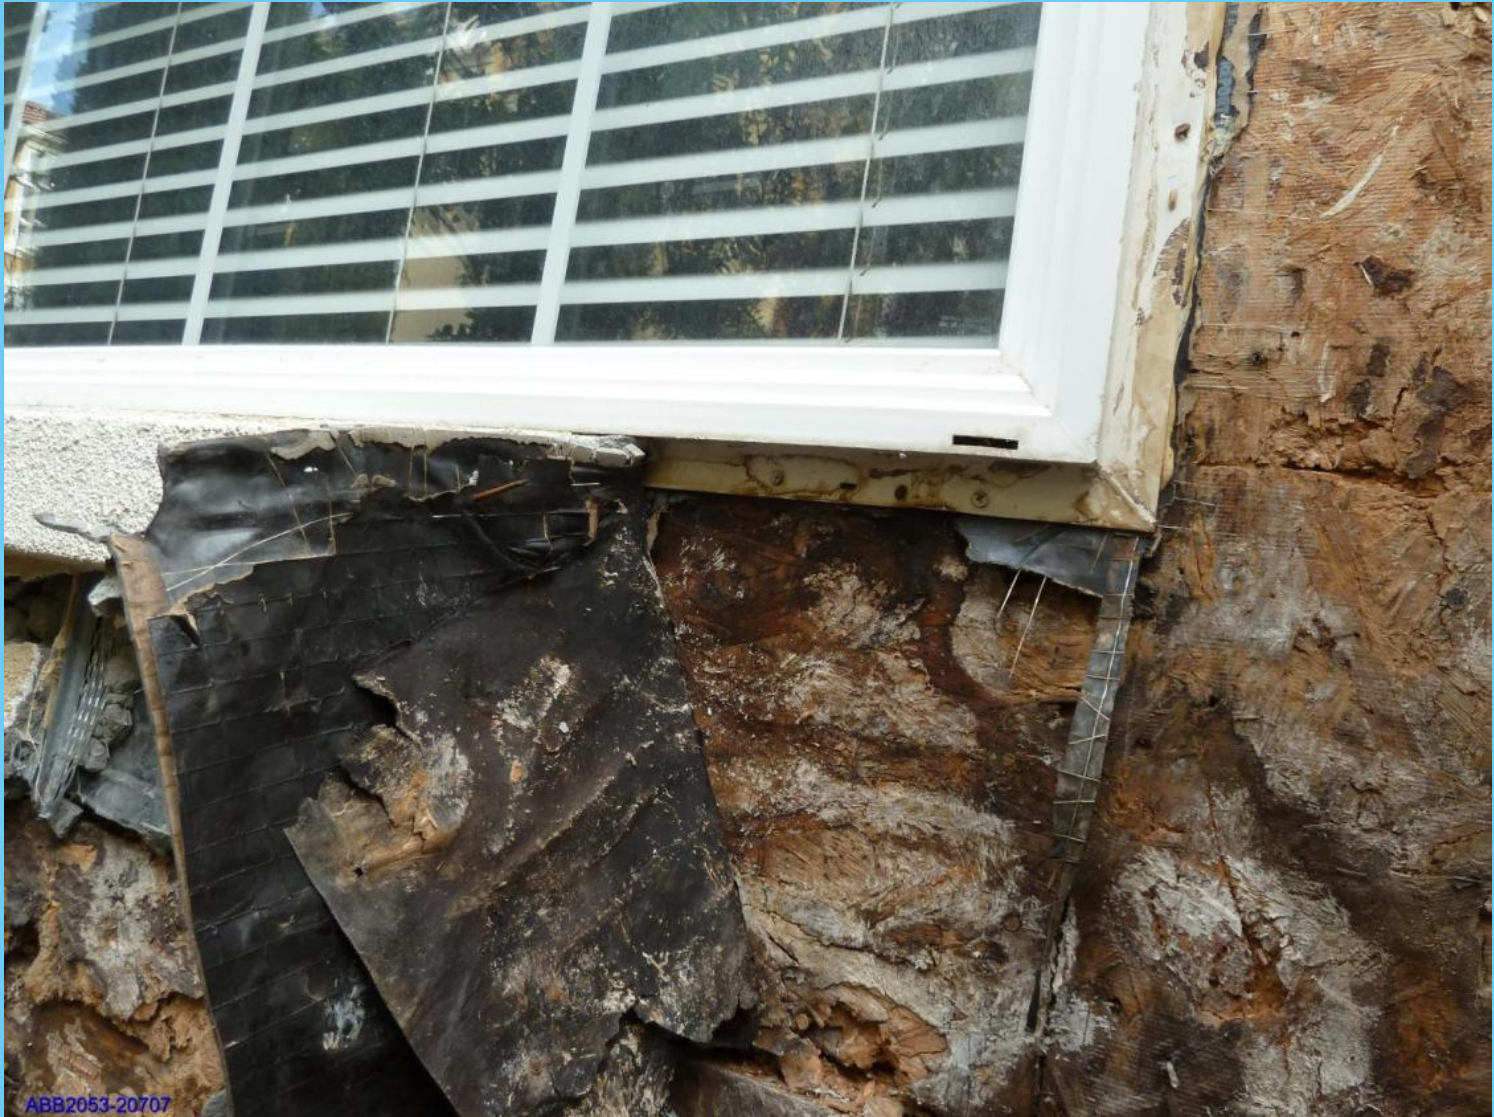
# Damage from Window Flashing Issues

ID: Window-2104 LR, Unit: 2104, Window, Severe Damage, Peel and stick installed to face of fin and not adhered

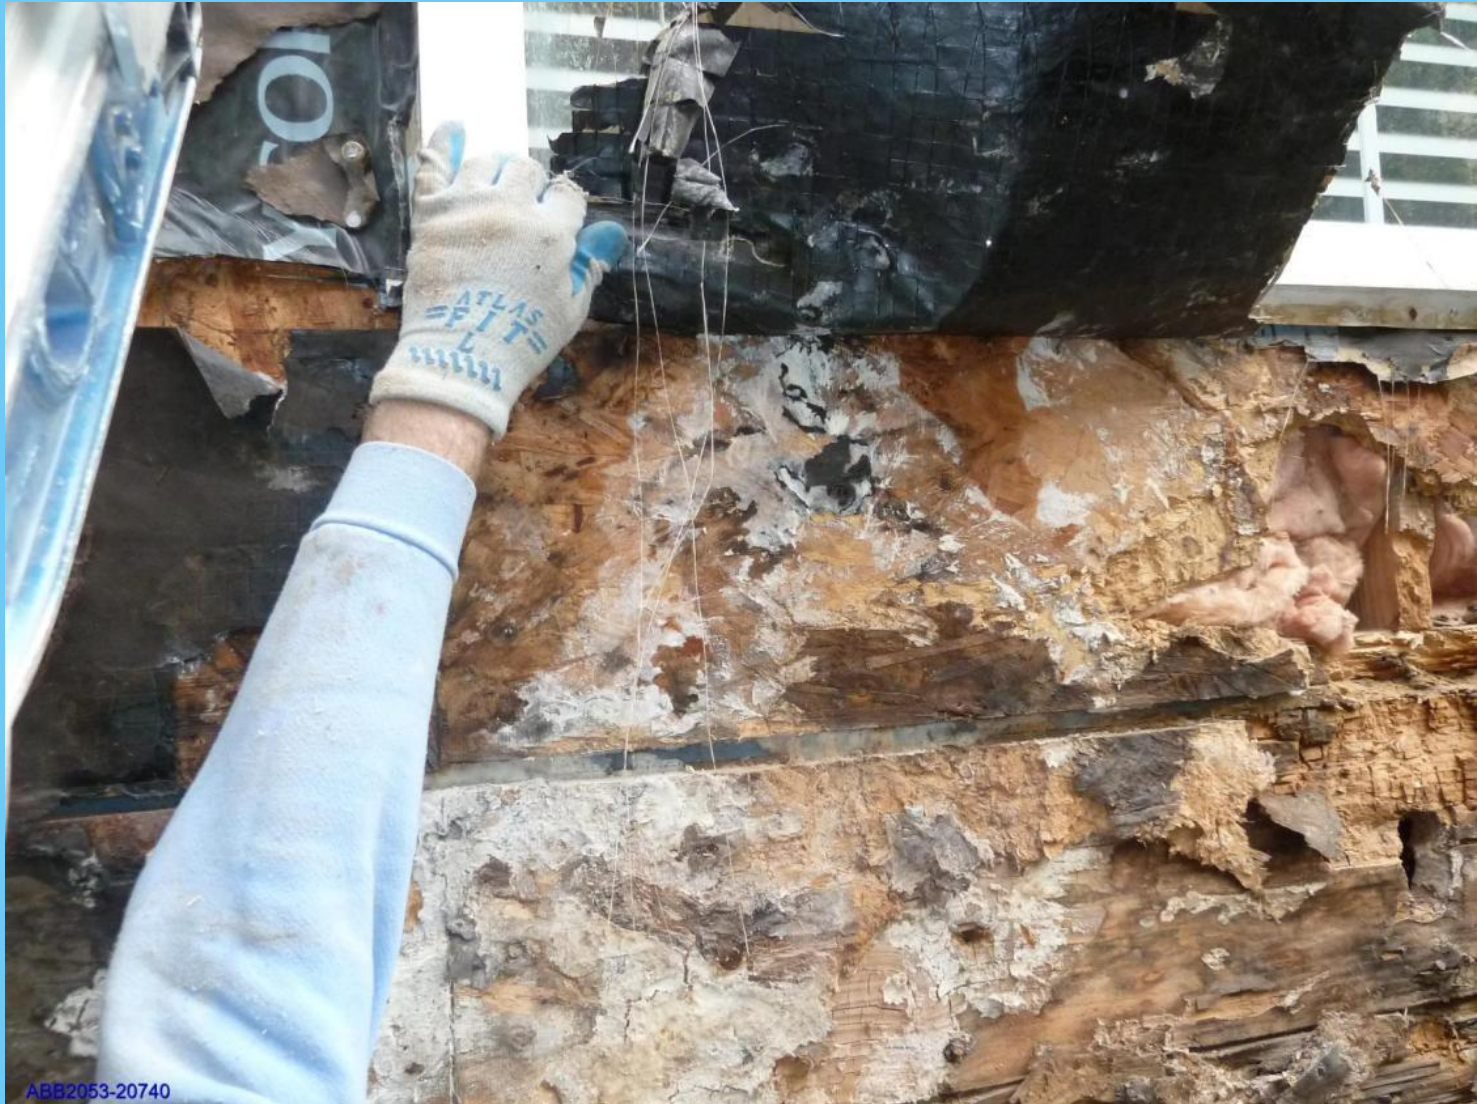
ABB2053-20740

# Improperly Installed Window Flexible Flashings

ID: Window-2104 LR, Unit: 2104, Window, Severe Damage, Peel and stick installed to face of fin and not adhered

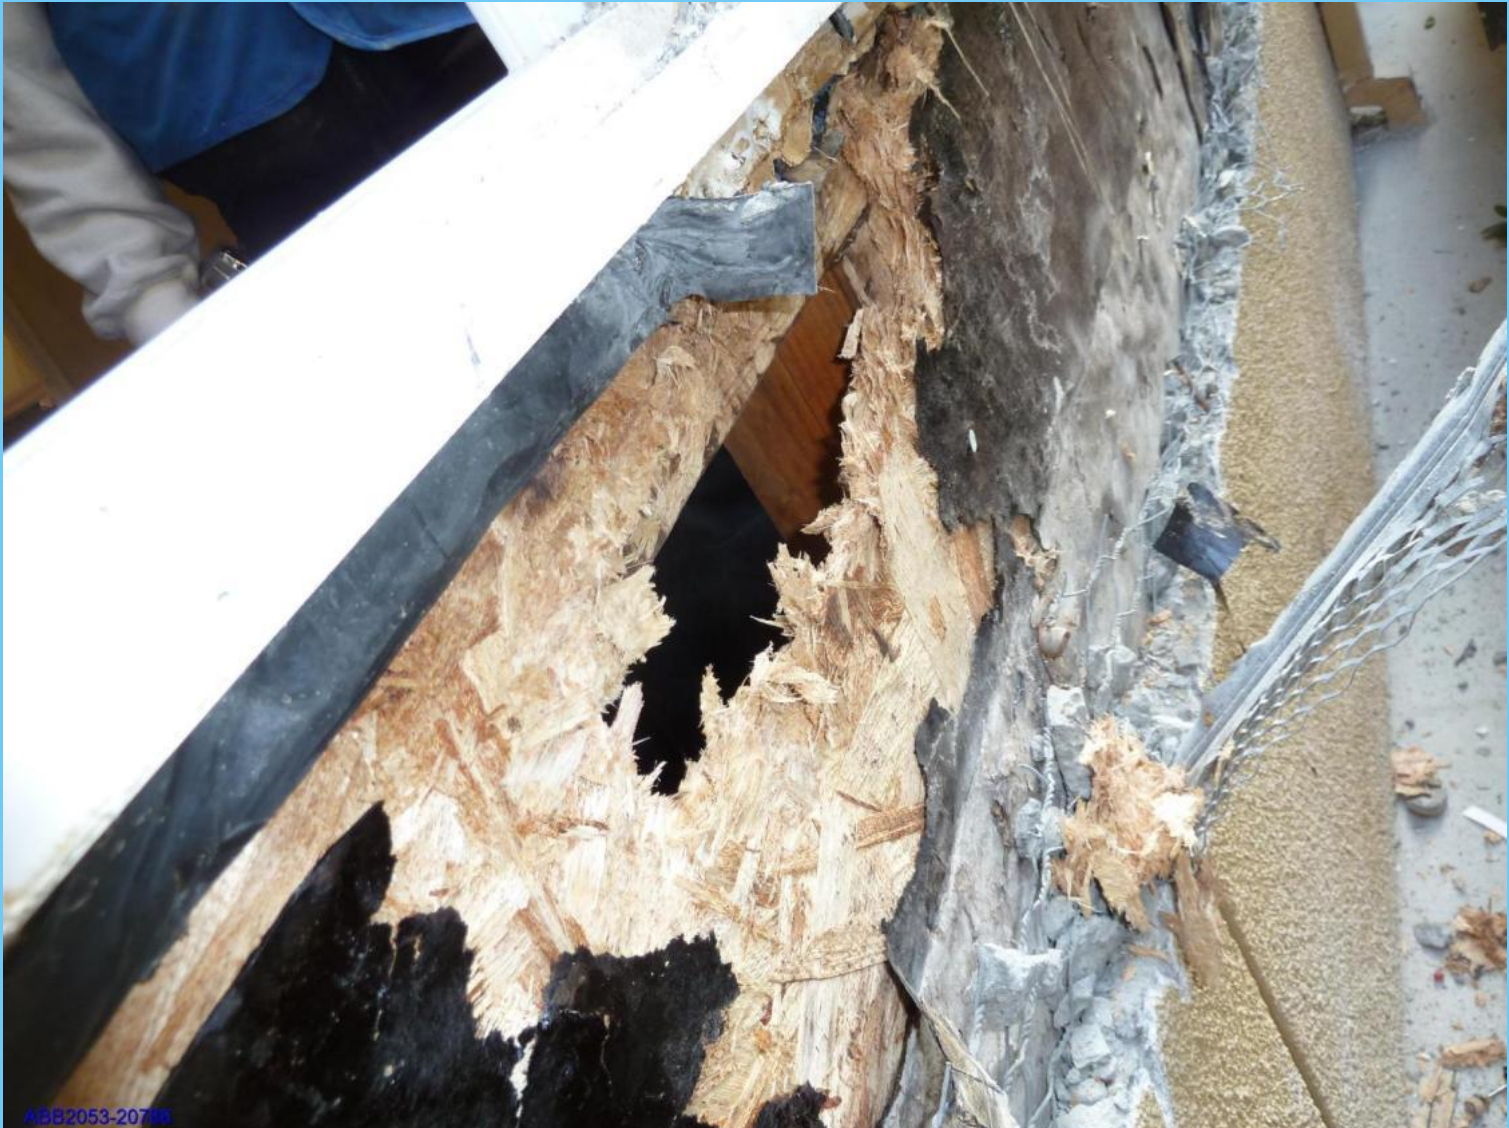
ABB2053-20788

## Under Window Damage to OSB

ID: Window-3108, Unit: 3108, Window

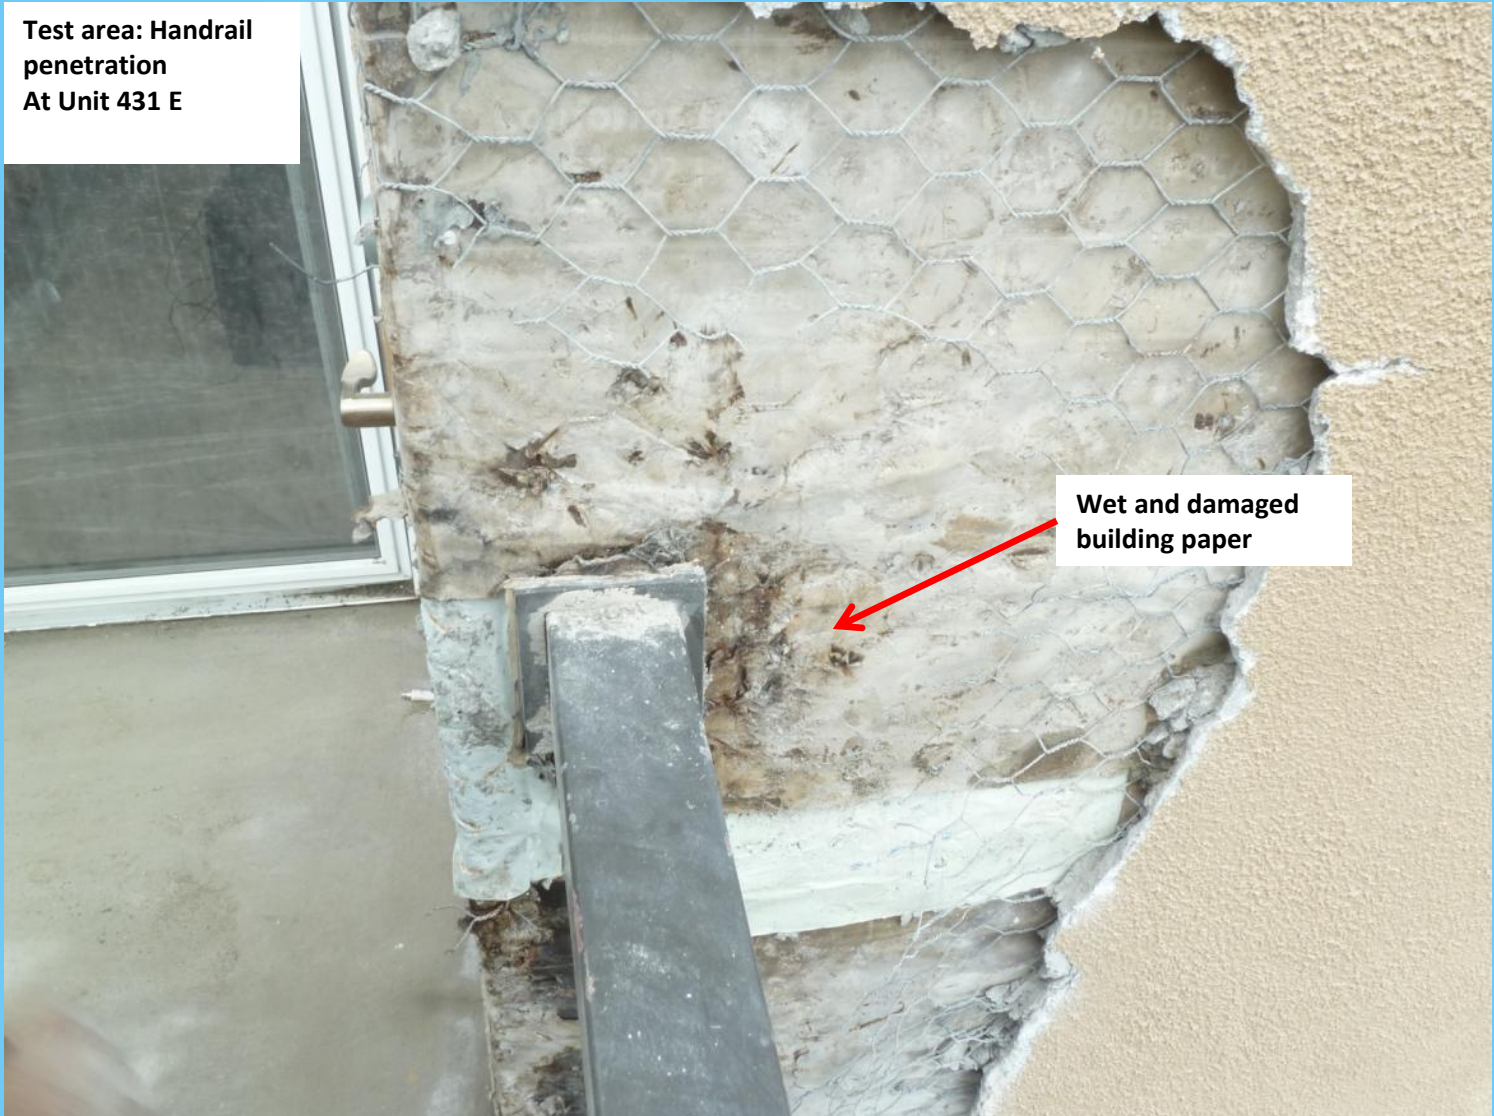
Test area: Handrail  
penetration  
At Unit 431 E

# Stucco Demo at Handrail Penetration

Wet and damaged  
building paper

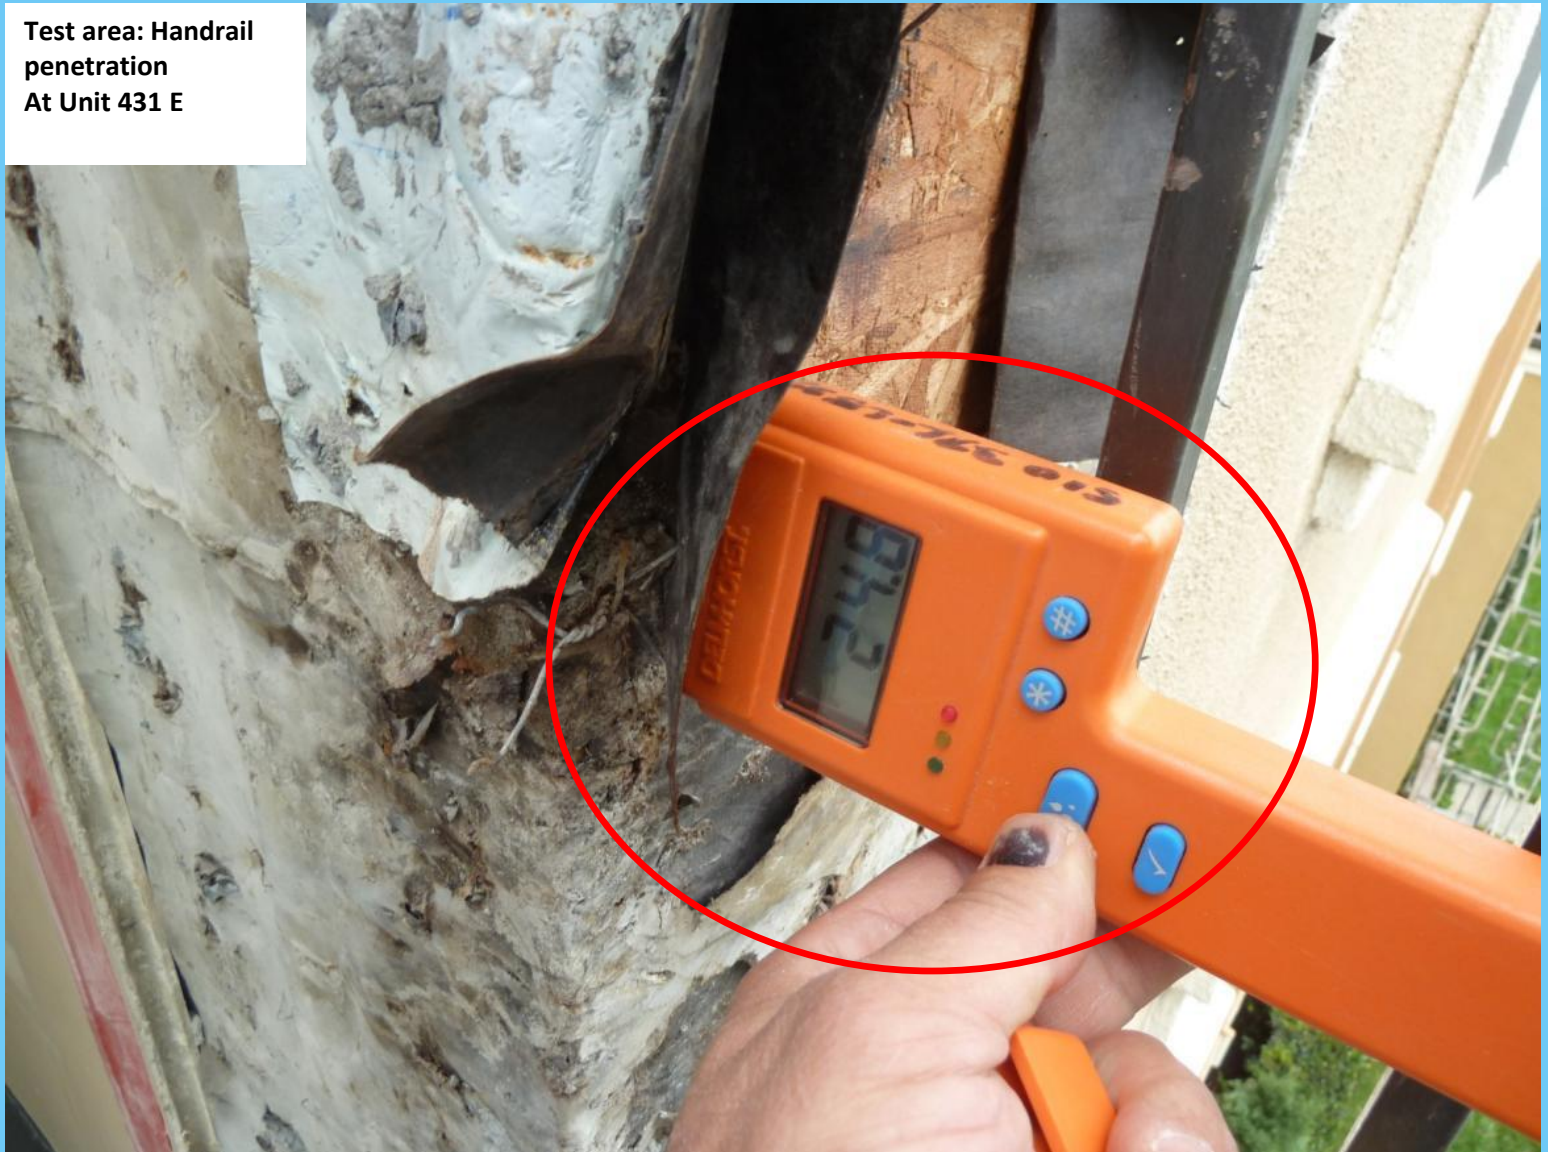
Test area: Handrail  
penetration  
At Unit 431 E

# High Moisture Content in OSB 24.8%

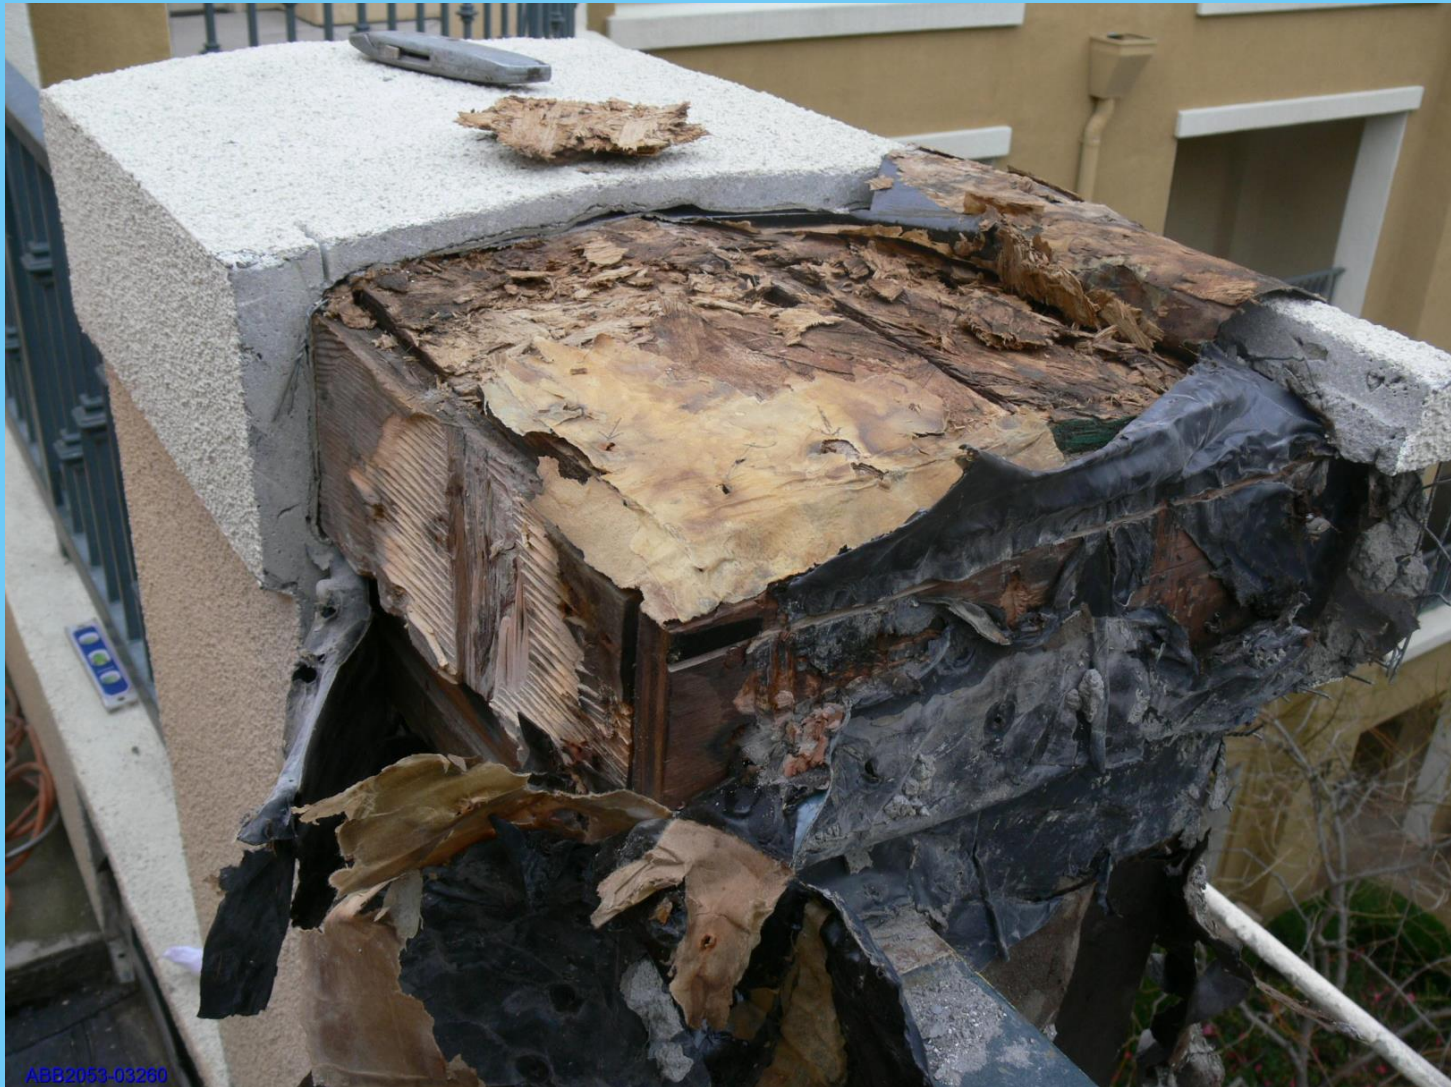
ABB2053-03260

## Horizontal Areas Of Plaster

ID: Walkway-1406, Unit: 1406, Scupper at Walkway  
2010-01-12 Chris Johnson
