# **Building Envelope Technology Symposium**

# **Performance of Weather Resistant Barriers in Stucco Assembly**

**Karim P. Allana, PE, RRC, RWC**

**Allana Buick & Bers, Inc.**

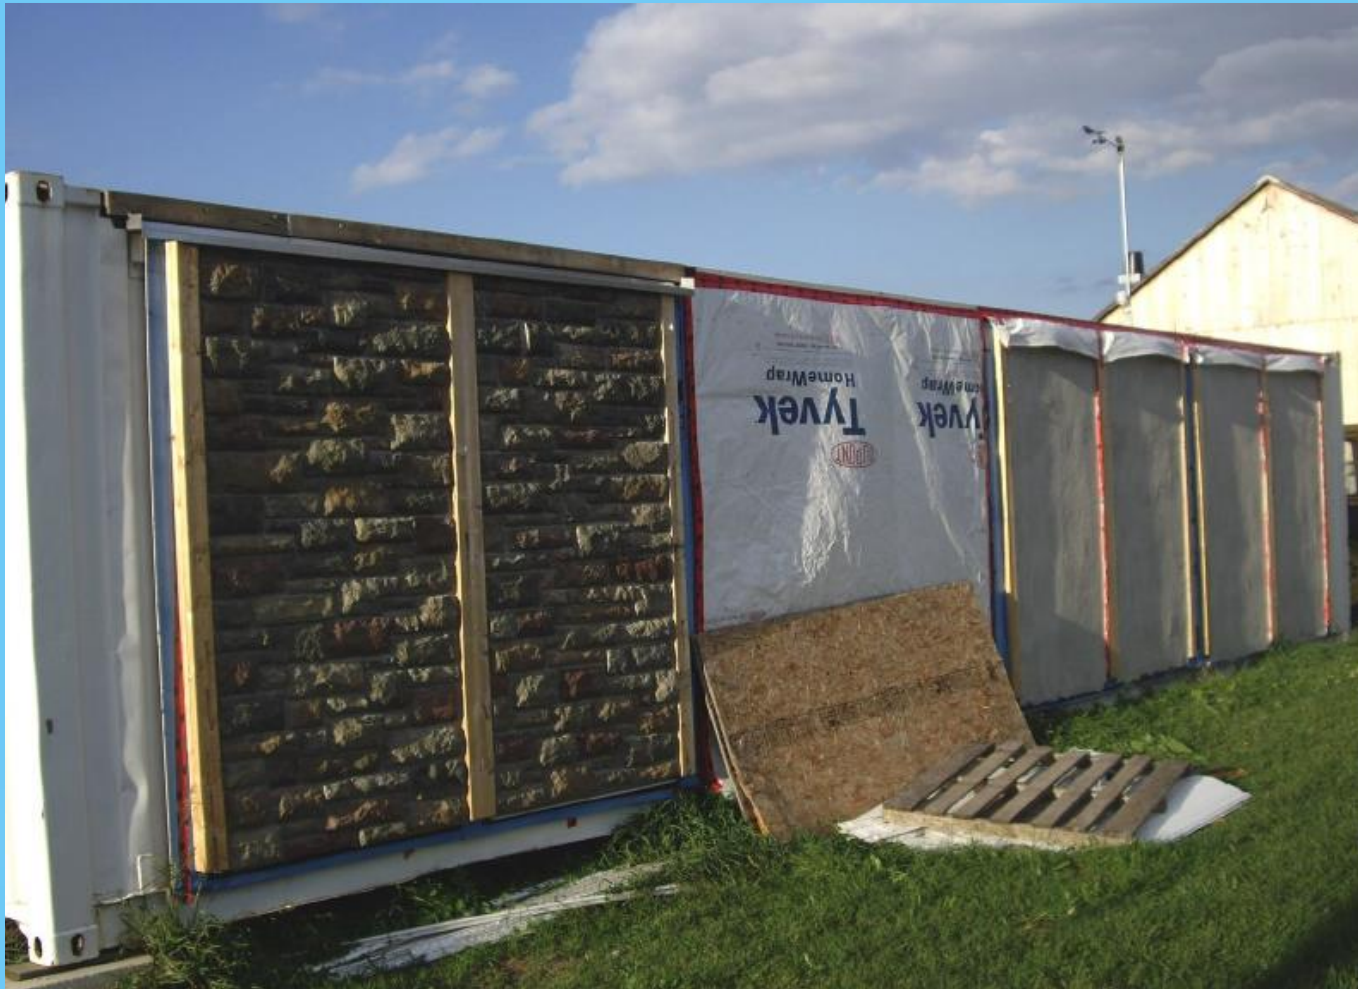
Field performance testing at testhut in Waterloo, ON  
Dr. John Straube, Building Science Corporation

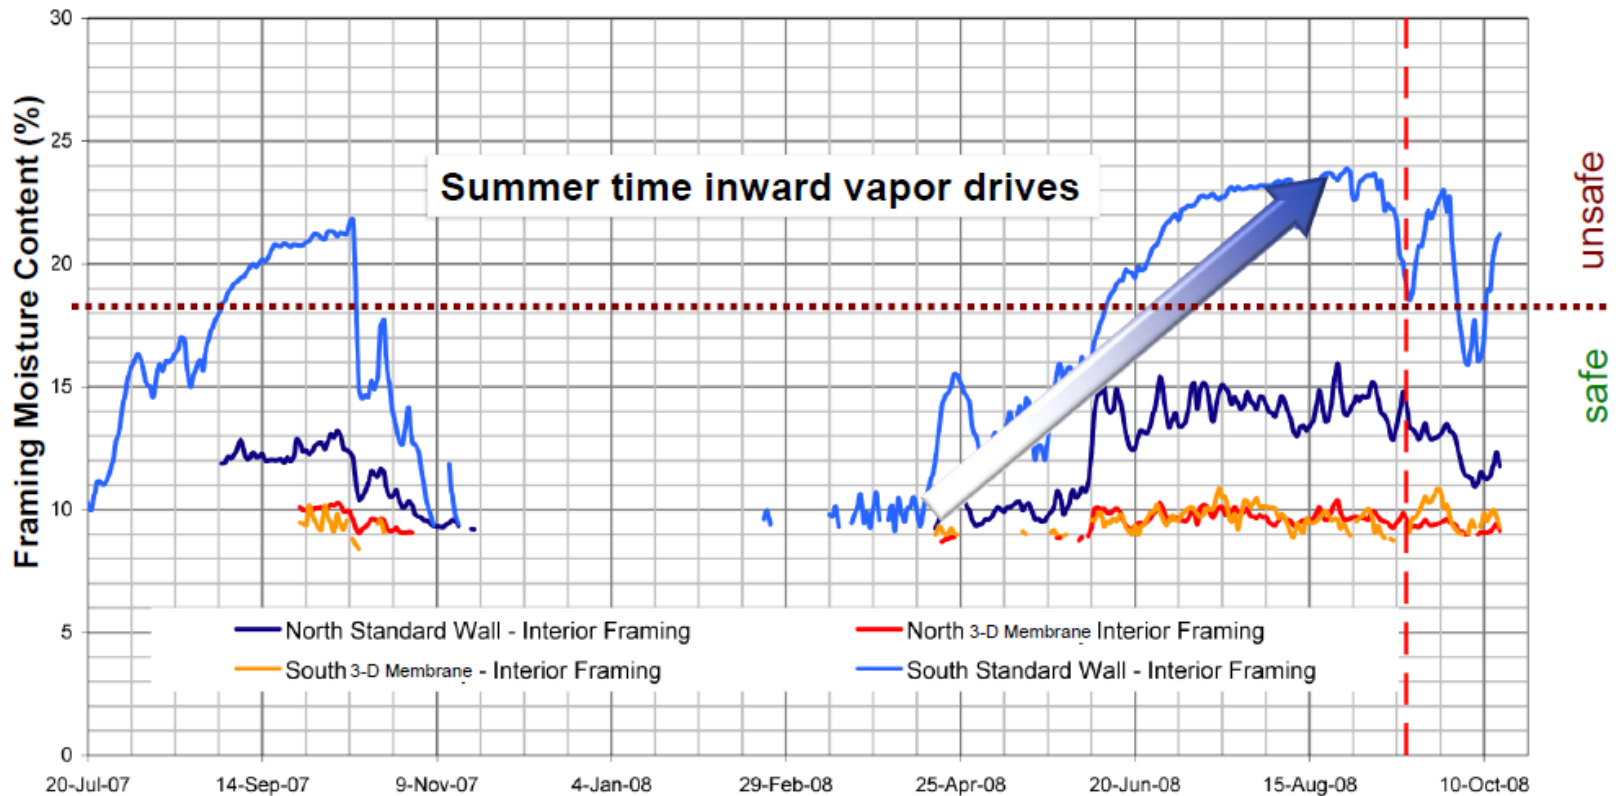
# Absorption of Water Can Lead To Damage

## Framing Moisture Content

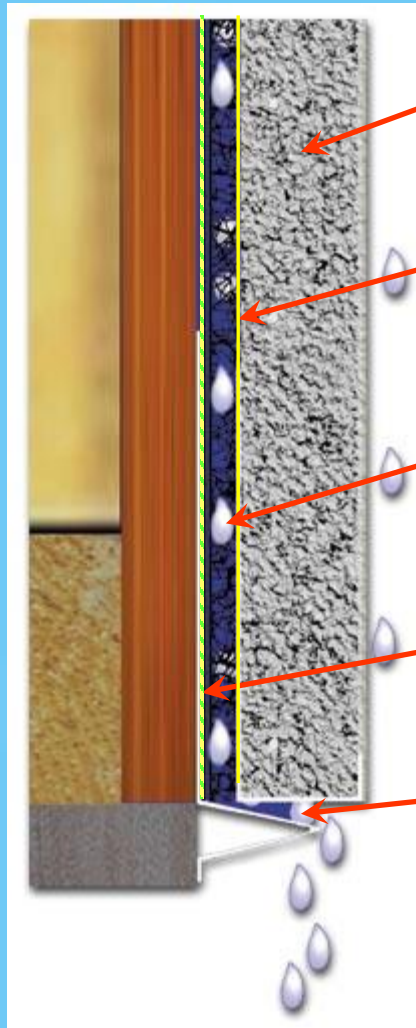
# Moisture Management System With Drain Mat

Exterior cement plaster

Outboard moisture barrier

Drainage cavity

Inboard moisture barrier

Weep provision

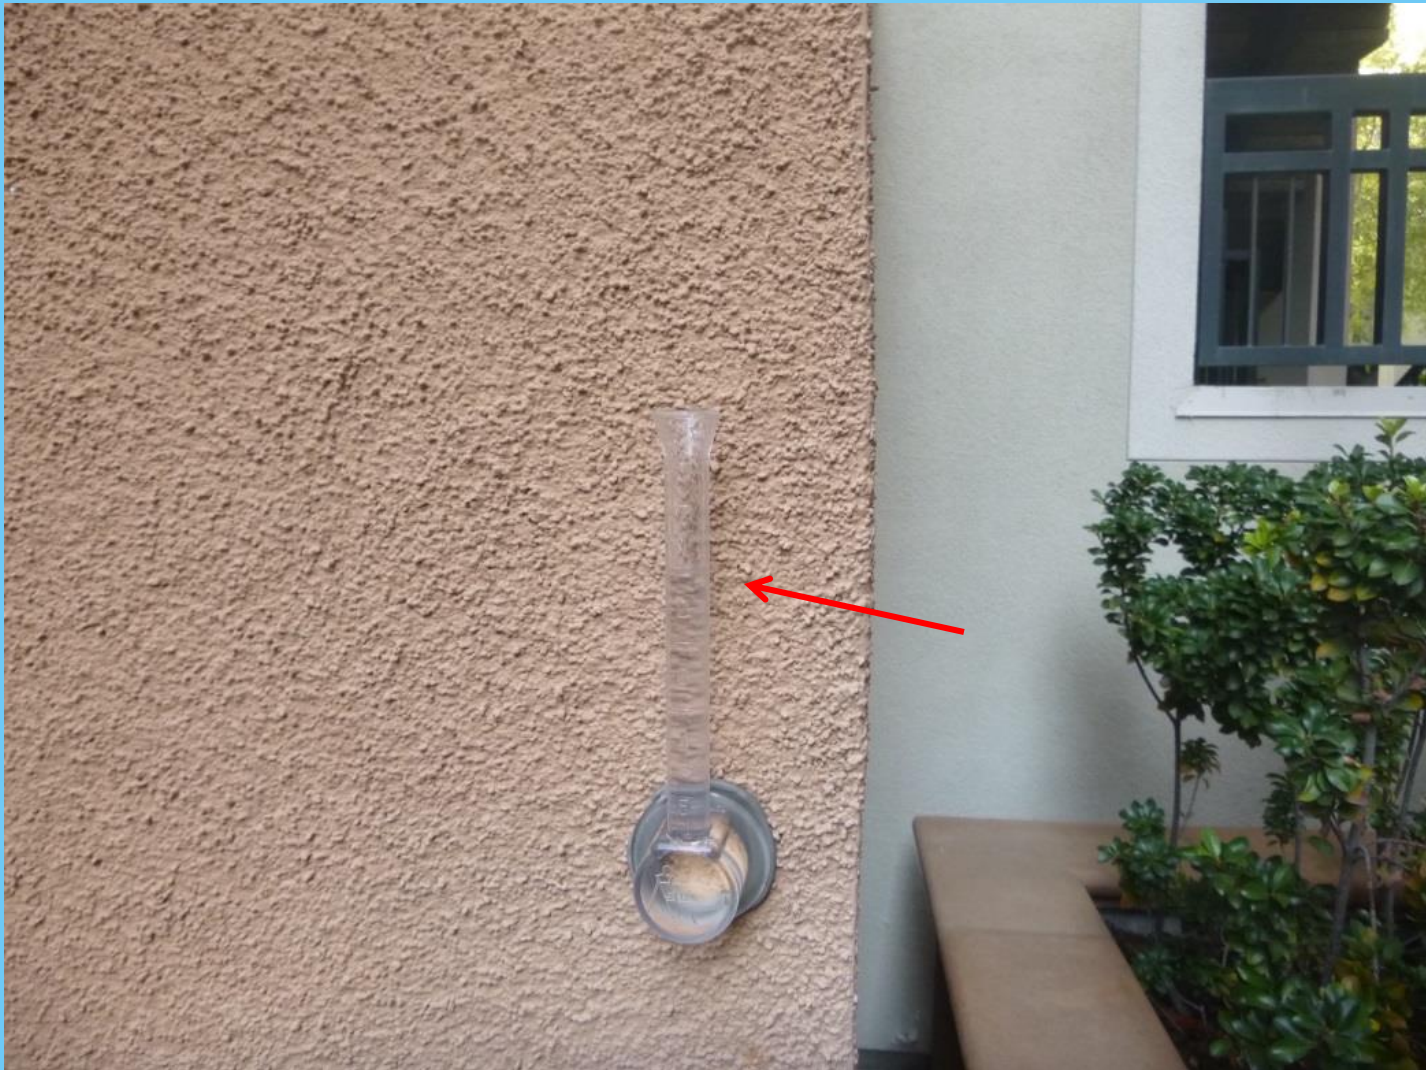
## Pines B2 - Water Dropped Almost Immediately

Building 4-Location 8-A. Water dropped to a level almost immediately before we could take a photo of full tube.

- **Pines B-2**
  - 11/18 locations significantly lost water = 61%
- **Pines B-1 STO Finish**
  - No locations lost water
- **Pines B-1 BMI Stucco**
  - No locations lost water

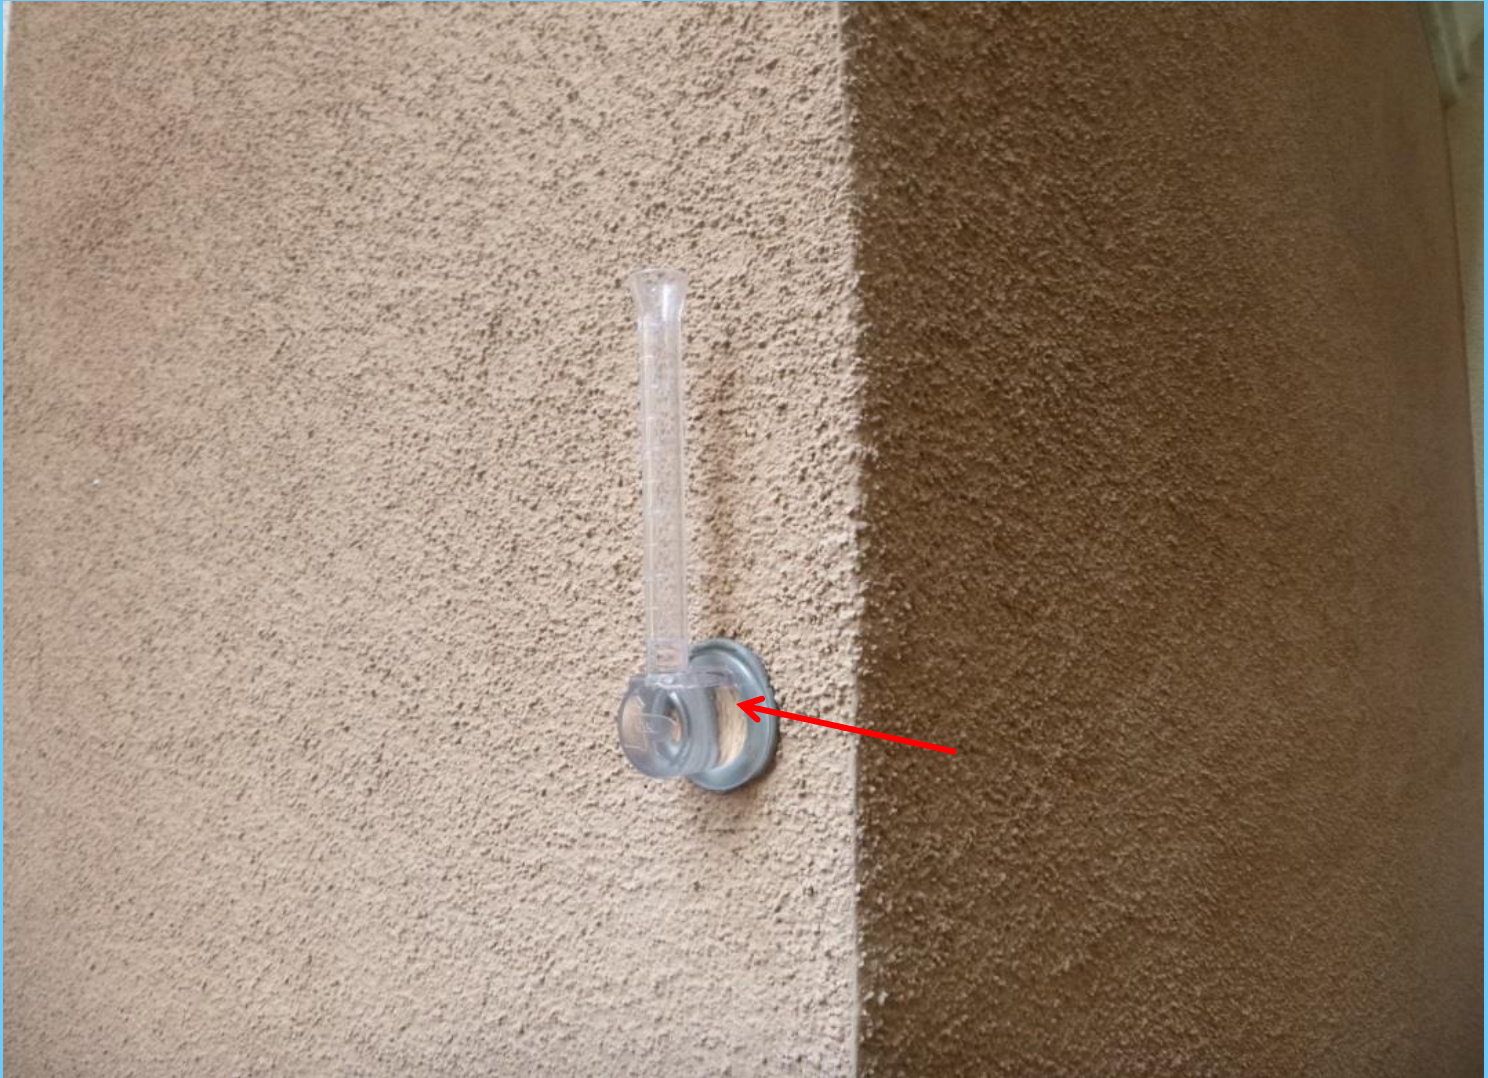
## End of Test – In 15 Minutes

Building 4-Location 8-A. Water dropped to bottom of the tube near the end of the test.

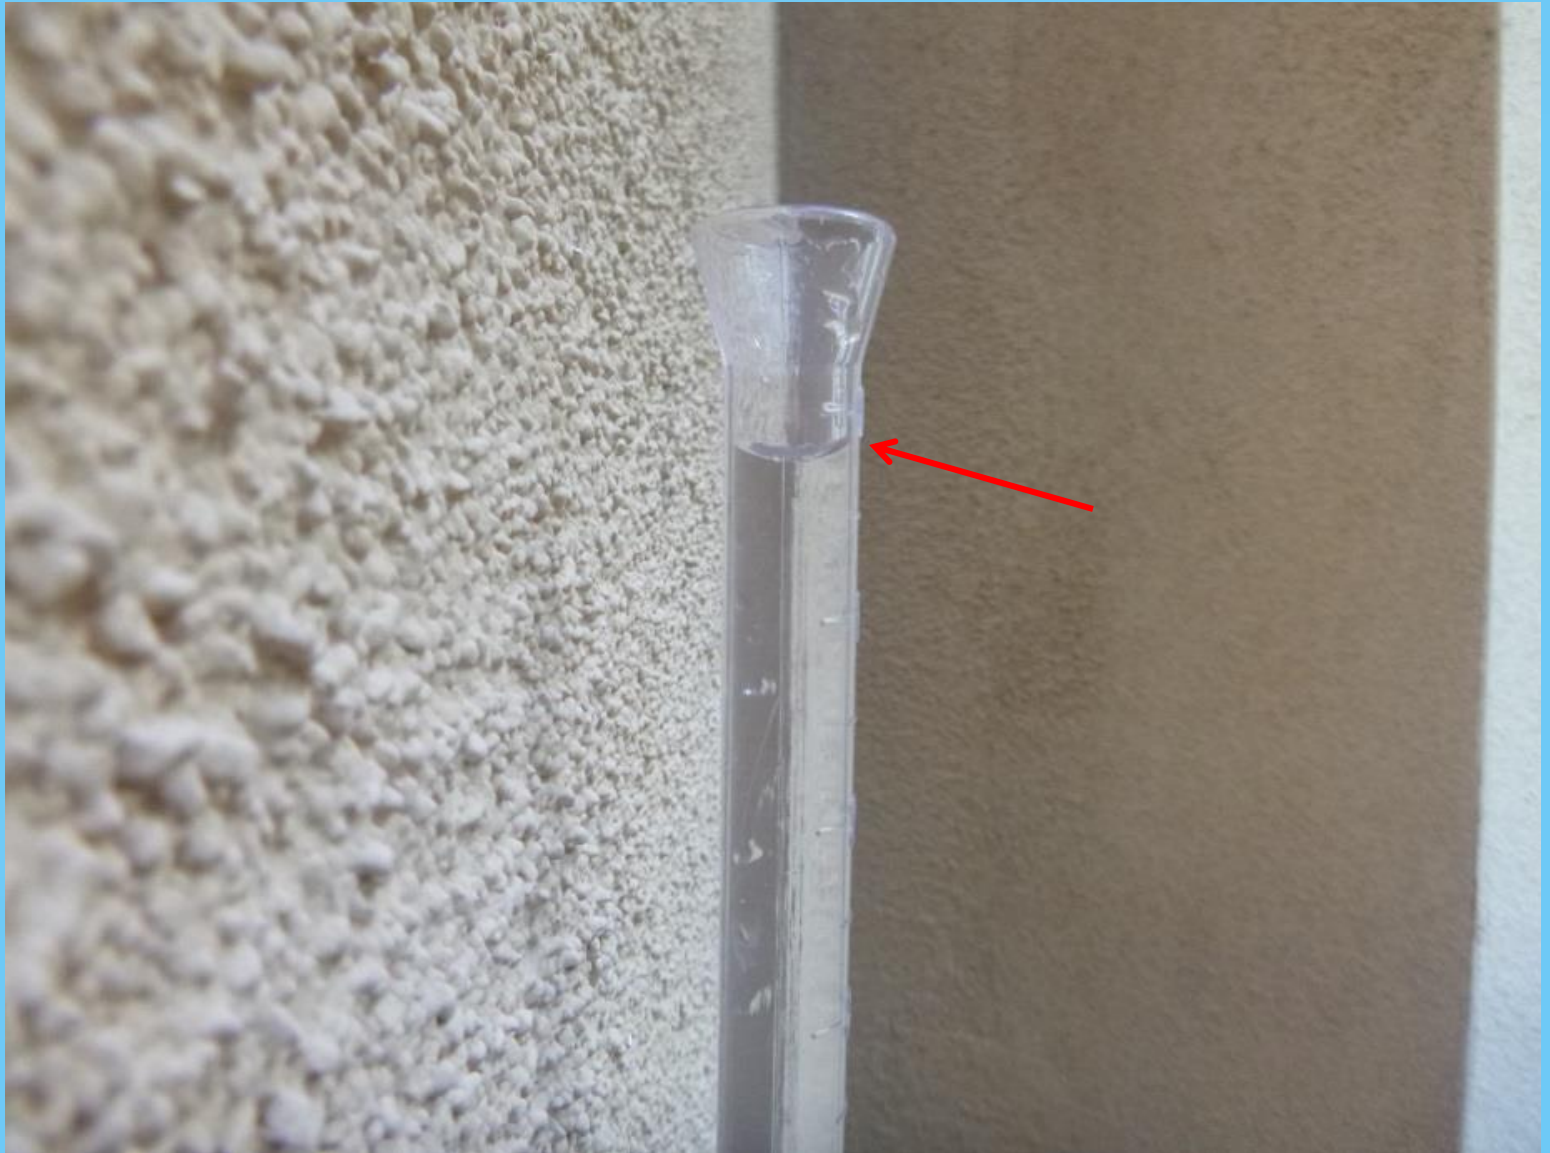
Building 3 Location 6-A, full Rilem tube

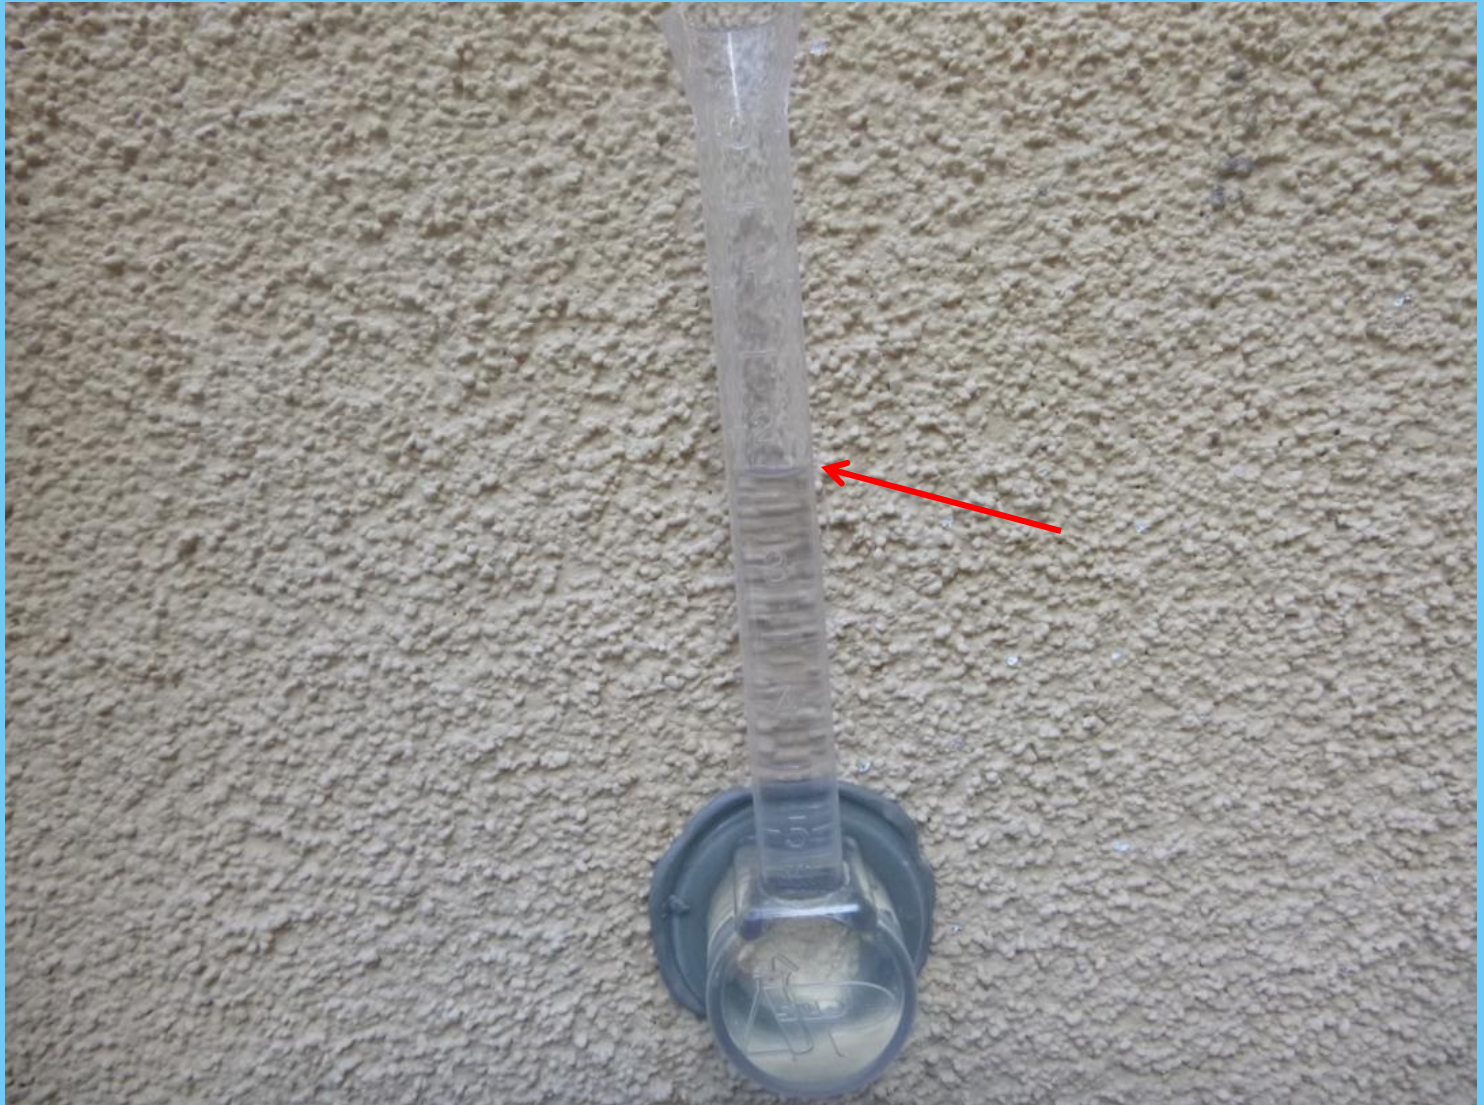
## Rilem Tube Level Dropped in 15 min

Building 3 Location 6-A, water level at end of test.

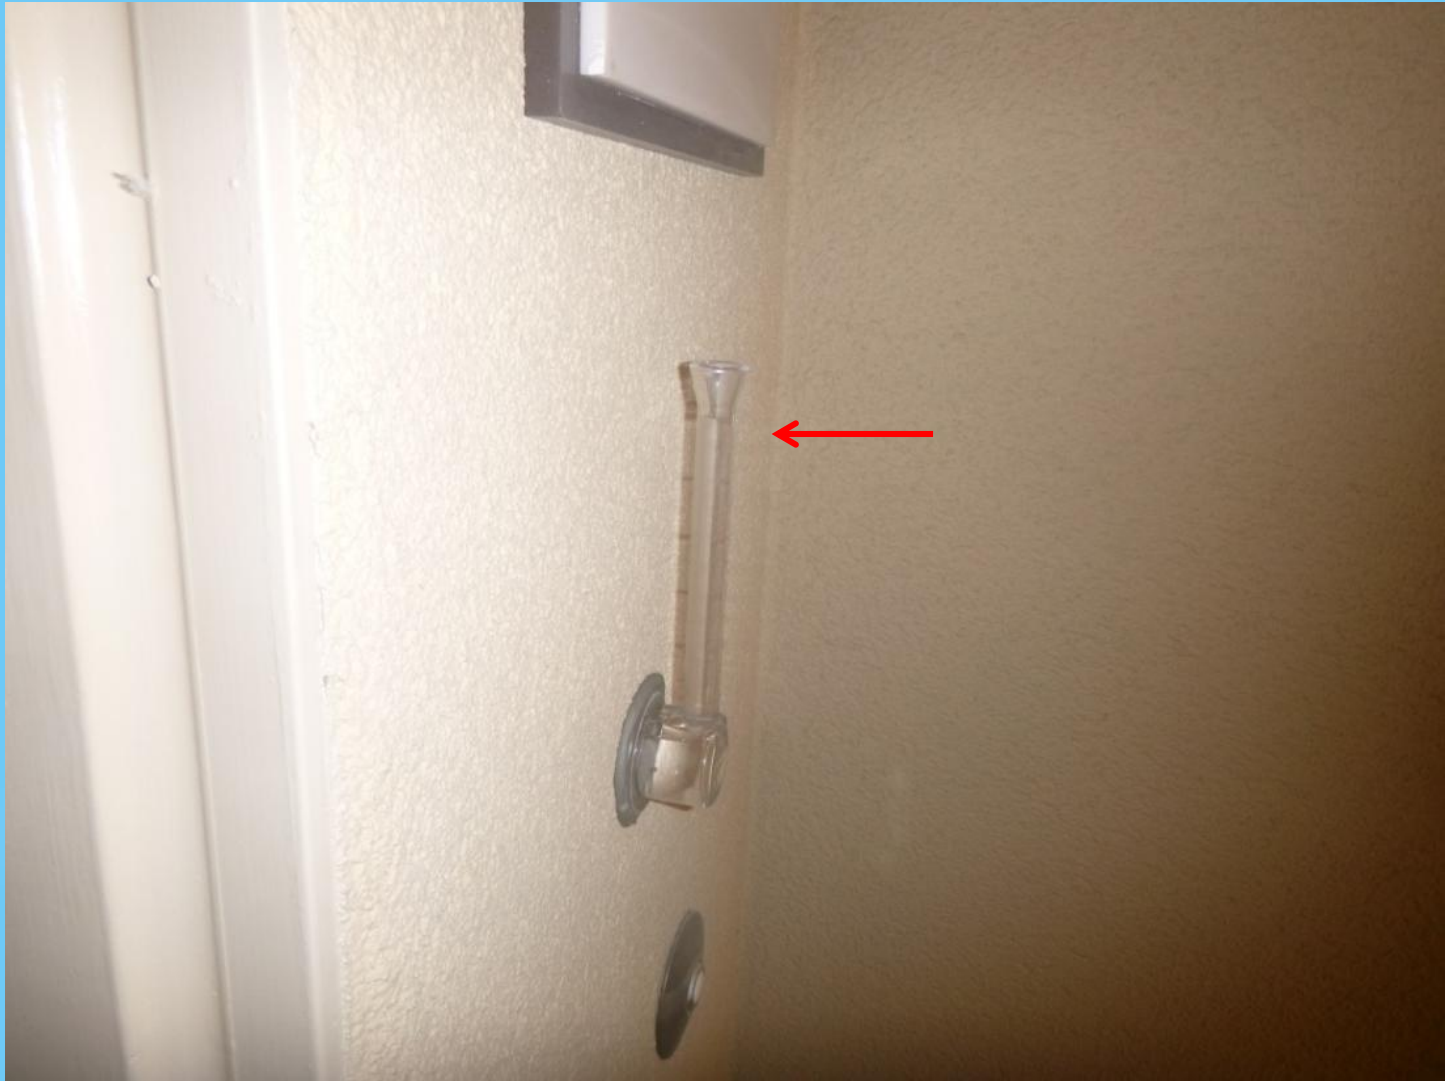
## STO Finish - End of Test –Tube Full

Building Pines B-1 Bldg. 1 Unit 1111 Rilem test over new Sto Finish-Tube is full at end of test.

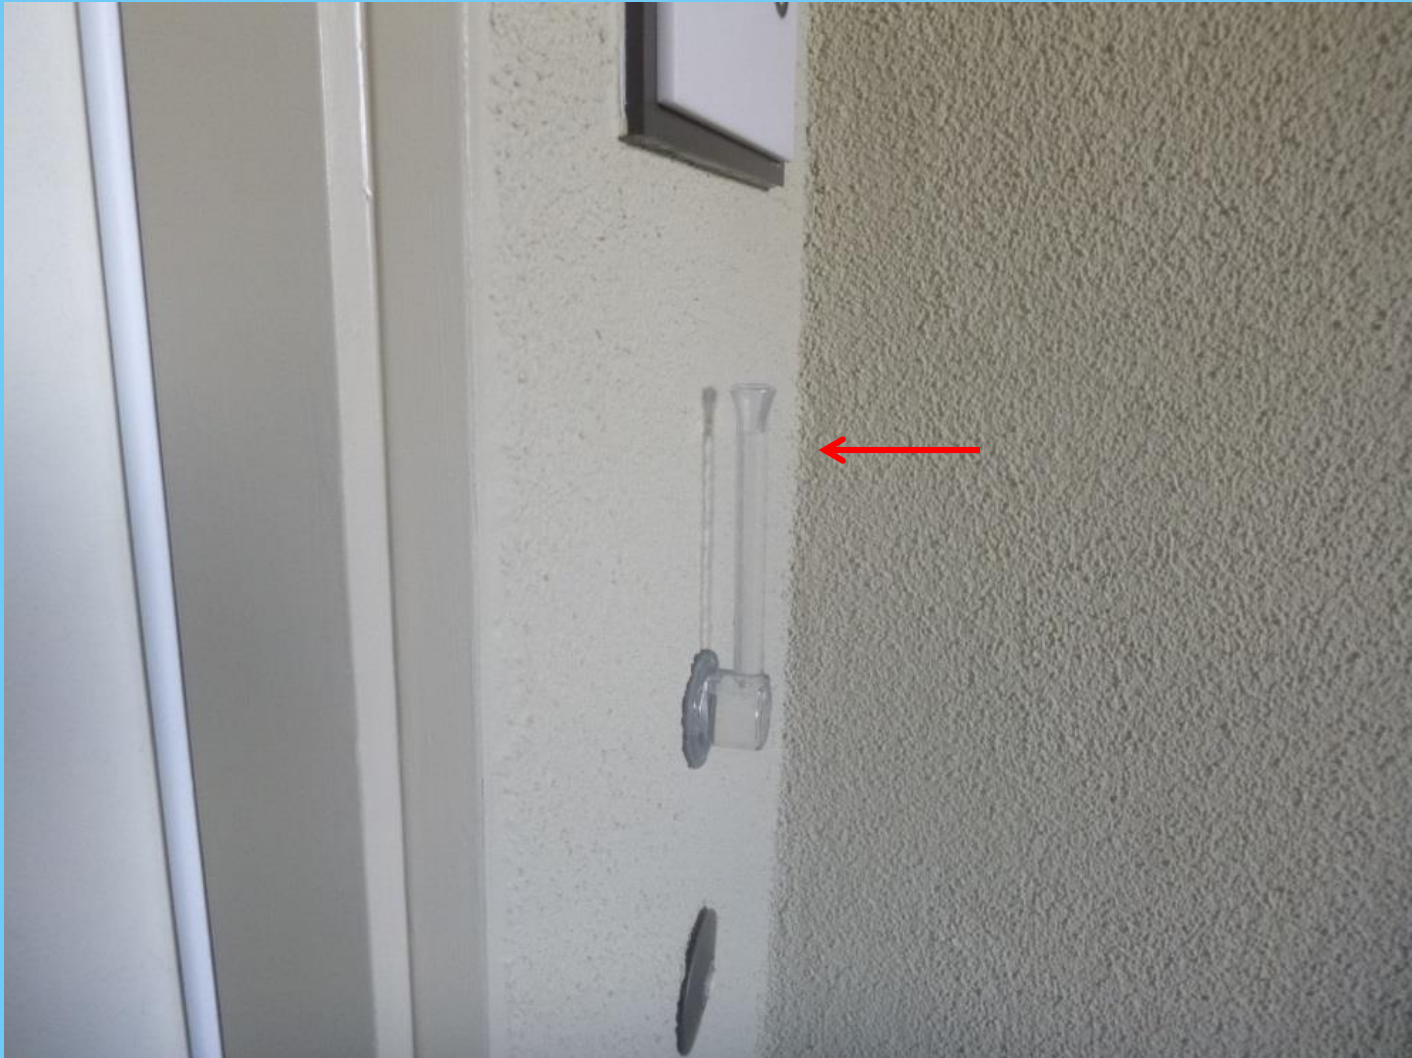
## Pre-Mix Stucco - End of Test –Tube Full

Building Pines B-1 Bldg. 2 Unit 2110 Rilem test over new BMI stucco-tube is full at end of test.

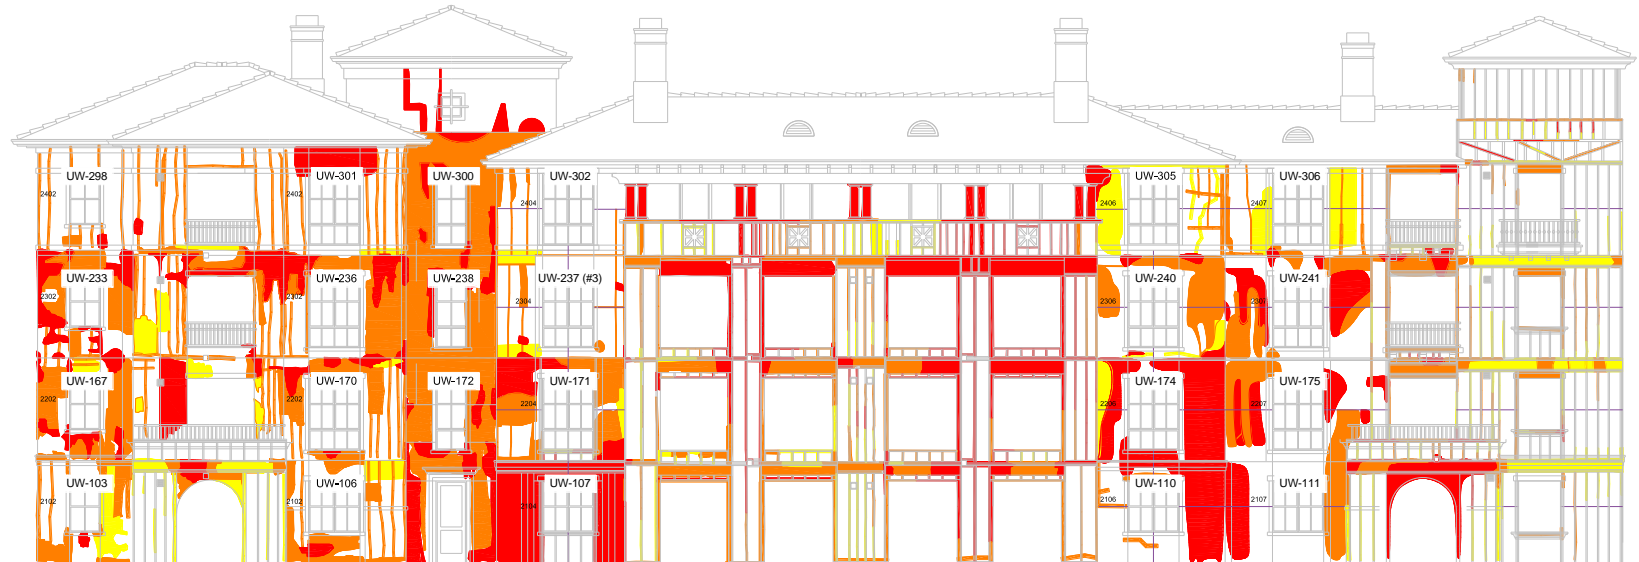
# Damage - San Jose Apartment West Elevation

<span style="background-color: yellow; border: 1px solid black; display: inline-block; width: 20px; height: 10px;"></span>	Slight:	Water Stains
<span style="background-color: orange; border: 1px solid black; display: inline-block; width: 20px; height: 10px;"></span>	Moderate:	High Moisture Content
<span style="background-color: red; border: 1px solid black; display: inline-block; width: 20px; height: 10px;"></span>	Severe:	Decay / Rot

~ Cracks  
— Control Joint

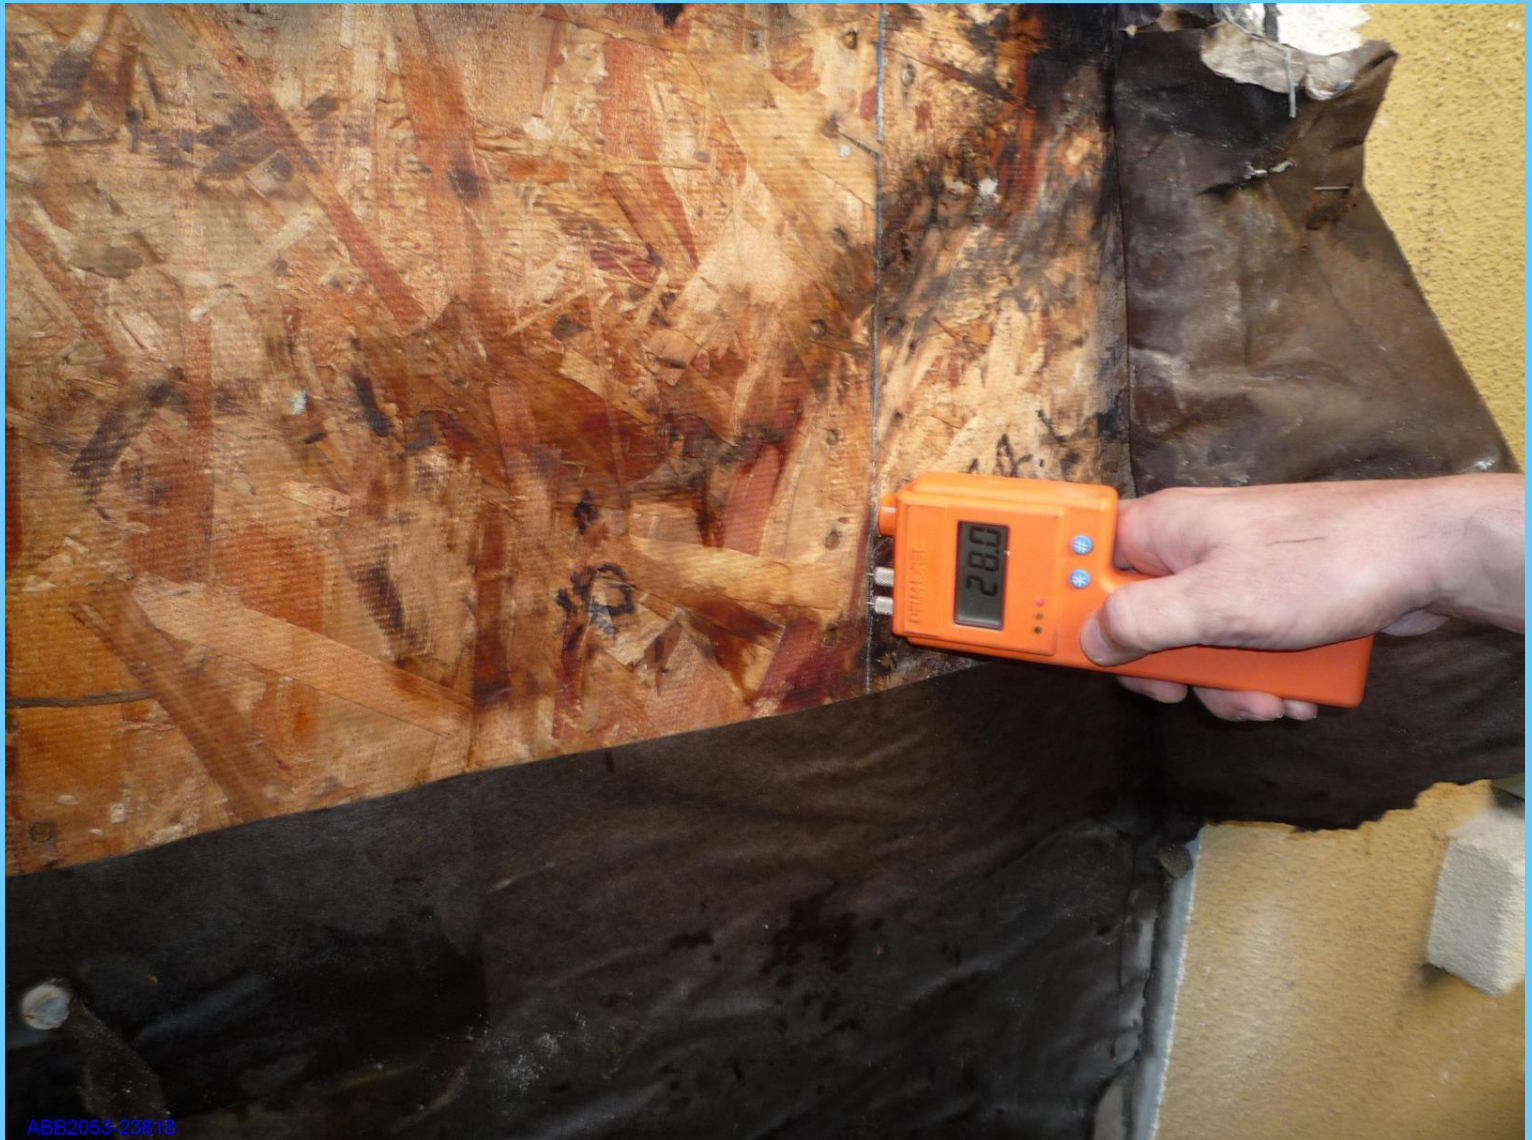
ABB2053-23818

## Damage Ranges From Slight To Severe

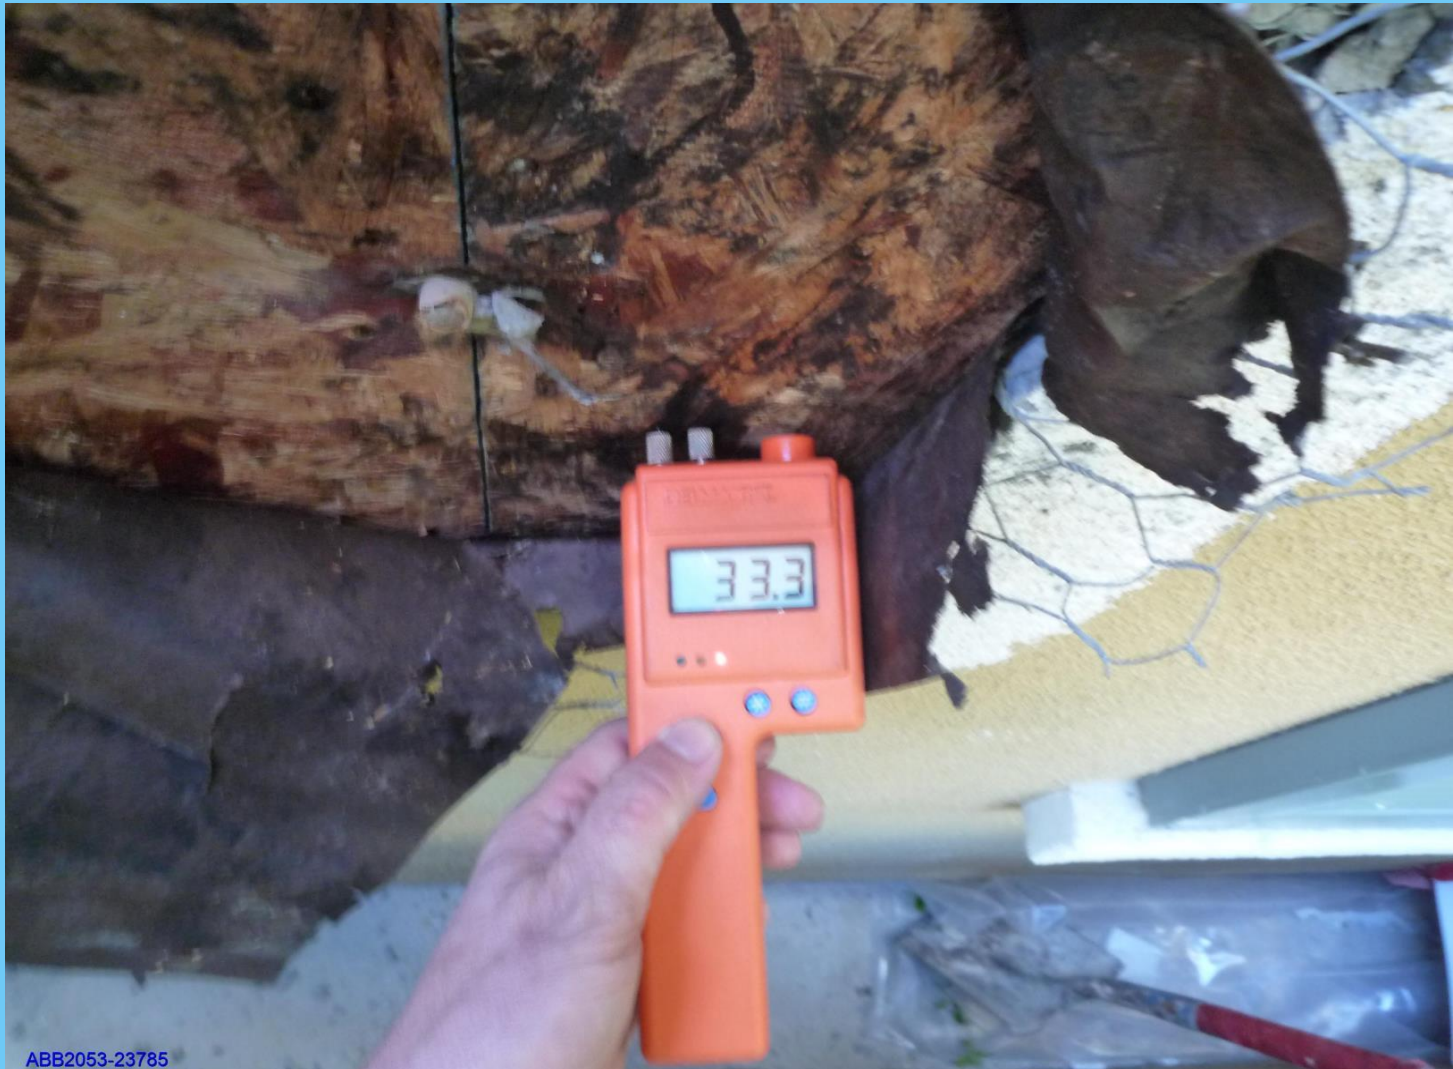
ABB2053-23785

## OSB Damaged State: Severe Damage

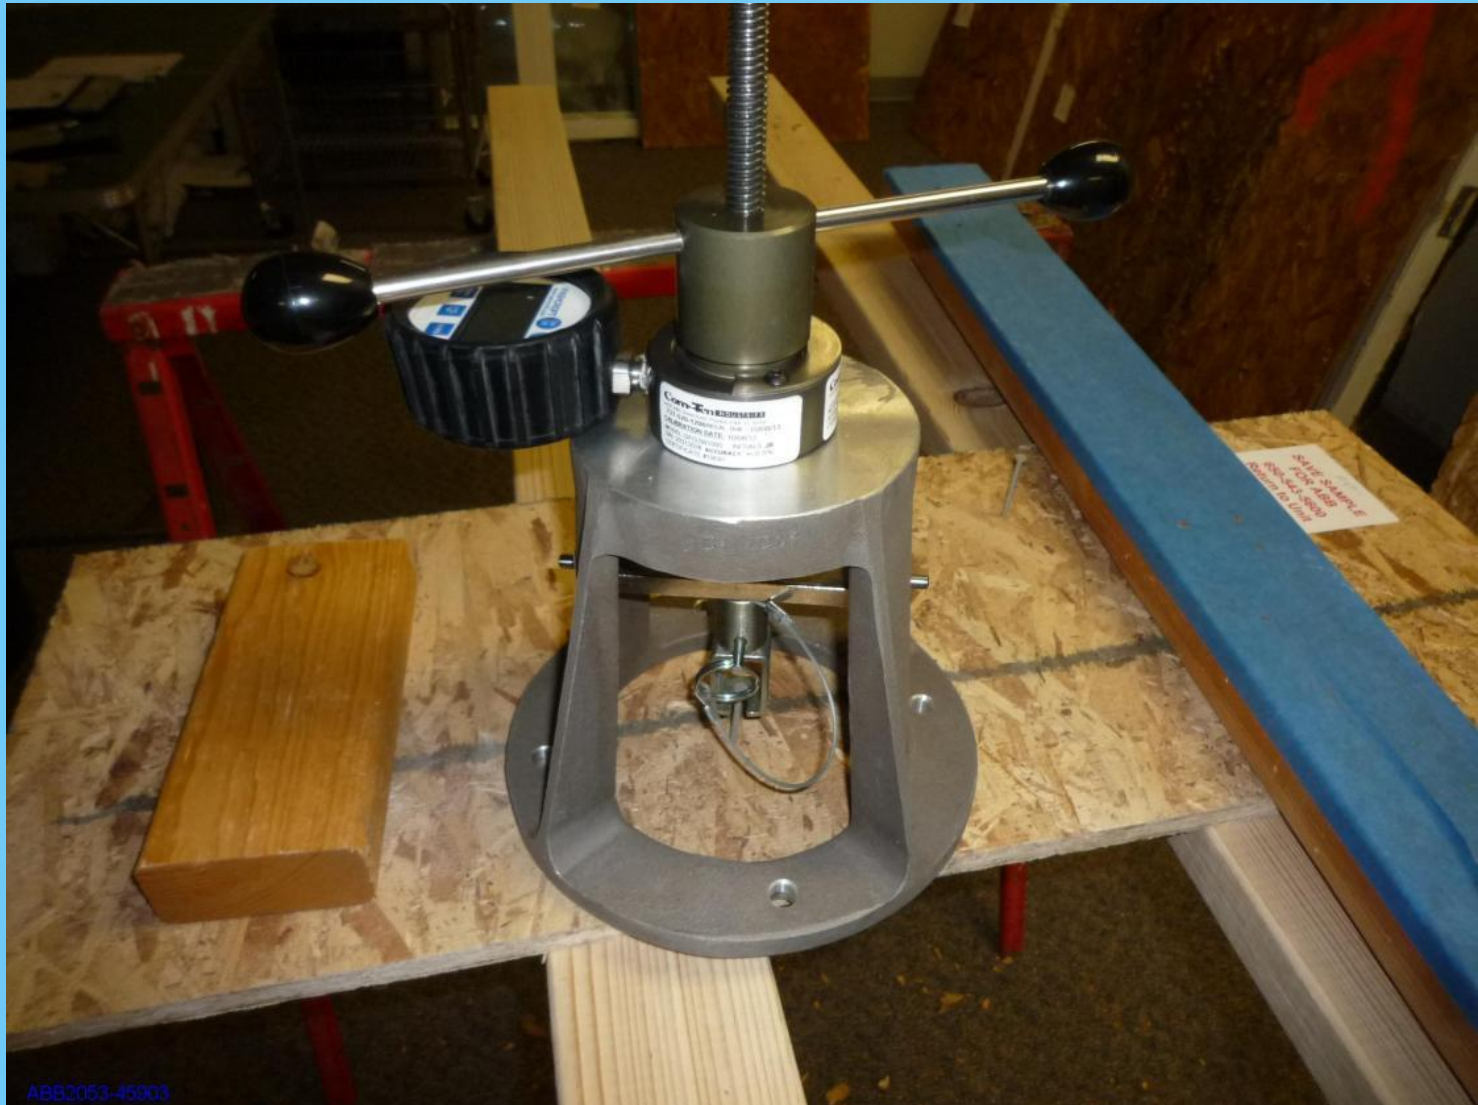
# Nail Pull Through Strength Test: ASTM D1037

- ABBAE performed 5 pull tests of each damage state level of Pines OSB Per ASTM 1037
- A Pull Through Test is an indication of loss of strength and structural integrity

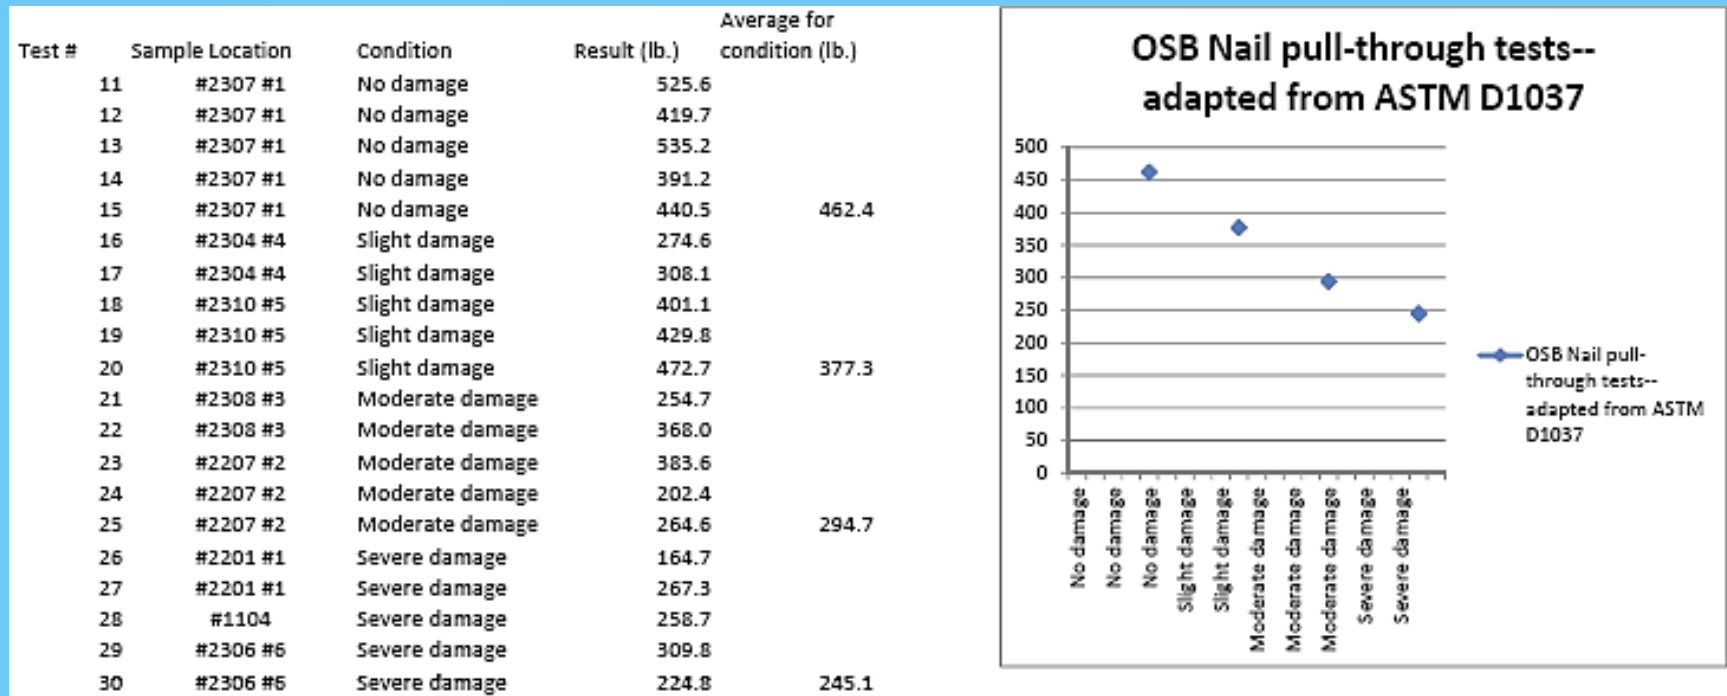
Pull through test results are:

2053: Pines Parcel B-1, Tests Performed by Dennis Wobber 10/9/2012

OSB Nail pull-through tests--adapted from ASTM D1037

Water Damaged Panels significantly lose structural strength:

Slight Damage	19% less nail pull out strength
Moderate Damage	36% less
Severe Damage	46-100% less

In shear tests, panels typically fail from edge nail pull out or panel tear-through.

The above results show the projected approximate loss of shear values for each damage level.

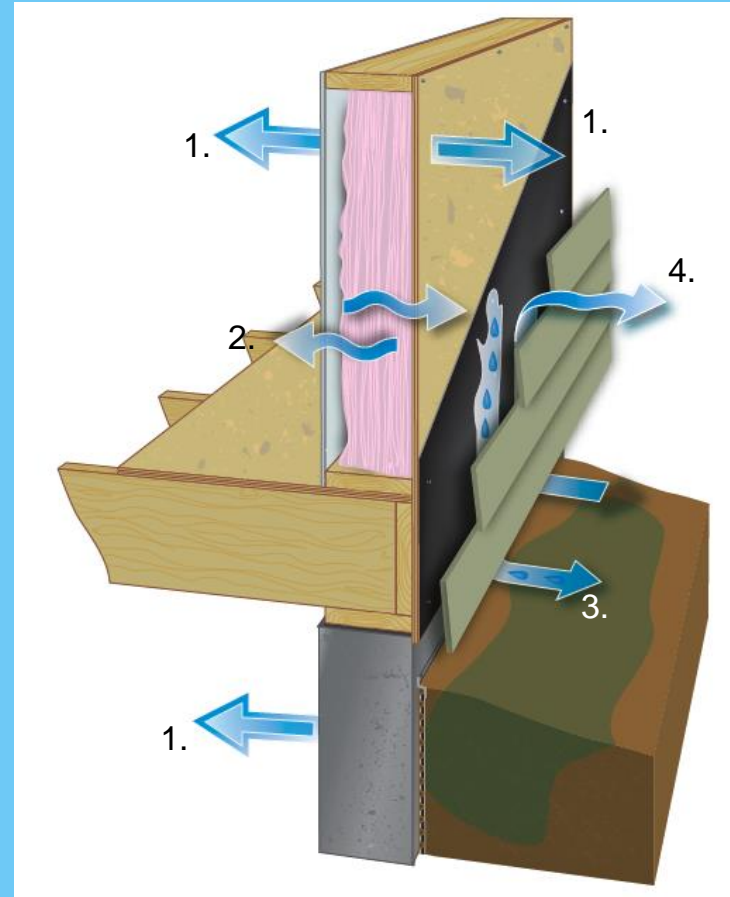
# Wall Drying Mechanisms

1. Surface Evaporation
2. Diffusion / Convection
3. Drainage
4. Air Exchange (Ventilation)
