CURTAIN WALL ISSUES, PROBLEMS, AND SOLUTIONS

Karim P. Allana, PE, RRC, RWC

RCI, INC., 2012 Symposium on Building Envelope Technology

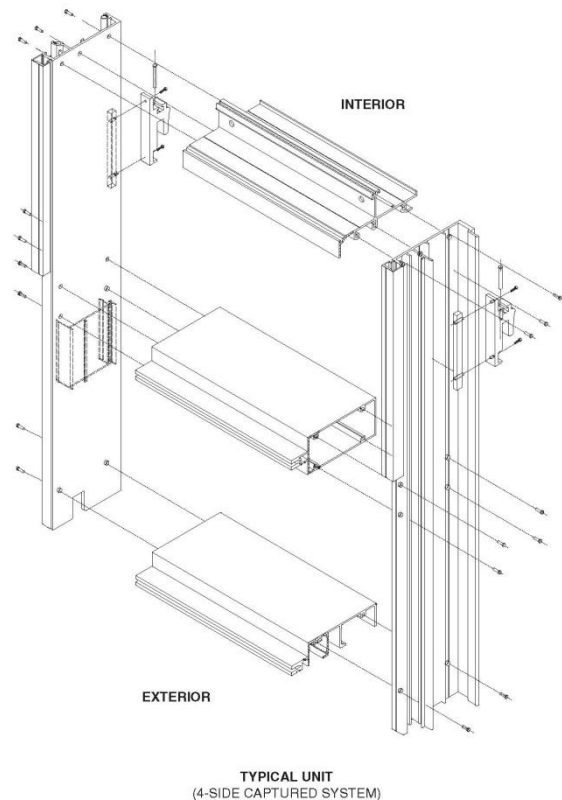
Figure 1. Exploded view of curtain wall components.

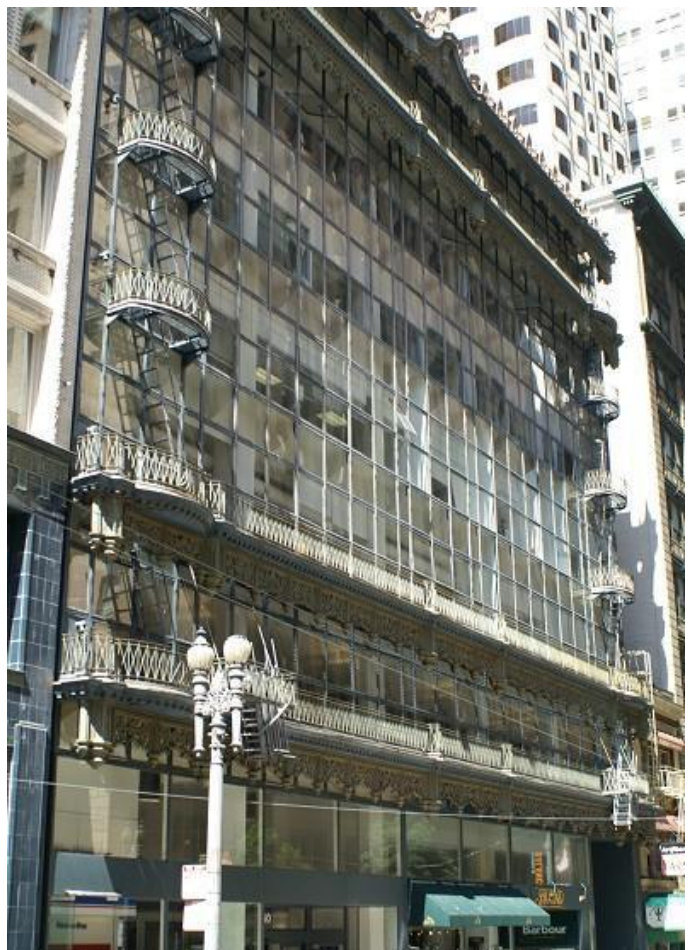
Figure 3. Hallidie Building, San Francisco, California.

(See Figure 3.) Note the steel mullions (vertical members) and other support members. Glass was typically held in place with clips and weather proofed with glazing compound.

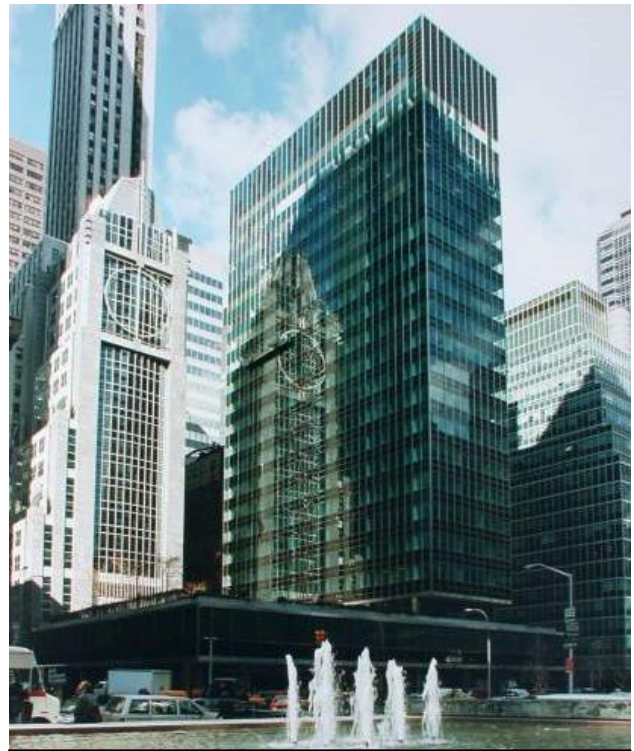
Figure 4. Lever House, New York City.

The first curtain wall installed in New York City, in the Lever House building (Skidmore, Owings and Merrill, 1952), was a major innovation in the extensive use of steel mullions. (See Figure 4.)

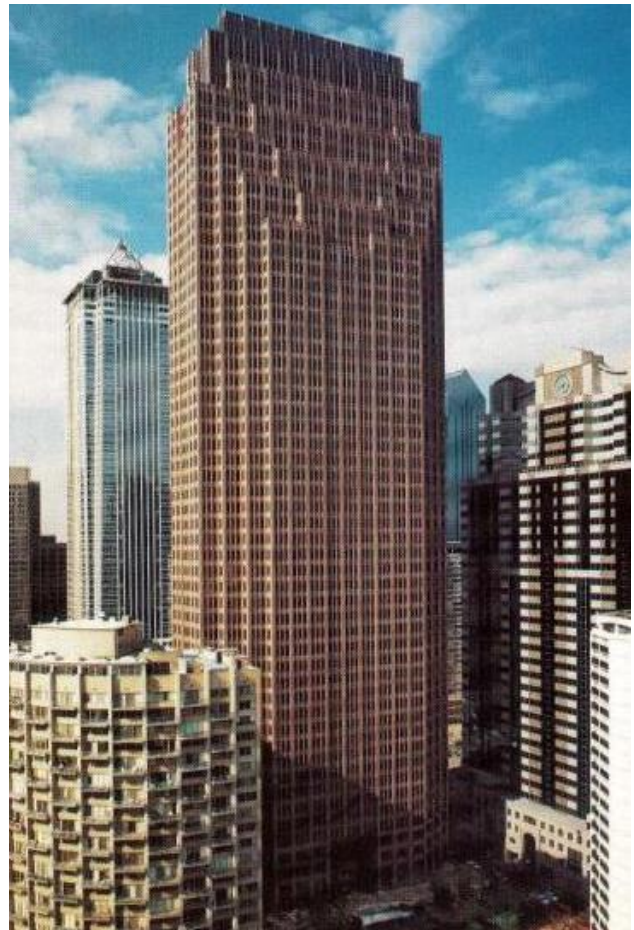
Figure 5. Bell Atlantic Tower, Philadelphia, PA.

Figure 5 depicts the Bell Atlantic Tower in Philadelphia, clad in glass and 65% granite. The stone for this 500,000 SF curtain wall was quarried in Sweden, then shipped in blocks to Italy where it was fabricated into 3cm thick infill panels having polished, honed and flamed finishes. The granite panels were then shipped to Miami, installed into 10,500 unitized panels and, by flatbed trailers, shipped to Philadelphia where the typical floors 3 through 42 were wrapped in curtain wall at the rate of 2 floors per week.

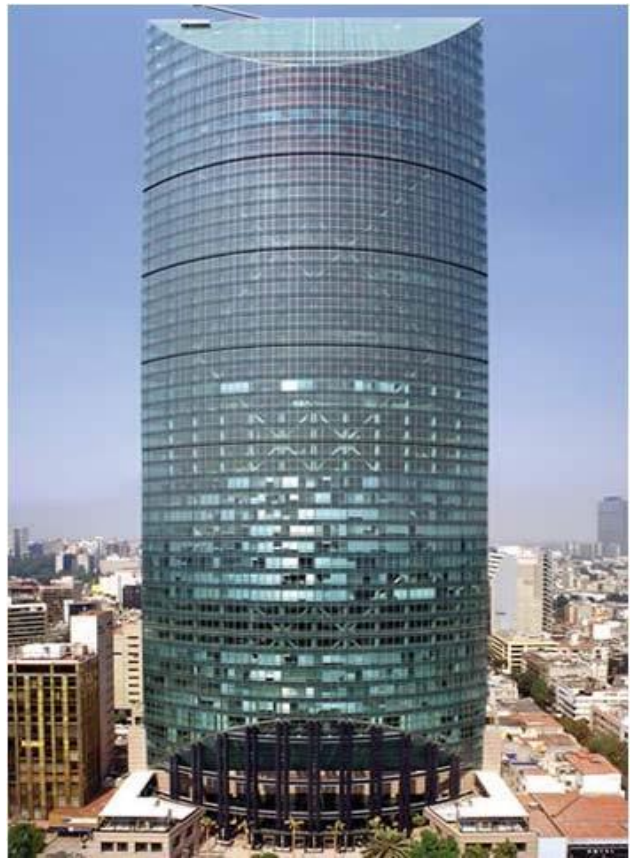
Figure 6. Torre Mayor Building, Mexico City.

Two other unique examples of curtain wall are the Torre Mayor Building in Mexico City, and The Espirito Santo Plaza, an office building in Miami. The first building, shown in Figure 6, measures 738 feet, consisting of 55 stories. Due to Mexico City's location in known earthquake areas, it was designed to withstand an earthquake measuring 9 on the Richter Scale. It was built with 96

hydraulic dampers installed diagonally in the elevator shafts, perpendicular to the diamond or X patterned bracing steel faintly visible through the convex façade in Figure 6. In January 2003, a 7.6 magnitude earthquake shook Mexico City, although the building was not damaged and many occupants were unaware of the quake. This curtain wall provided design challenges due to sloped and reverse slope glazing, and building face curvature achieved with segmented panels.

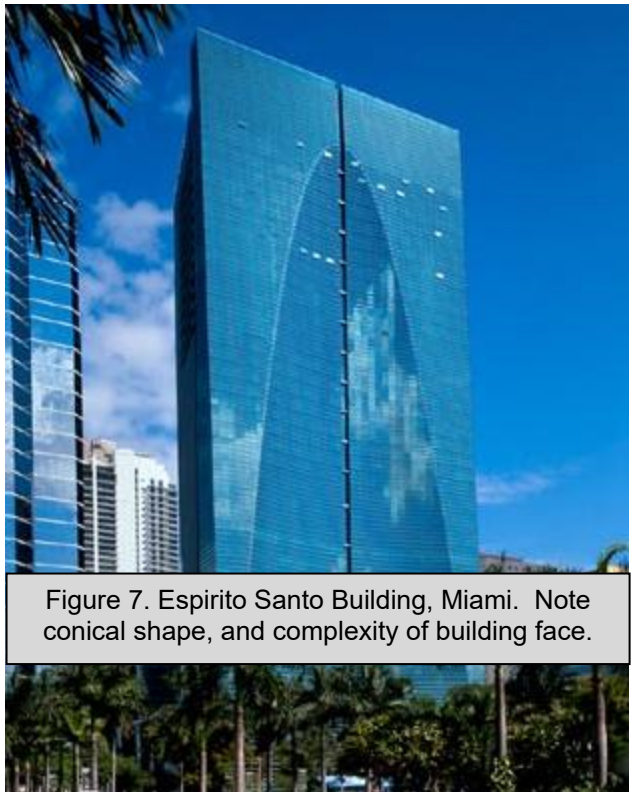
Figure 7 is a photo of the Espirito Santo Building, the 36-story Miami building, the architecture of which is based loosely on the Saint Louis Arch. Design and installation challenges faced in this building also included sloped glazing, the conical façade, hundreds of custom extrusions, a very large number of complicated construction details, thousands of fabrication document sheets, and extensive laboratory testing, including large and small missile impact. Design wind loads for the curtain wall were +140/-180 PSF. The design and construction of this building was aided by 3D modeling.

Figure 7. Espirito Santo Building, Miami. Note conical shape, and complexity of building face.

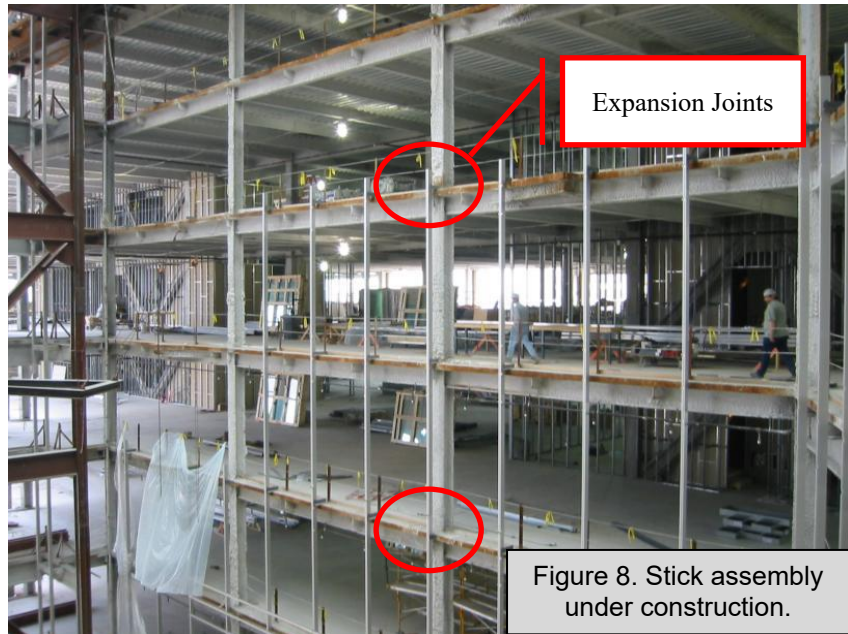
Figure 8. Stick assembly under construction.

The original glass curtain wall structural framing was hot rolled steel sections, erected in piece by piece fashion or in “sticks.” As noted previously, the use of steel sections, highly susceptible to rust, was abandoned in favor of tubular aluminum extrusions. Not only is aluminum “rust proof” it can be easily extruded into more complex shapes than would be possible with steel. The improved weatherability of aluminum, combined with this ability to address complex architectural detailing, has made it the material of choice today.

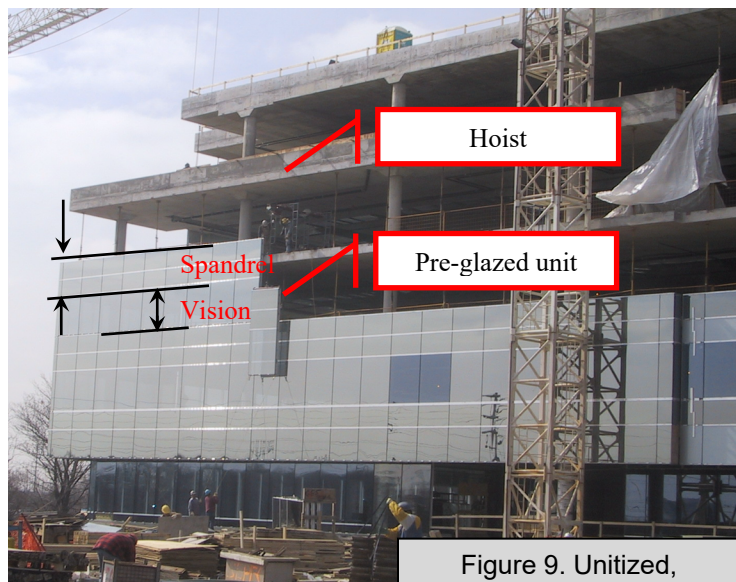
Figure 9. Unitized, modular construction.

Unitized curtain walls are composed of large units that are assembled and glazed in the factory, shipped to the site and erected on the building. Vertical and horizontal mullions of the modules mate together with the adjoining modules. Modules are generally constructed one story tall and one module wide but may incorporate multiple modules. Typical units are five feet wide. Unitized curtain walls can also have the advantages of speed, lower field installation costs, and enhanced quality control within an interior climate controlled fabrication environment. Considerable economic benefits, i.e., lower costs can be realized on larger projects. Appropriate lead time will need to be factored into project timeline as Unitized systems require engineering. Often the additional cost for the engineering is prohibitive to smaller projects and only economically makes sense on larger projects.

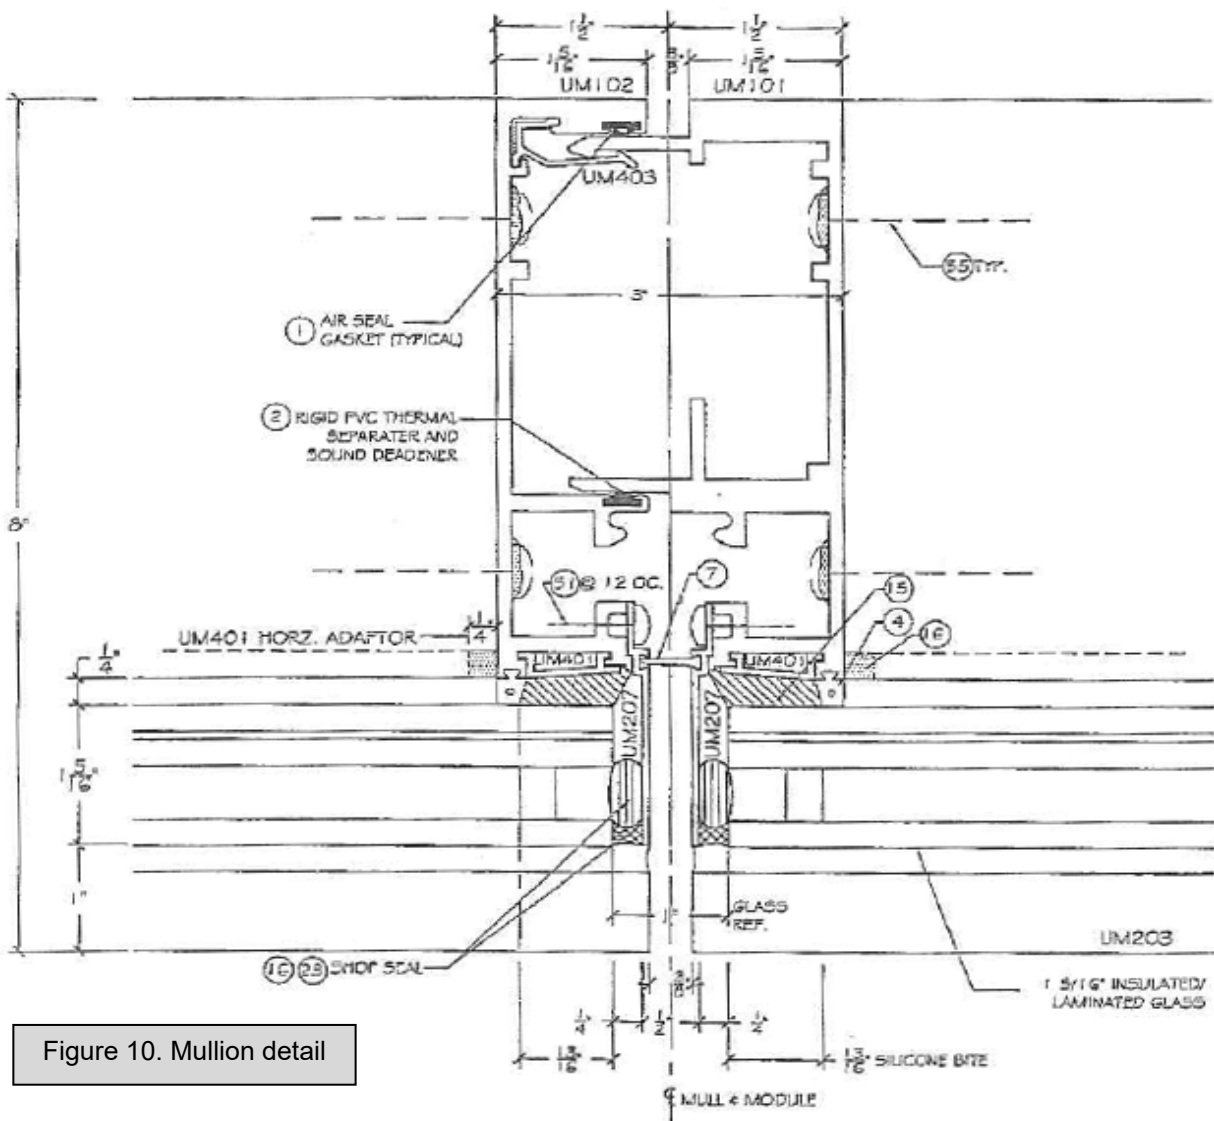
from the wetted surfaces. This is accomplished by incorporating into the design, interior chambers that are vented to the exterior side, thus creating pressure equilibrium between the exterior and the chambers. This design minimizes development of a static water head created during periods of rainfall driven by high winds. (See Figures 10 and 11.)

USE $\pm 13/16"$ TOTAL STACK JOINT MOVEMENT

- Thermal movement, production and erection tolerances, differential floor deflections, and column shortening/long term creep, are all addressed in dimensioning the stack joint, i.e., the joint on each floor where the upper unit is stacked atop the lower unit. (See Figure 11.)
- Seismic displacement is addressed via the tipping motion of adjacent units as the 2 piece male and female mating vertical mullions slide vertically, relative to each other, as the floor above moves left/right relative to the floor below. Using edge blocking in the vertical glazing rabbets, glass to aluminum, enable the units/panels to retain their rectangular shape, and prevents edge of glass contact with the frame. This retention of the glass within the opening is further enhanced if the perimeter of each lite is fully adhered to the frame with structural silicone adhesive. (See Figures 10 and 11.)

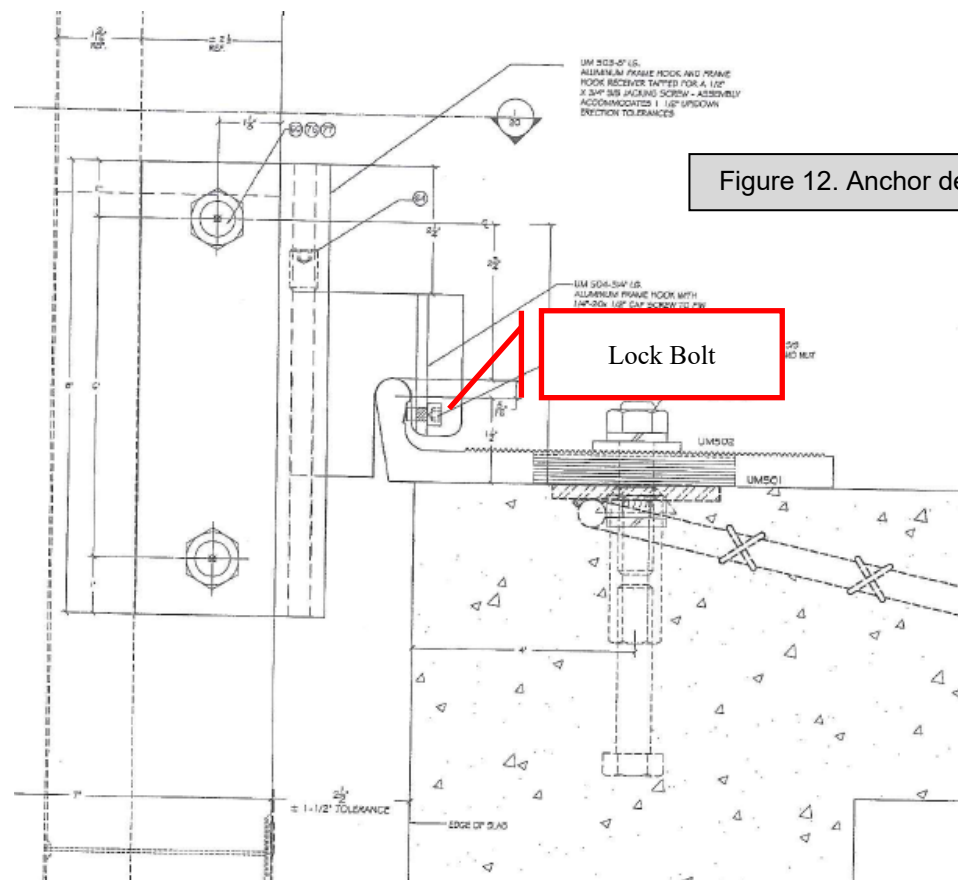
Figure 12. Anchor detail

(Note: This project did not require a pocket on top of slab due to computer flooring, and the slab insert was custom made.)

Typical connections are to the top of a slab cast with a recessed pocket and Halfen embedded inserts. An extruded aluminum or formed steel angle plate, is then bolted to the insert and cantilevered off the slab, toed up, to engage with a mating anchor bolted to each side of the units. The mating frame hook anchors contain jack bolts used to raise the units to the correct elevation. The bottom of each unit nests within the head of the lower unit and a lock-bolt is used so the units do not “walk” post-installation. In all applications, stick or unitized, curtain walls must be cantilevered outboard of the slab to allow room for AISC or ACI tolerances for steel and concrete erection, plus differences in as built floor registration, one above the next. To accommodate this build up of clearances, it is not uncommon to design clearances from the back of mullion to face of slab of 2.5 inch, +/-1.5 inch. (See Figure 12.)

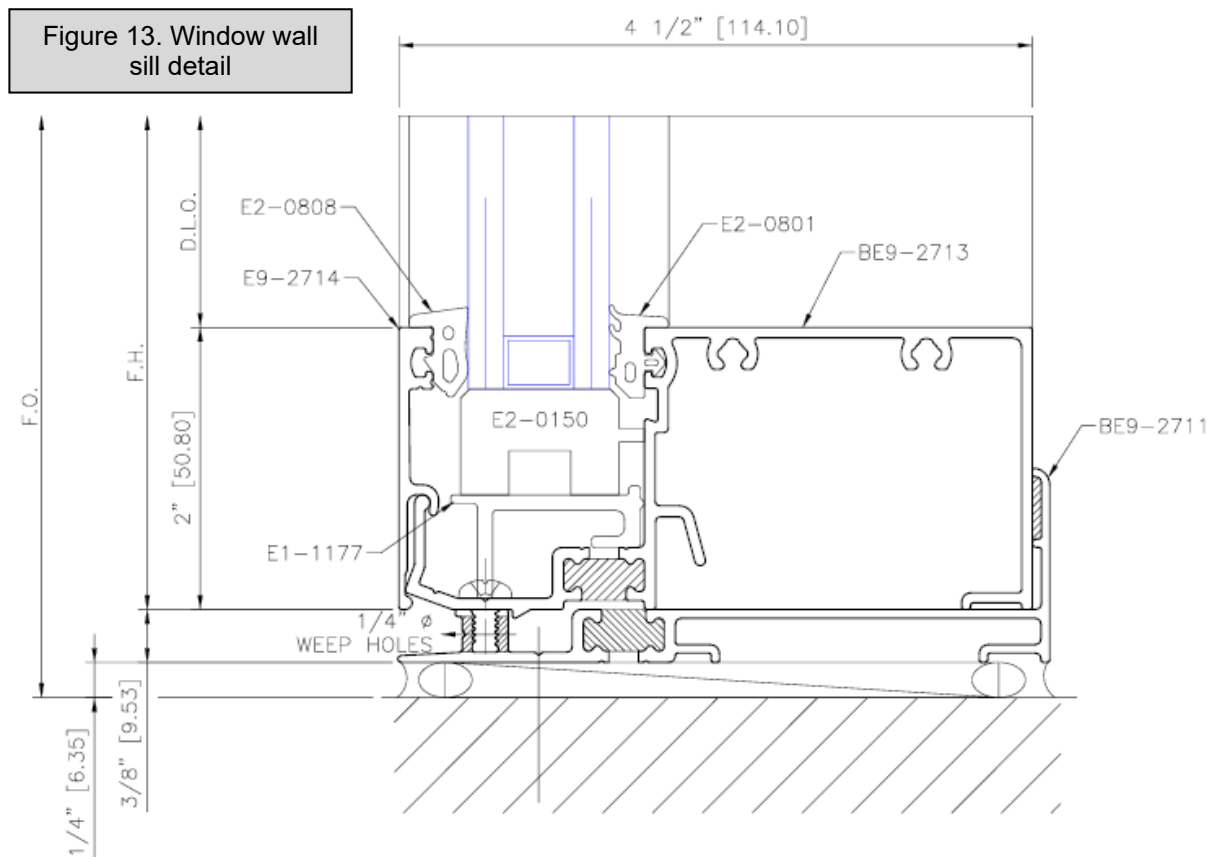
This horizontal ribbon of fixed or operable windows is always connected between slabs or other construction such as stud framing, CMU, pre-cast or GFRC. The wind load transfer occurs at each end of the vertical mullions and jambs with the dead load transferred at the sill. Industry best practice dictates the use of continuous sill flashing or extruded sill starters/sill cans, the latter of which not only provides access to seal the fastener penetrations, but also mechanically locks the frame sills to resist wind loads. Depending on the height of the window wall, an extruded head receptor/head can be required as a means of anchorage, also allowing vertical/lateral movements. In all cases the window wall head condition and jamb condition require proper integration with surrounding waterproofing. Figure 13 depicts a typical window wall sill.

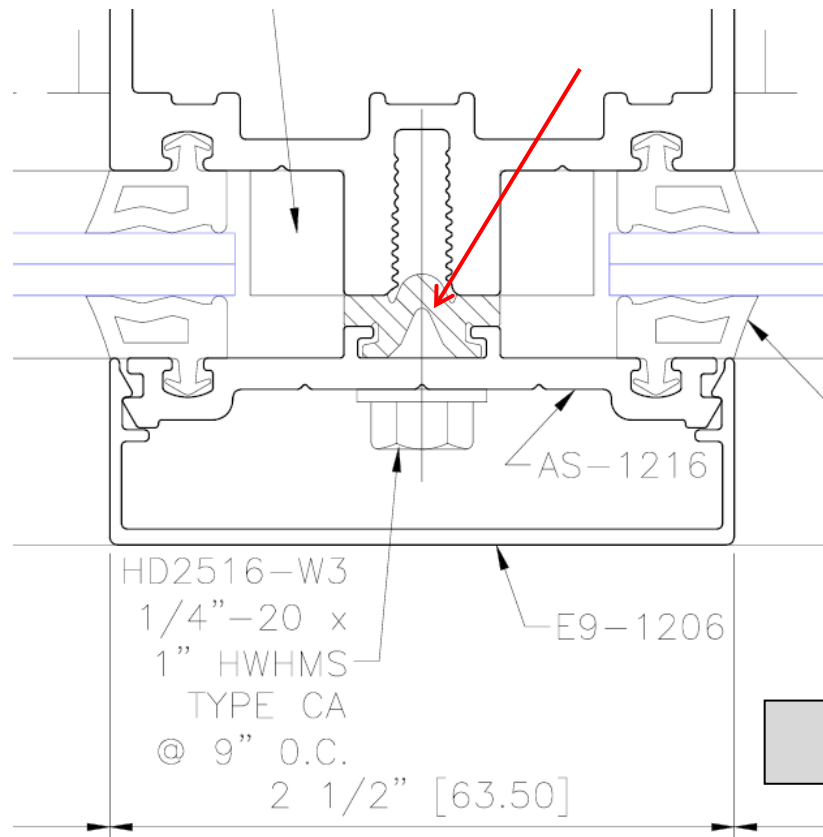
Figure 14. Thermal separator detail

- Thermal Separators Such as PVC or Elastomeric Gaskets (See Figure 14.)
- Poured and De-bridged Polyurethane Thermal Breaks (See Figure 15.)
- Glass Reinforced Polyamide Thermal Breaks (See Figure 16.)
- Structural Silicone Glazing (SSG) 2-side or 4-side (See Figure 17.)

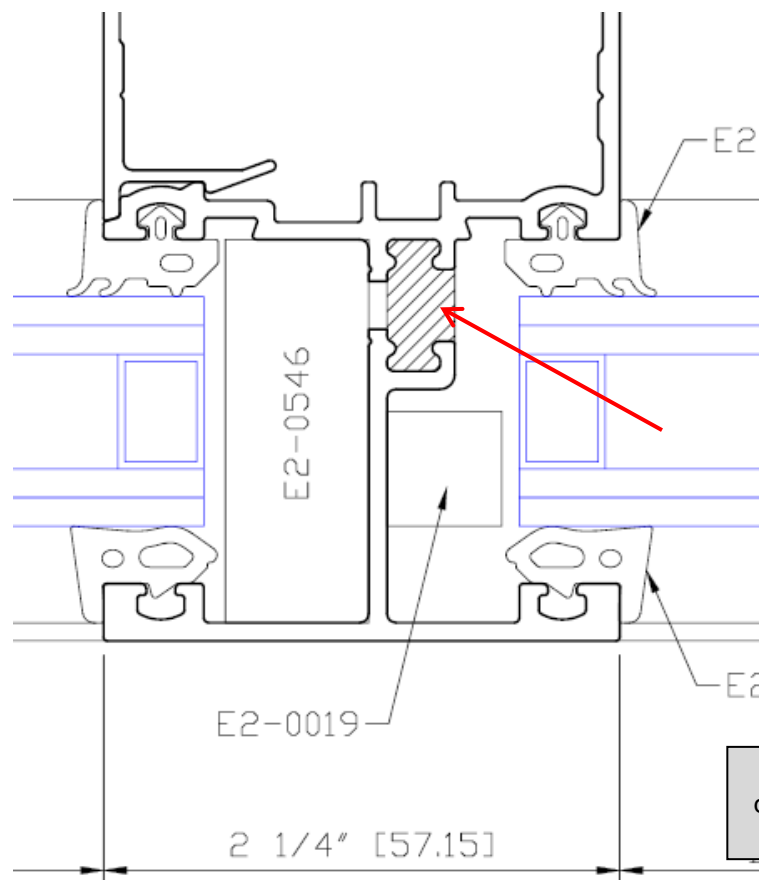
Figure 15. Poured and de-bridged polyurethane thermal breaks detail

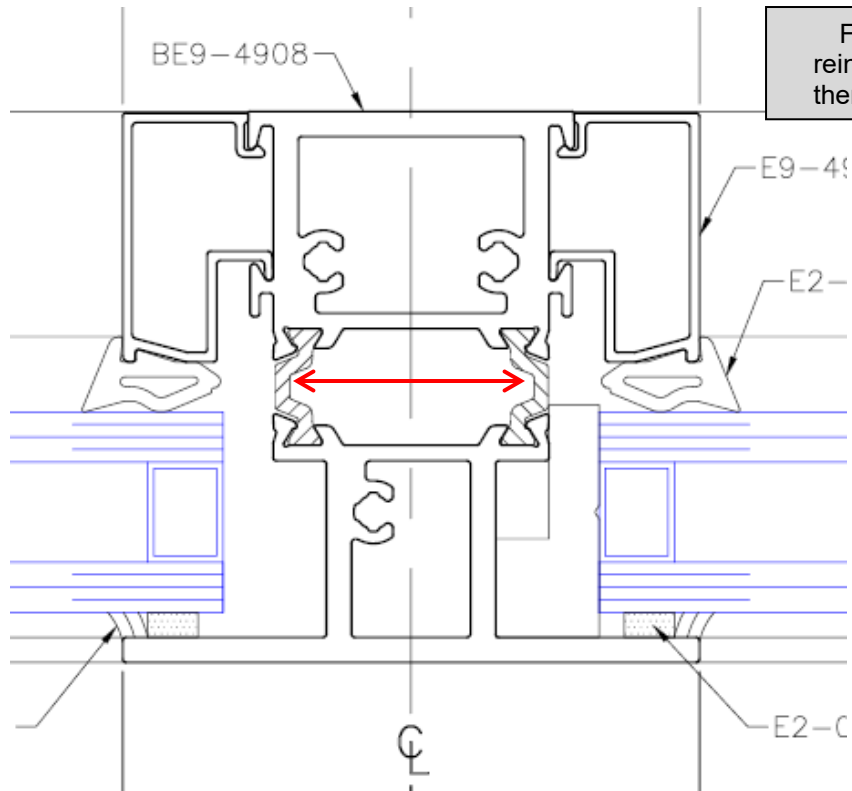
Figure 16. Glass reinforced polyamide thermal breaks detail

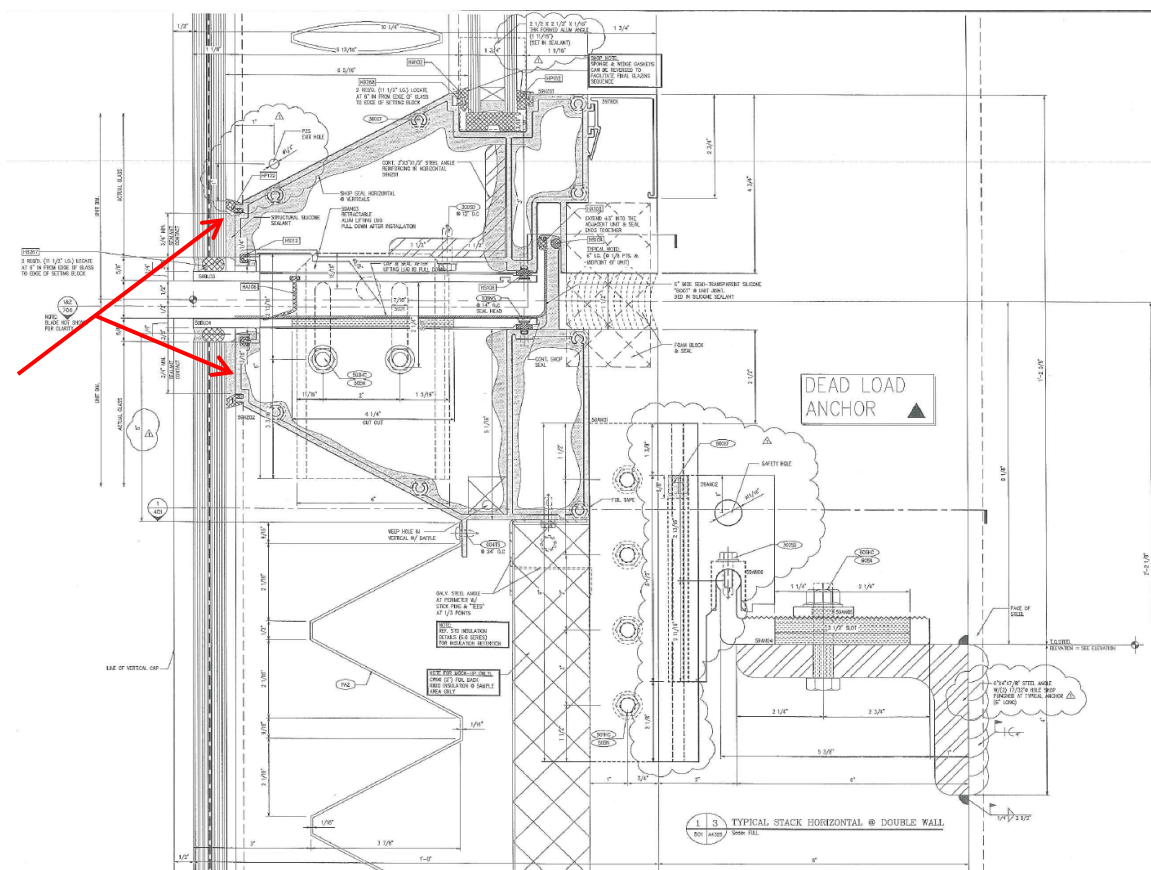
Figure 17. Structural silicone glazing (SSG) detail

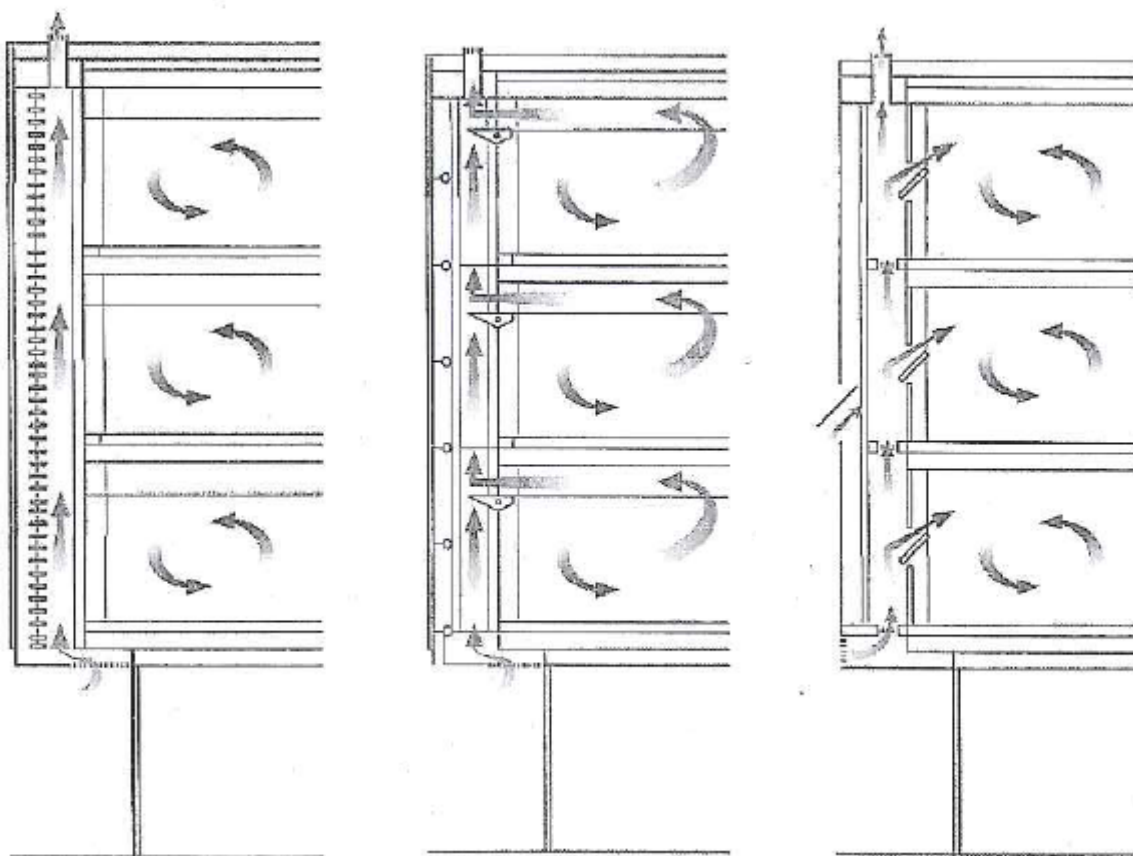
Figure 18. Double skin façade (DFS) – buffer facade; extract air facade; twin face facade

- Double Skin Façade (DFS) (See Figure 18.)
- Shading Devices (See Figure 19.)

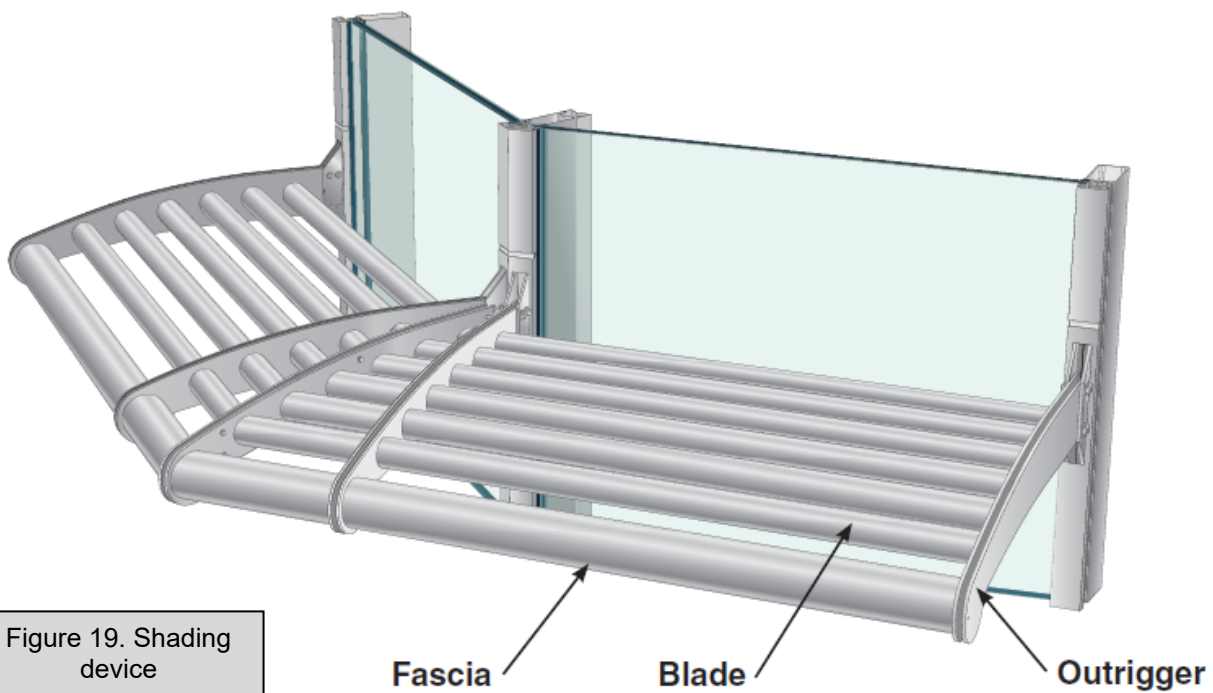
Figure 19. Shading device

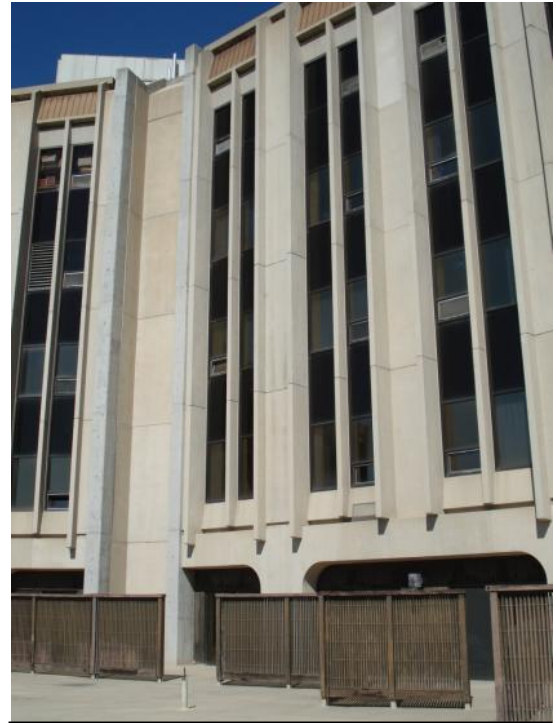
The linear coefficient of thermal expansion of aluminum is double that of concrete. Narrow vertical aluminum strip windows were installed 4 floors high between pre-cast concrete panels, see Figure 20. The sealant at the window jambs failed and caused water infiltration.

Figure 20. Sealants failure between precast / curtain wall

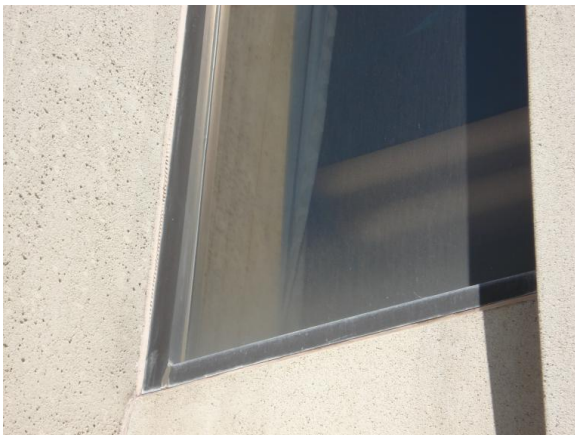
The sealant joint at the window jambs was not designed wide enough to accommodate the resulting shear forces from differential thermal movement. (See Figure 21.) These joints were even too narrow to preclude replacing the existing sealant with one having twice the extension capacity of the original.

Figure 21. Sealant joint width too narrow to handle shear in sealant

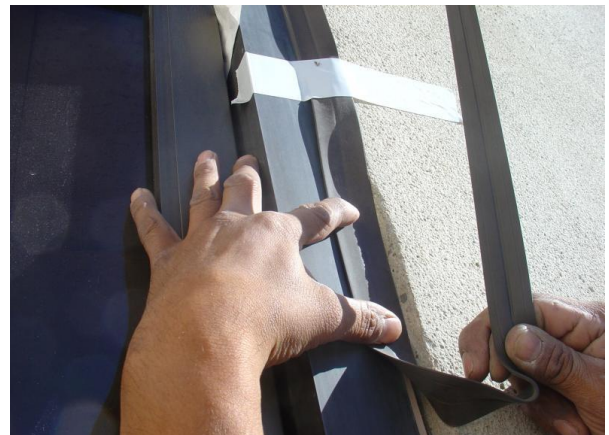
Figure 22. Pre-cured sealant can handle 200% extension

The most cost effective remedy to this leaking problem was to overlay the failed sealant with pre-cured silicone having at least four times the extension capacity of the original sealant. (See Figure 22.) One half inch of each edge of the pre-cured silicone was adhered to the aluminum and concrete with silicone sealant.

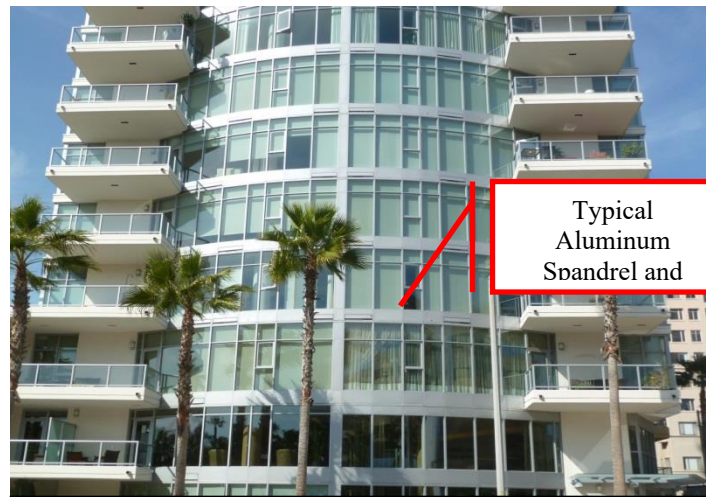
The segmented (chorded in plan) window wall was unitized and installed from the building interior. (See Figure 23.) Like all window walls, it was anchored between other construction – floor slabs in this case – but the bottom 8 to 10 inches were notched vertically to permit the remaining 2.5 inch exterior portion to bypass the face of slab, terminating with a sealant joint against the outboard cantilevered head receptor of the window wall on the floor below. (See Figure 24.)

Figure 23. Segmented window wall

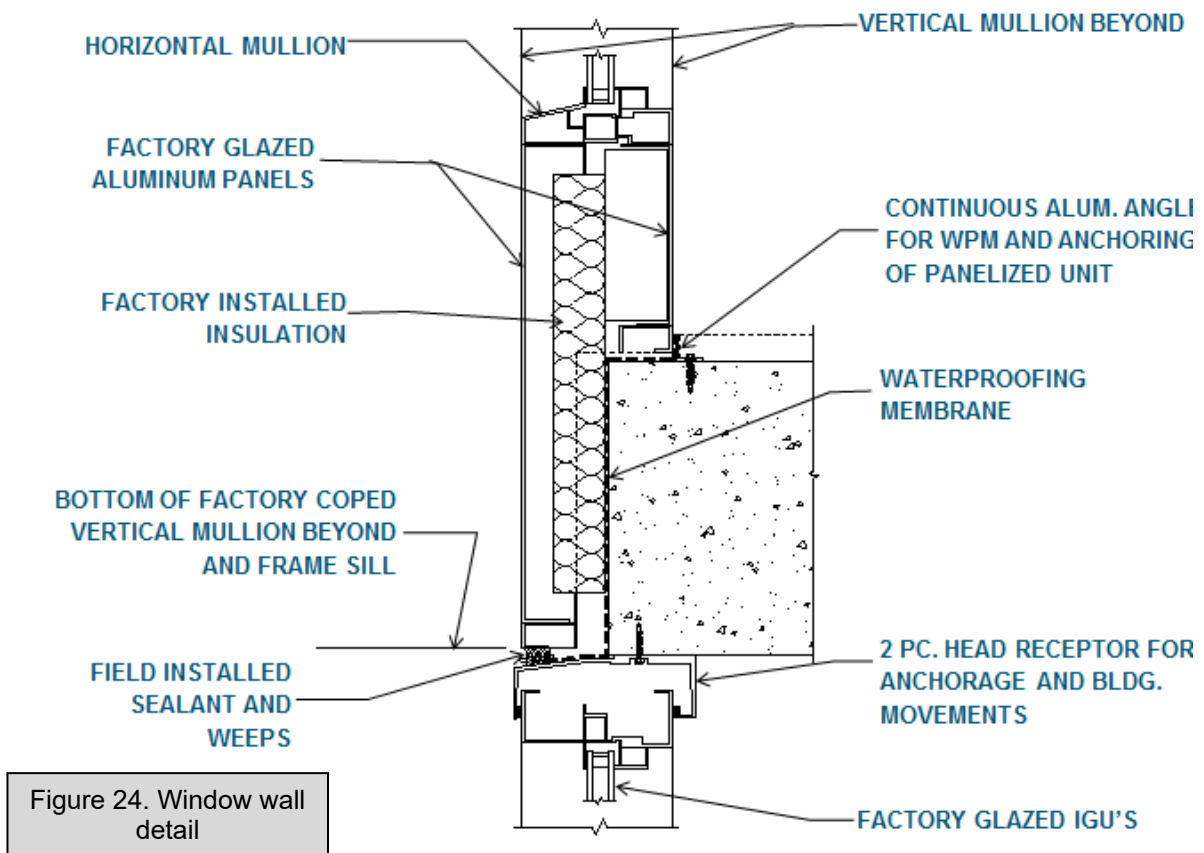
Figure 24. Window wall detail

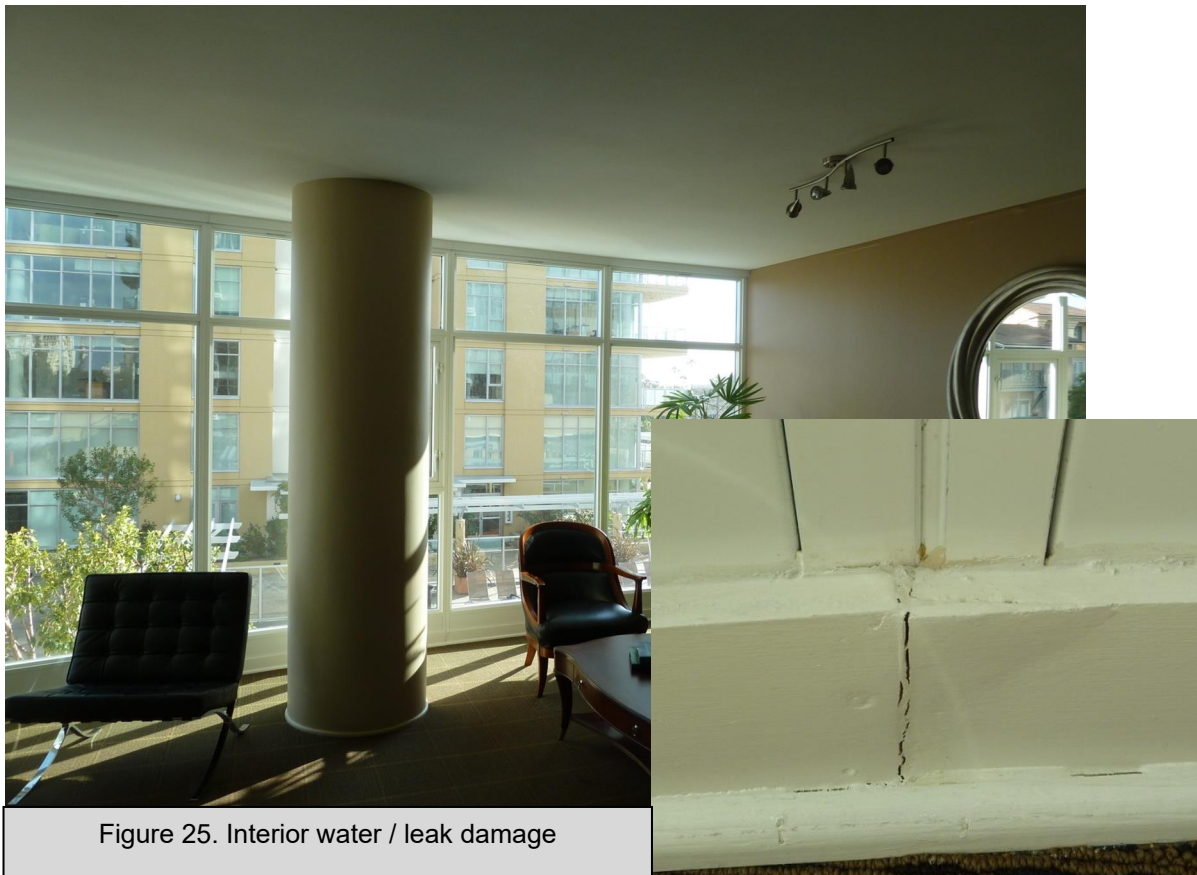
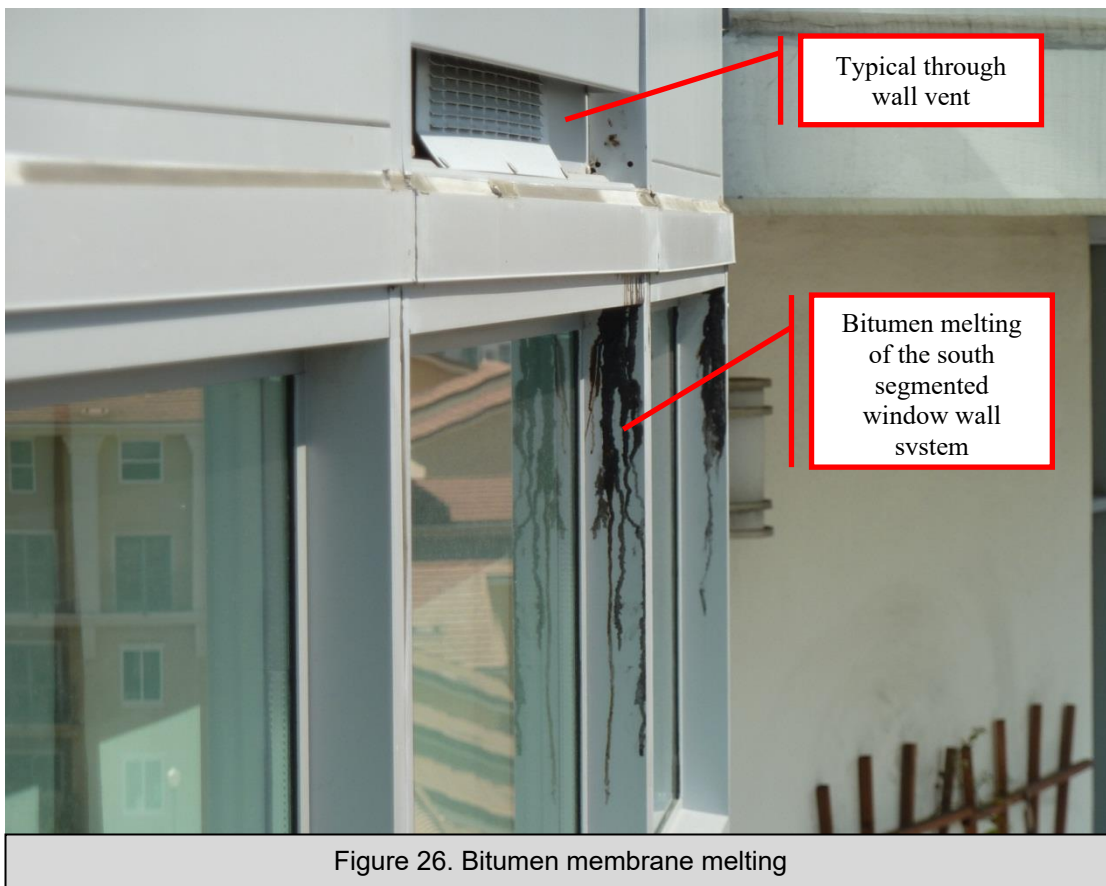
Evidence of water penetration (see Figure 25) was subsequently proven to occur by ASTM E 1105 water testing. The most difficult problem to remedy was the on-going slow dissolving of the bitumen contained in the waterproofing membrane. (See Figures 26 and 27.) This problem was traced to chemical incompatibility between the waterproofing membrane and lap sealants / head receptor perimeter sealant. Due to the overlapping, shingle design of the window wall above and outboard the membrane (refer back to Figure 24) the only remediation possible is to demolish and replace the entire window wall and membrane.

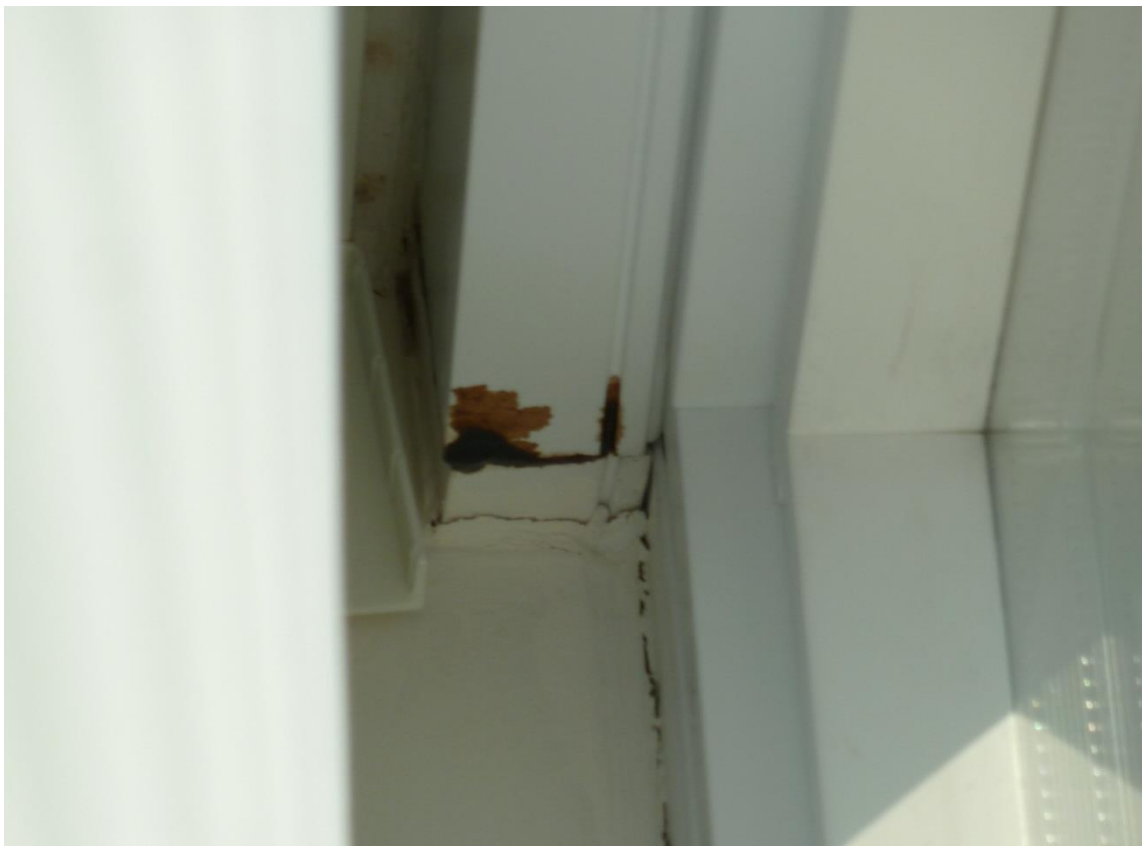
Figure 27. Interior stains from melting bitumen
