# **PERFORMANCE OF WEATHER RESISTANT BARRIERS IN STUCCO ASSEMBLY**

Karim Allana, PE, RRC, RWC

2016 Symposium on Building Envelope Technology  
October 17-18, 2016 - Houston, Texas

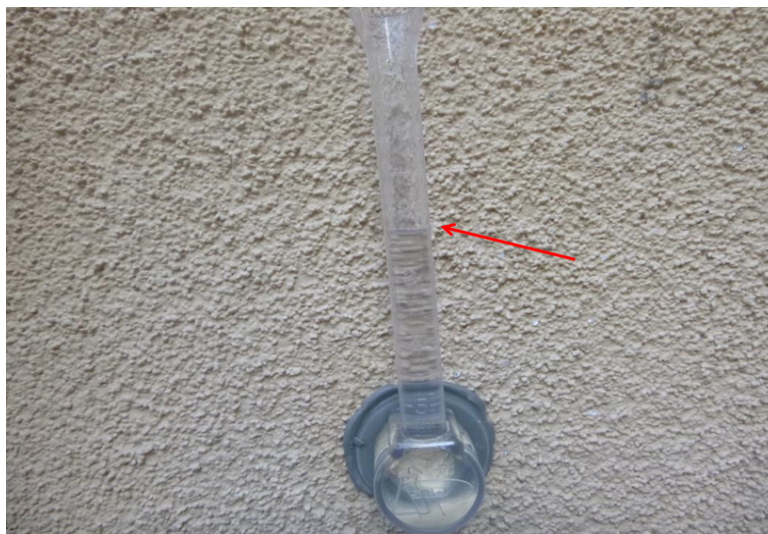
Figure 5: Rilem Tube Level Dropped in 15 Minutes

Therefore, as we have become more energy efficient using wall insulation, and impermeable moisture barriers that reduce air and water movement, we have also created a new set of problems – how to remove moisture that becomes trapped within a wall cavity. Rilem Tubes (Figure 5) enable the assessment of water absorption properties of walls or other substrates. Higher absorption of the cement plaster or cement board type siding can greatly increase the moisture permeation through the wall.

While there is no clear standard for absorption testing with a Rilem tube for many cladding materials, it does provide a great relative scale to measure absorption. In cement plaster assemblies, we find that absorption rates can vary greatly in a 20-minute test, ranging from 0" loss to several inches. In many cases, we found that a traditional moisture drained assembly without a drain mat or rainscreen, (more porous assemblies) results in greater and uniform damage to the substrate and higher interior humidity levels. Electronic moisture measurement devices that rely on transduction to measure the change in conductivity are used to measure moisture content of softer assemblies such as gypsum or wood sheathing. Levels of moisture in plywood sheathing can vary from exterior face of the plywood/OSB to interior face of plywood/OSB depending on the cycle of wetting and drying. The amount of moisture in a building sheathing or wall cavity will vary with airflow, exterior and interior humidity and temperature. Moisture meters, either surface or pin-type, are only qualitative measurement devices, measuring specific relative moisture levels, and not the relative humidity within an environment.

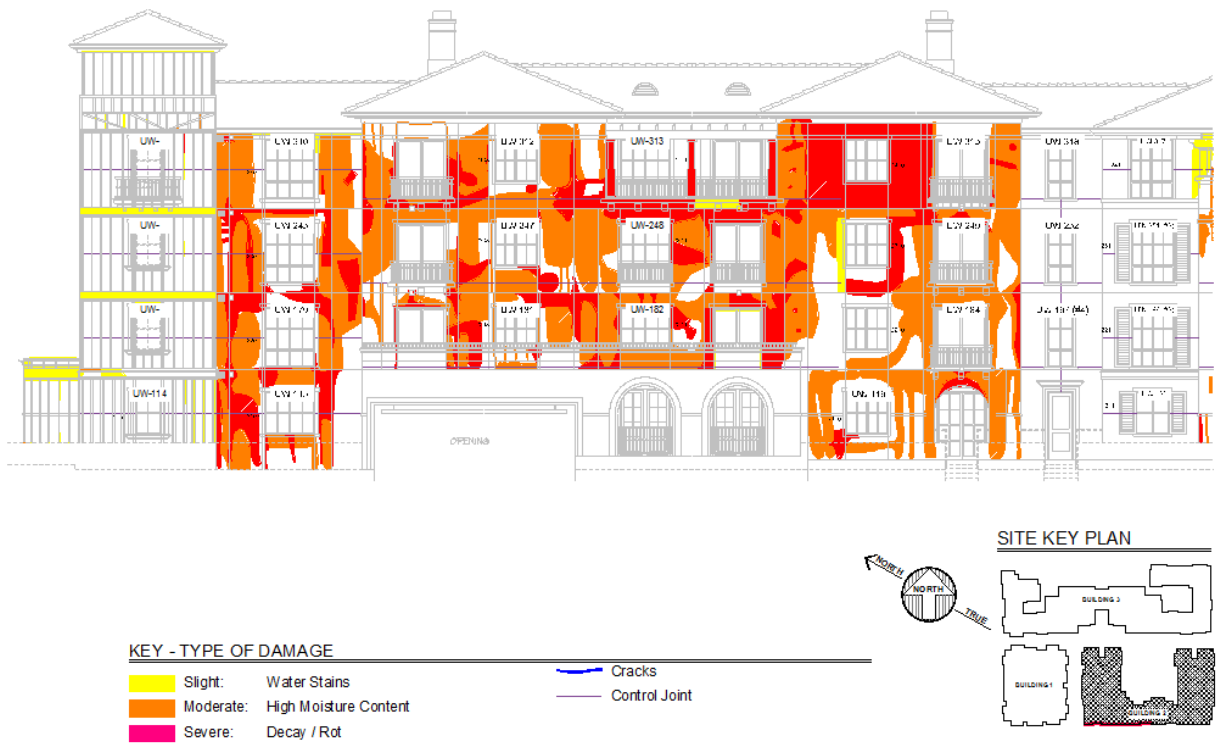
Figure 6A: Damage – South Elevation – Partial

We had the opportunity to conduct an extensive study of dozens of large multi-family buildings and some large single-family homes with traditional building paper and either cement board siding or stucco. In both, siding types of assembly and stucco assembly, the siding/stucco was completely removed to expose the condition of the OSB or plywood or gypsum sheathing. While some of the damage to the sheathing was definitely due to leaks from wall penetrations or improperly flashed horizontal waterproofing systems, we surprisingly documented a lot of moisture movement and damage due to moisture soaking through the building paper and damaging the wood sheathing (Figures 6A and 6B).

Depending on the elevation, we observed and documented damage to the wood sheathing and graphed it visually to depict damage. We realized that other than poking the sheathing with an awl, most experts were not using any scientific means for analyzing the damage to the sheathing. Surprisingly, even though the sheathing was discolored due to different levels of water damage, slight, moderate and some severe areas passed the “awl” poke test.

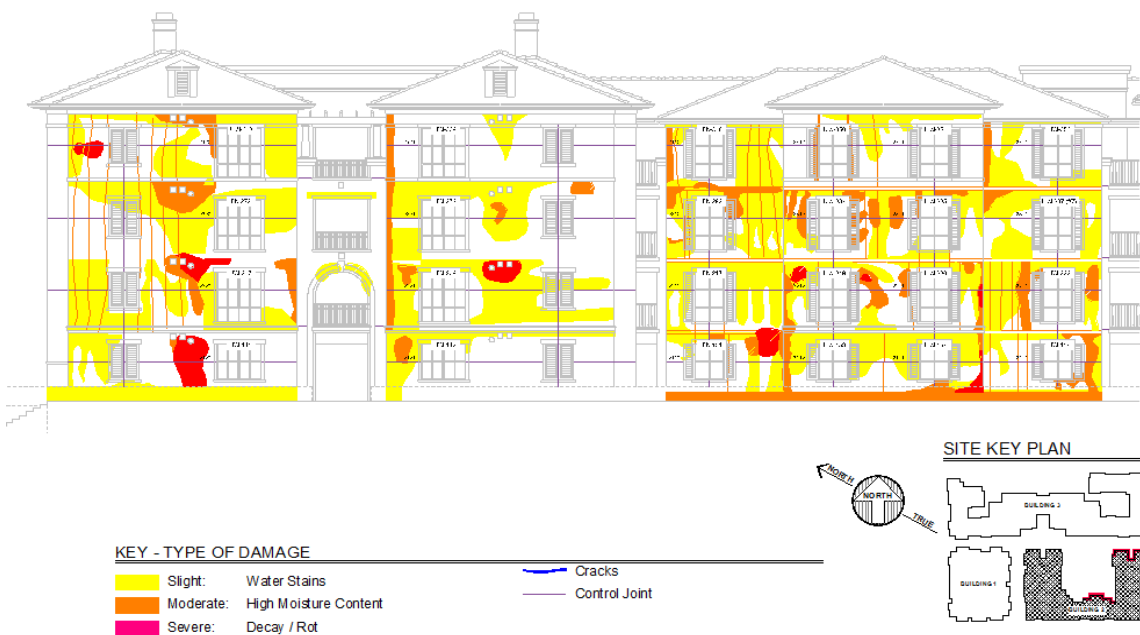
Figure 6B: North Elevation - Partial

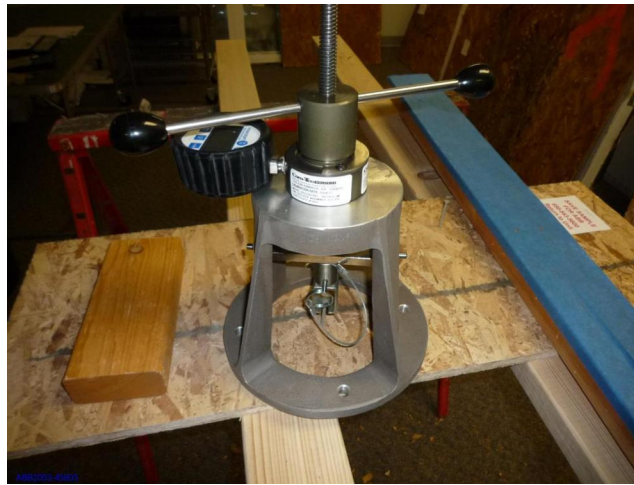
Figure 6C: ASTM D-1037 Nail Pull Tests – Loss of Strength

To make the assessment process more scientific, we went on to create a testing protocol using ASTM D1037, which is a nail pull through test (Figure 6C). The nail pull through tests were more telling and representative of loss of structural value such as shear value. These types of tests can provide a detailed profile of force exerted over time and gives a more realistic assessment of the loss in structural capacity (Figure 6D). Using the standard measurements, we were able to demonstrate a significant difference in nail pull out strength between slight, moderate and severely damaged areas.

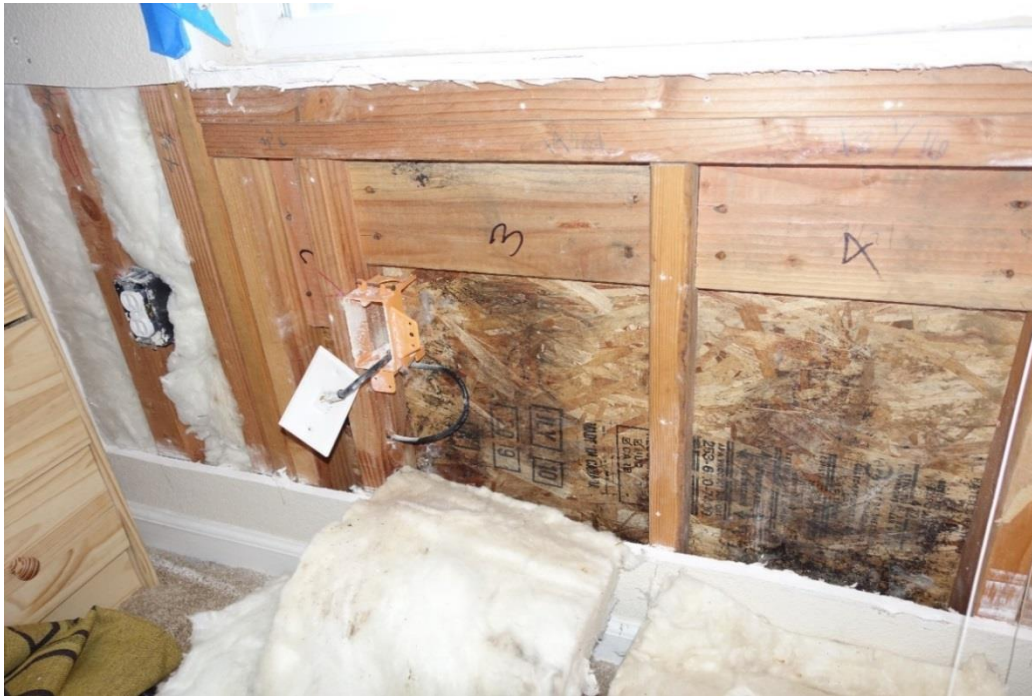
Figure 8: Uniform Damage Behind Fiber Cement Siding

Tightly fastened horizontal control joints, expansion joints or reveals create water cut-offs and water tends to collect above them. Generally, we see fastener rusting and moderate to severe damage both above and below horizontal control/reveal joints. Unsealed joints in control, expansion and reveal joints as well as screeds and corners can be a source of unintended water on WRB. Applying flexible flashings behind these joints, reveals and screeds, both on the horizontal and vertical helps mitigate some of the damage. Examples of this type of assembly and the results of damage are in Figures 7 and 8.

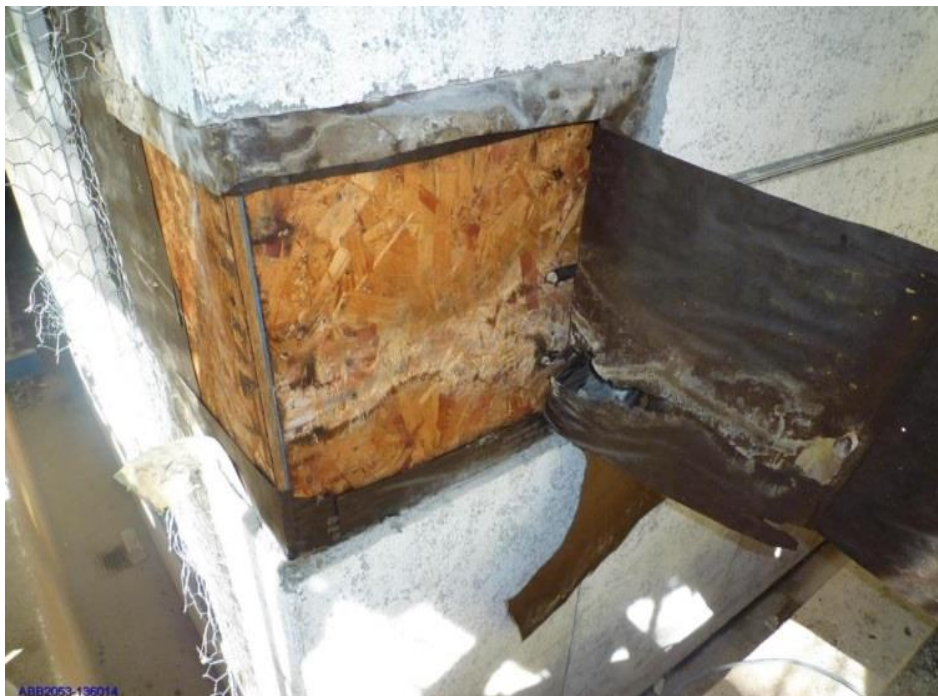
Figure 9B: Control Joint Impedes Water Drainage
