# **Building Envelope**

# Curtain Wall Failures

**Karim Allana, PE, RRC, RWC**

Allana Buick & Bers, Inc.

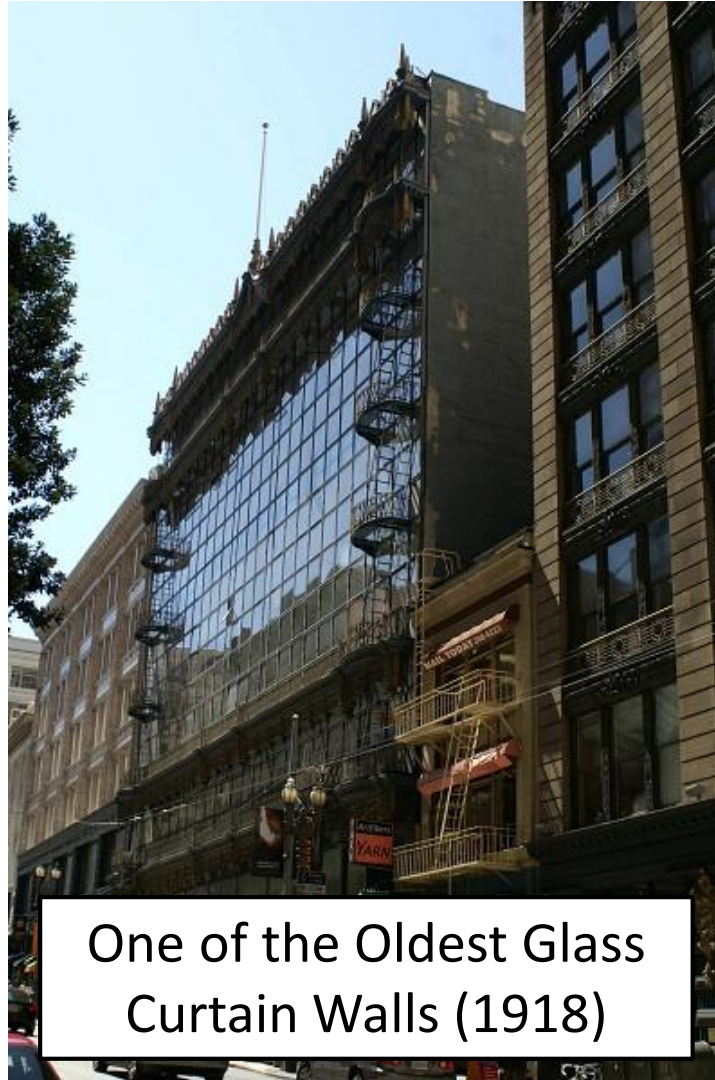
# The Hallidie Building, SF

One of the Oldest Glass  
Curtain Walls (1918)

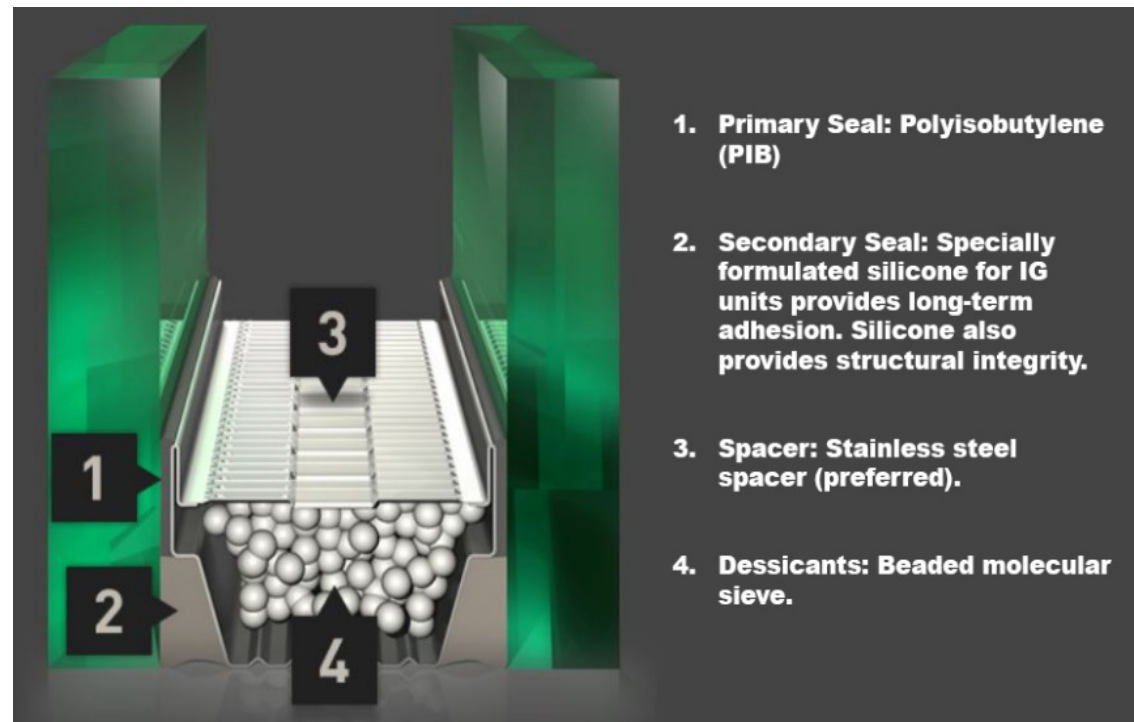
# PIB Migration

- PIB (primary) and secondary sealants prevent air/ water infiltration in IGU airspace
- PIB moves from window edge, obscuring vision
