# Building Skin Failures

**Karim Allana, PE, RRC, RWC**

Allana Buick & Bers, Inc.

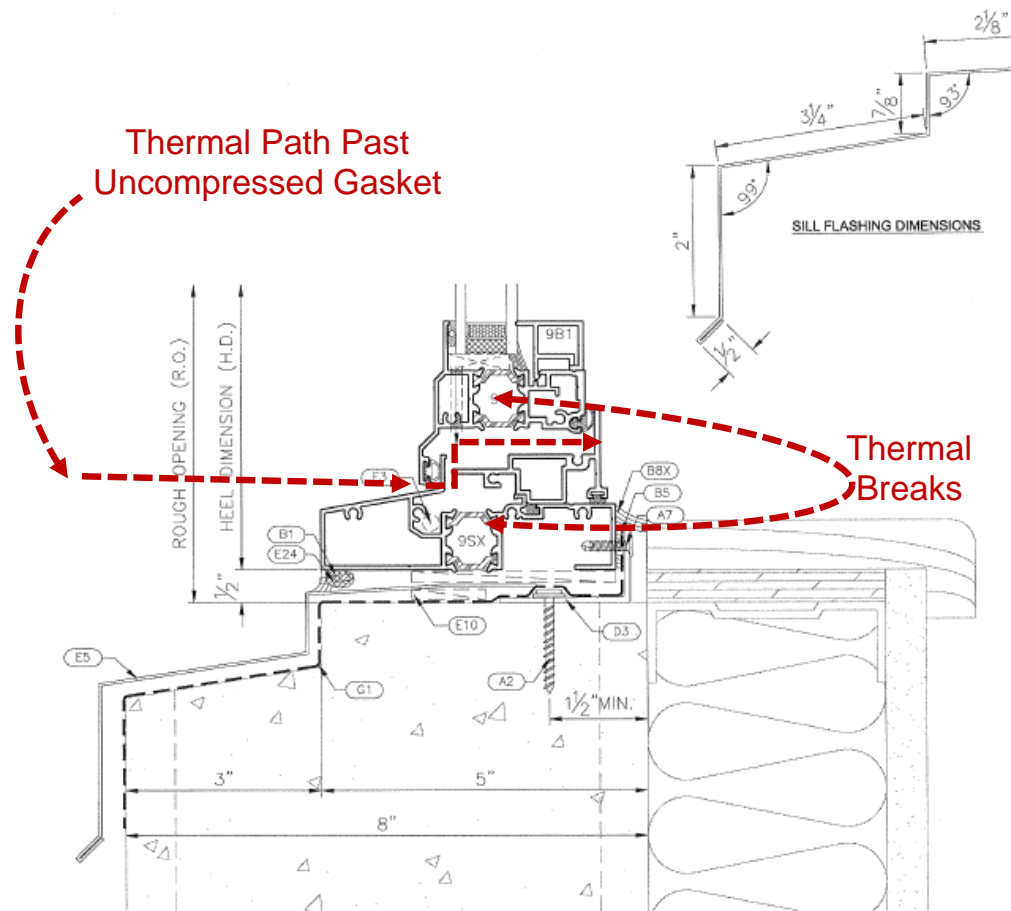
# How Condensation Can Occur

Thermal  
Path

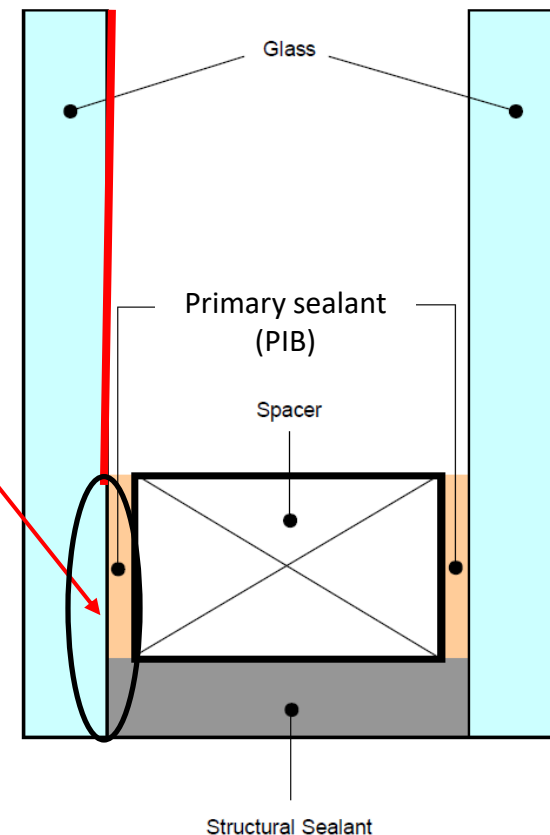
Low-E coating is edge deleted

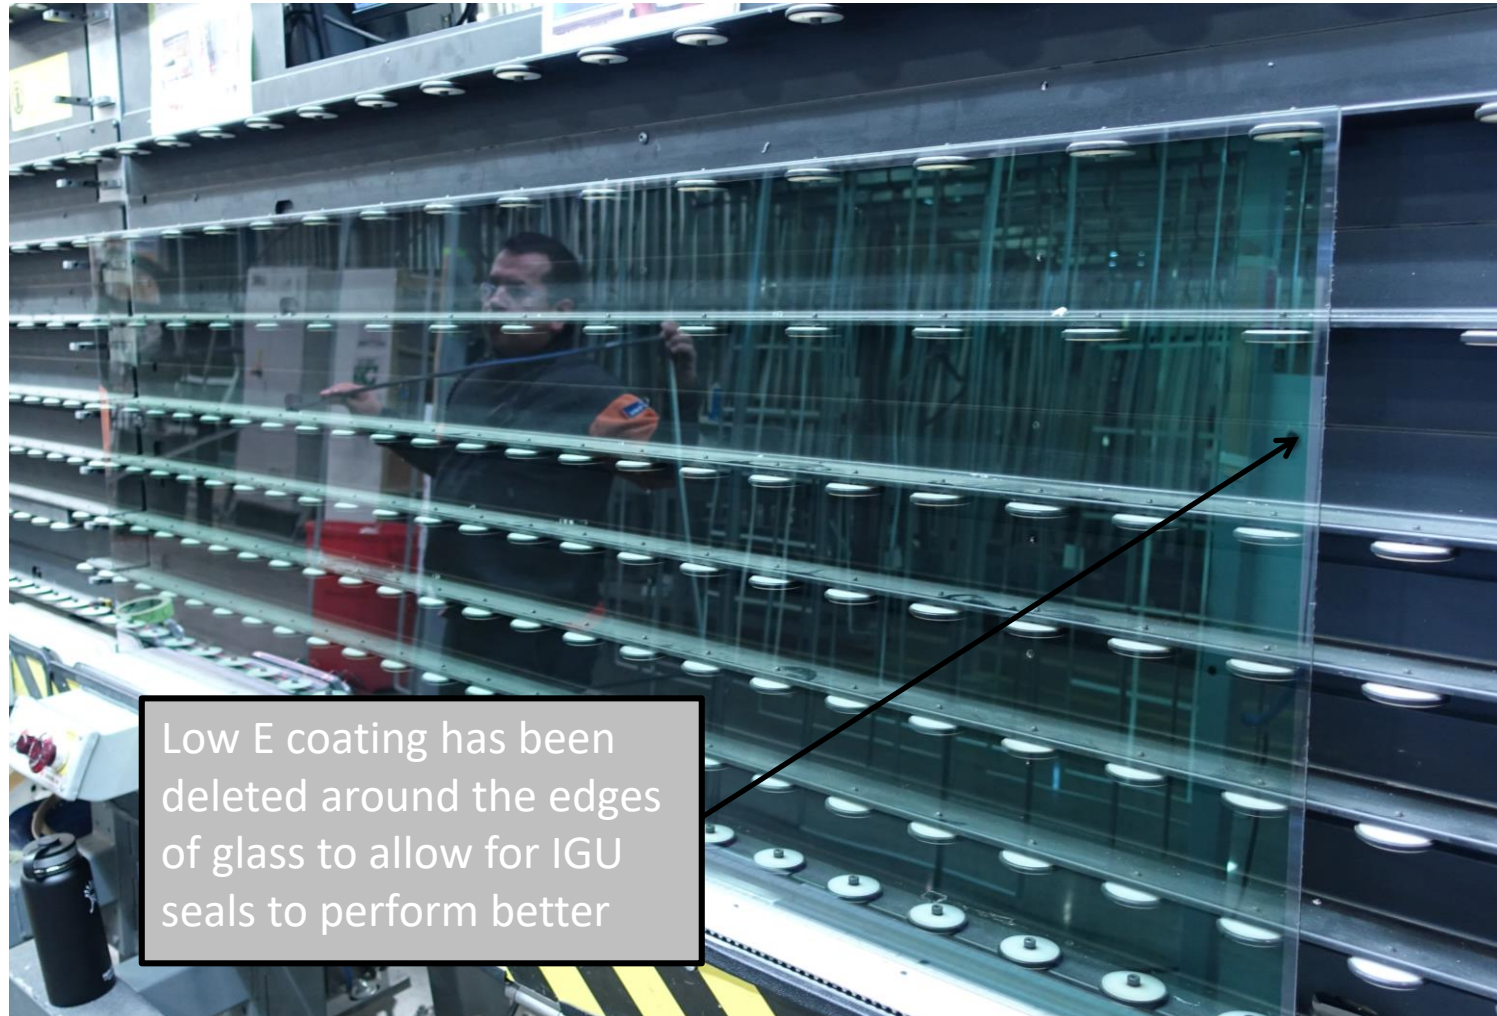
# Edge Deletion During Manufacturing

- Proper edge deletion needs to occur during the manufacturing process to ensure moisture does not attack edge of coating
- Design of the glazing and curtain wall assembly should not allow water to stand on top of the silicone sealant because, silicone is permeable
- Design installation of glass should be on blocks and properly drained to prevent dual glazing to sit in water

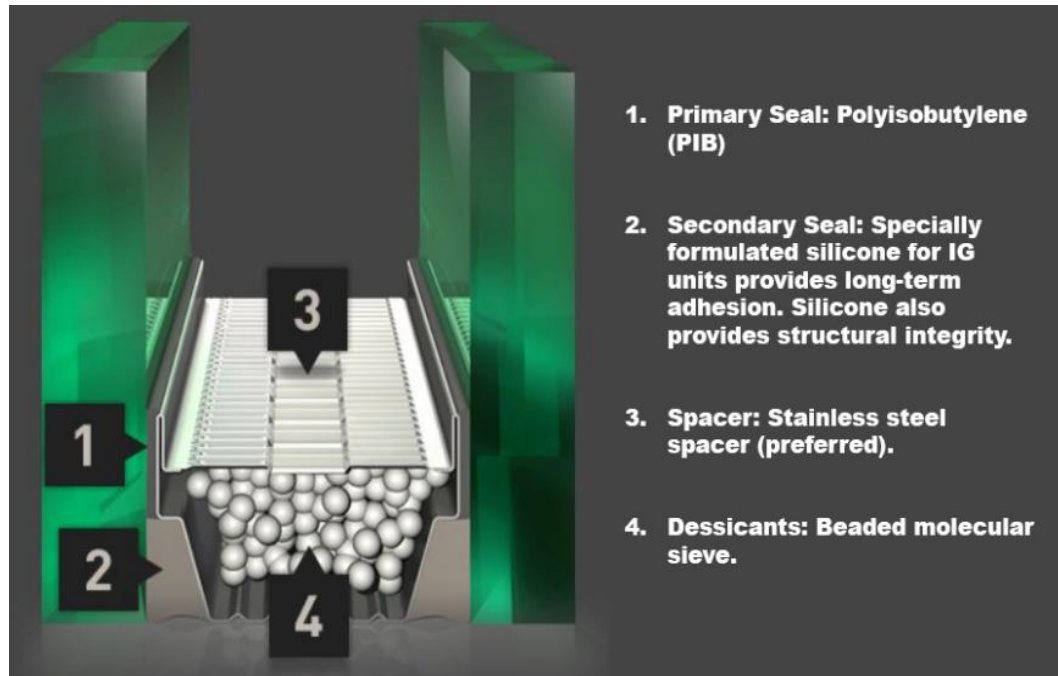
- PIB (primary) and secondary sealants prevent air/ water infiltration in IGU airspace
- PIB moves from window edge, obscuring vision
