WINDOW CONDENSATION AND LEAK ISSUES

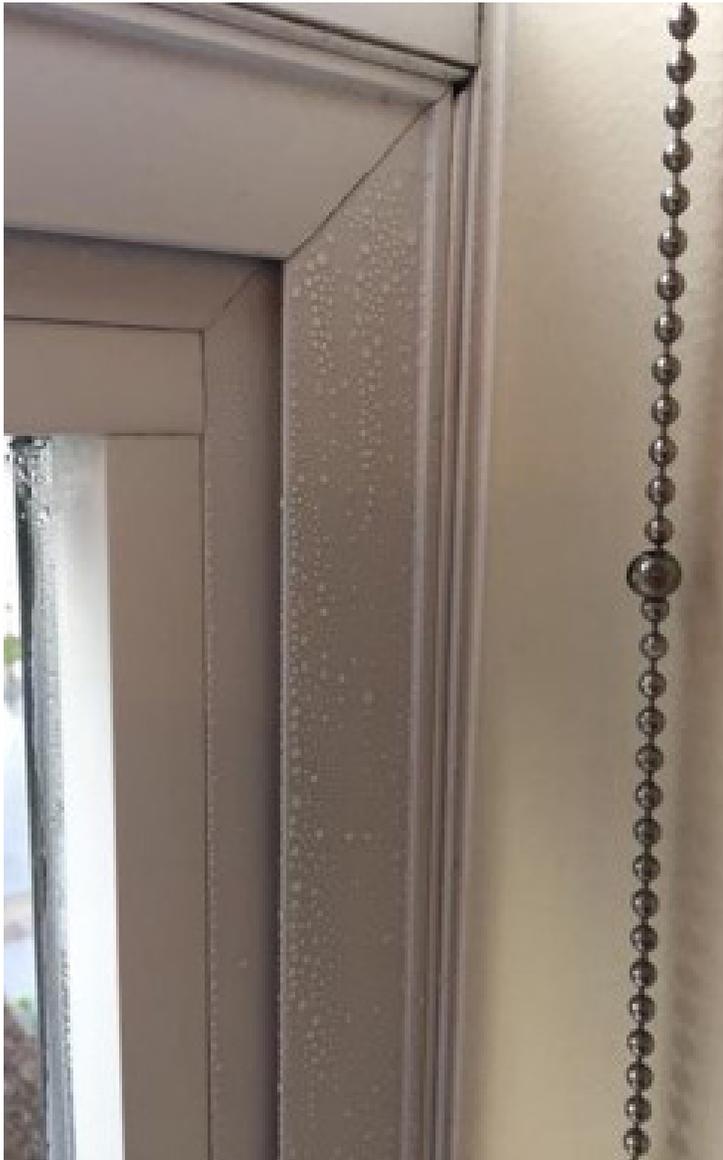
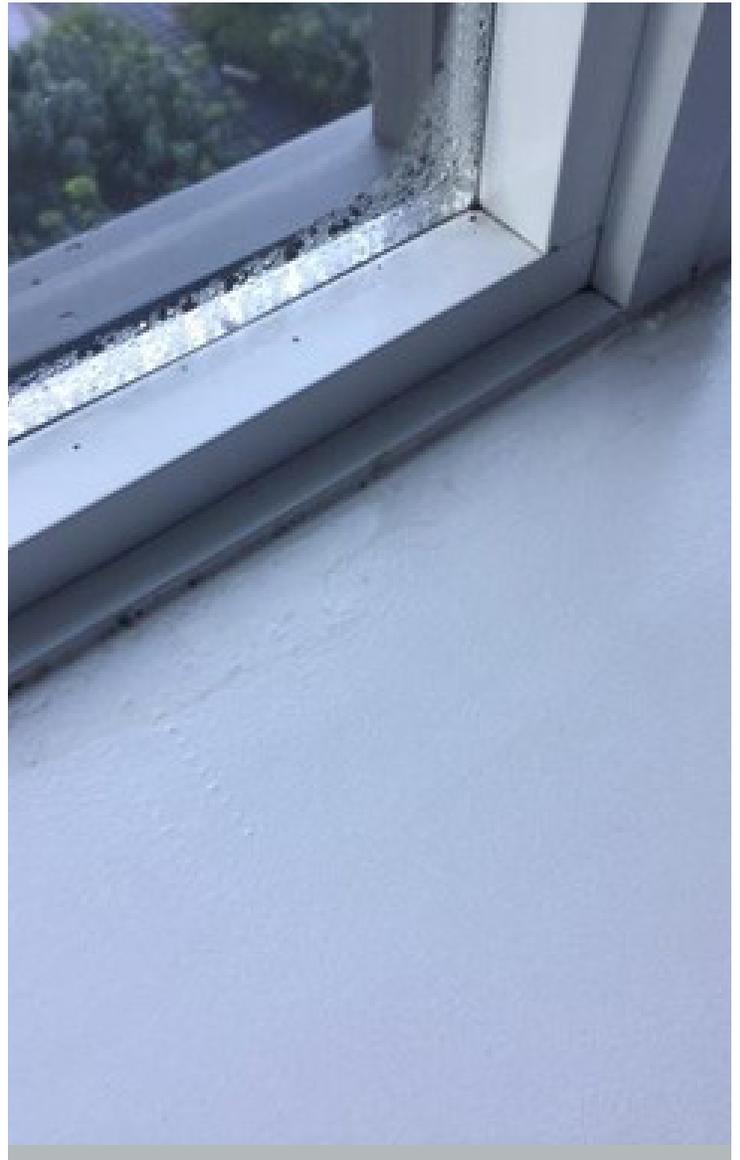
- Leaks occurring at the window frame at jamb/sill junction
- Exterior wall leaks at the wall/window assembly
- Roof or other leaks in the wall assembly
- Wet or moist crawl space
- Inadequate ventilation in the house
- Inadequate ventilation, especially in wet areas, or lack of proper exhaust fans in rest rooms
- Improperly ducted clothes dryer
