33RD RCI INTERNATIONAL CONVENTION & TRADE SHOW

Avoiding Condensation in Low-Slope Roofing Assemblies

Case Study

San Francisco Apartment

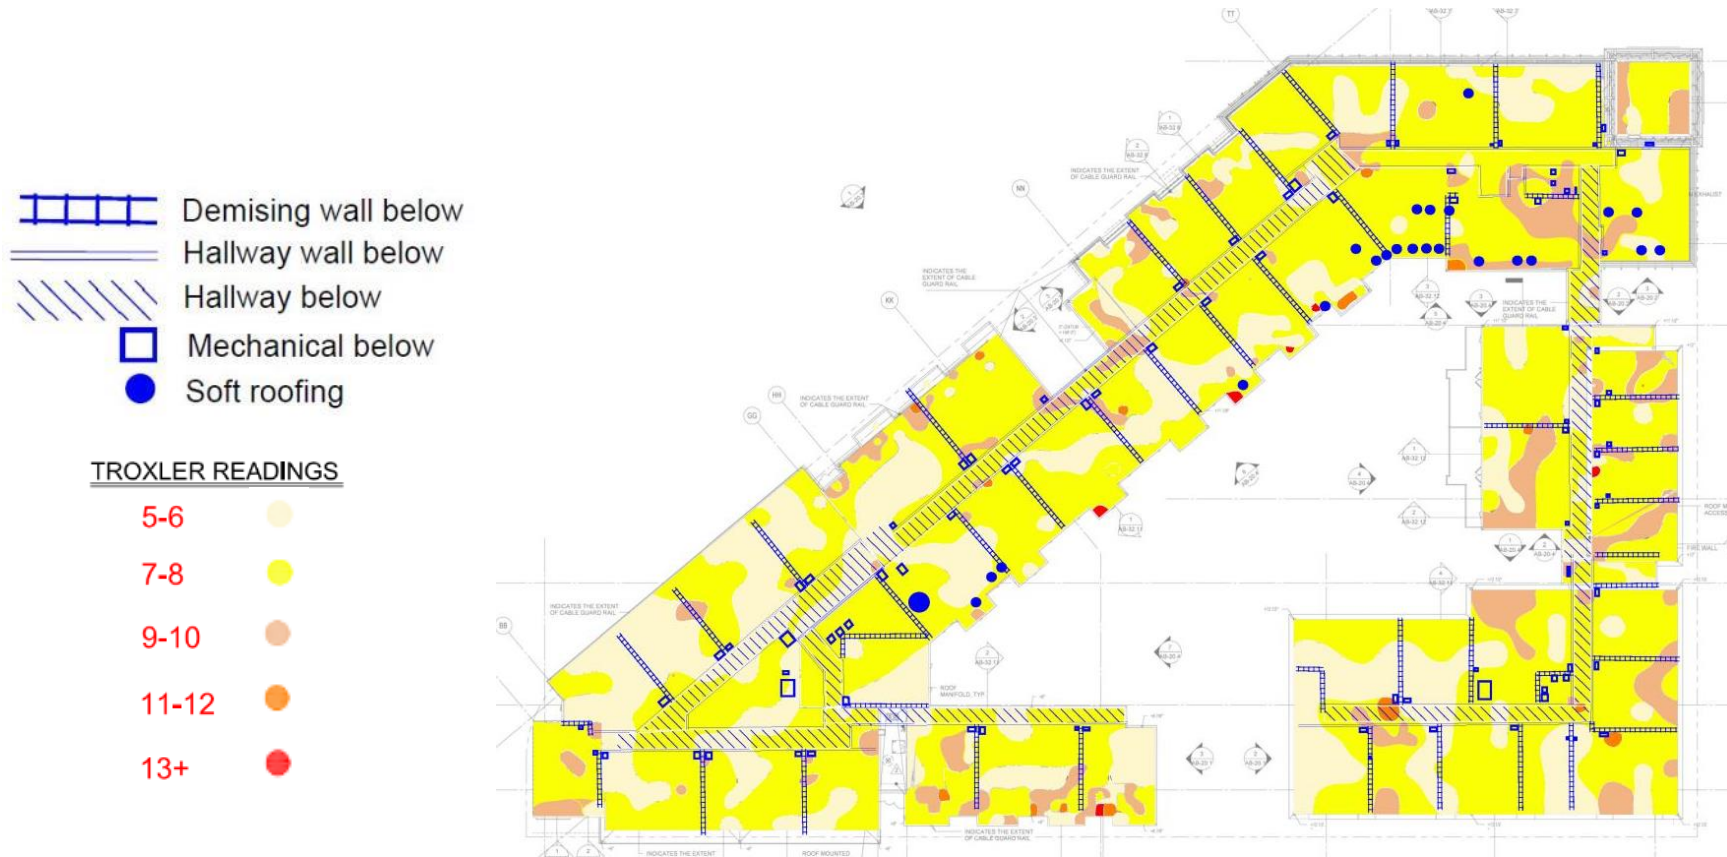
Non-Destructive Nuclear Gauge Survey Results

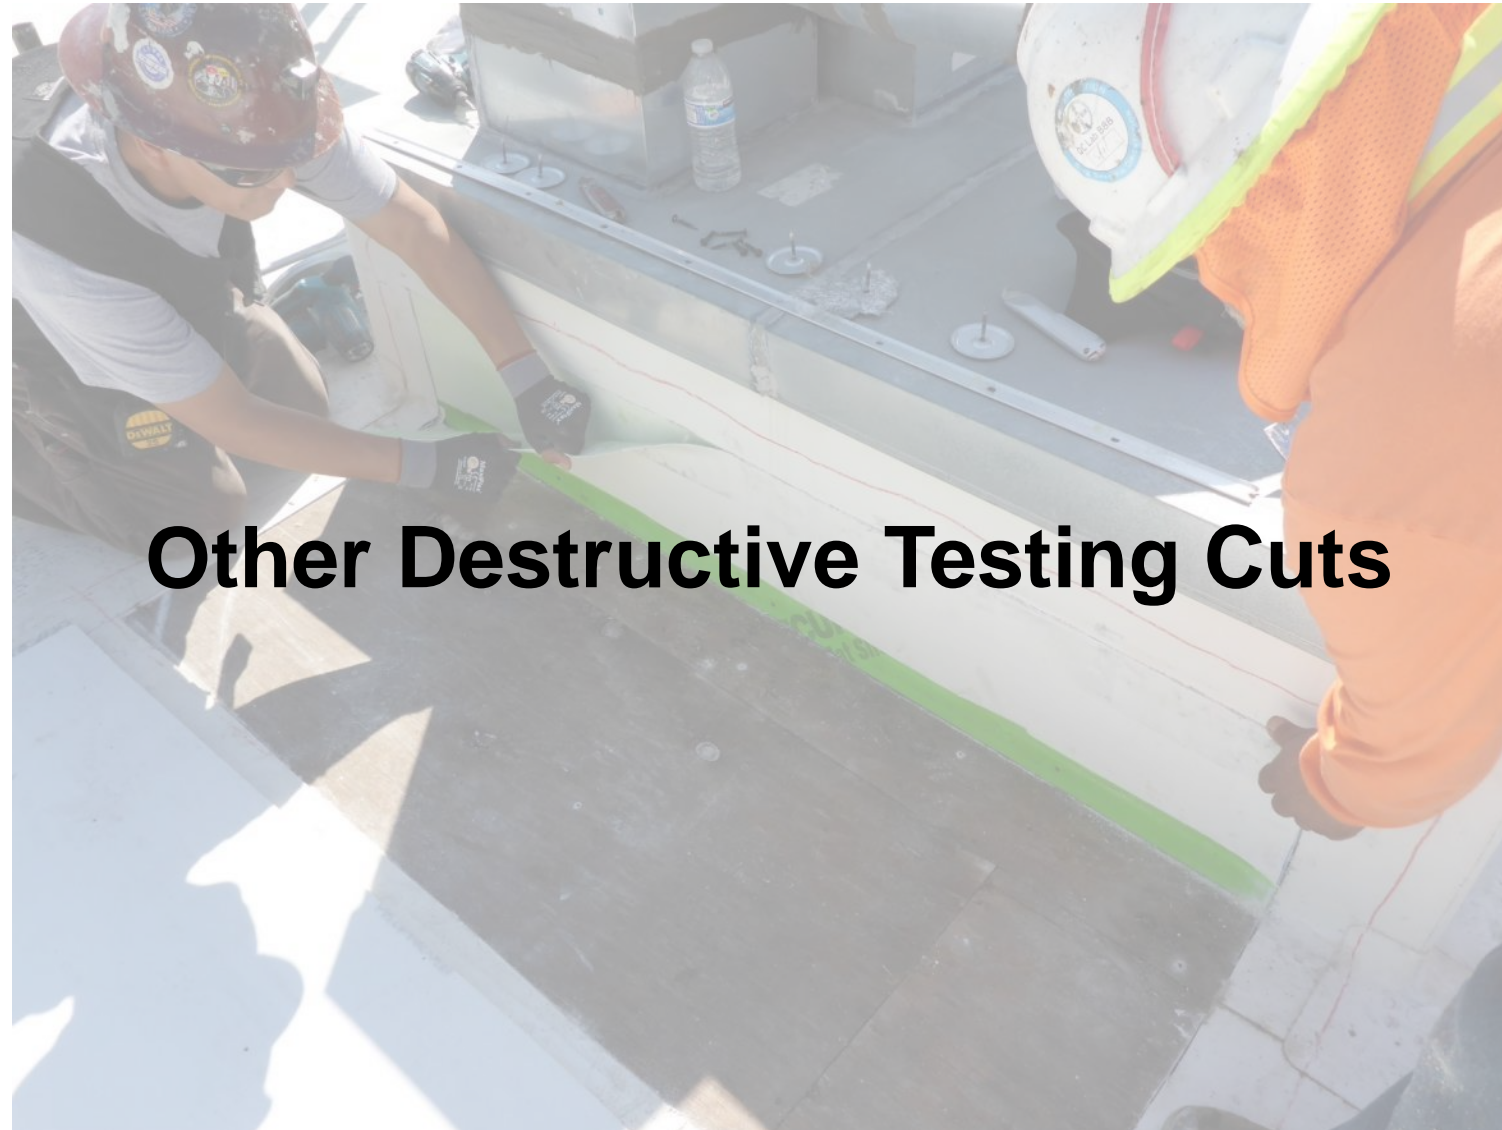
Calibration Test Cut #1a

Level 5 Roof Area

Test cut exhibiting damage from vapor intrusion, high nuclear gauge moisture content levels.

Calibration Test Cut #1a,
Damage Level Severe
(condensation related)

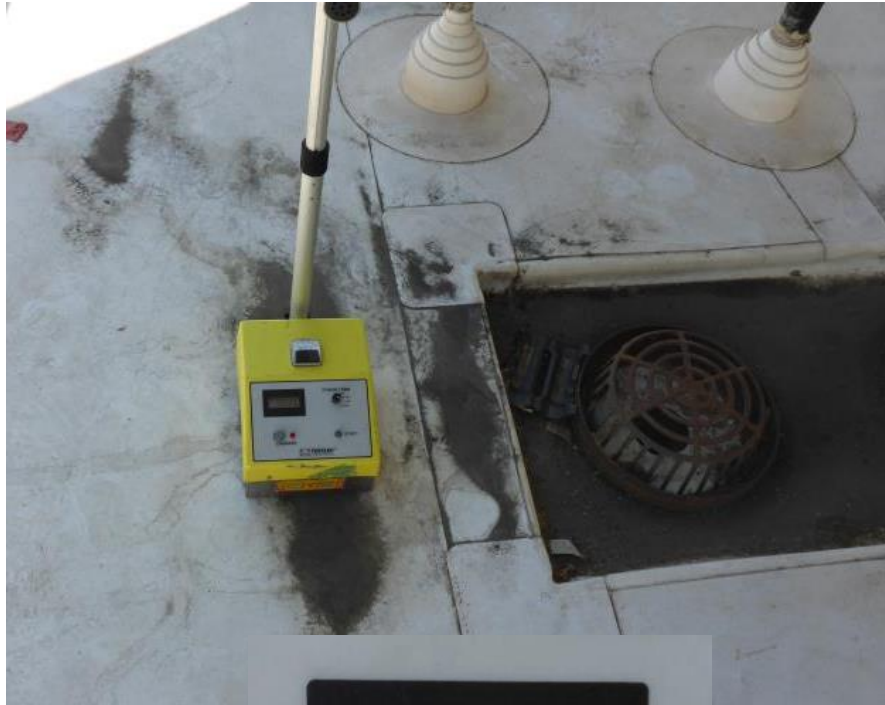
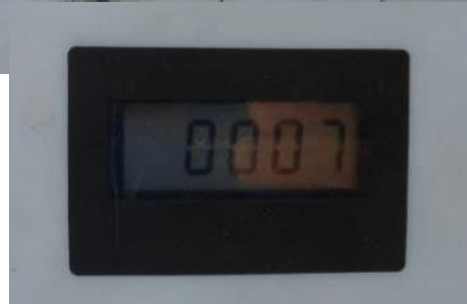
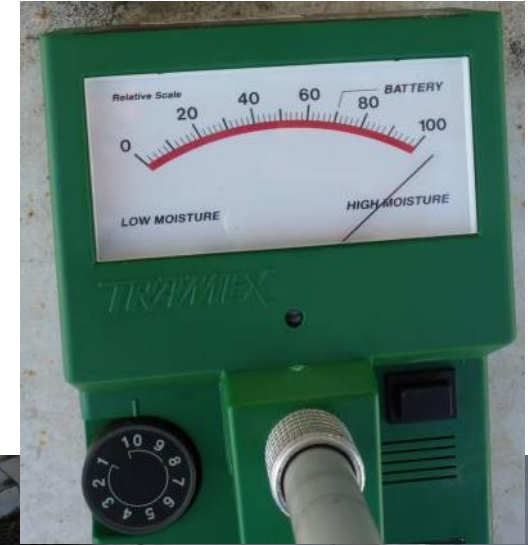
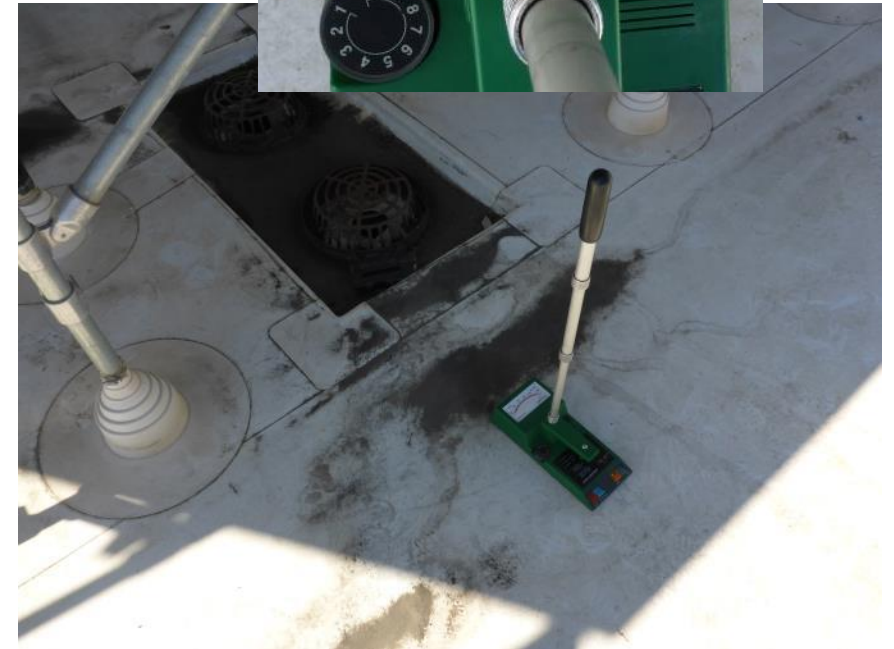
Destructive Test Cut #7b (Soft Spot)

- Test Cut Location: Level 5 Roof Area, Adjacent to roof drains
- Test cut exhibiting severe condensation damage, noted soft spot, had a low Troxler reading, and had high Tramex moisture content levels.

Moisture Scan Results

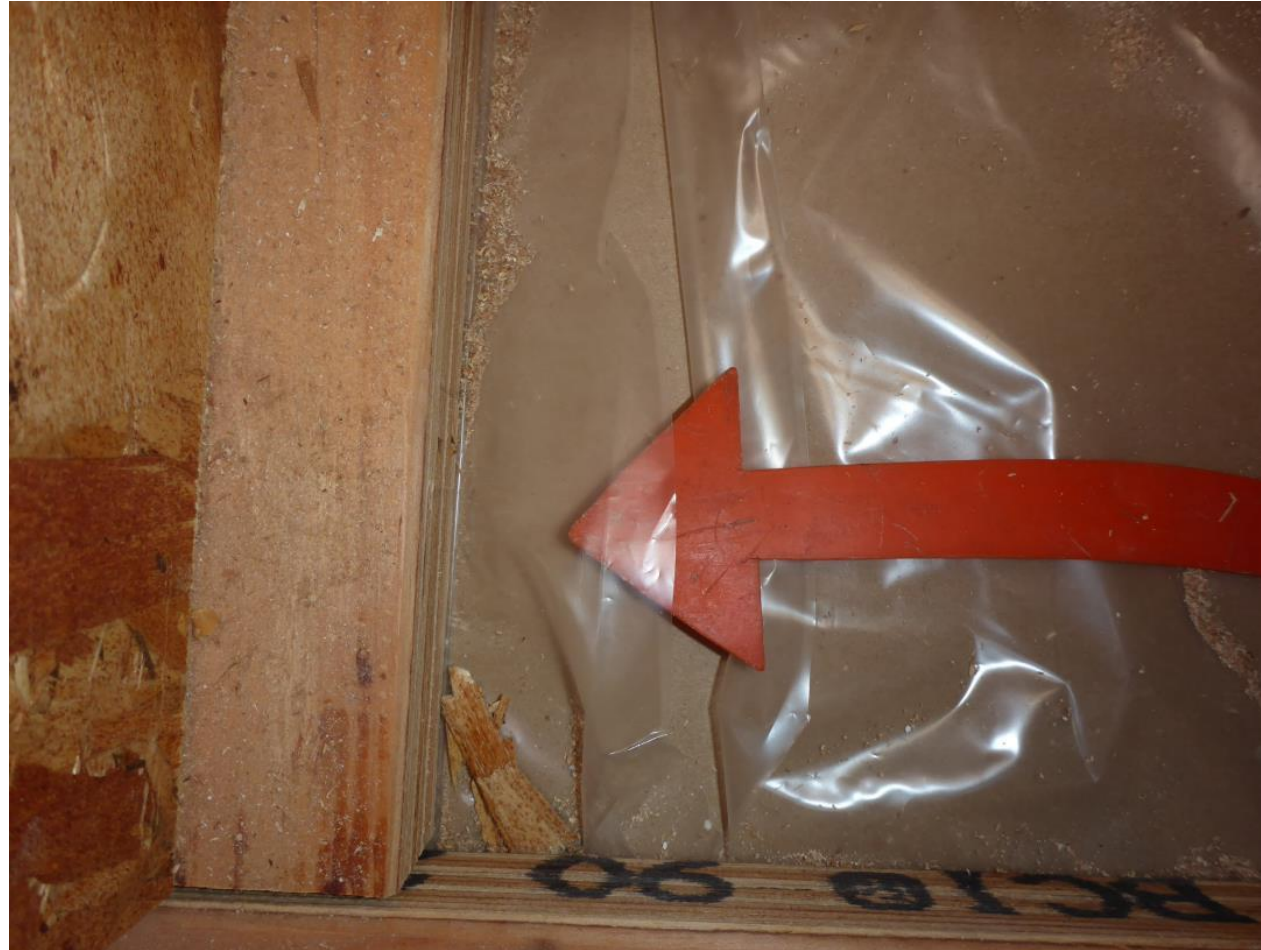
Destructive Test Cut #2b

1.01 Unsealed Lap in Vapor Retarder

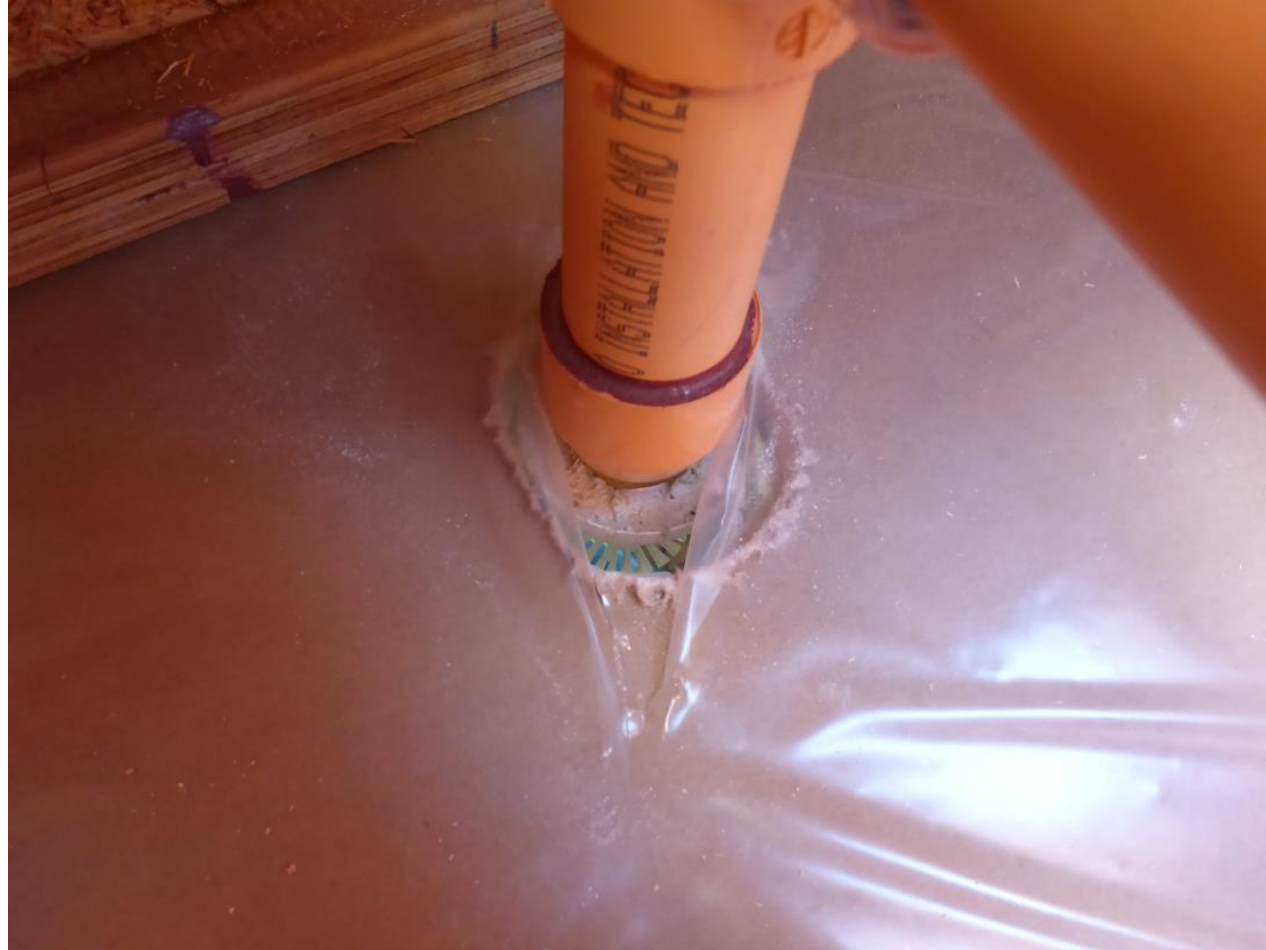
Destructive Test Cut #5b

Vapor Retarder Unsealed at Pipe Penetrations
