33RD RCI INTERNATIONAL CONVENTION & TRADE SHOW

Avoiding Condensation in Low-Slope Roofing Assemblies

Case Study

San Francisco Apartment

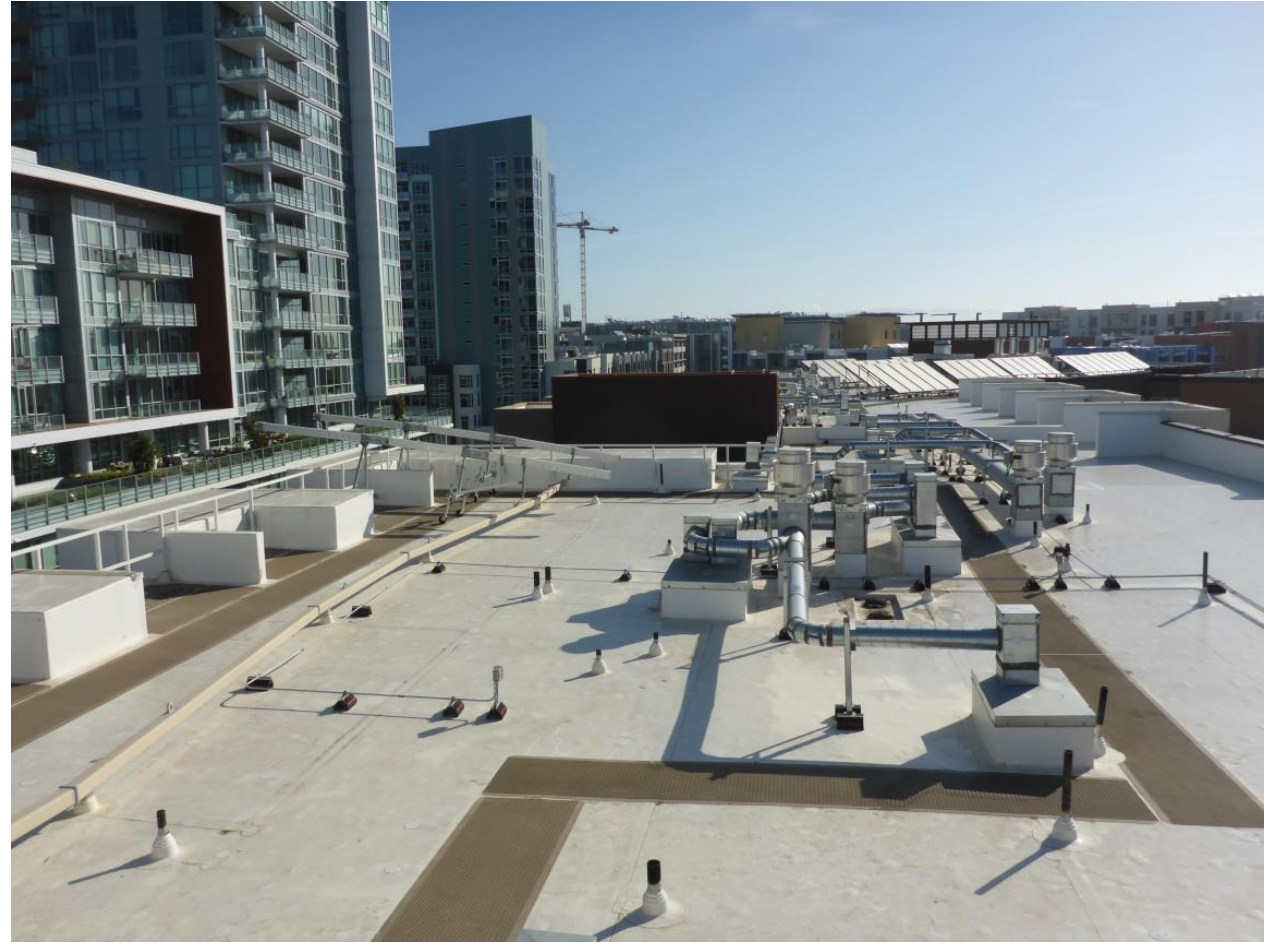
Looking northeast from
Level 6 roof upper area

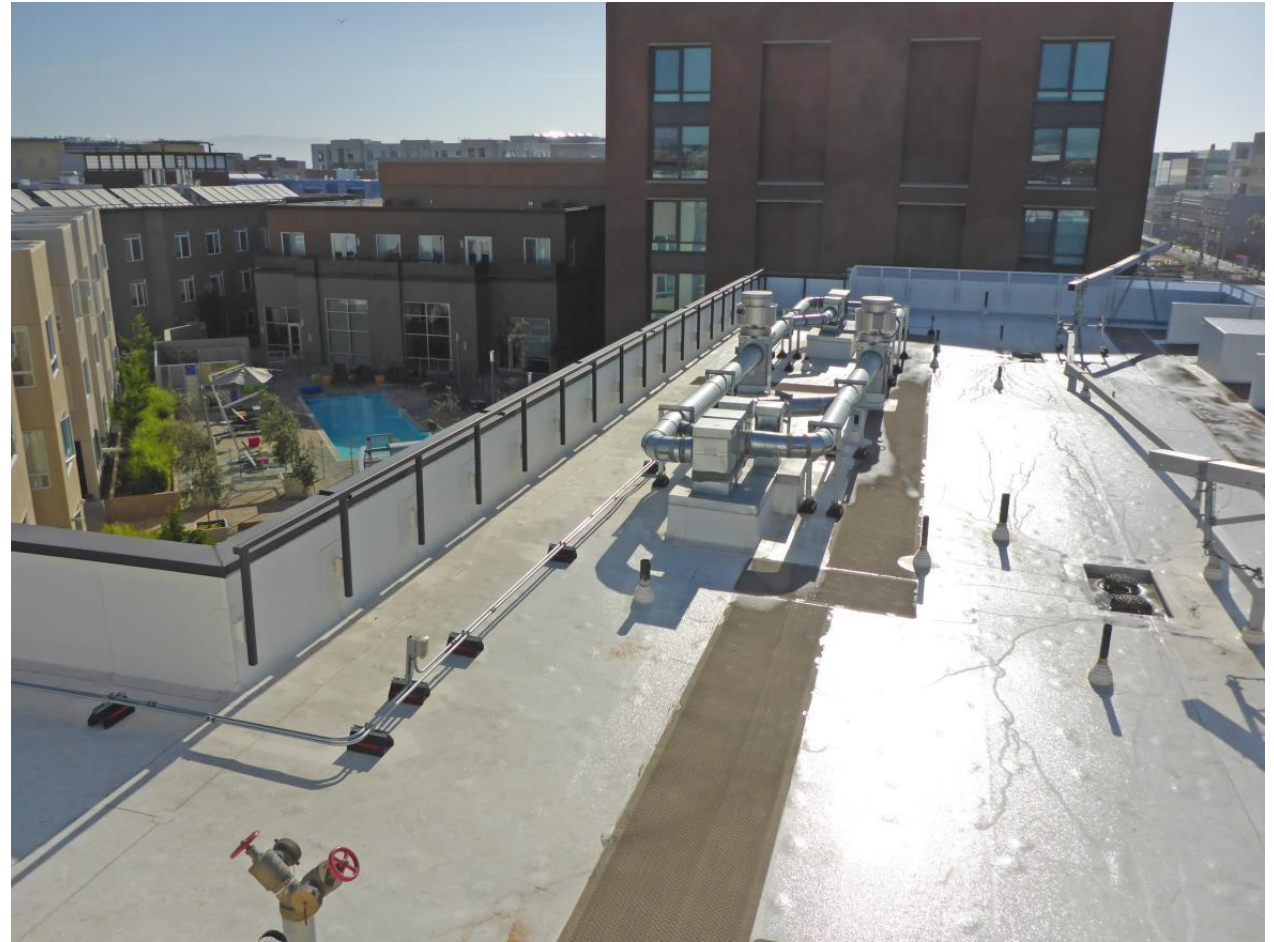
Looking east from
Level 6 upper roof
area

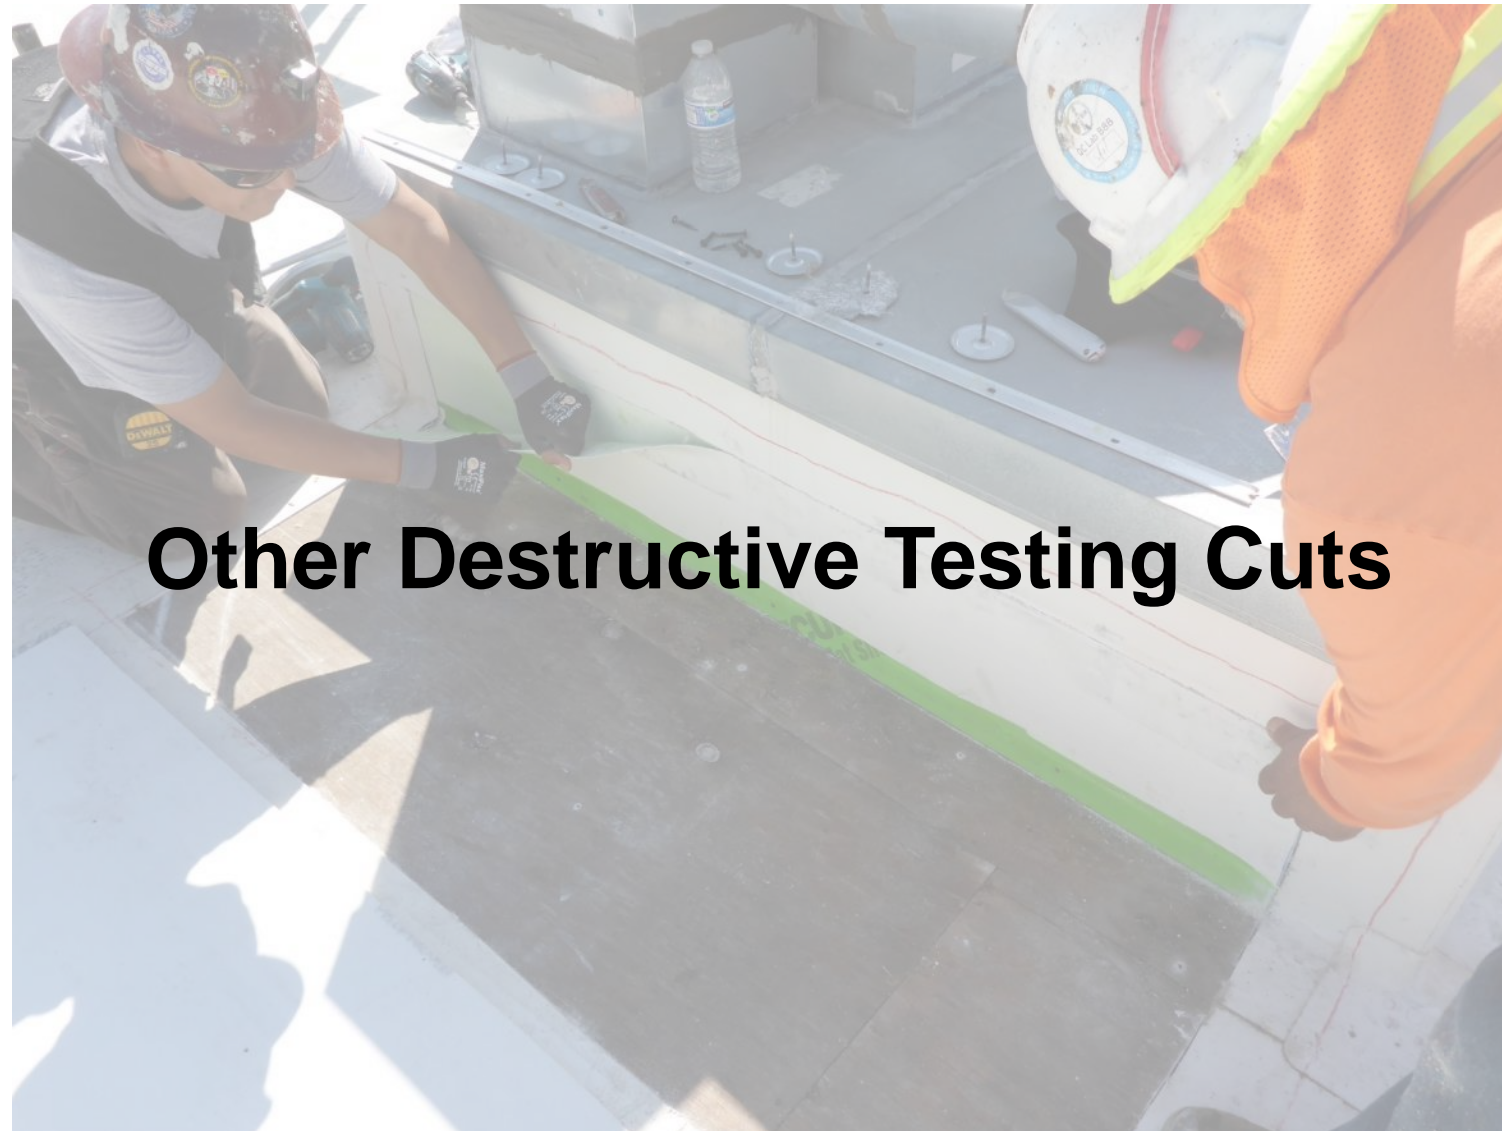
ST - Staple not installed into framing at vapor retarder layer

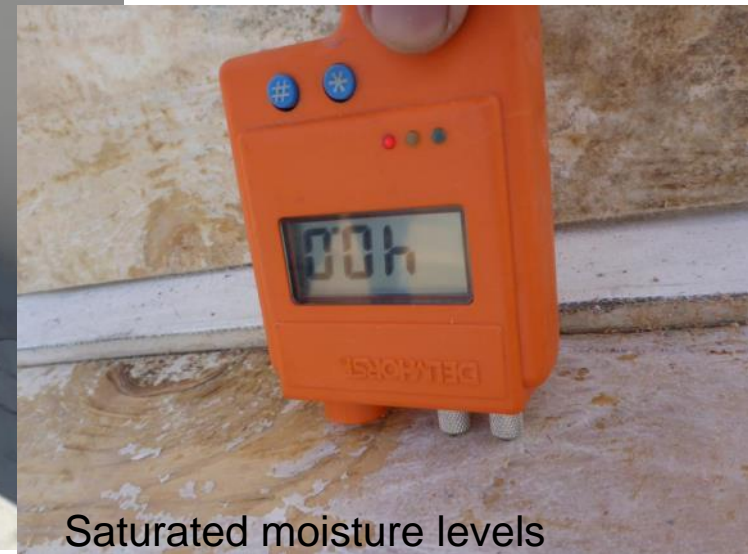
Test Cut #3b, Damage Level
900 (condensation related)

Nail Pull Thru Testing:
5/8" Moderate Damage
Avg. 298 lb.

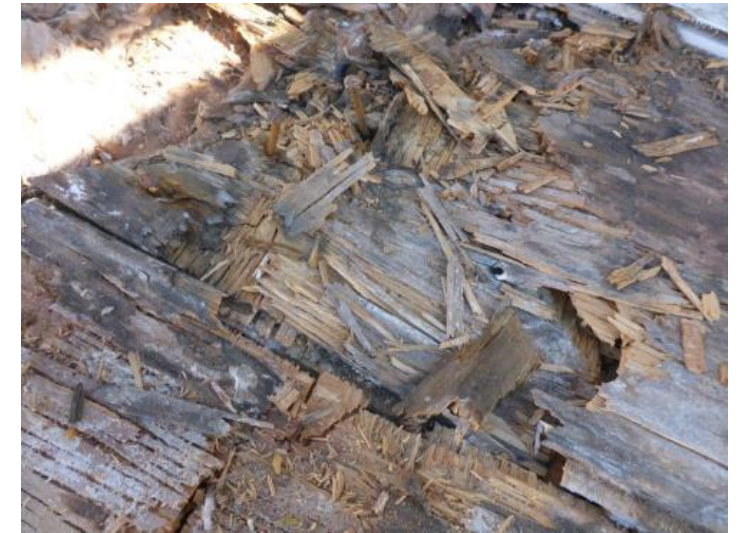
Destructive Test Cut #7b,
Damage Level 900
(condensation related)

Wood Rot and Elevated Moisture Content

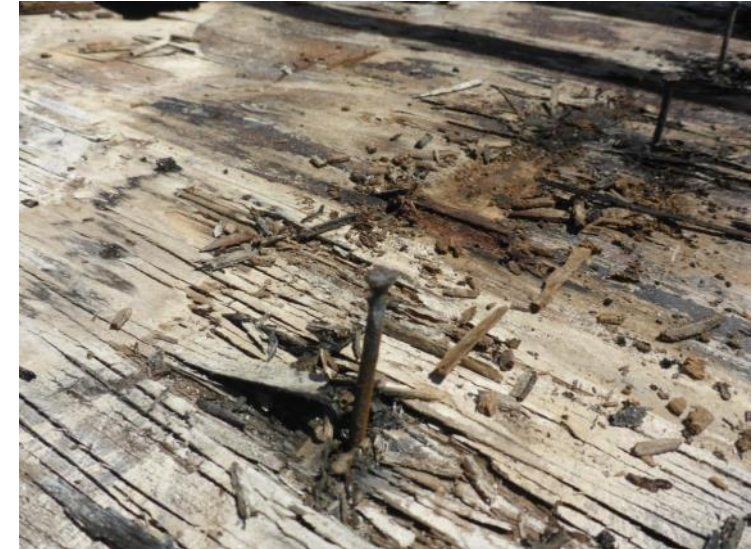
Severe Damage at Metal Hand Railing Base

Destructive Test Cut #6b, Damage level 900 (condensation related)

- Demolition and replacement of 100% of cricket plywood and framing
- Selective replacement of structural sheathing where damaged
- Replacement of 100% of the roofing and flashings
- Replacement of 100% the sheet metal roofing coping caps

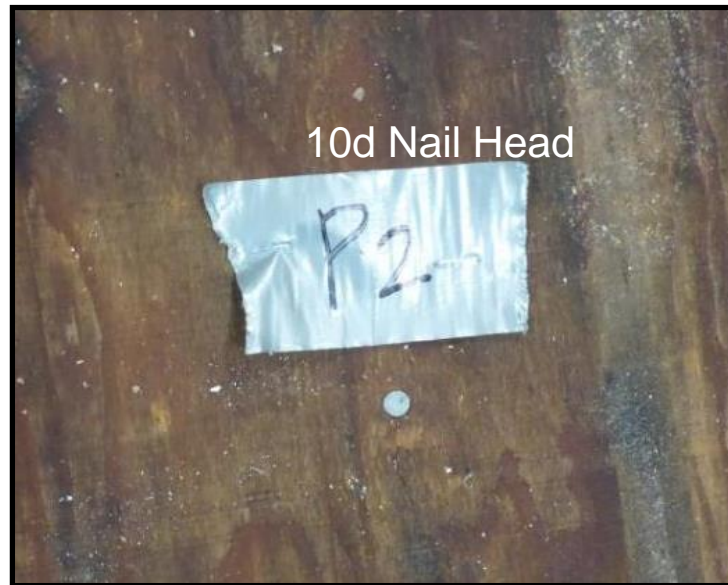
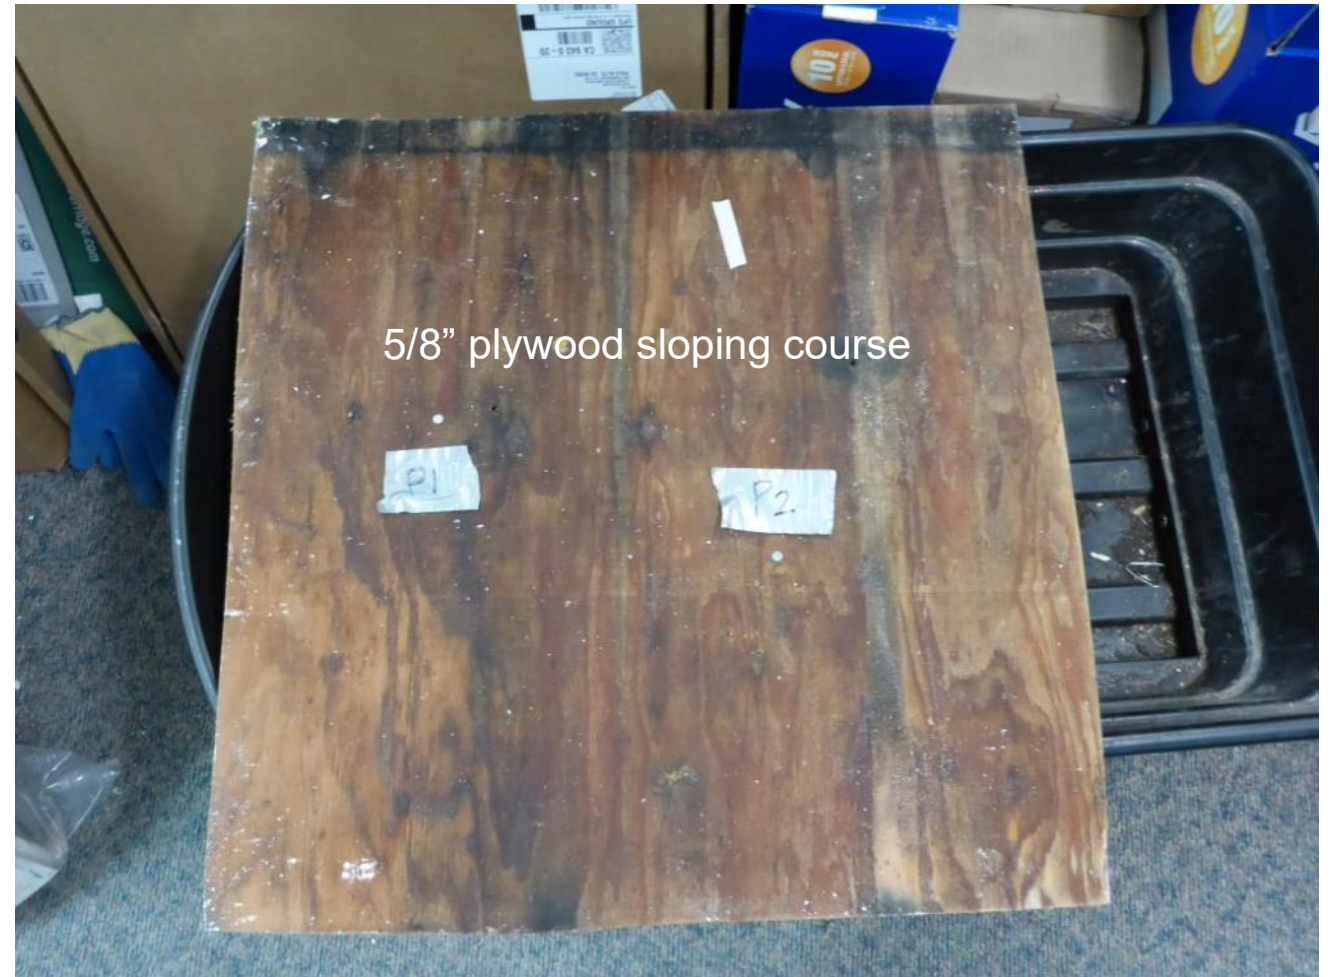
Plywood sample retained in the field with nail pull thru testing locations

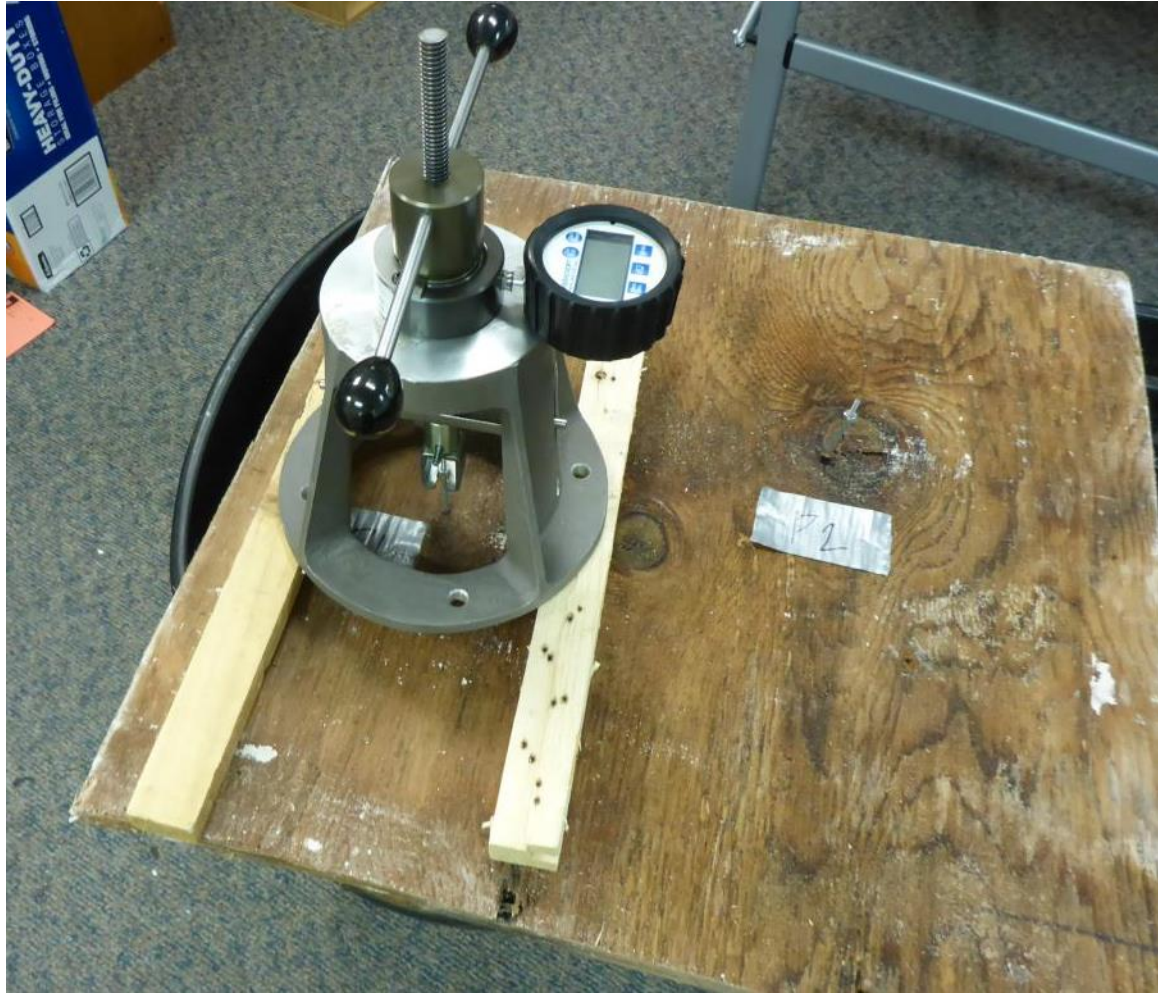
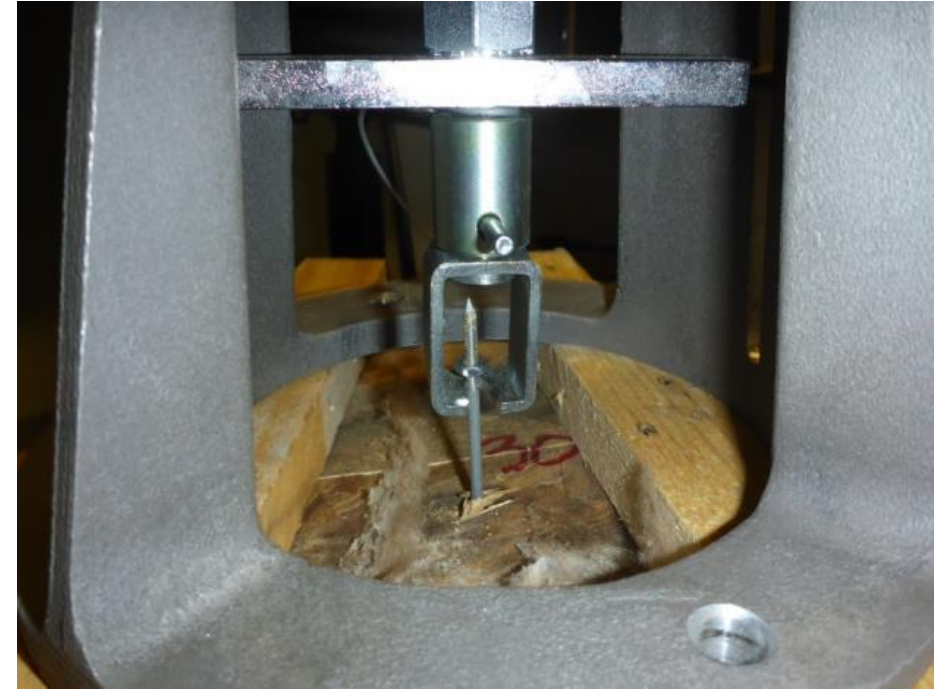
COM-TEN Digital Pull Tester in place during testing

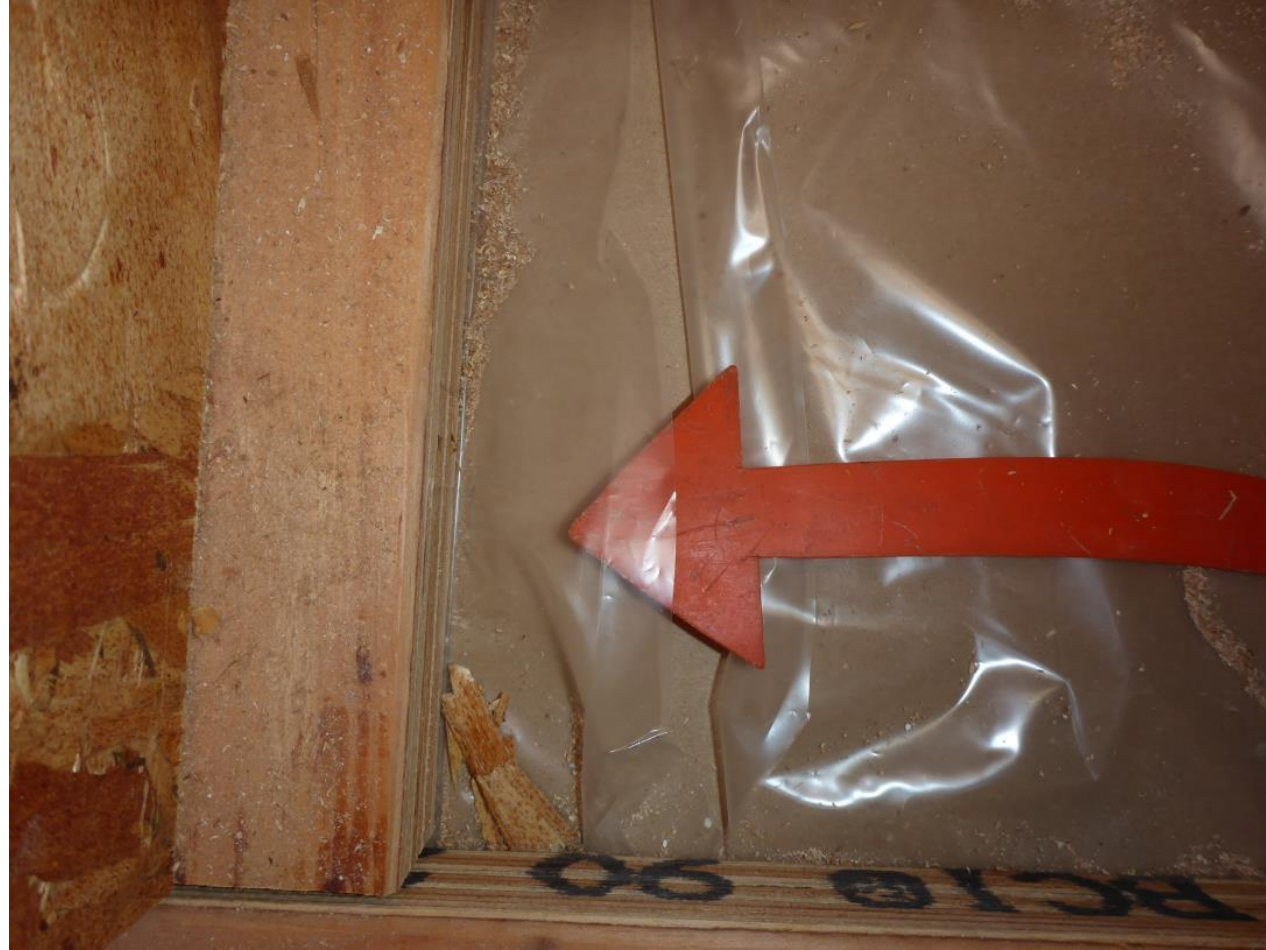
Destructive Test Cut #2b

1.01 Unsealed Lap in Vapor Retarder

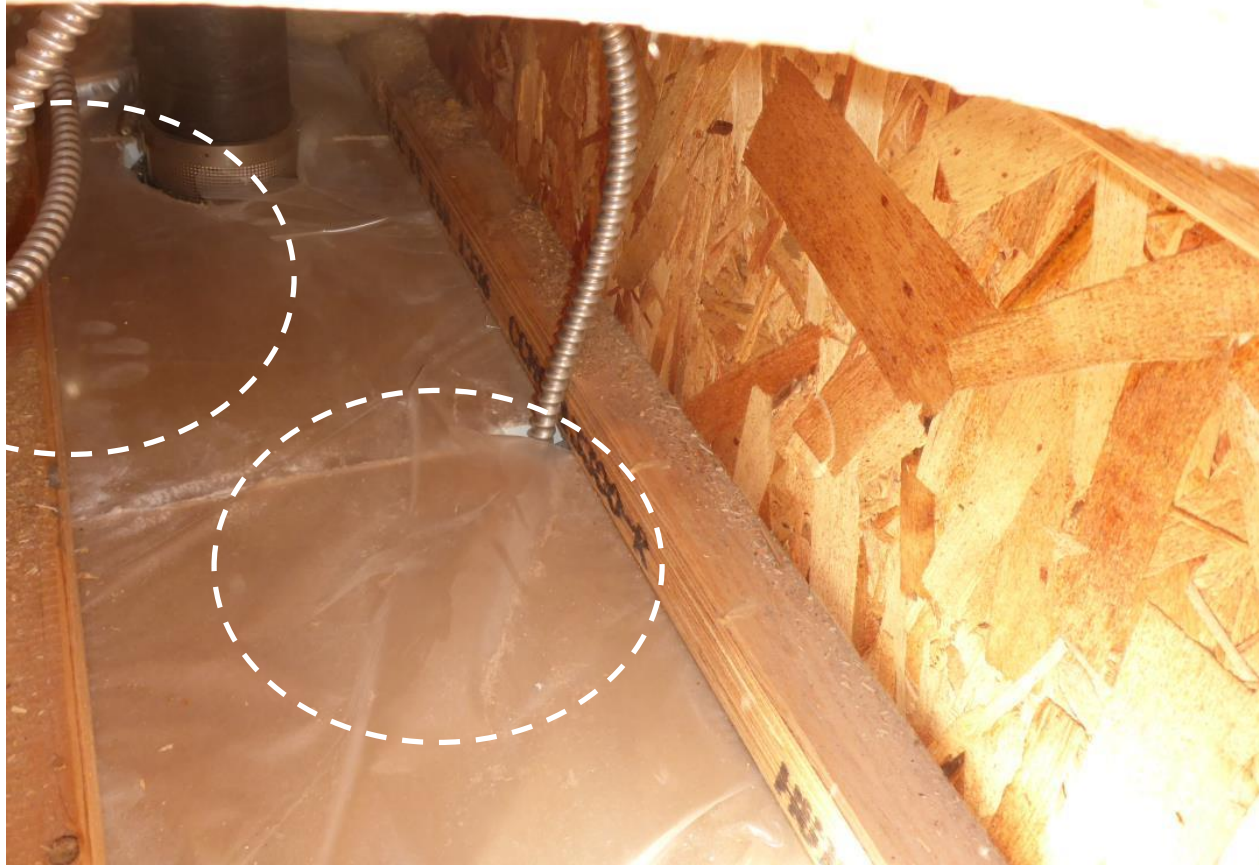
Destructive Test Cut #2b

Vapor Retarder Unsealed at Penetrations

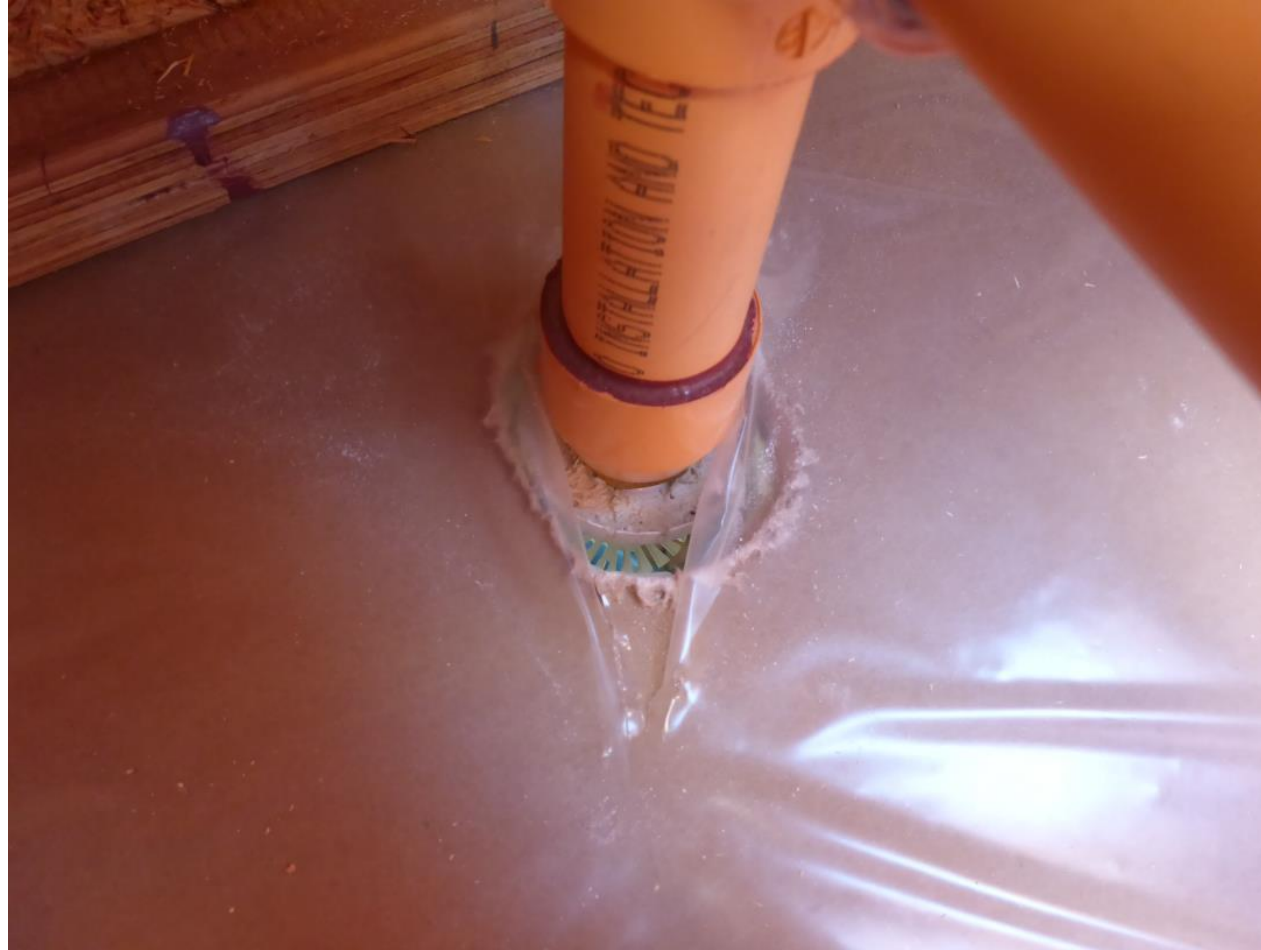
Destructive Test Cut #5b

Vapor Retarder Unsealed at Pipe Penetrations
