Building Envelope

Curtain Wall Failures

Karim Allana, PE, RRC, RWC

Allana Buick & Bers, Inc.

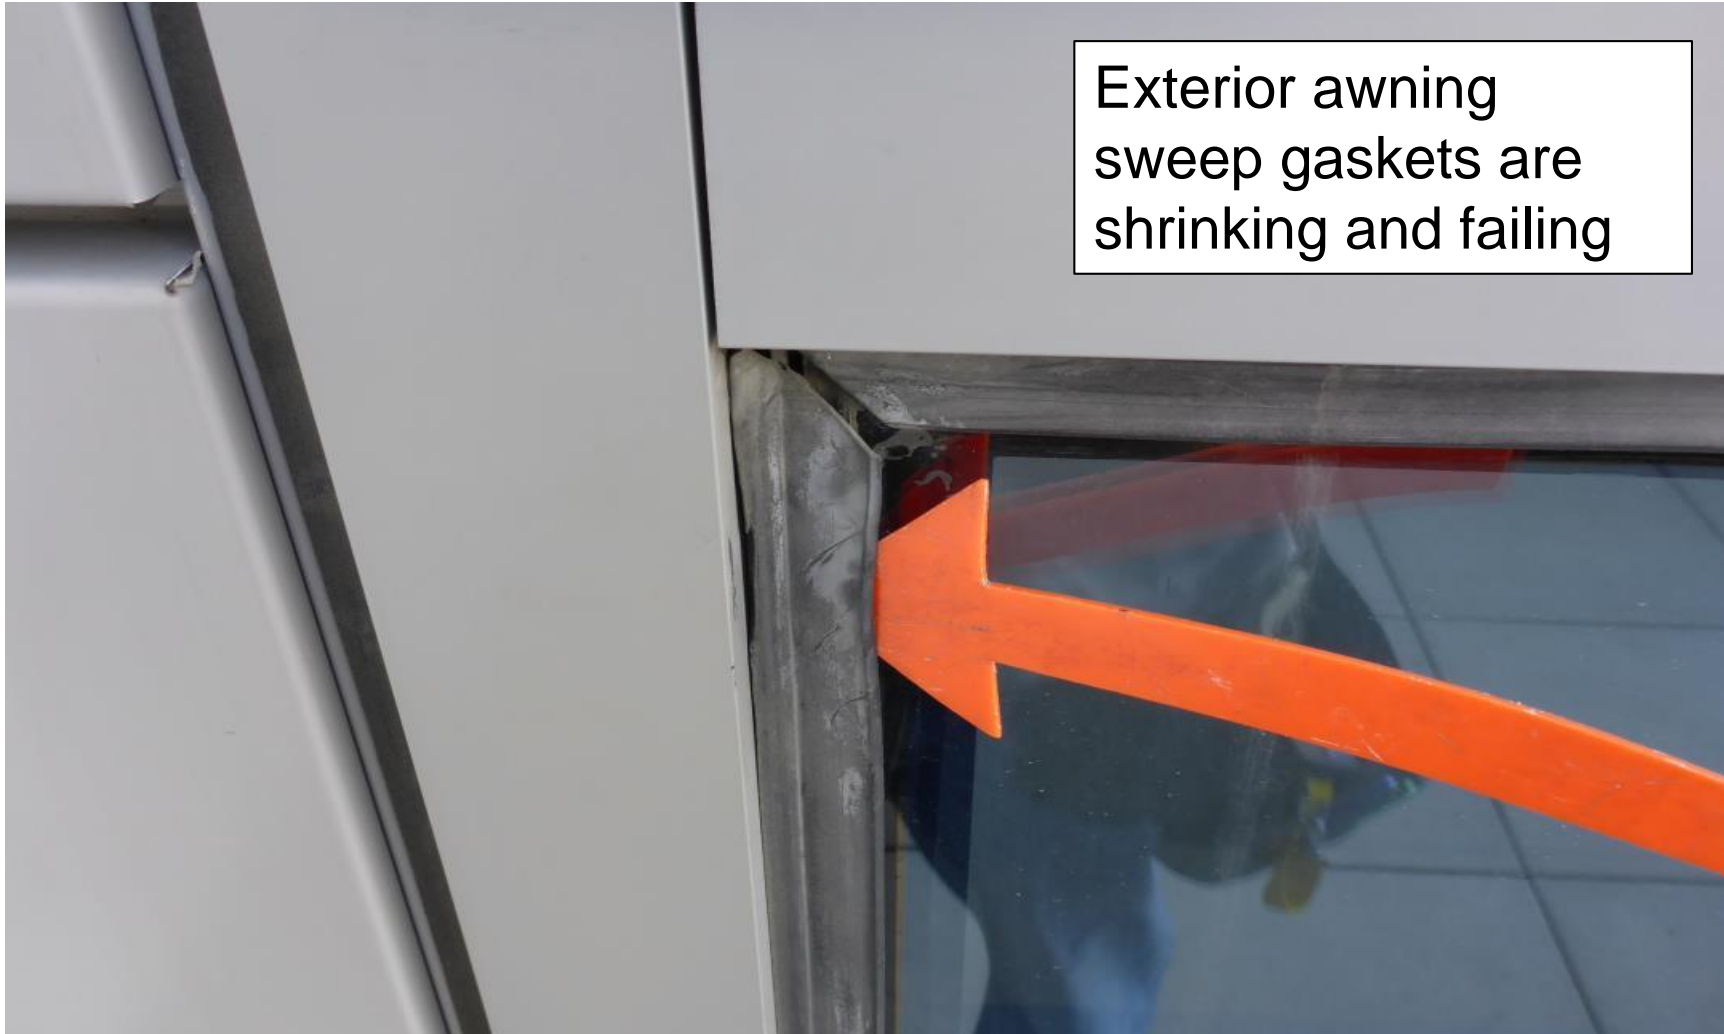
Gasket Failure - San Jose Condo

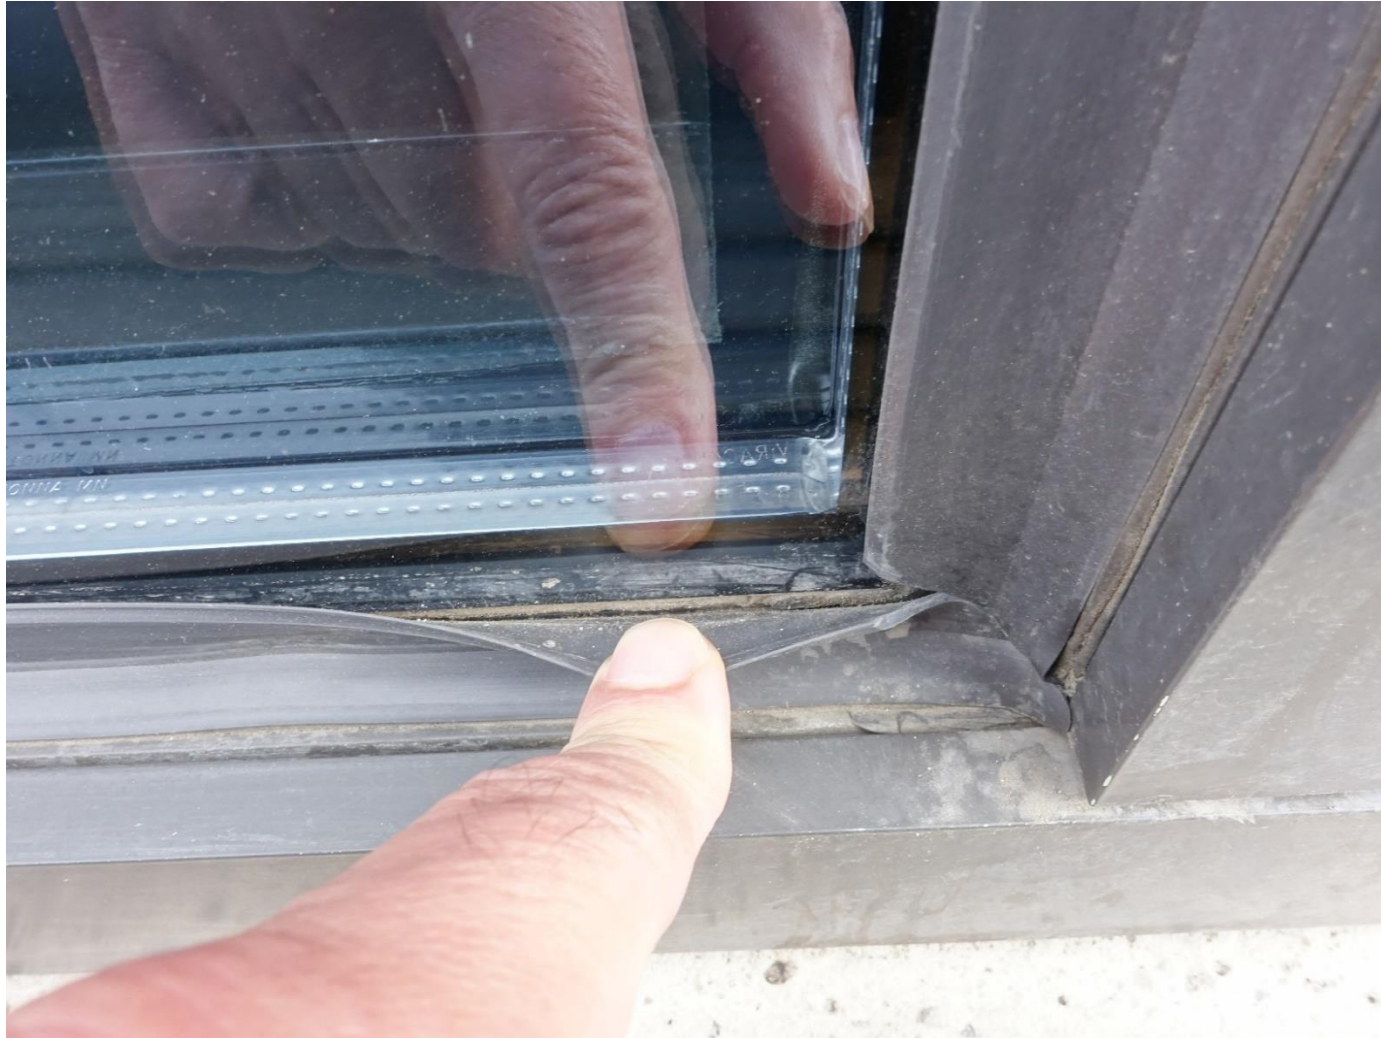
Gasket Failure- San Jose Condo

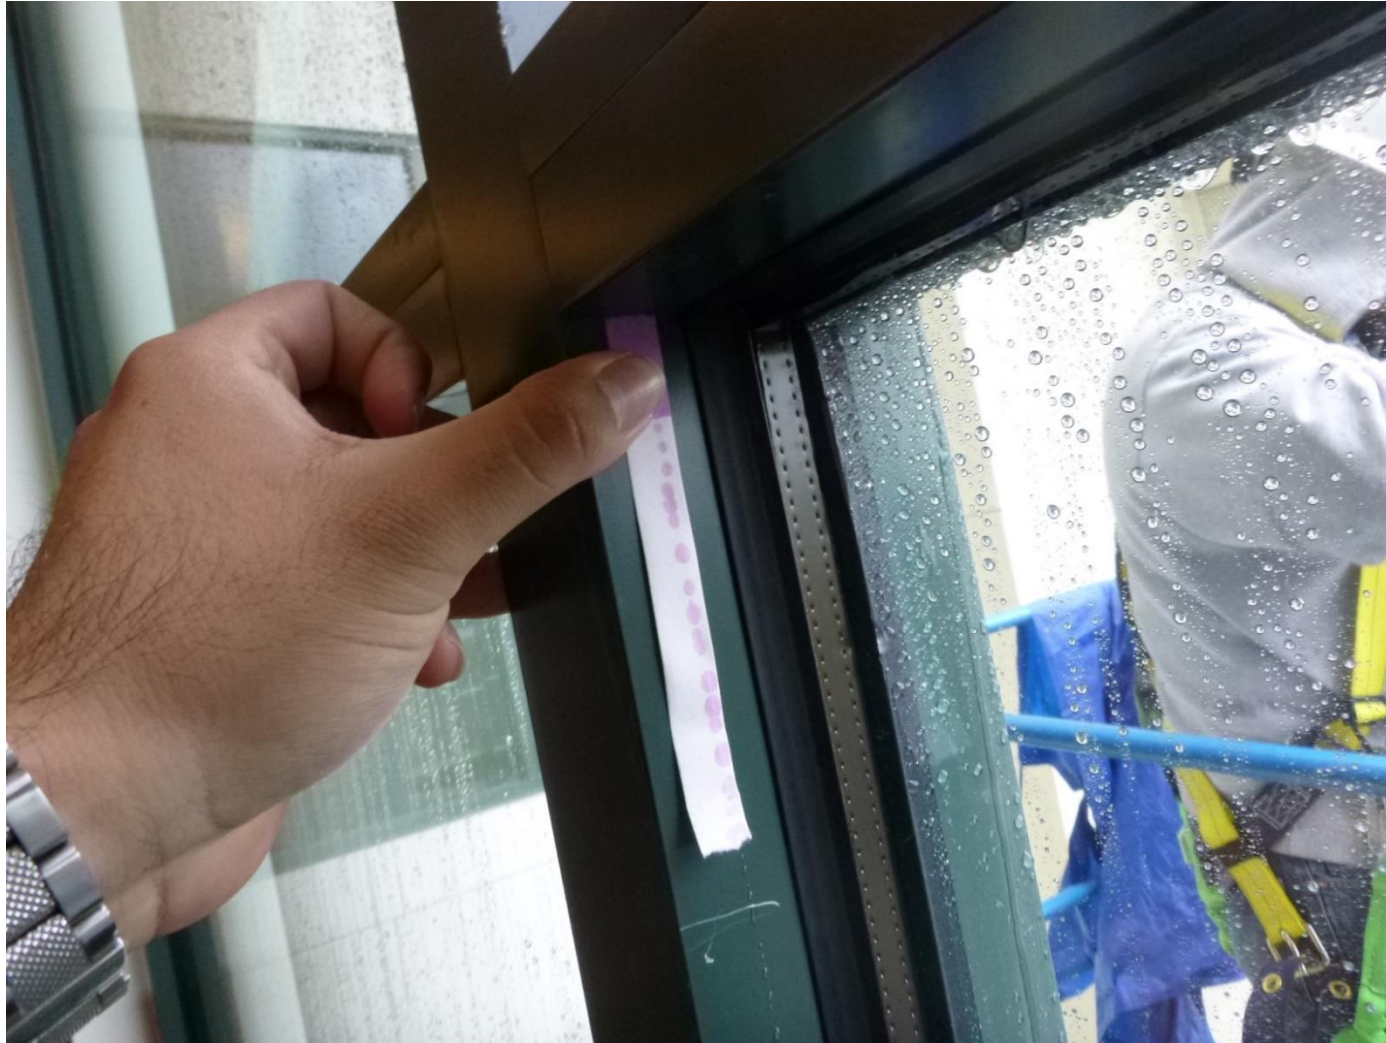
Gasket Failure- Causing Leaks

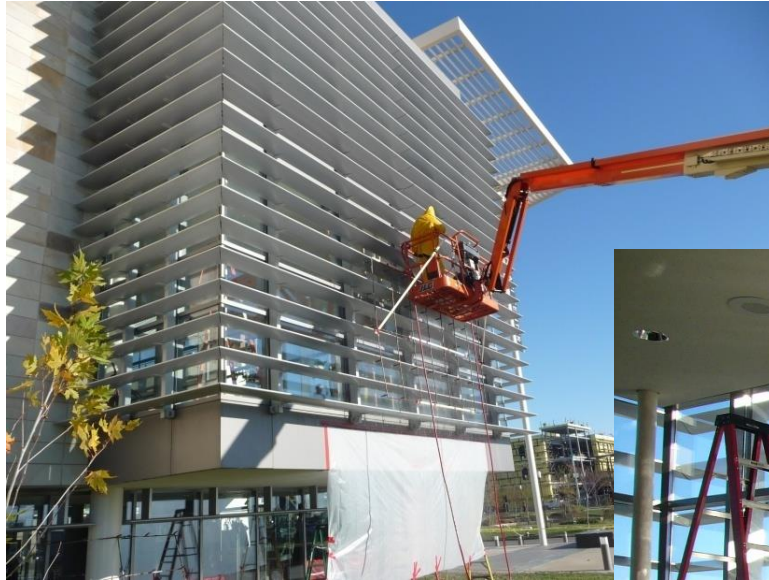
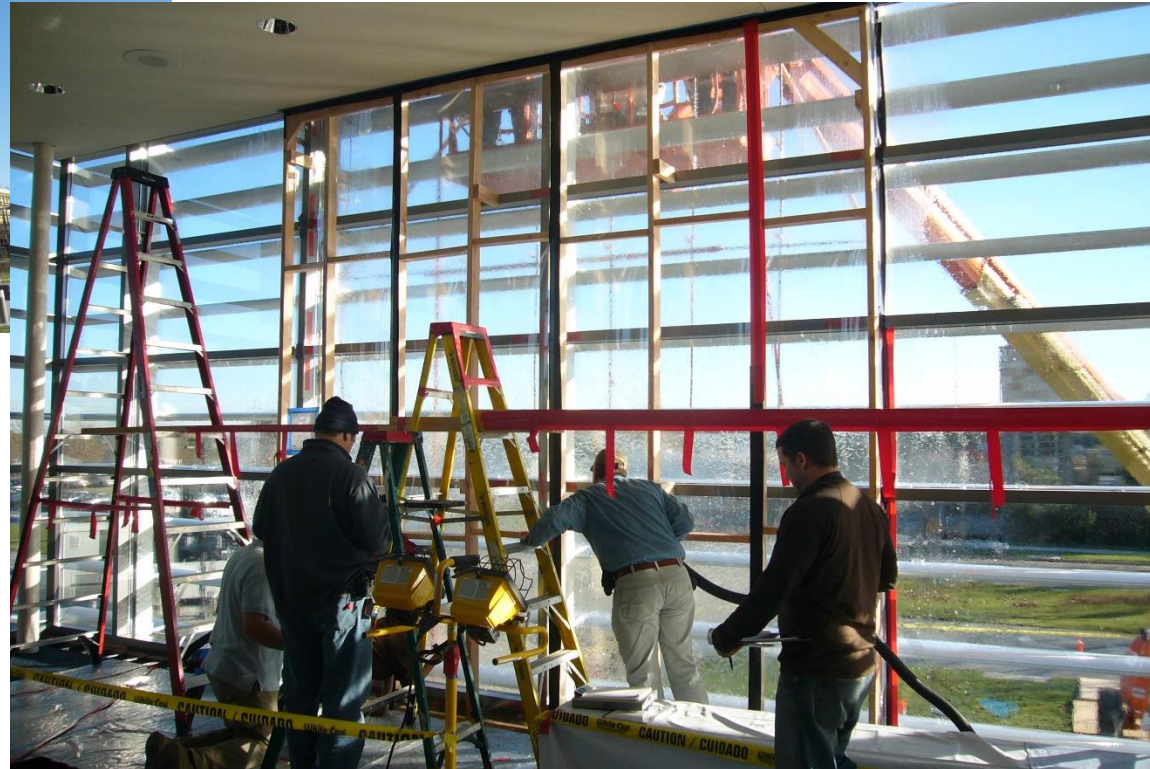
Leaks Due To Gasket Shrinkage

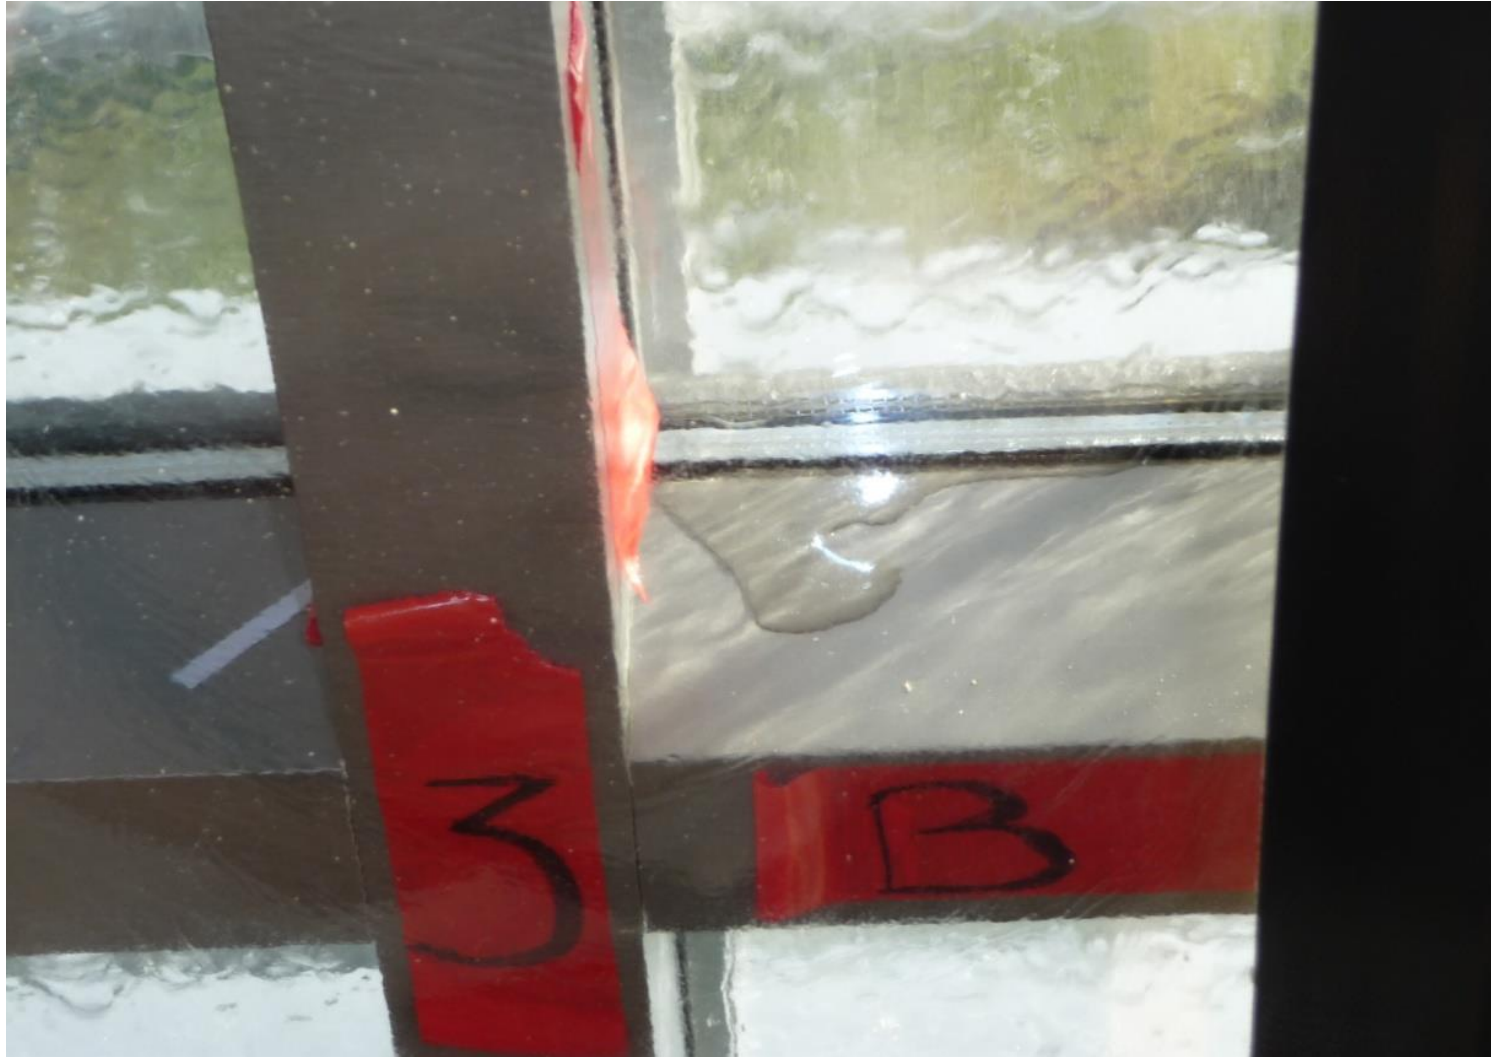
Leaks Due To Gasket Shrinkage

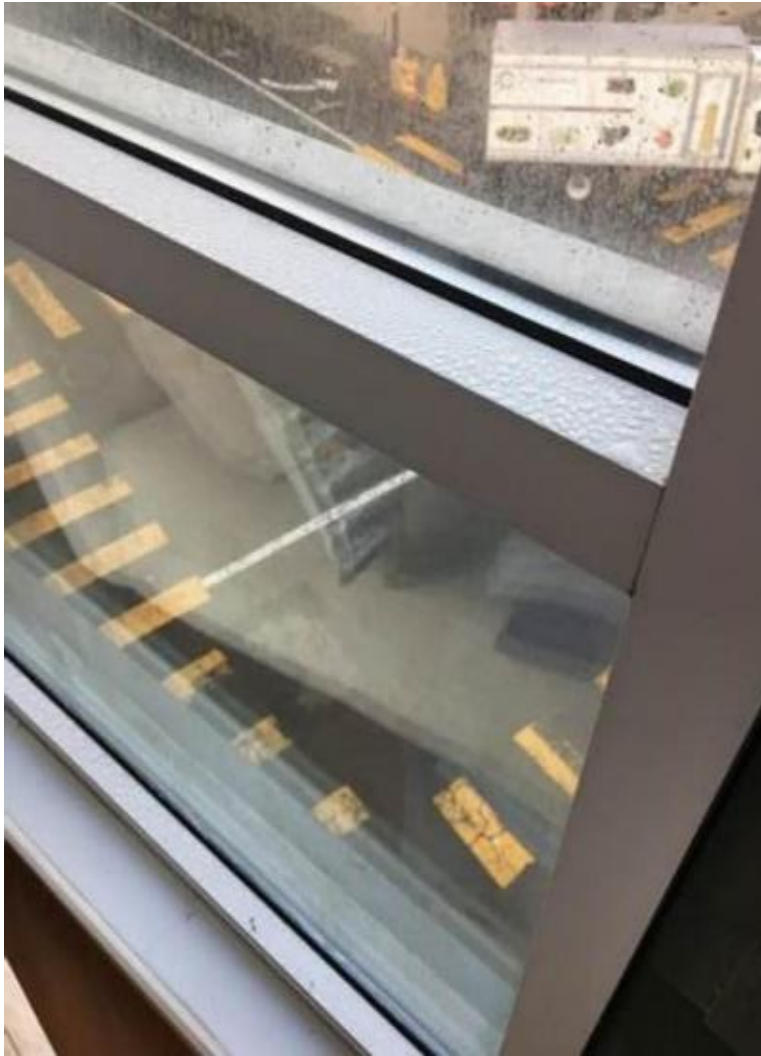
Condensation Due to Gasket Shrinkage

- Specifying high quality gasketing materials
- Quality control testing/commissioning to check for specified materials
- Using wet seals on inside in conjunction with gaskets

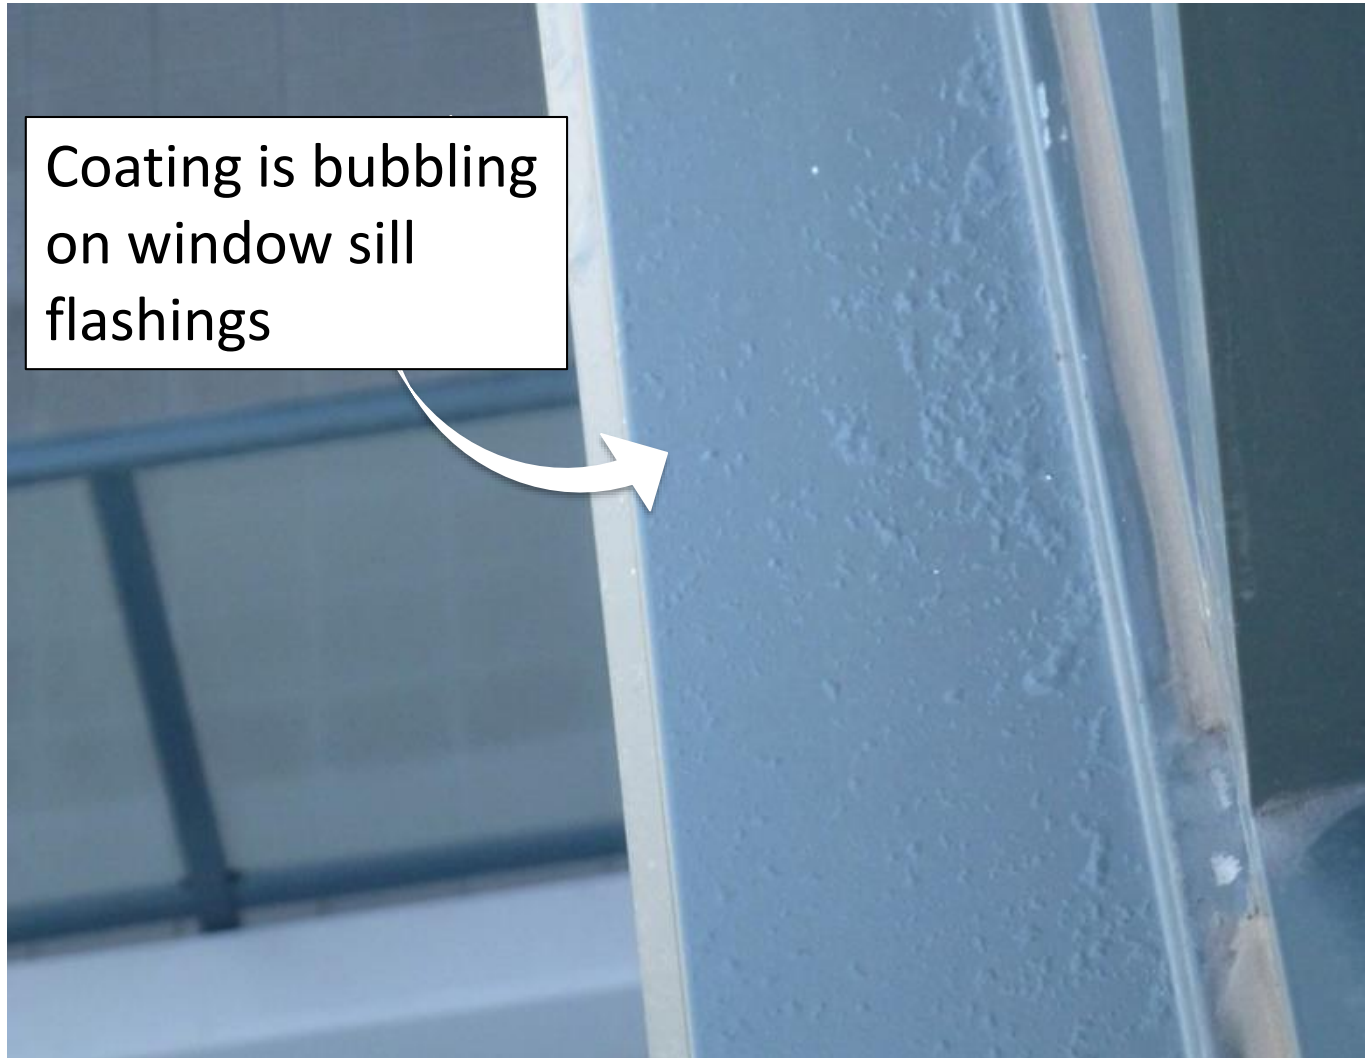
San Francisco Condo #1

Coating is bubbling
on window frames

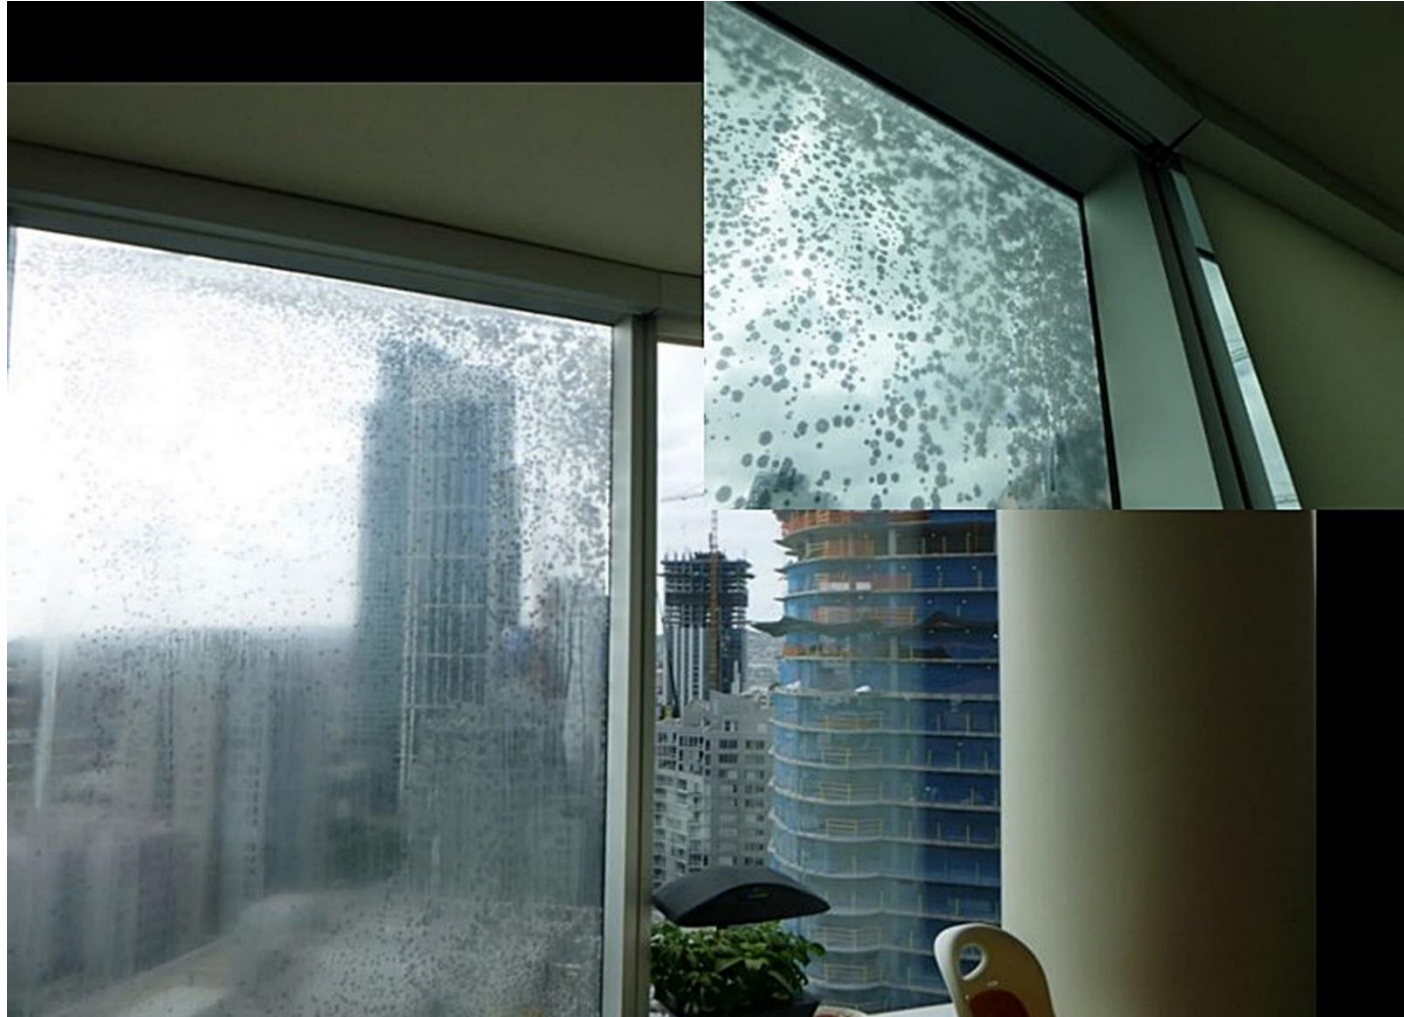
Corrosion/Tarnishing of Silver Coatings

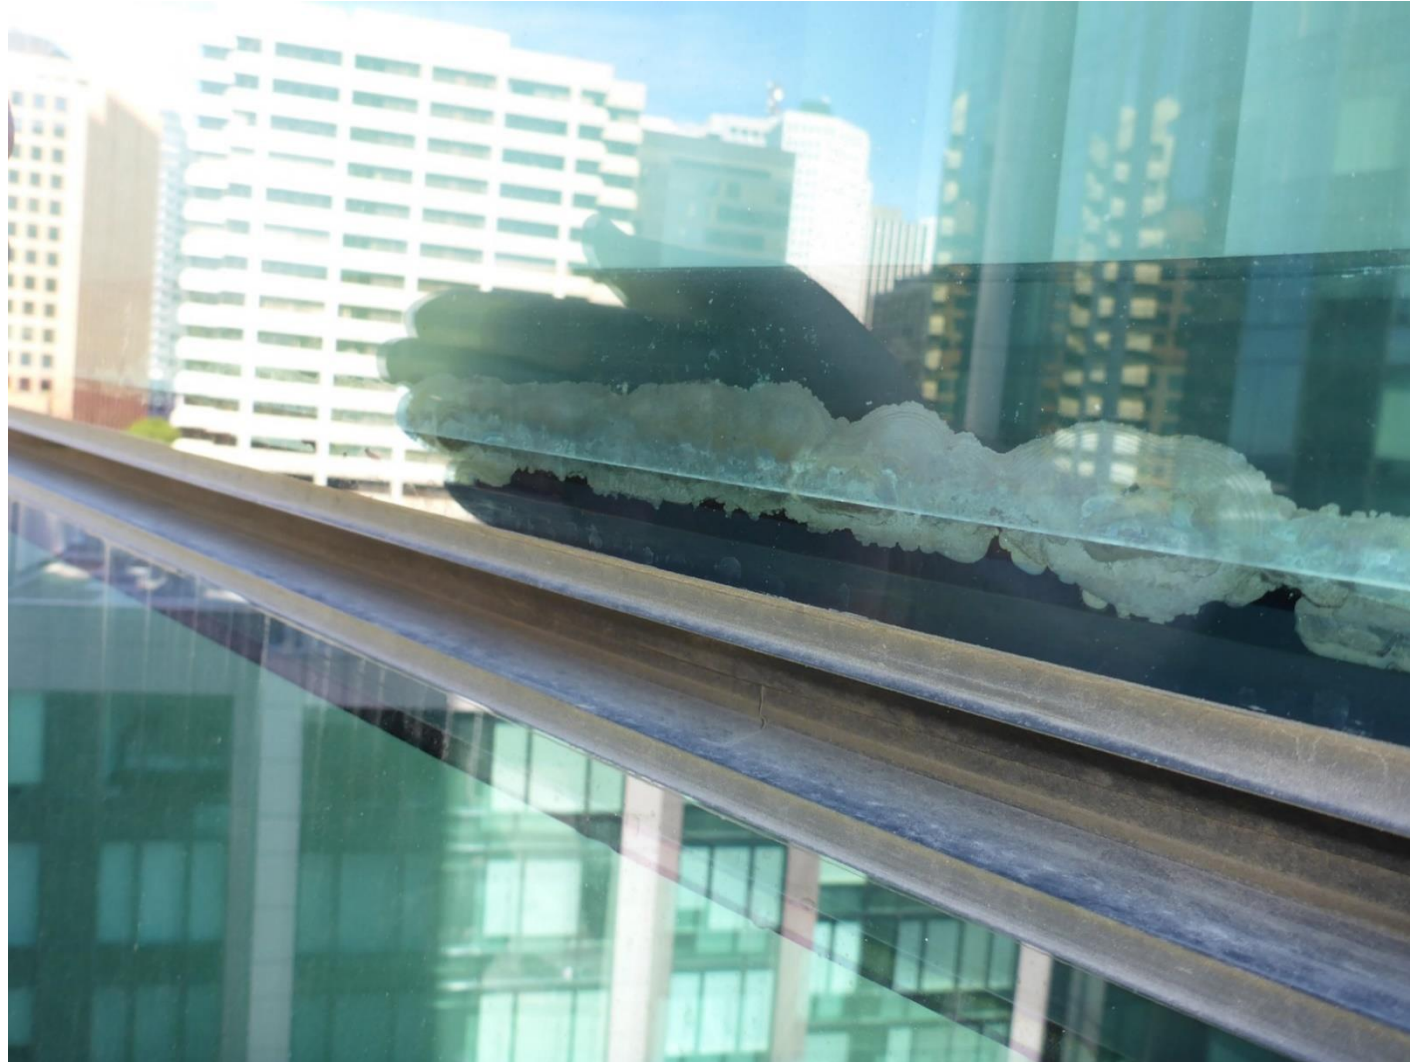
Continuing Low-E Coating Corrosion

- Edge Deletion Failure
 - Leads to IGU glazing failure
- Standing water on top of silicone sealant

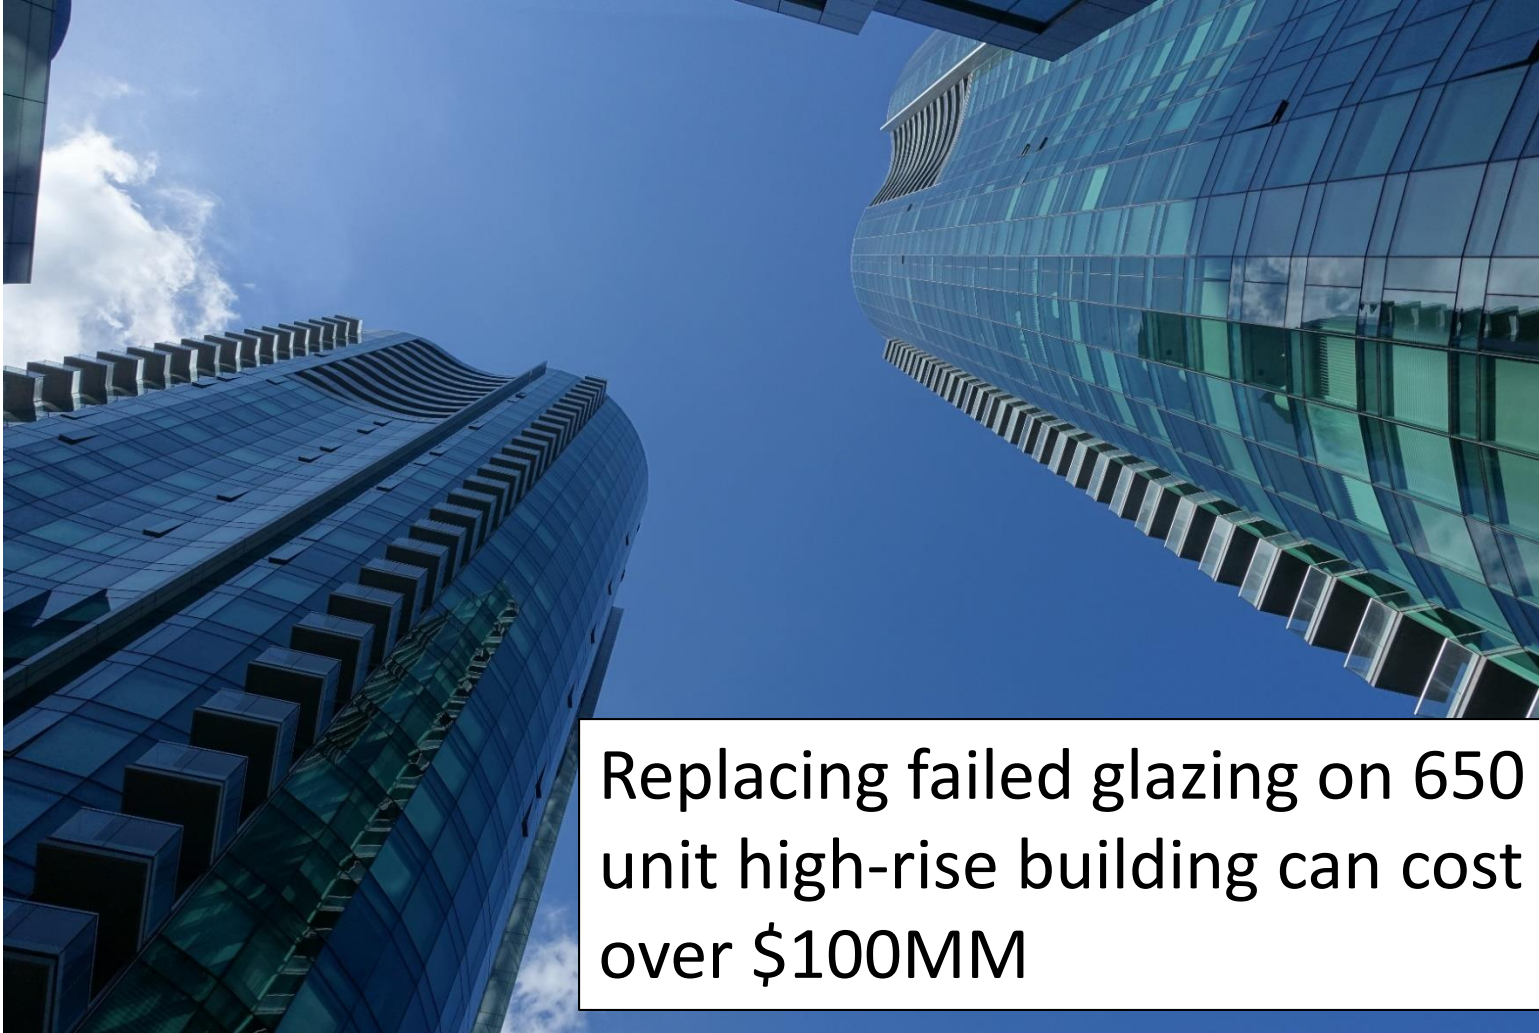
Case Study – SF Condo

Failure is most likely the result of extended water contact due to the flexible vertical tubing retaining water, which allowed water to migrate along the tops of the IG units. It appears there is installation issues with the lack of vertical tube drainage as well as IG manufacture by not edge-deleting properly. The PIB is of good quality and could have resisted water penetration if it were not adhered to the low-E which is attacked by the water contact, resulting in bond/seal loss.

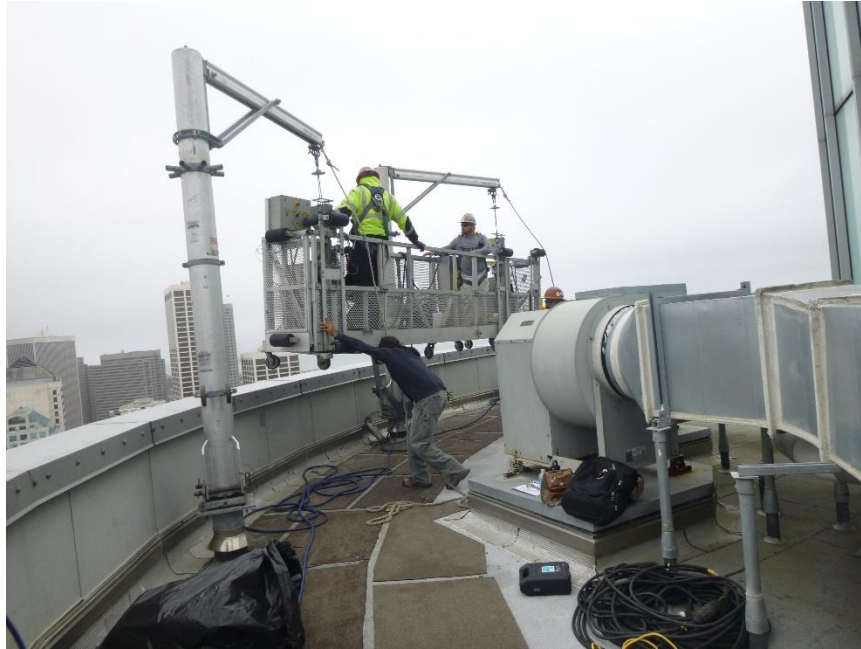
Replacing Glass, Slow and Tedious

2 guys on window
washing rigs

3 guys on the inside
handling glass

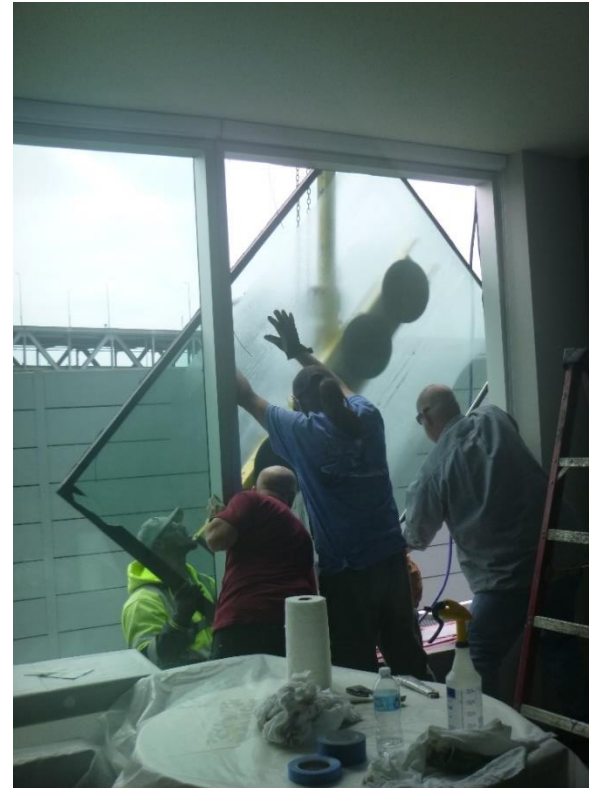
Replacing Glass, Slow and Tedious

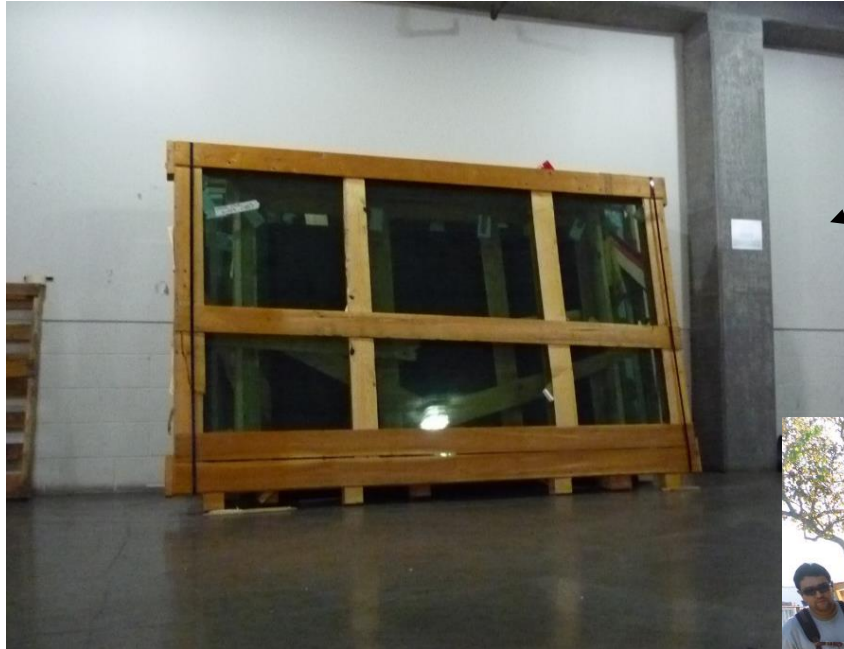
Removed glass
from site

Labeled and crated,
shipped to lab

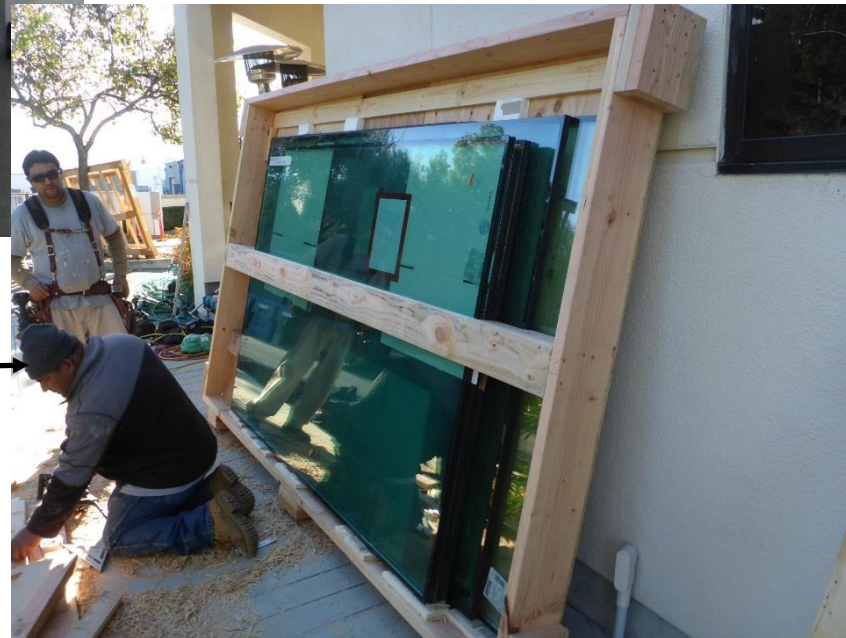
Water Infiltration at Head Stands on IGU Seal

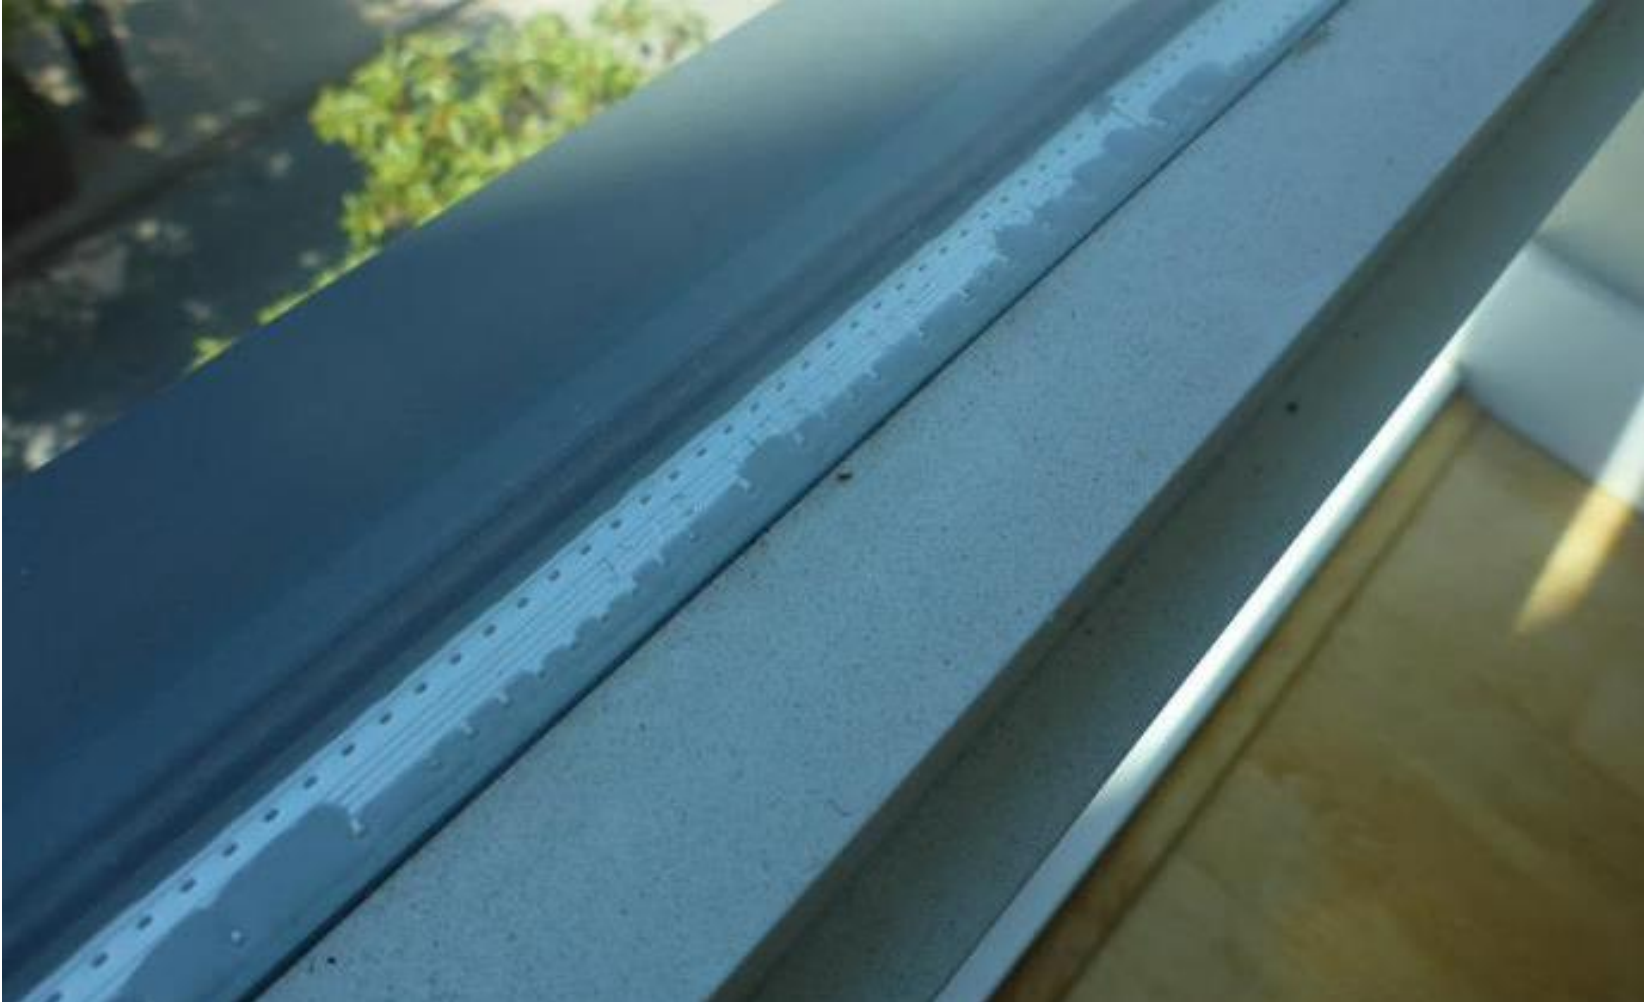
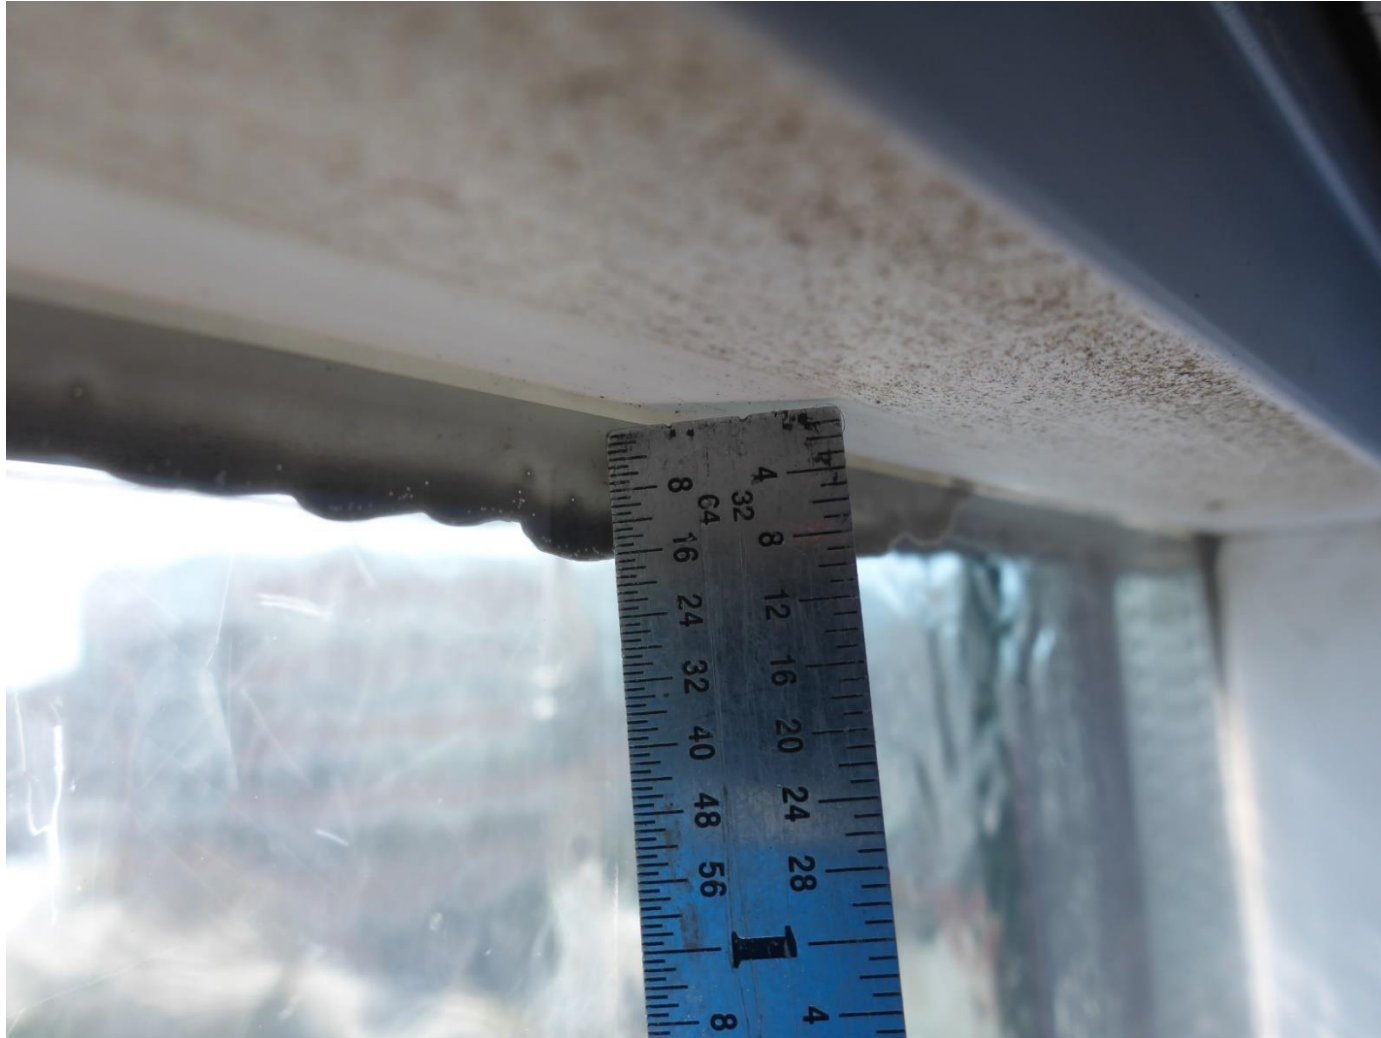
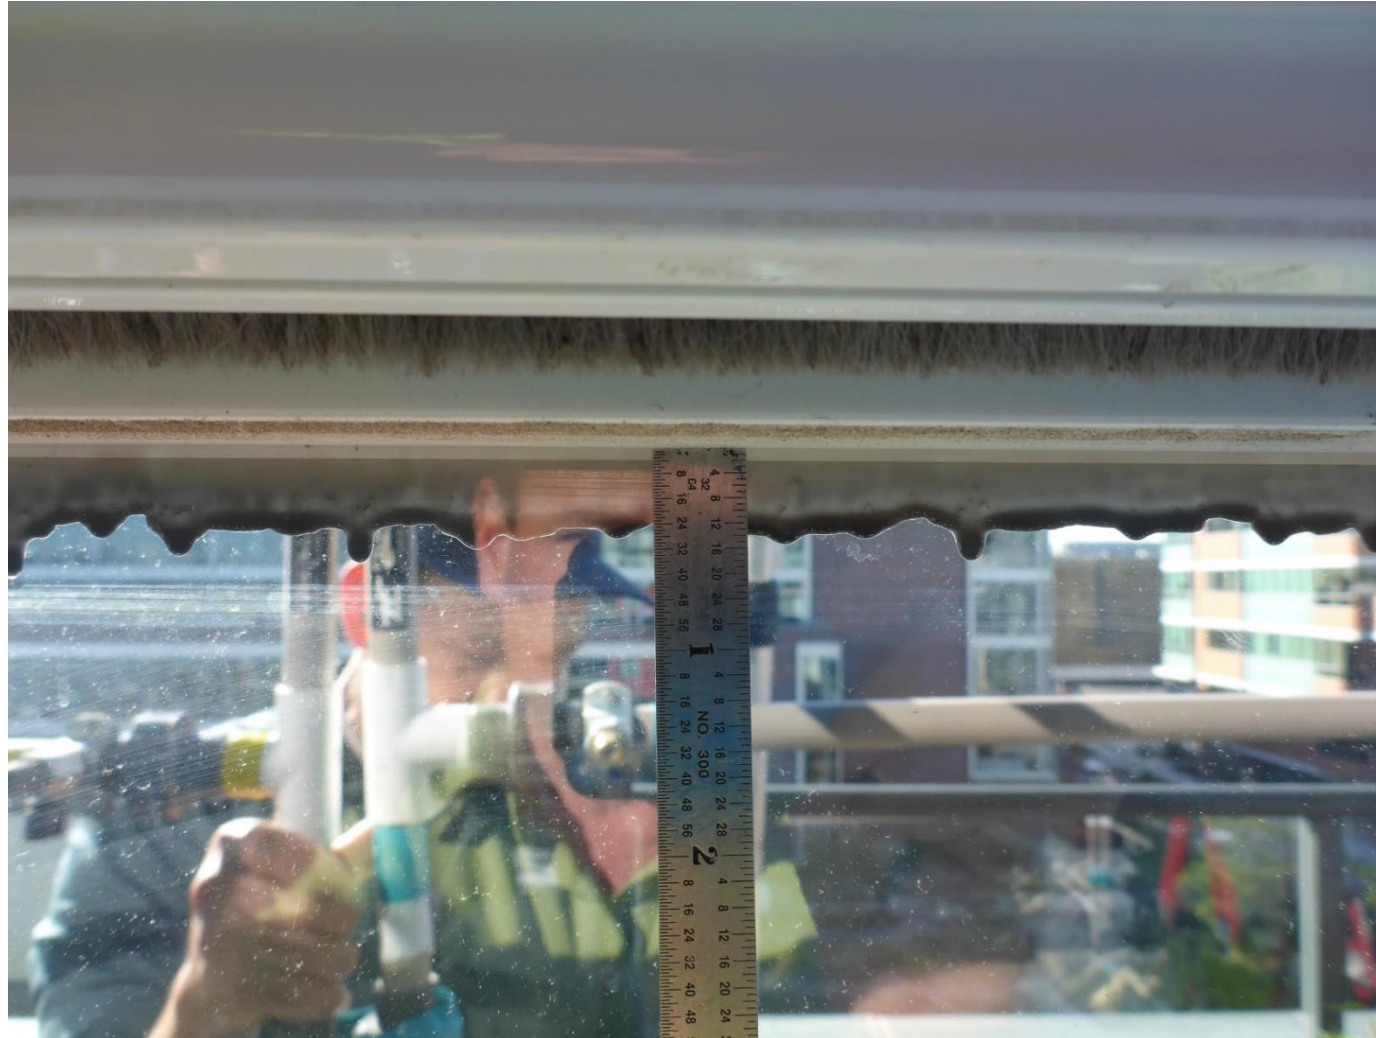
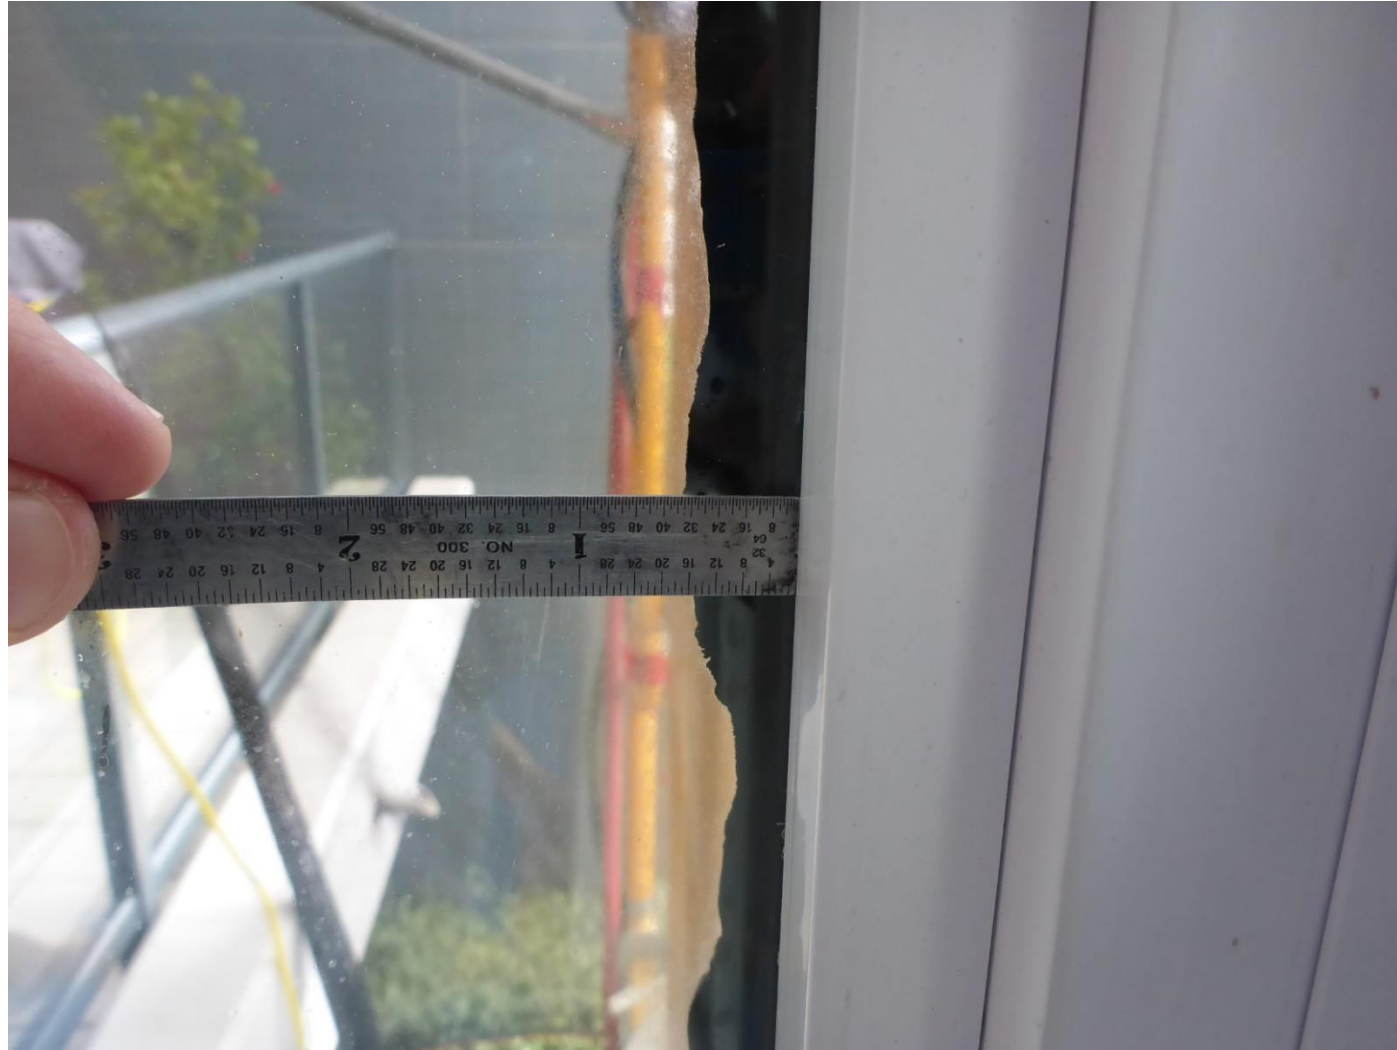
Case Study- SF Condo w/ PIB Migration

- PIB (primary) and secondary sealants prevent air/ water infiltration in IGU airspace
- PIB moves from window edge, obscuring vision

- Requires glazing replacement
- Limited to gray PIB
- Gray PIB contains 64.8% polymer with plasticizers as low as 2.6%
 - PIB control samples are 97.5% polymer and 30% plasticizer
