Building Envelope

Curtain Wall Failures

Karim Allana, PE, RRC, RWC

Allana Buick & Bers, Inc.

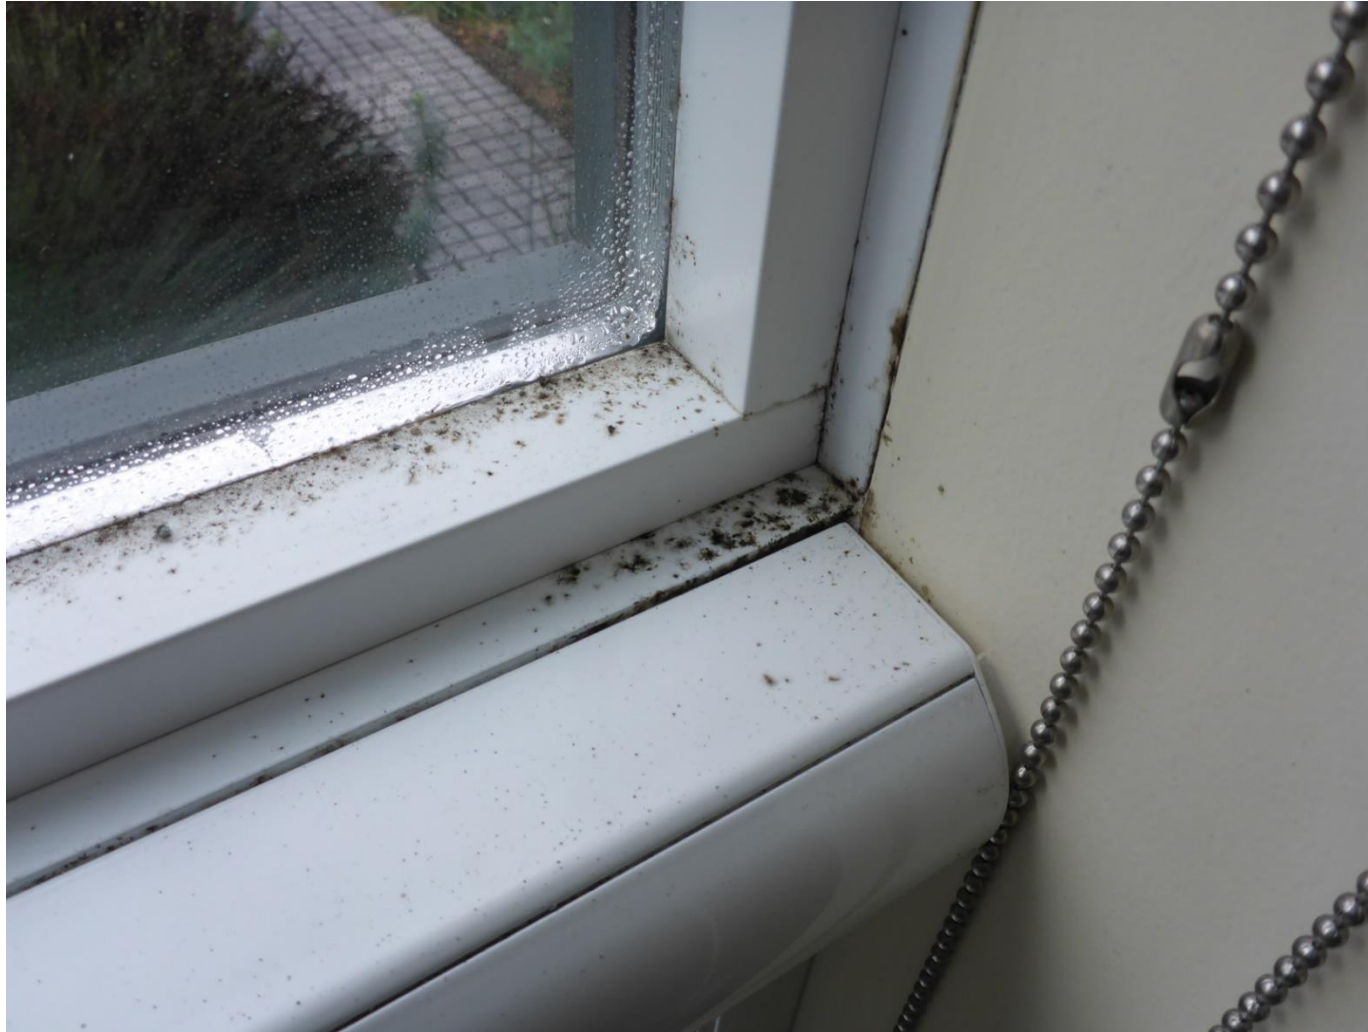
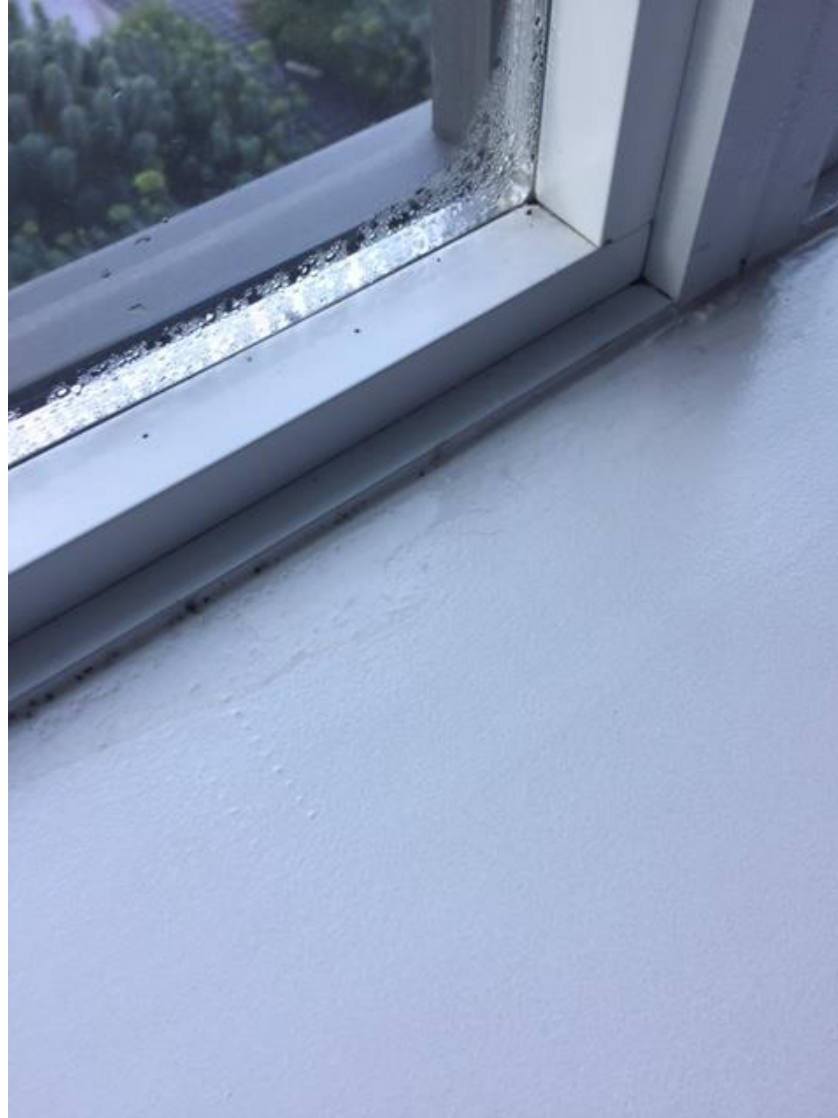
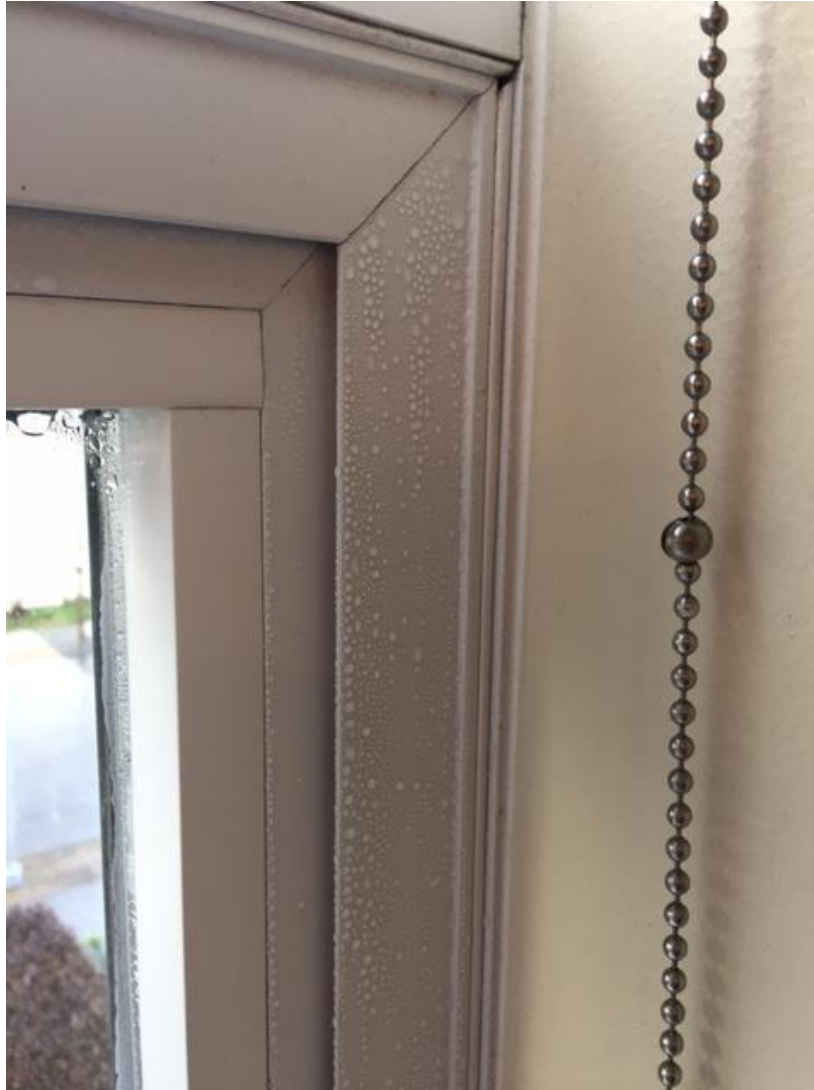
SF Condo

Thermal Break Failure

- Can cause condensation on frame
- Aluminum frame in contact with concrete
- Occurs when thermal breaks are missing or bypassed
